**REMEDIAL SYSTEM OPTIMIZATION  
FOR  
CLAREMONT POLYCHEMICAL CORPORATION SITE**

**505 WINDING ROAD  
OLD BETHPAGE, NASSAU COUNTY NEW YORK 11804**

**Site Code: 130015  
WA# D006130-19**

**Submitted: August 17, 2012**

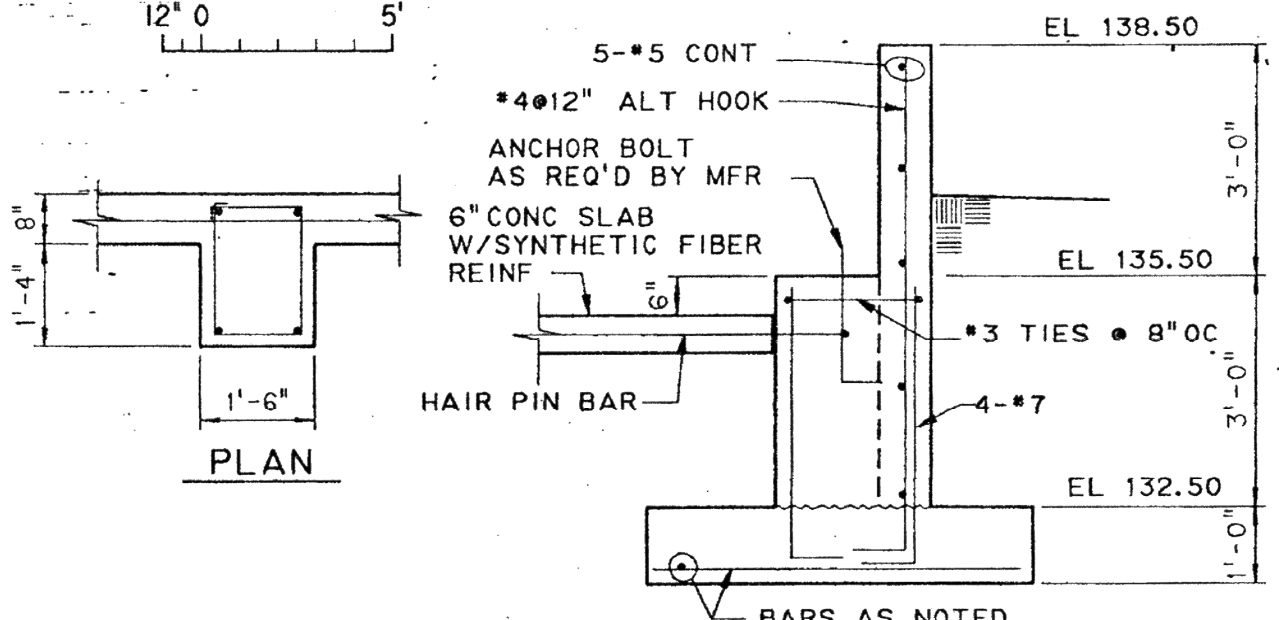
### DETAIL A

DETAIL APPLIES TO 10-AS-1

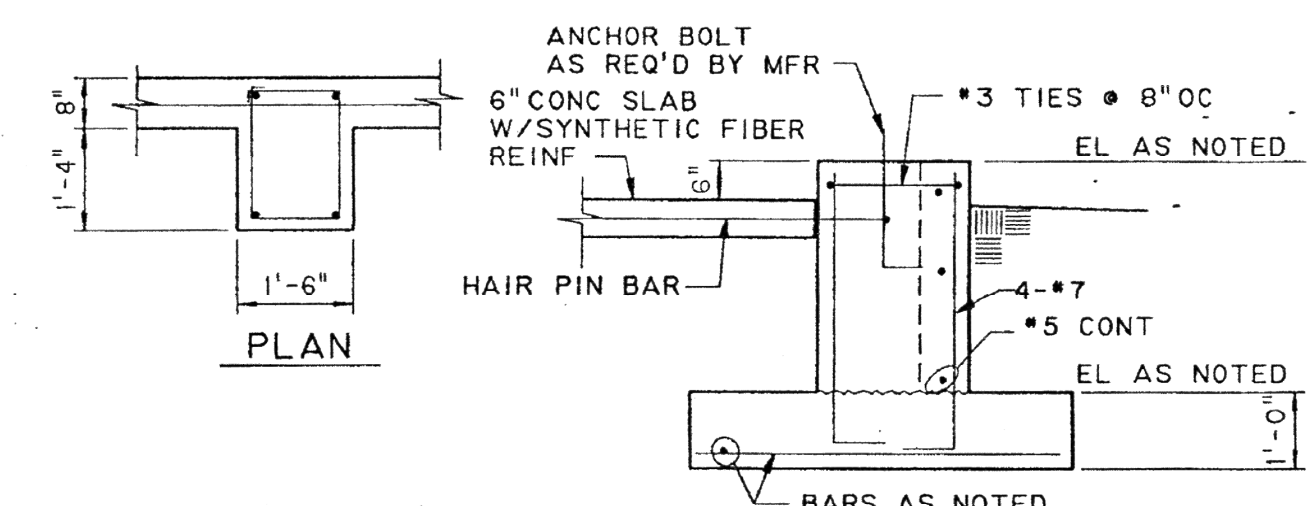
### DETAIL B

DETAIL APPLIES TO 10-AS-1

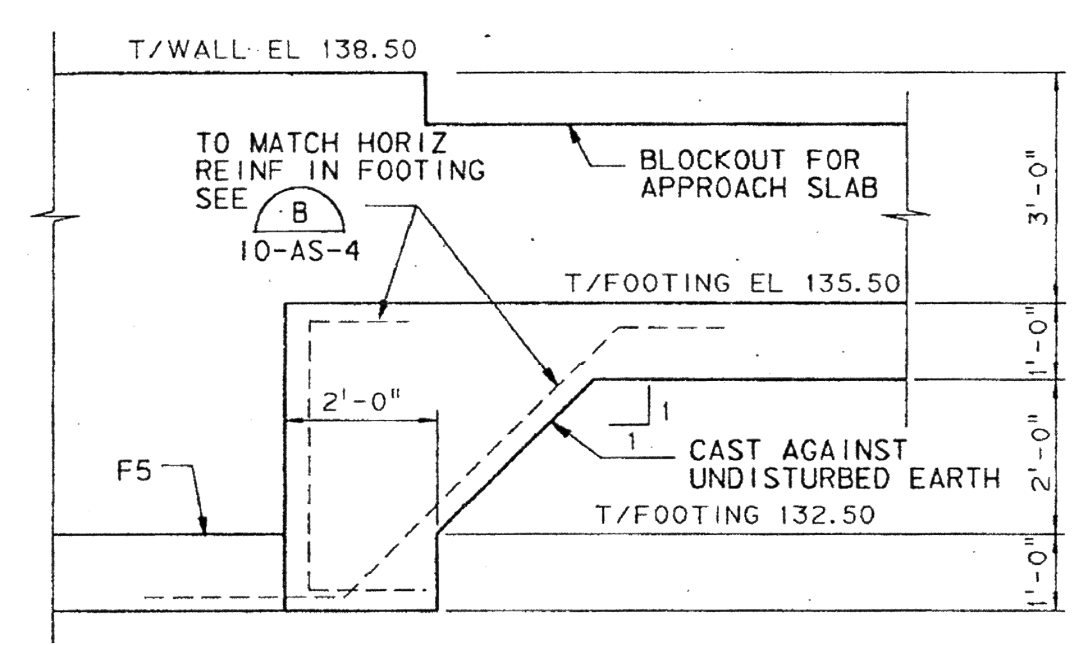
### DETAIL C

DETAIL APPLIES TO 10-AS-1

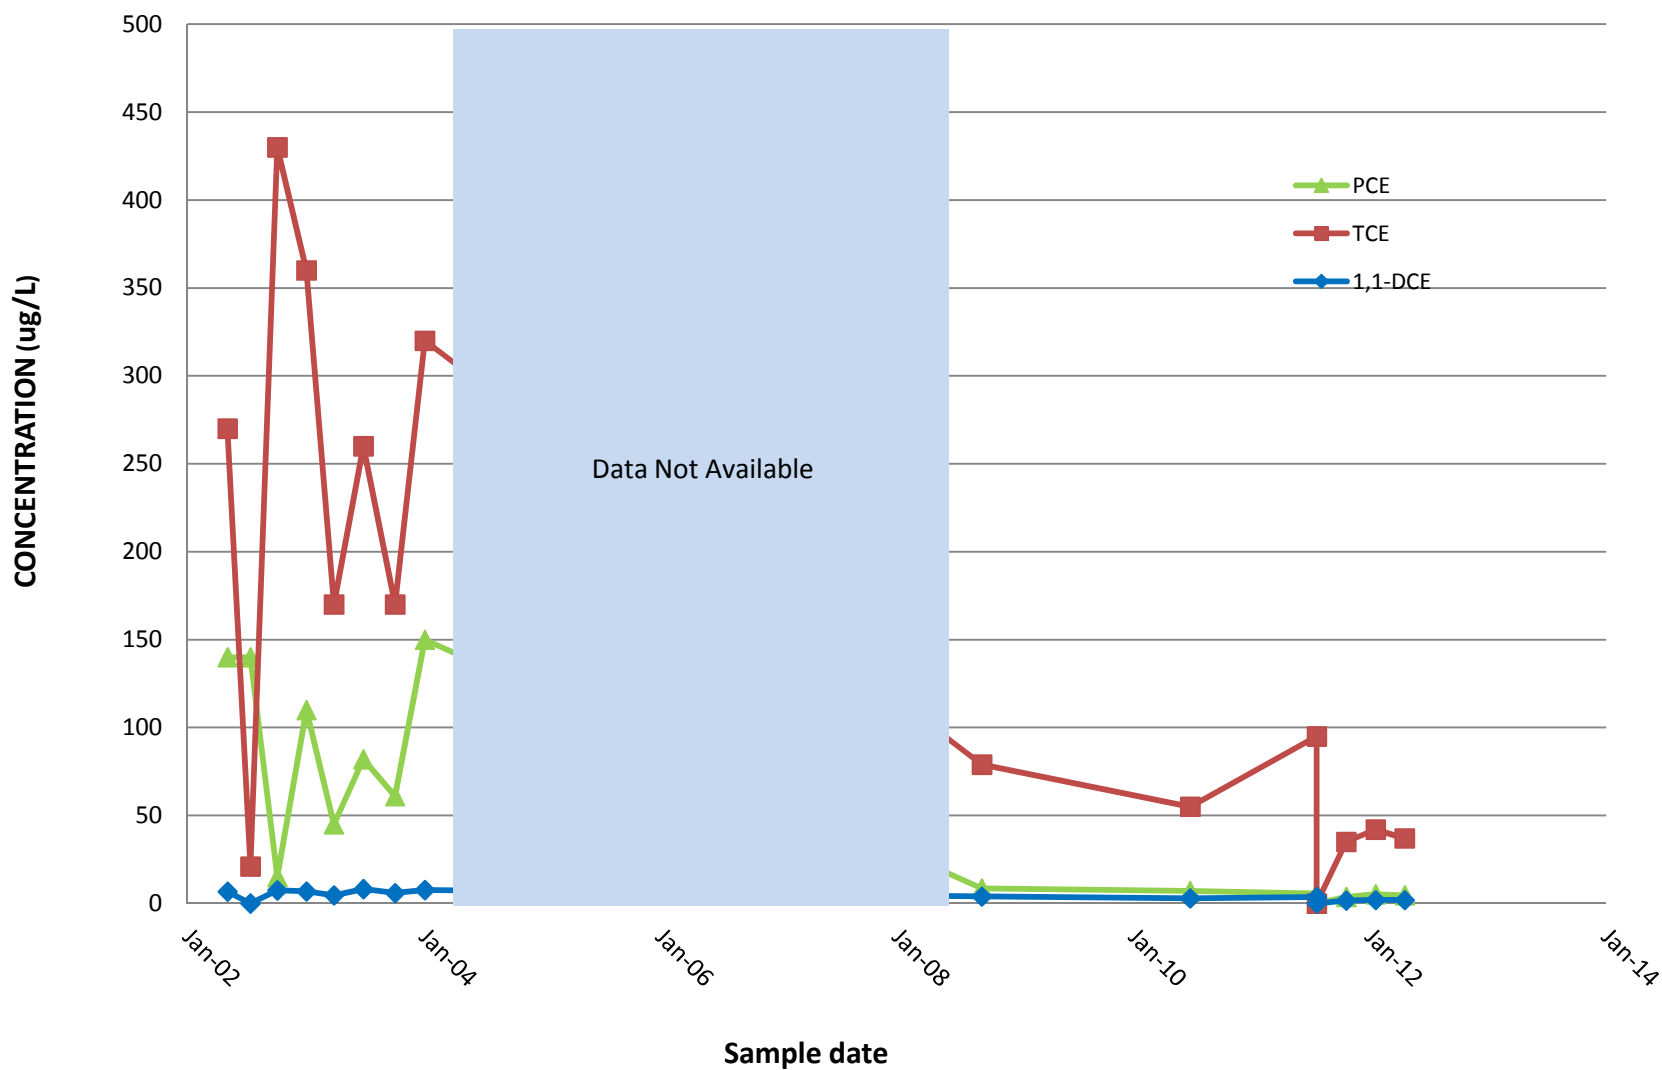
# Chart 1: Groundwater Influent Concentration (PCE, TCE, and 1,1-DCE) vs. Time

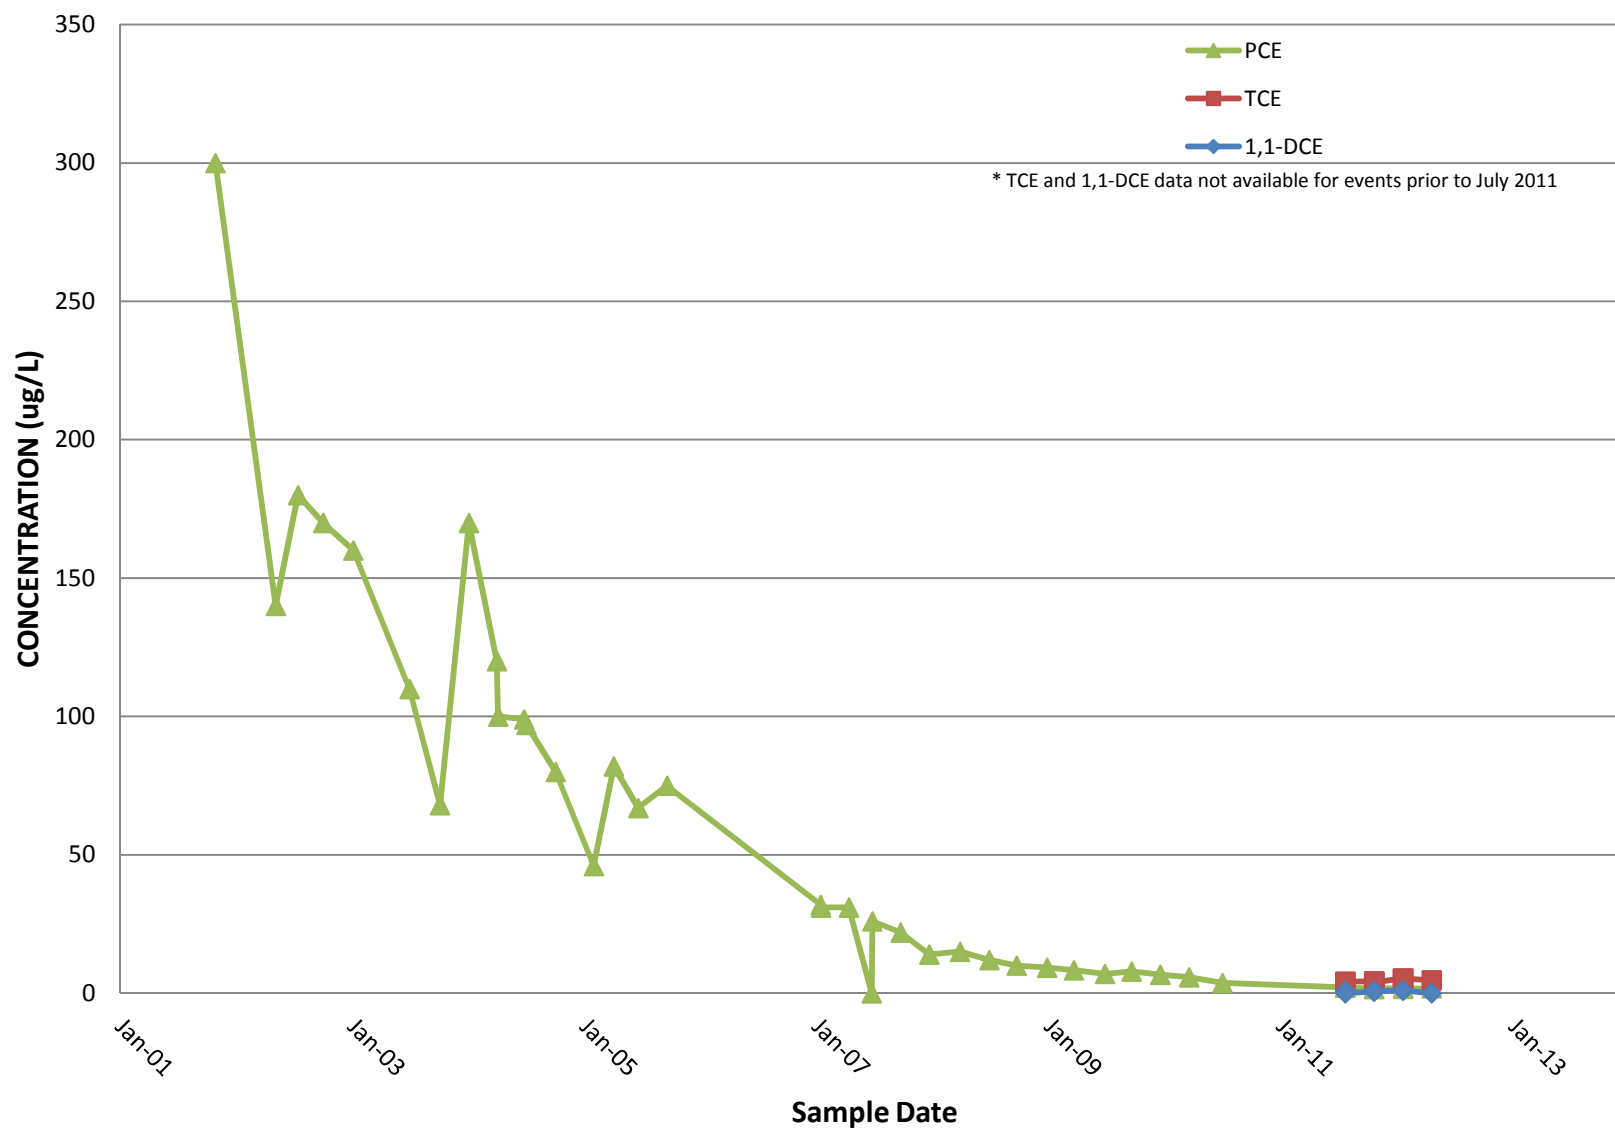
## Chart 1a: EXT-1 Concentration (PCE, TCE, 1,1-DCE) vs Time

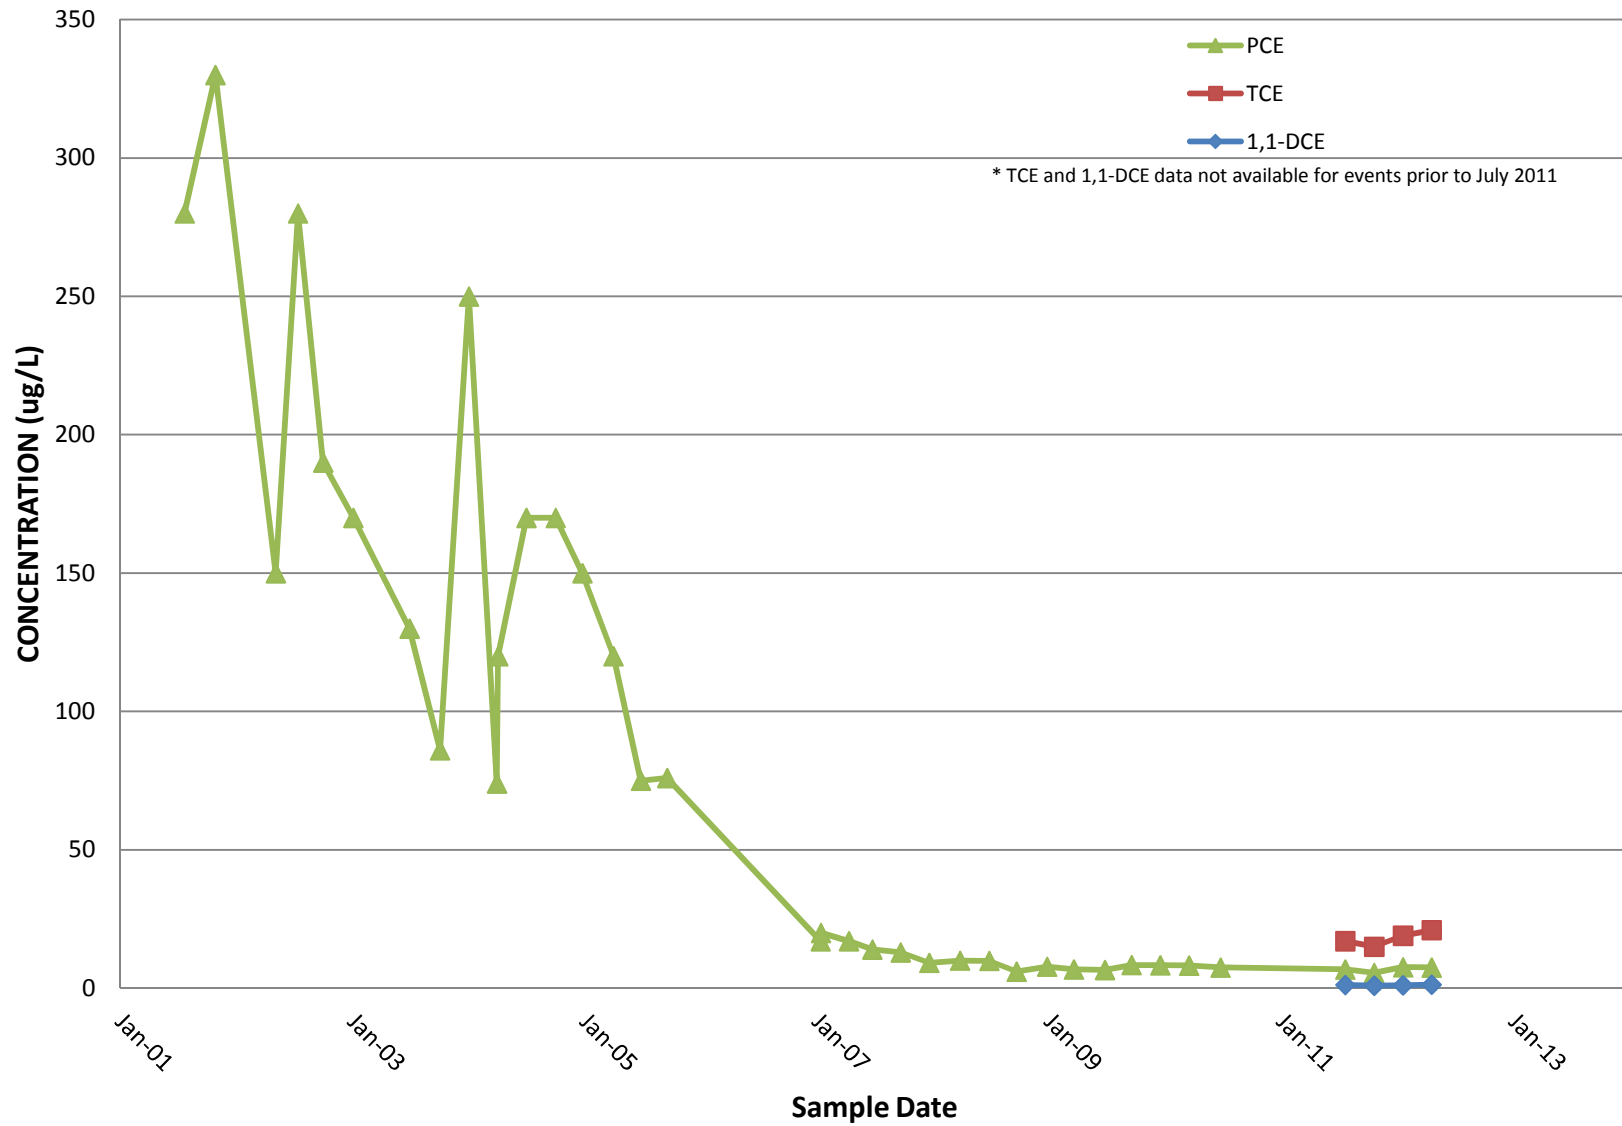
## Chart 1b: EXT-2 Concentration (PCE, TCE, 1,1-DCE) vs Time

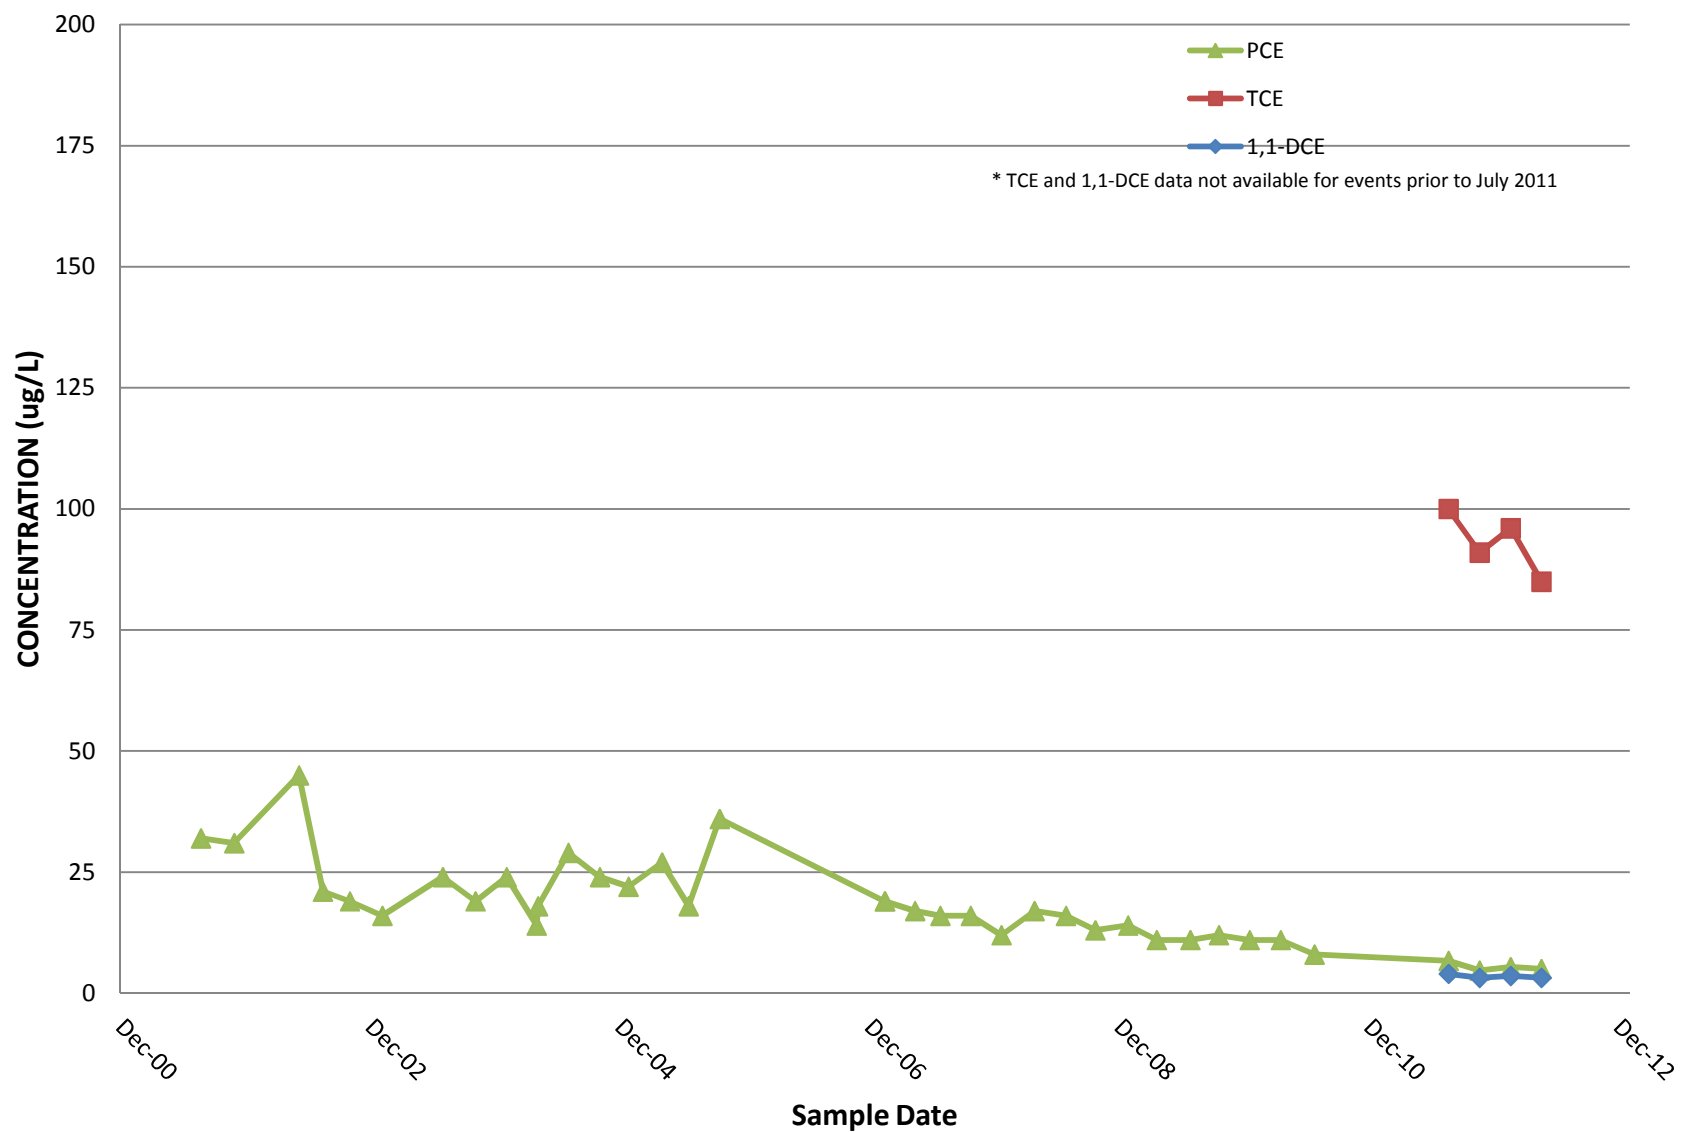
# Chart 1c: EXT-3 Concentration (PCE, TCE, 1,1-DCE) vs Time

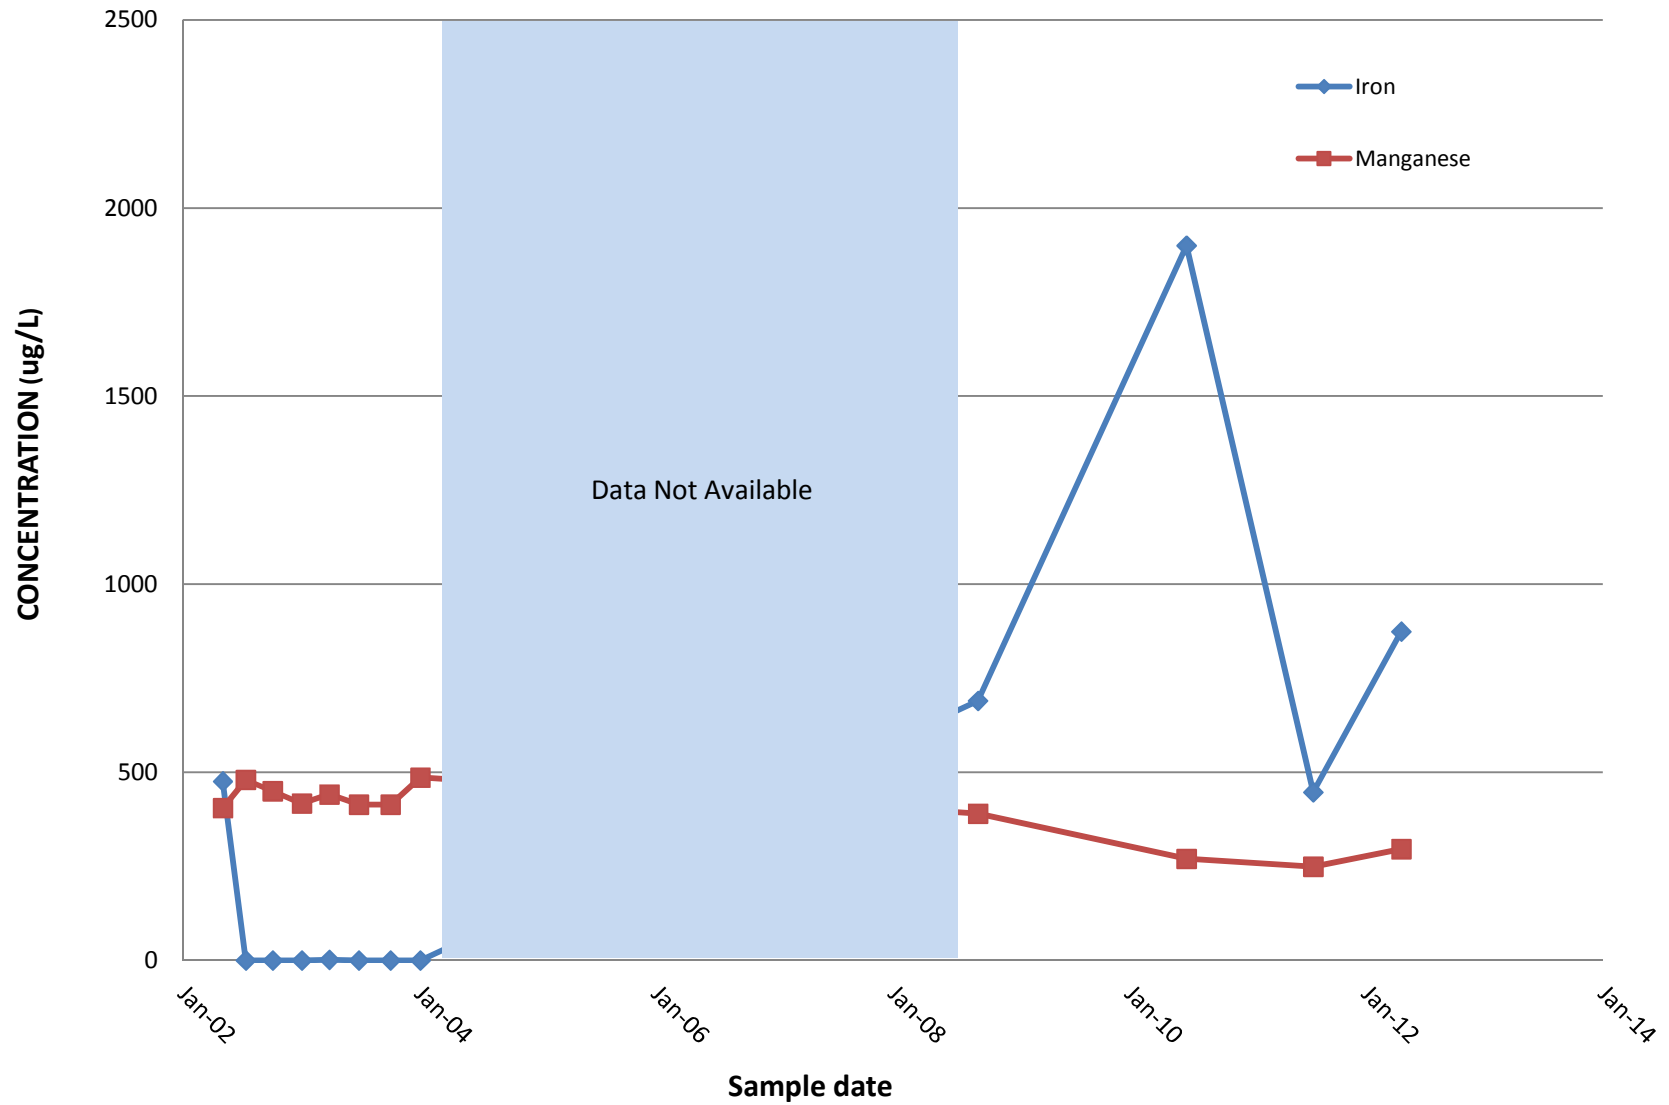
## Chart 2: Groundwater Influent Concentration (Iron and Manganese) vs. Time

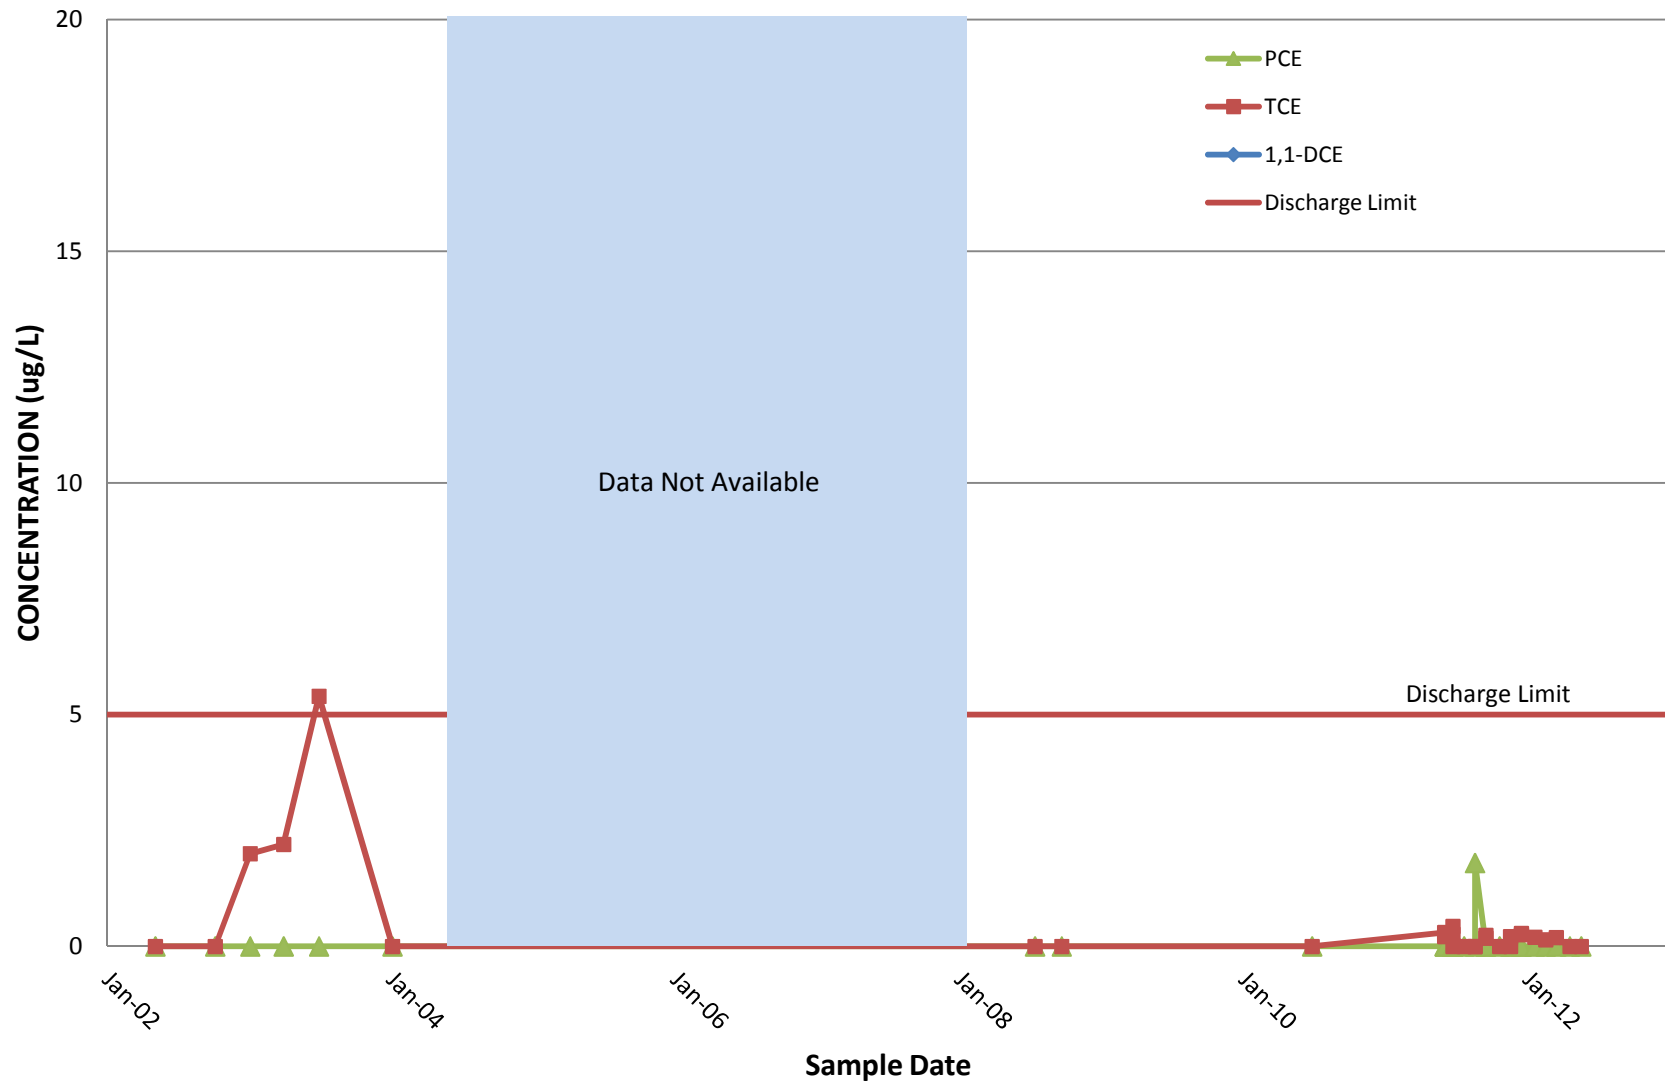
### Chart 3: Treated Effluent Concentration (PCE, TCE, 1,1-DCE) vs Time

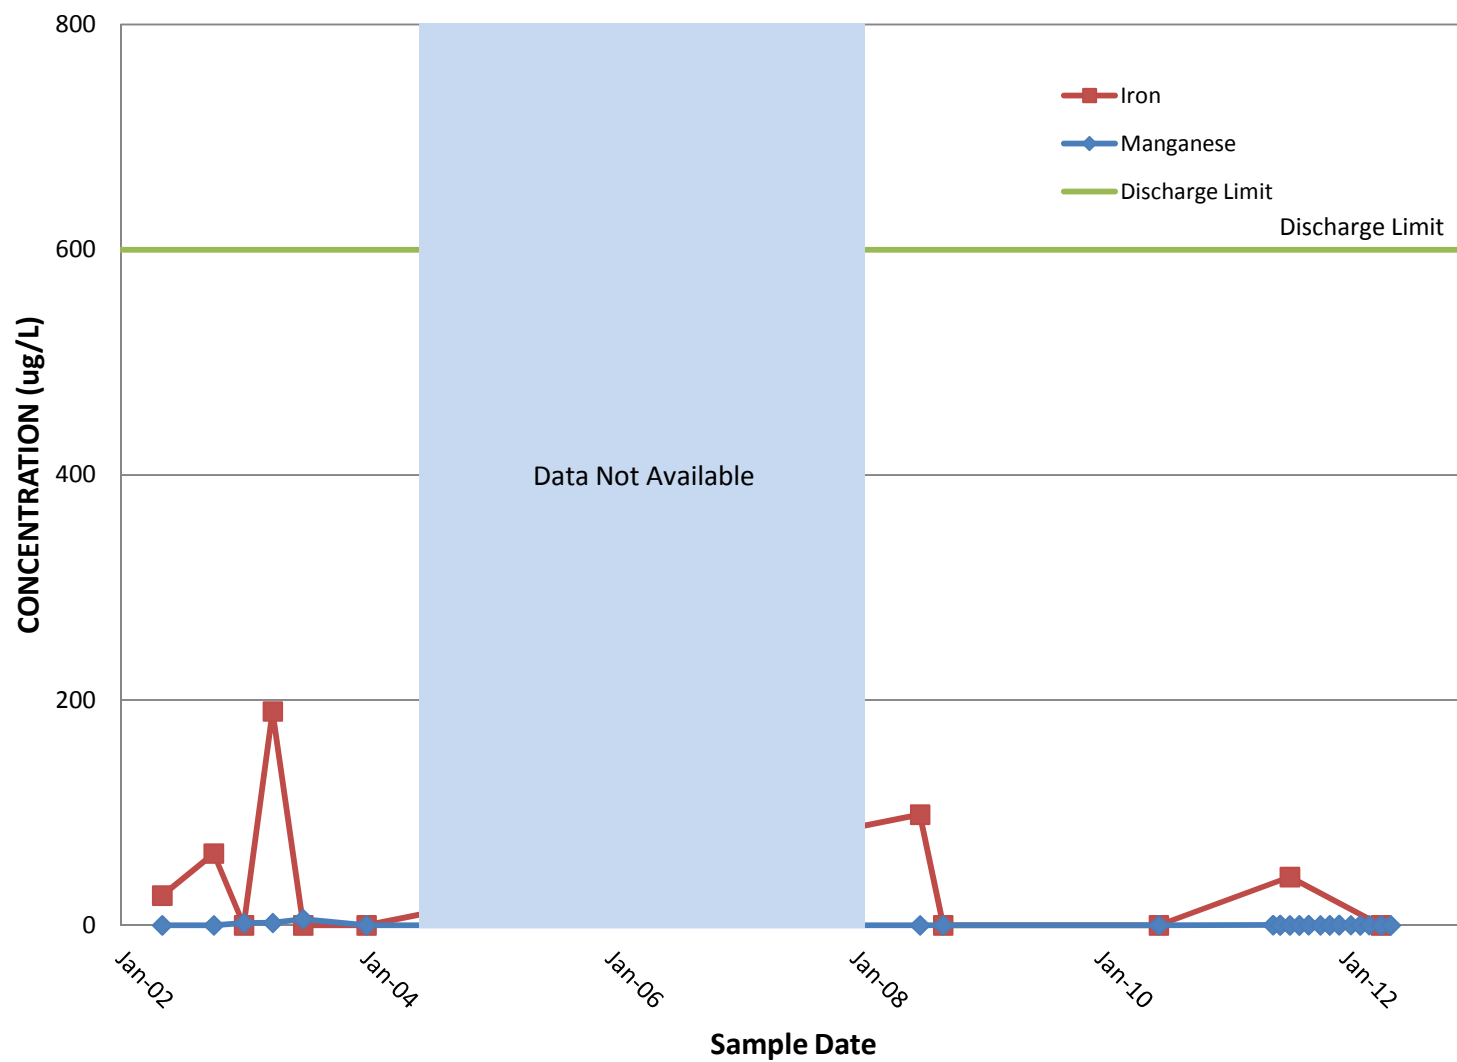
## Chart 4: Treated System Effluent Concentration (Iron and Manganese) vs Time

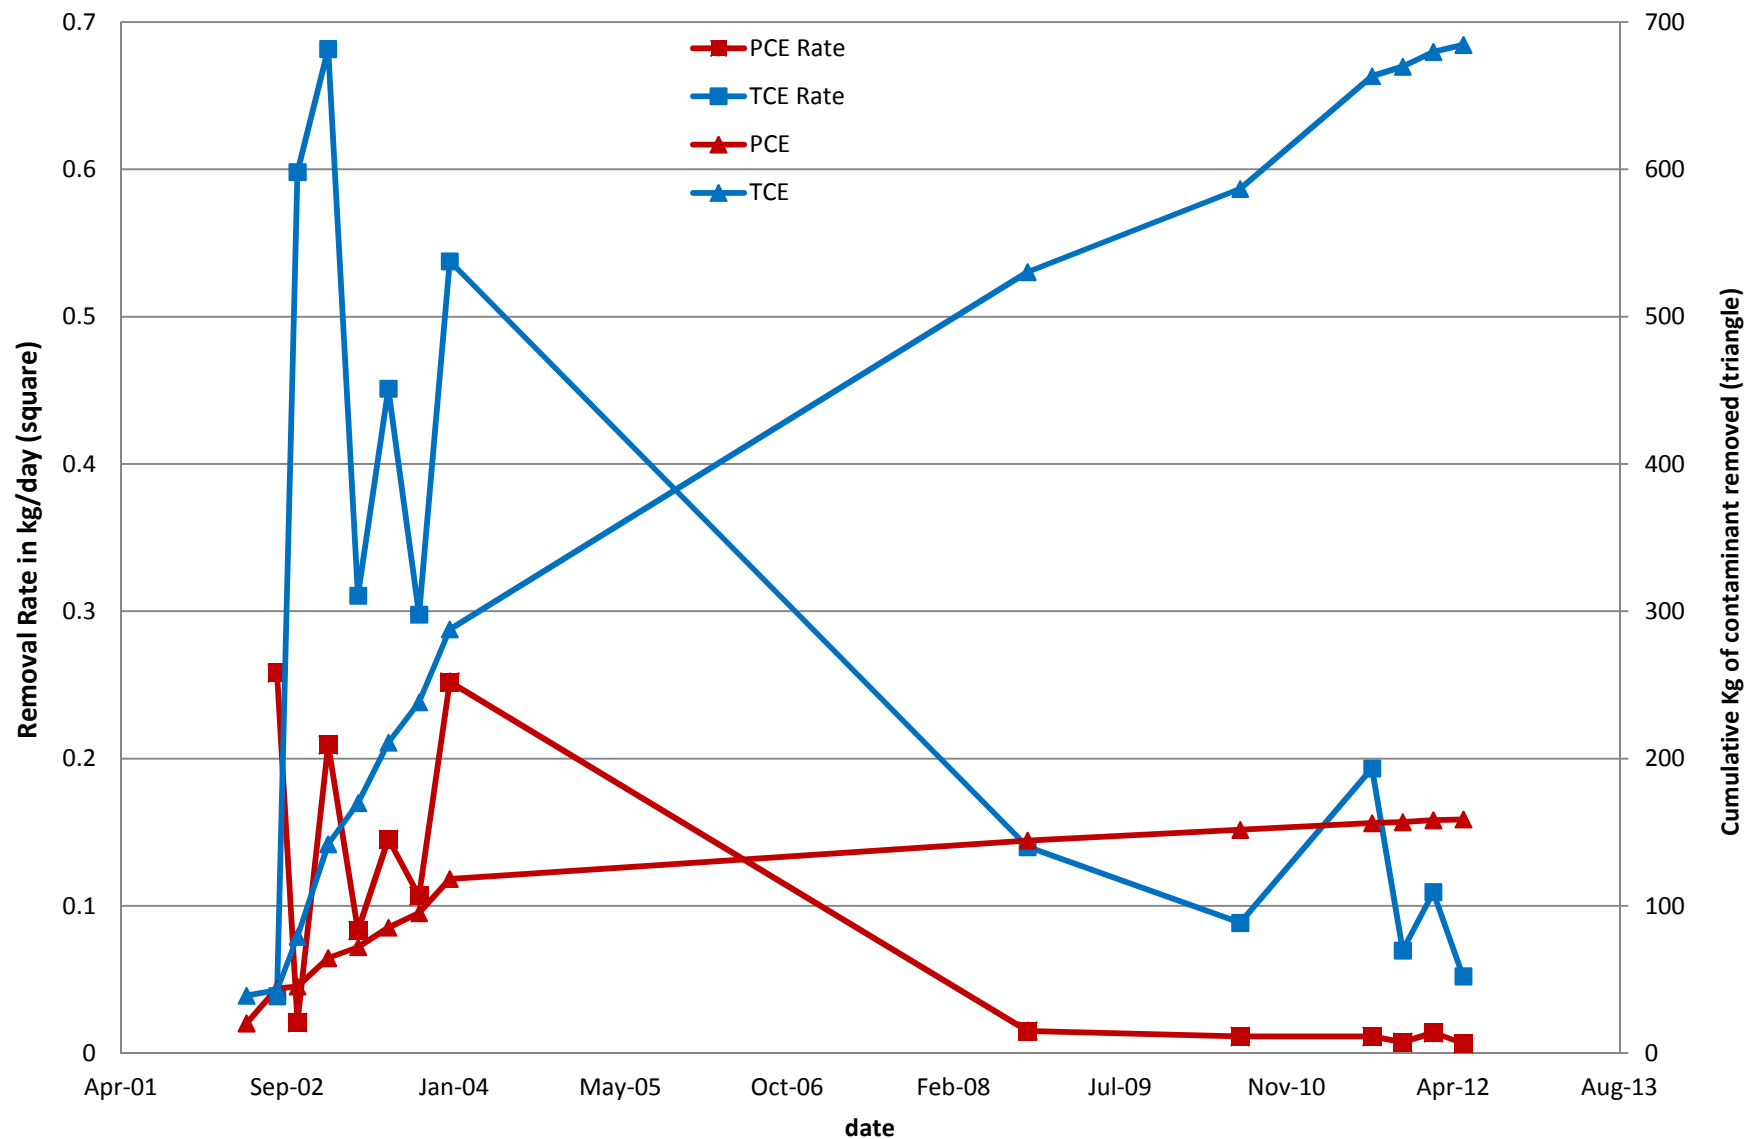
## Chart 5: VOC Removal vs Time (PCE, TCE)

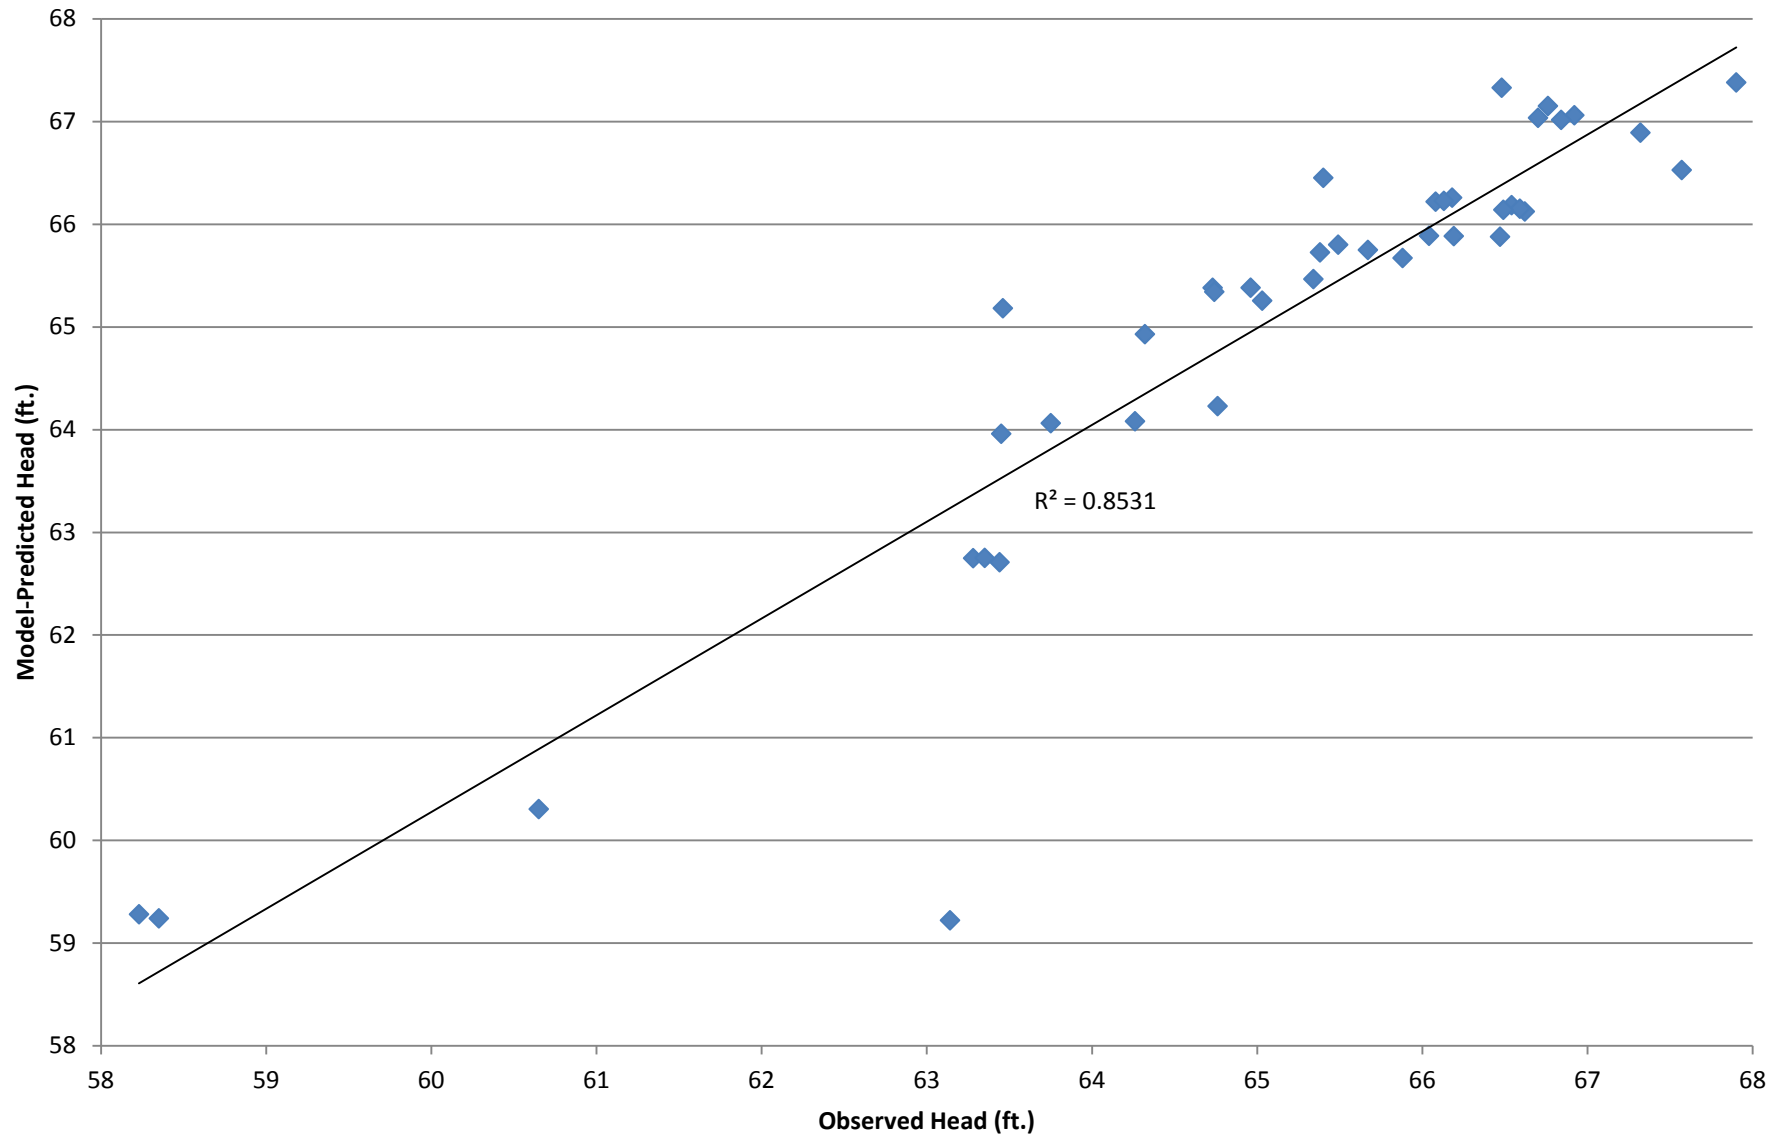
**Figure 2**  
**Observed vs. Model-Predicted Head (ft.) - July 2011**
