**CLAREMONT POLYCHEMICAL SUPERFUND SITE
Groundwater Treatment System
Old Bethpage, New York**

**MONTHLY REPORT
of the
Operations & Maintenance Activities
During
May 2013**

**HRP Associates, Inc
dba HRP Engineering, P.C.
197 Scott Swamp Road
Farmington, CT 06032**

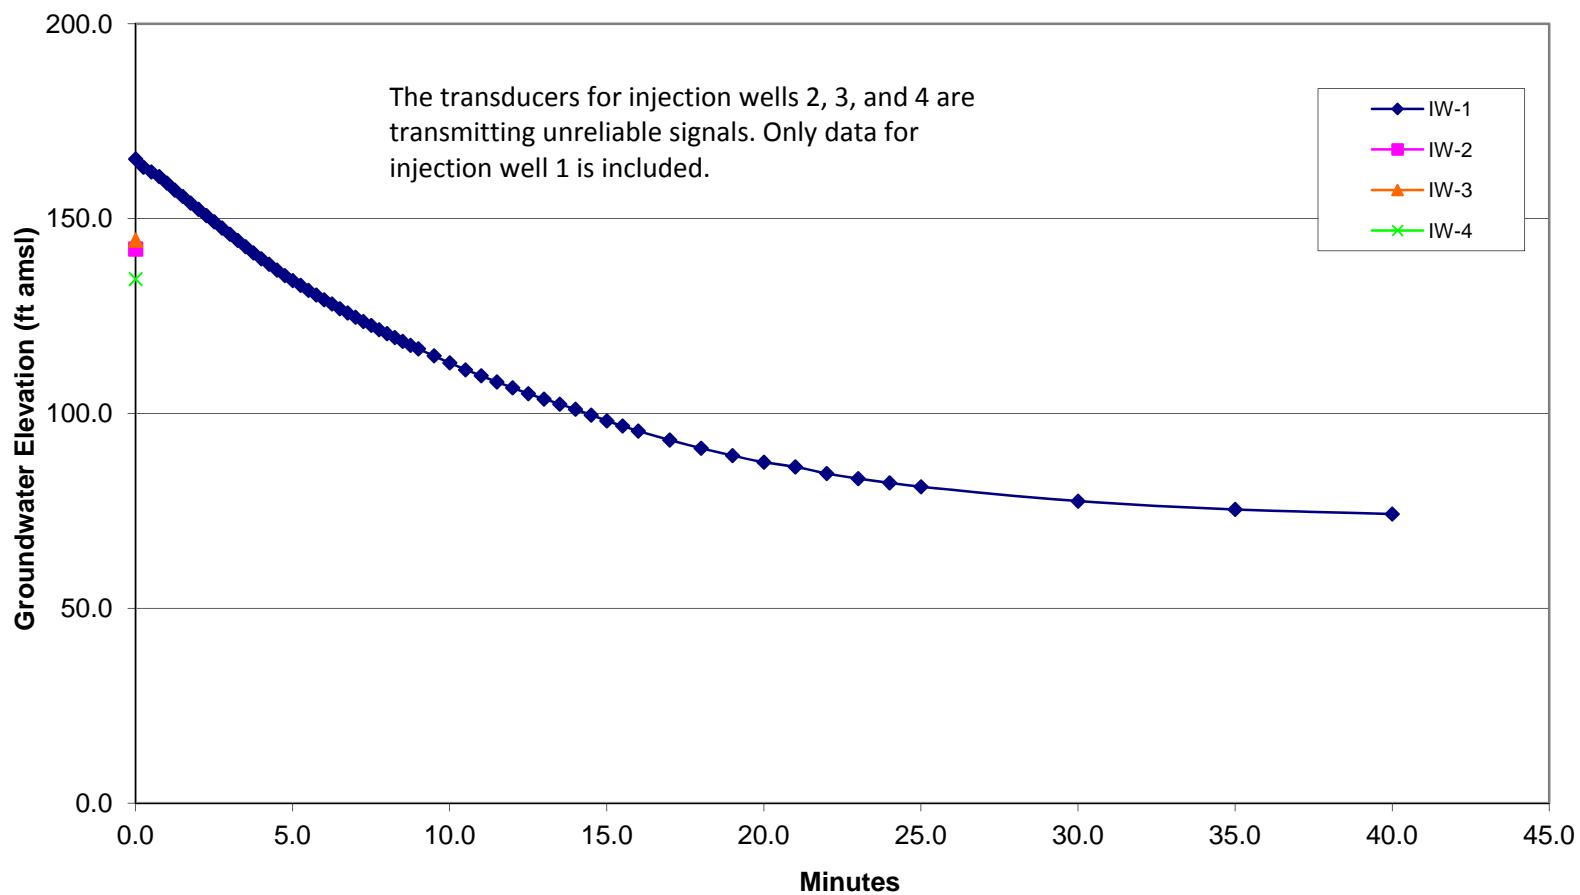
Figure 14-2 Injection Well Falling Head Test - May 23, 2013

The injection well falling head test was performed on May 23. Due to the questionable output of the level transducers, the only data recorded was for IW-1. A graphic representation of the time required to drop the water level to a static condition is presented in Figure 14-2. Comparisons of baseline data from March 2006 to that of recent tests (Figure 14-3) indicate that the performance of IW-1 is unchanged. All wells appear to be draining adequately.

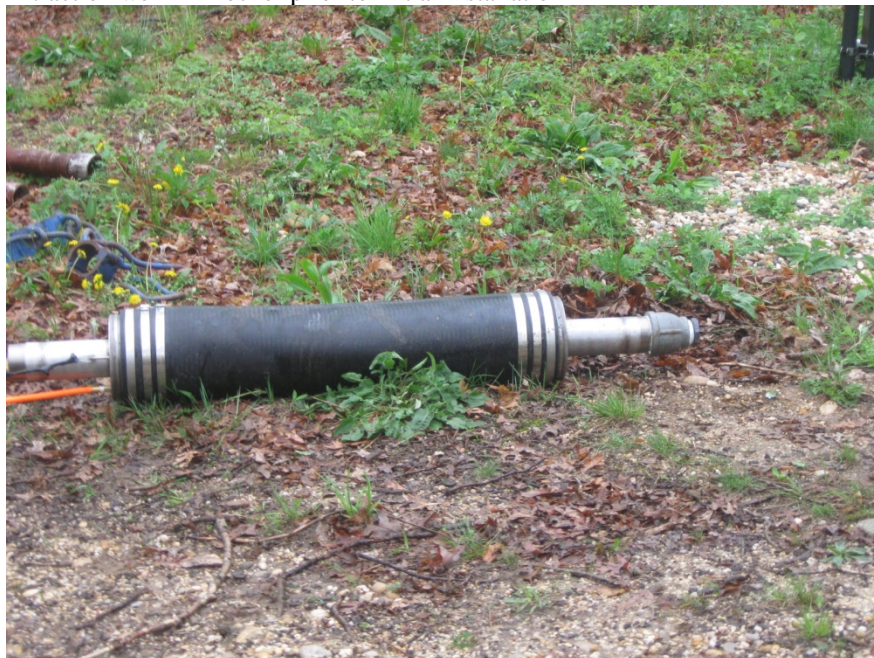
Extraction well 2 Blocker prior to initial installation

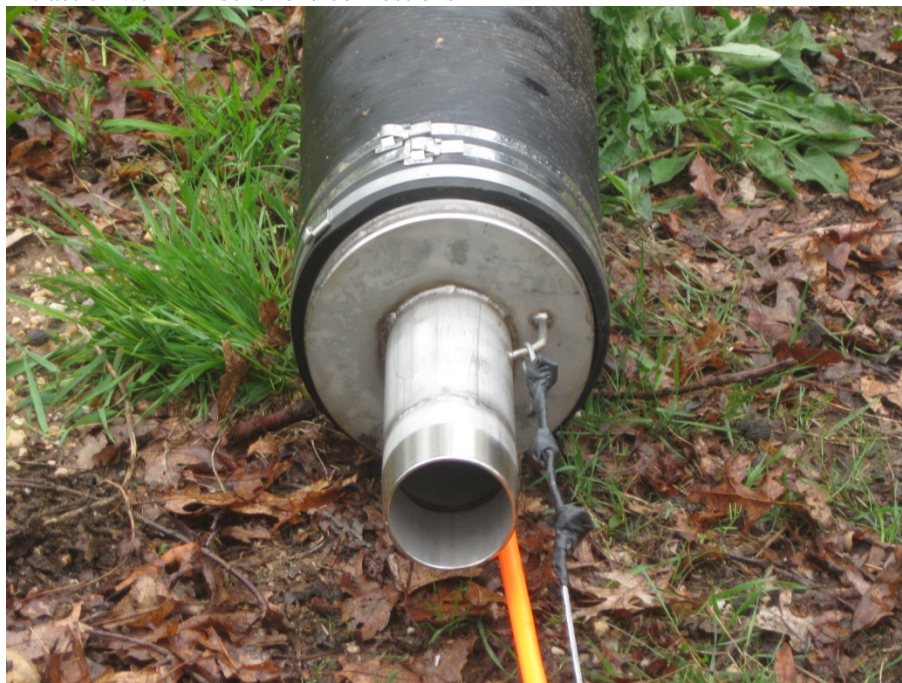
Extraction well 2 Blocker end connections

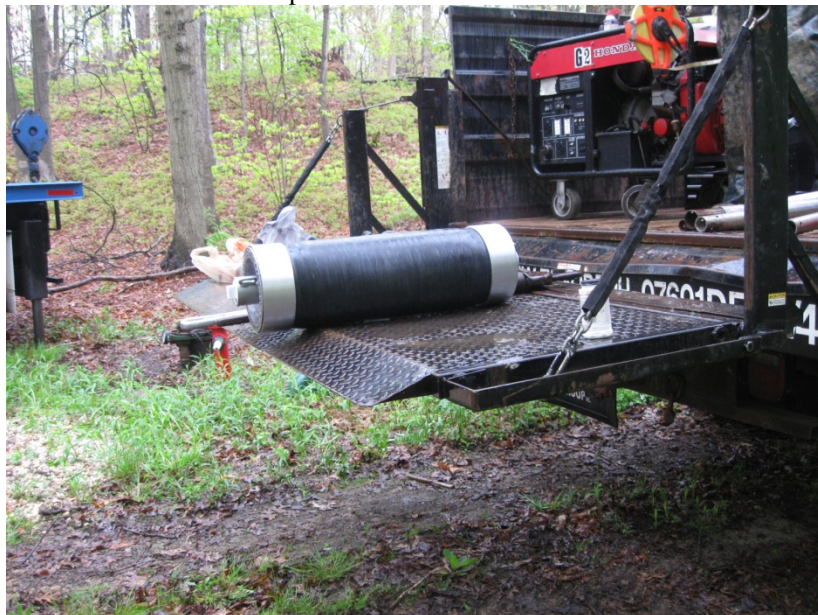
Extraction Well 1 Blocker prior to initial installation

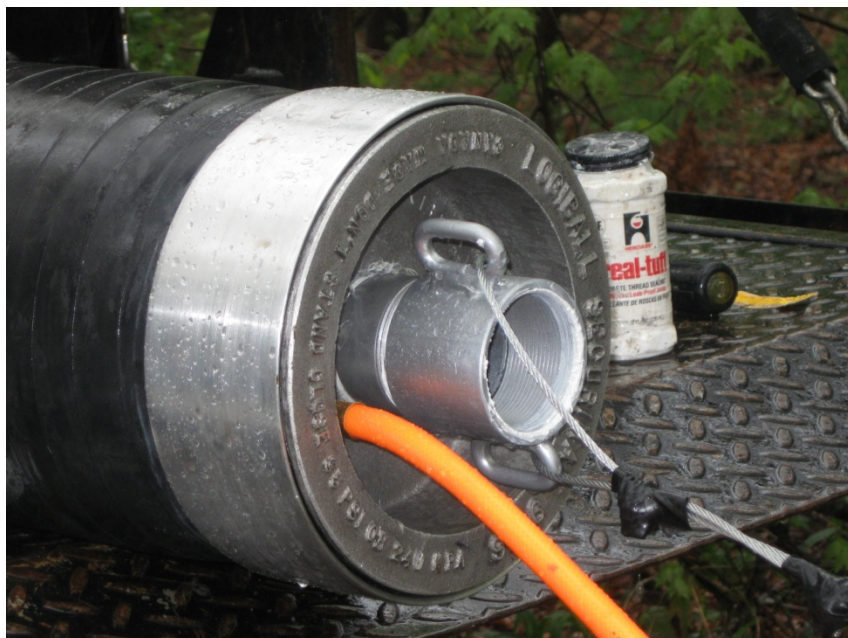
Extraction Well 1 blocker connections

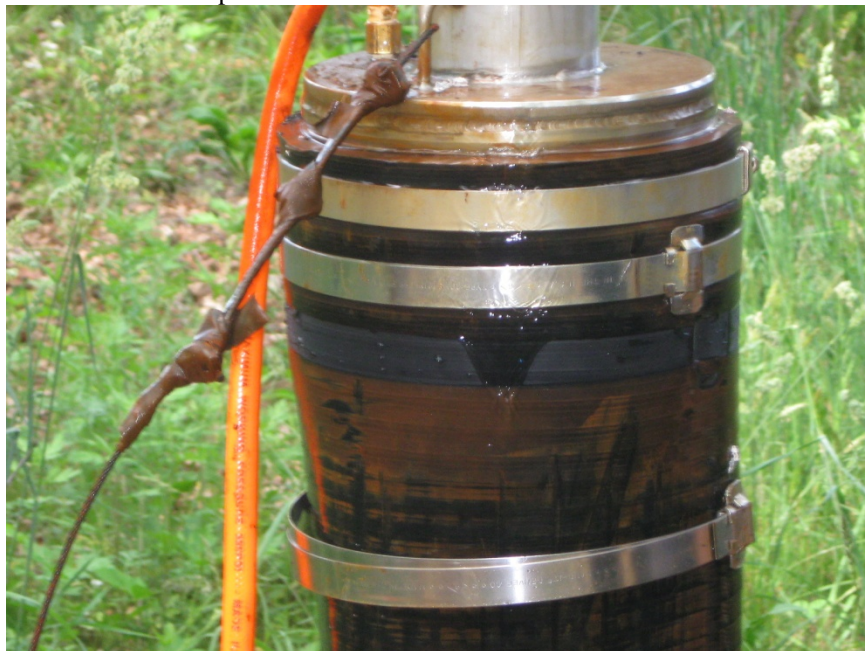
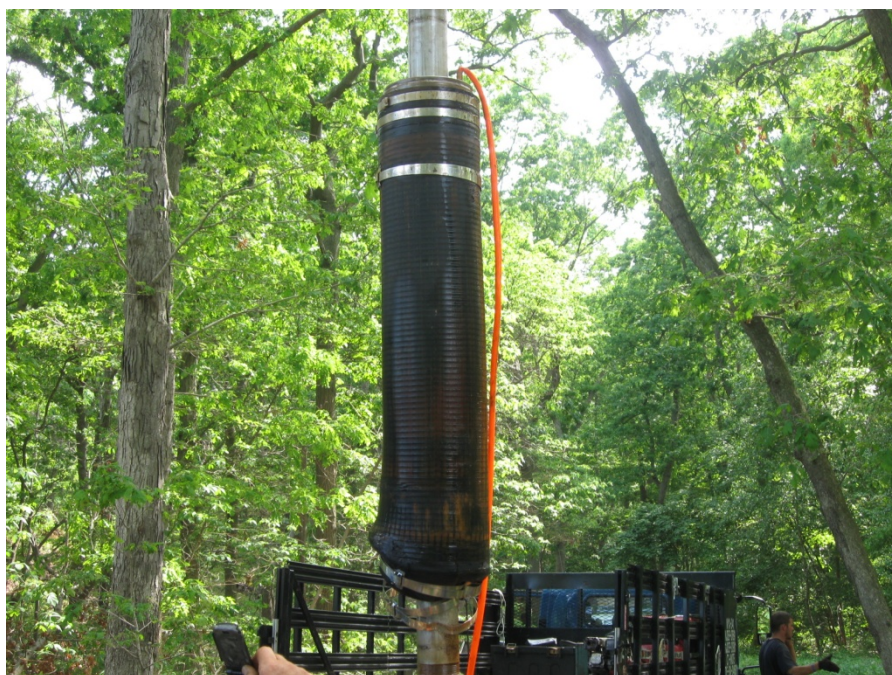
- Leak testing revealed that the well blocker systems were leaking. The pumps and blockers were pulled from the wells. Repairs were made for EX-1 and the blocker and pump were re-installed. The blocker for EX-2 was damaged and only the pump was re-installed in EX-2. Both pumps were started up and systems returned to service.

Blocker after it was pulled from EX-2

Miller Environmental was onsite to install well blockers in Extraction Wells 1&2. The well pumps for EX-1 and EX-2 were installed at new elevations. The pump for EX-3 was installed with its elevation unchanged. Miller Environmental returned to make repairs to leaking blockers. There continues to be concerns regarding the integrity of the blockers.
