**CLAREMONT POLYCHEMICAL SUPERFUND SITE
Groundwater Treatment System
Old Bethpage, New York**

**MONTHLY REPORT
for the
Operations & Maintenance Activities
During
November 2013**

WA D006130-19
SITE # 130015

**HRP Associates, Inc
dba HRP Engineering, P.C.
1 Fairchild Square,
Clifton Park, New York 12065**

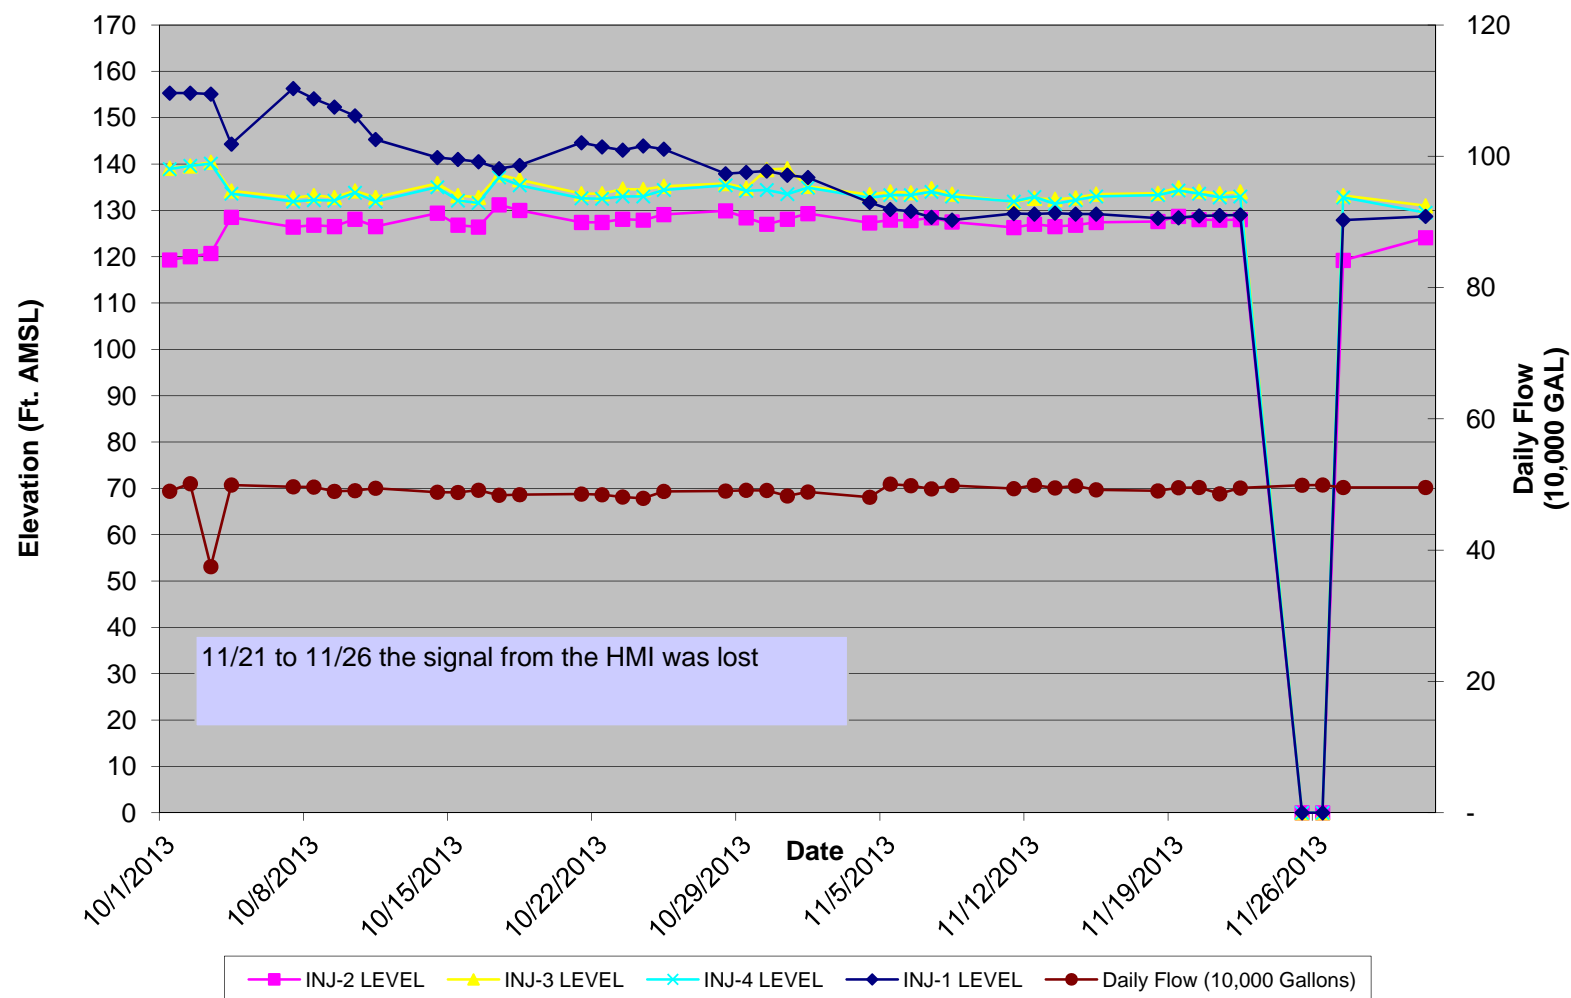
Figure 14-1 Injection Well Elevations and Daily Flow

Water elevations in the IWs are recorded on a daily basis from the well's transducer output. Although depicted in Figure 14-1, these water levels are from faulty instruments and are questionable. However, the IW levels were generally steady and are physically monitored. On 11/25 the DTW readings for the injection wells were recorded.

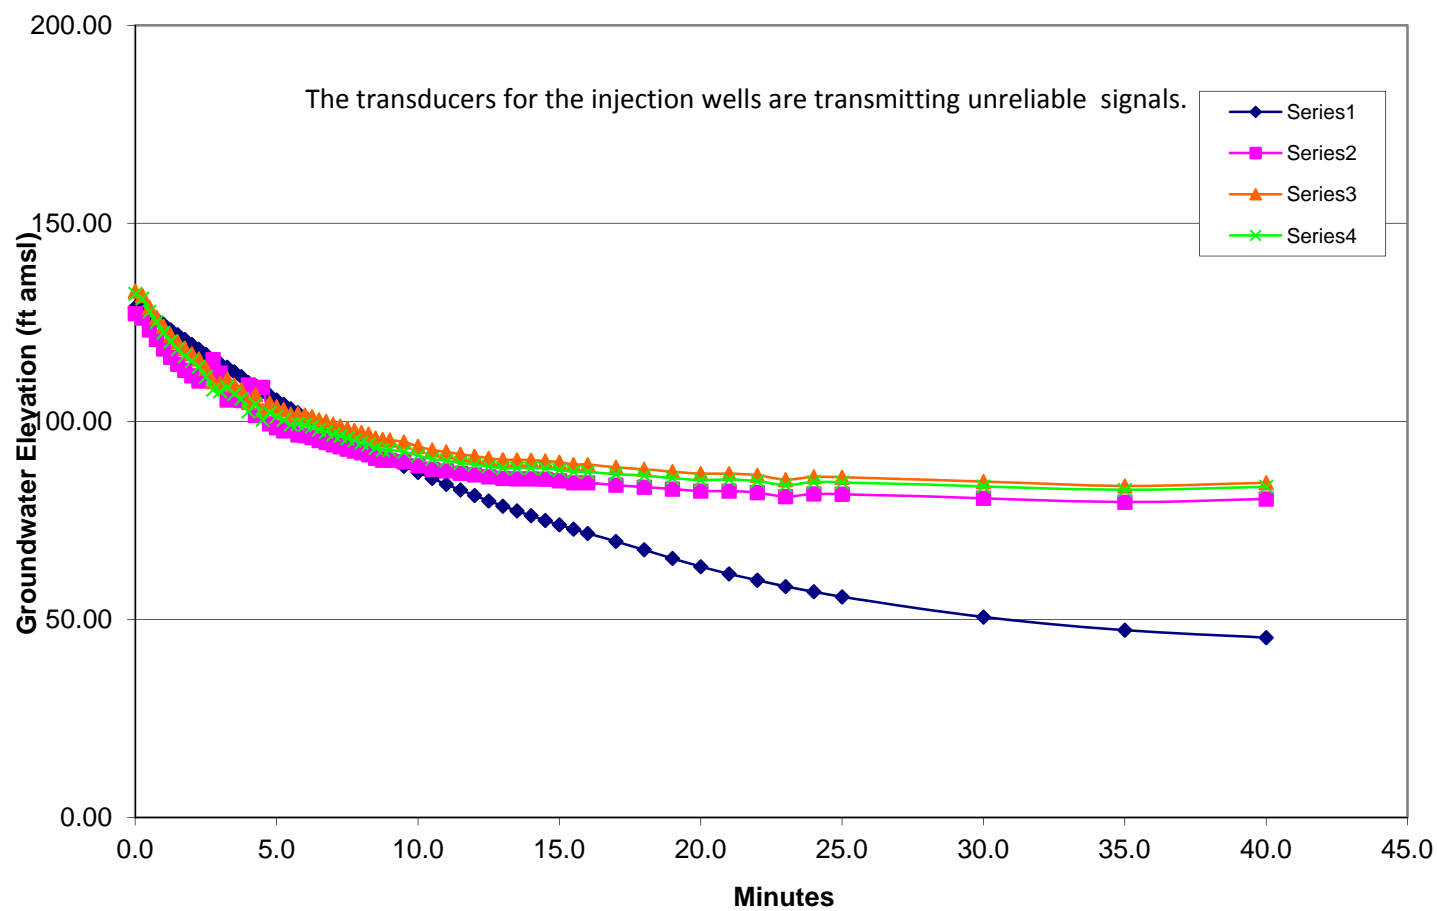
Figure 14-2 Injection Well Falling Head Test - November 21, 2013

Water level data from the injection well falling head test analysis was collected. Although the output of the level transducers is questionable, the data for all four wells was recorded. A graphic representation of the time required to drop the water level to a static condition is presented in Figure 14-2. Comparisons of baseline data from March 2006 to that of recent tests (Figure 14-3) indicate that the performance of the wells is unchanged. With the exception of IW-2, the wells appear to be draining adequately.

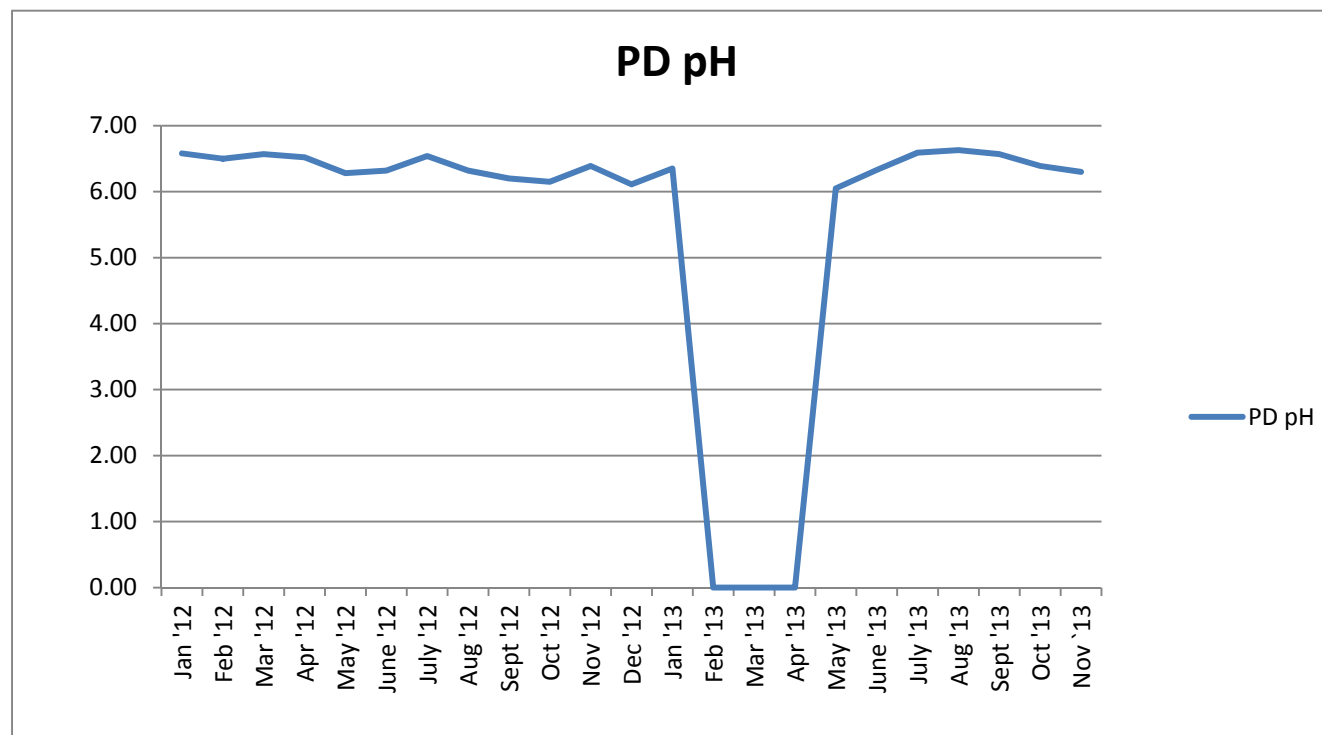
The NYSDEC discharge permit requires the plant discharge to have an average monthly pH greater than 5.50. The treatment plant effluent pH averaged 6.30 in November and met the monthly average pH discharge requirement. A graph of the plant discharge monthly pH average trend over several months is provided in Table 14-1.

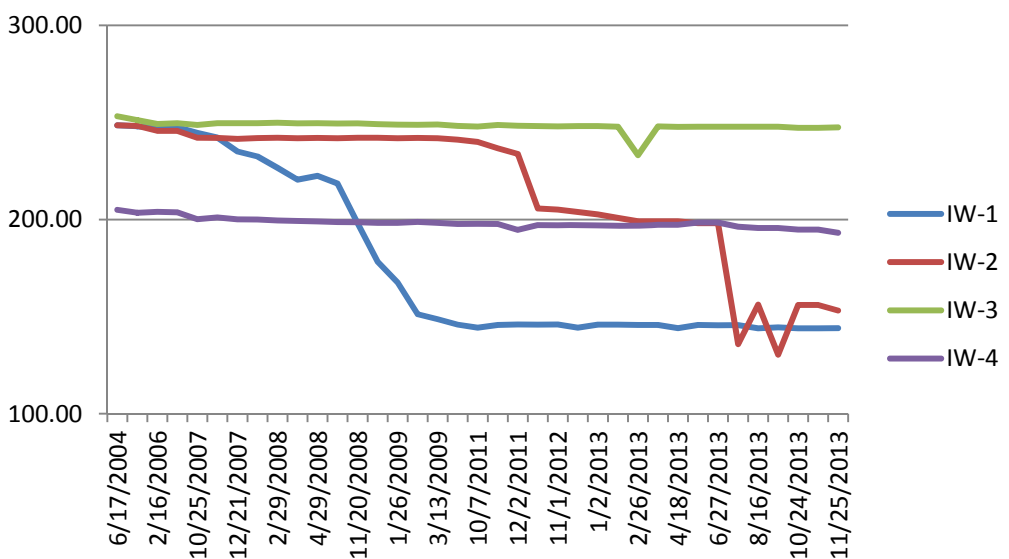
TABLE 14-2 Injection Well Soundings

The deposit of material into IW-2 seems to have slowed. Due to this blockage of a length of the well screen, water infiltration has slowed. The water level in the well has been rising and plant discharge flow to the well was cut back (85 gpm to 55 gpm).

Measurements to determine the well depth from the top of the injection well column to the bottom were taken on 11/25. A summary of the historical data is included in Table 14-2. Although there has been an accumulation of sediment in all four injection wells, the rate of infiltration appears to have stabilized. The flow of injected water into IW-2 remains restricted.
