**REMEDIATION ACTION REPORT**

CLAREMONT POLYCHEMICAL SUPERFUND SITE,  
OLD BETHPAGE  
PROCESS BUILDING REMEDIATION

OLD BETHPAGE,  
NASSAU COUNTY  
NEW YORK

GENERATED BY: U.S. EPA Region 2  
Emergency and Remedial Response Division  
New York Remedial & Removal Action Branches  
September 2014

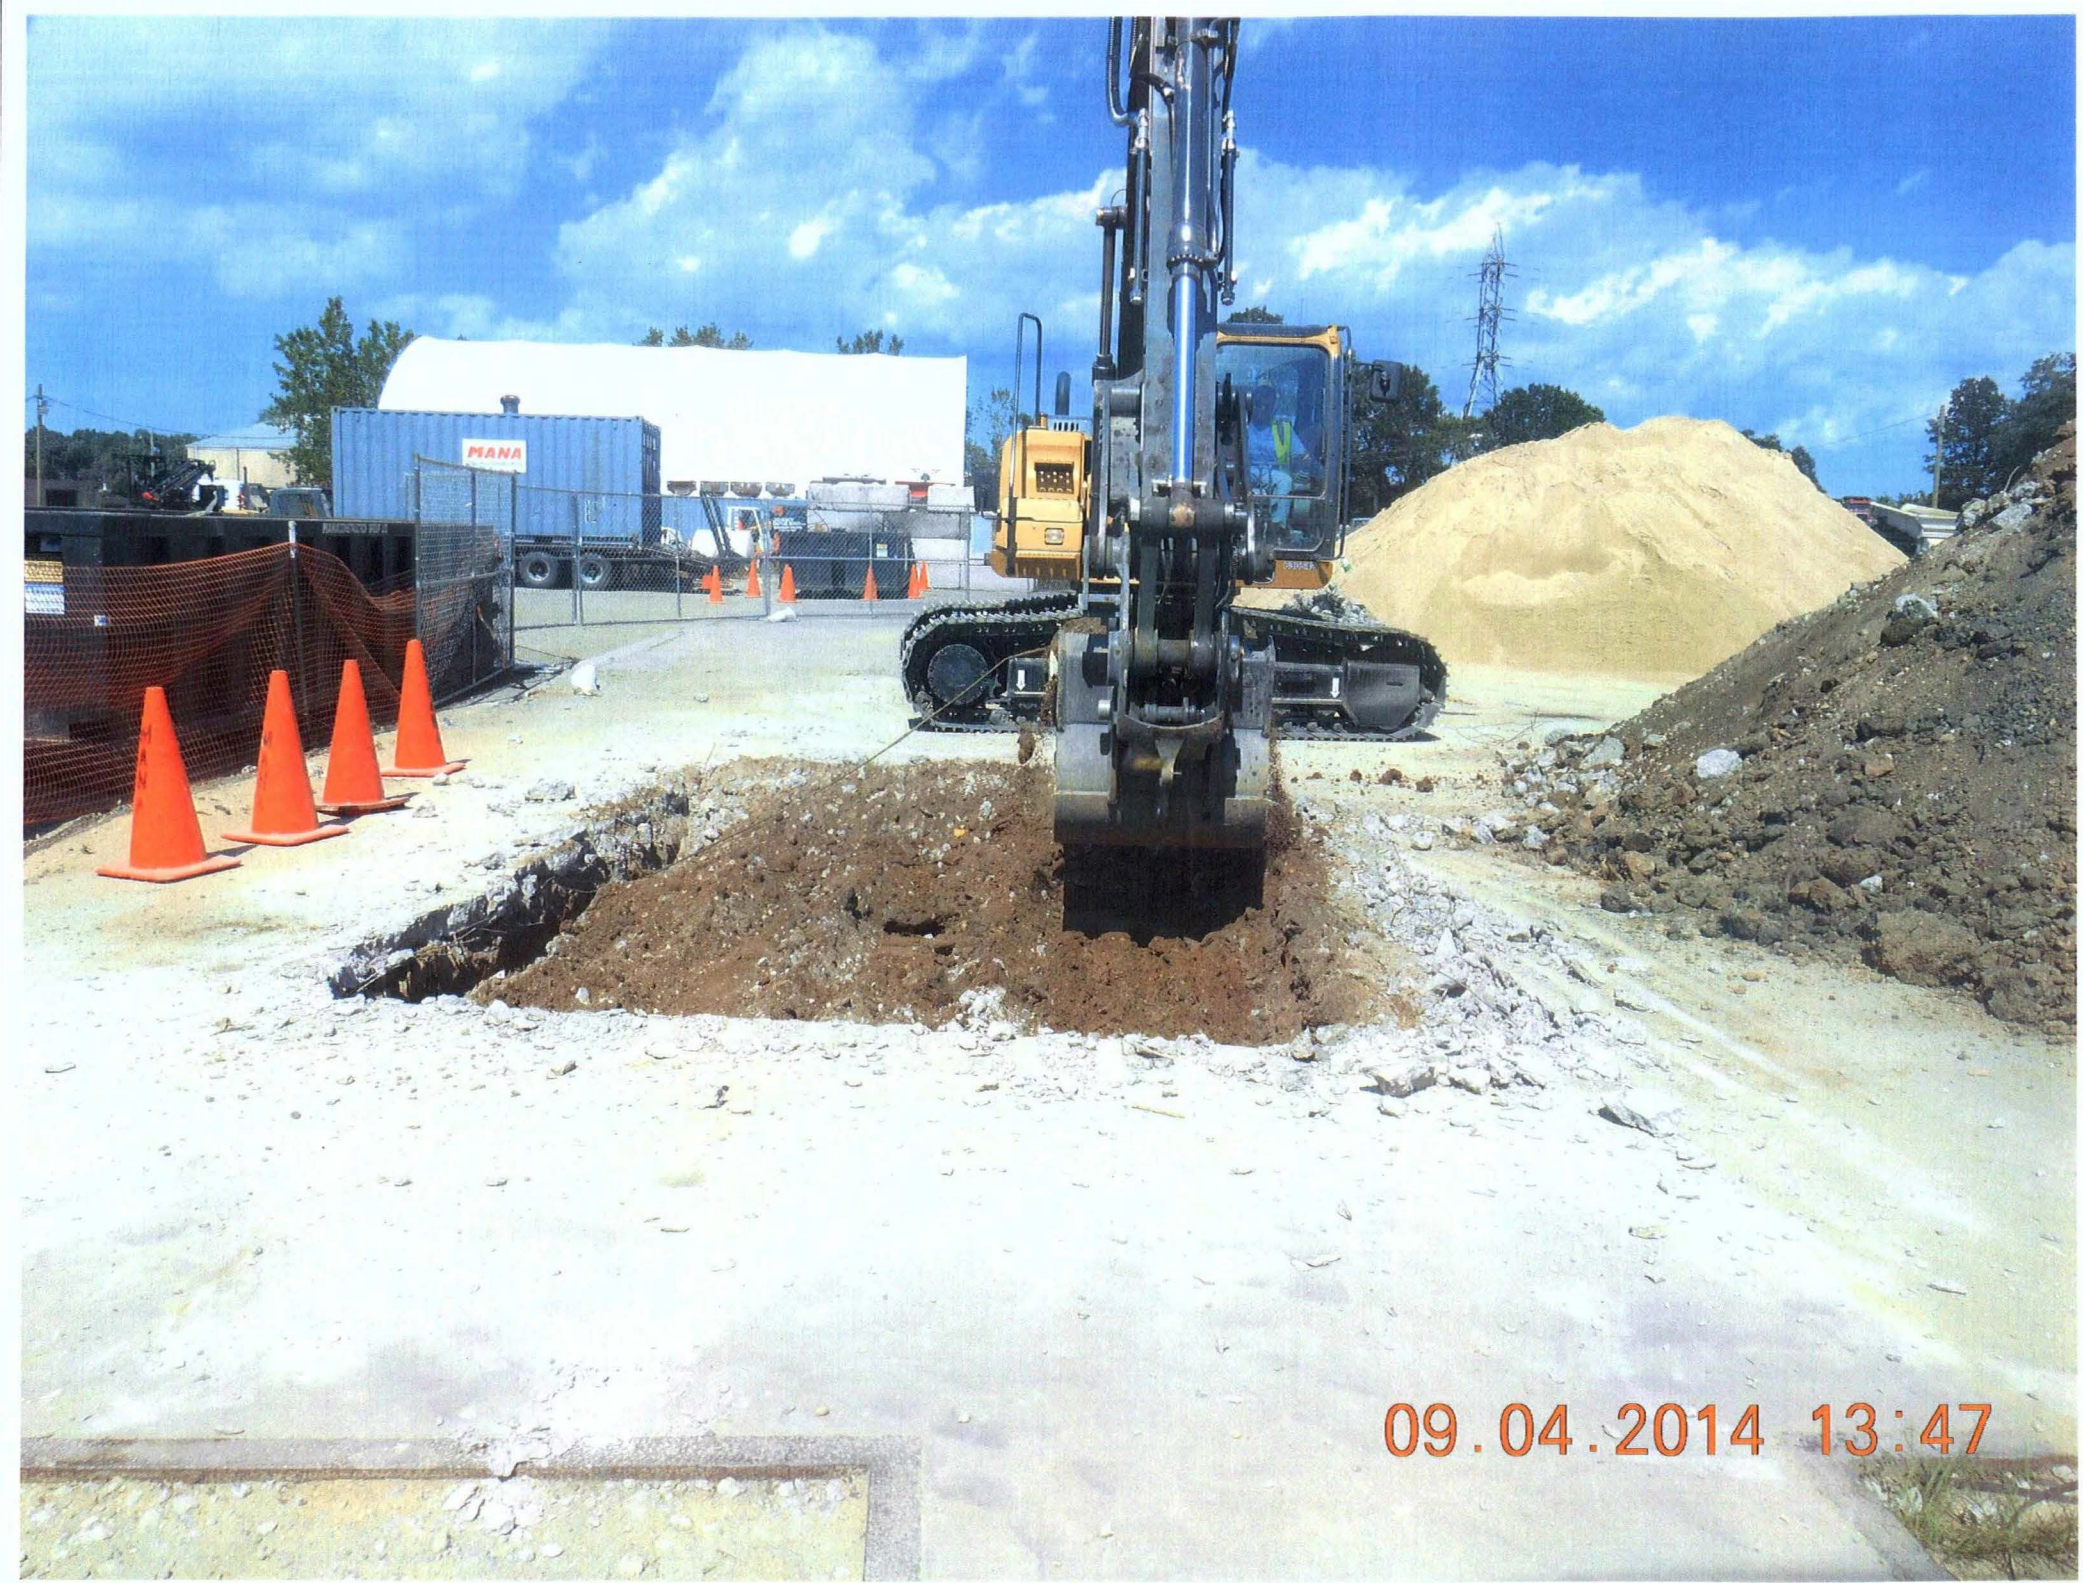
EXCAVATION AREA C

In *Area C*, correlating with former SVE-20, the side wall areas (south and east) were found to be below the site cleanup goals (see Table 5). The base continued to have elevated levels.

Sample results in *Area C* (SVE-20) base only, were also found to be below the site cleanup goals.
