# 2015 Third Quarter Groundwater Monitoring Report July – September 2015

Claremont Polychemical Corporation Site

505 Winding Road  
Old Bethpage, Nassau County, New York 11804  
Contract/WA No. D007625-19; Site No. 130015

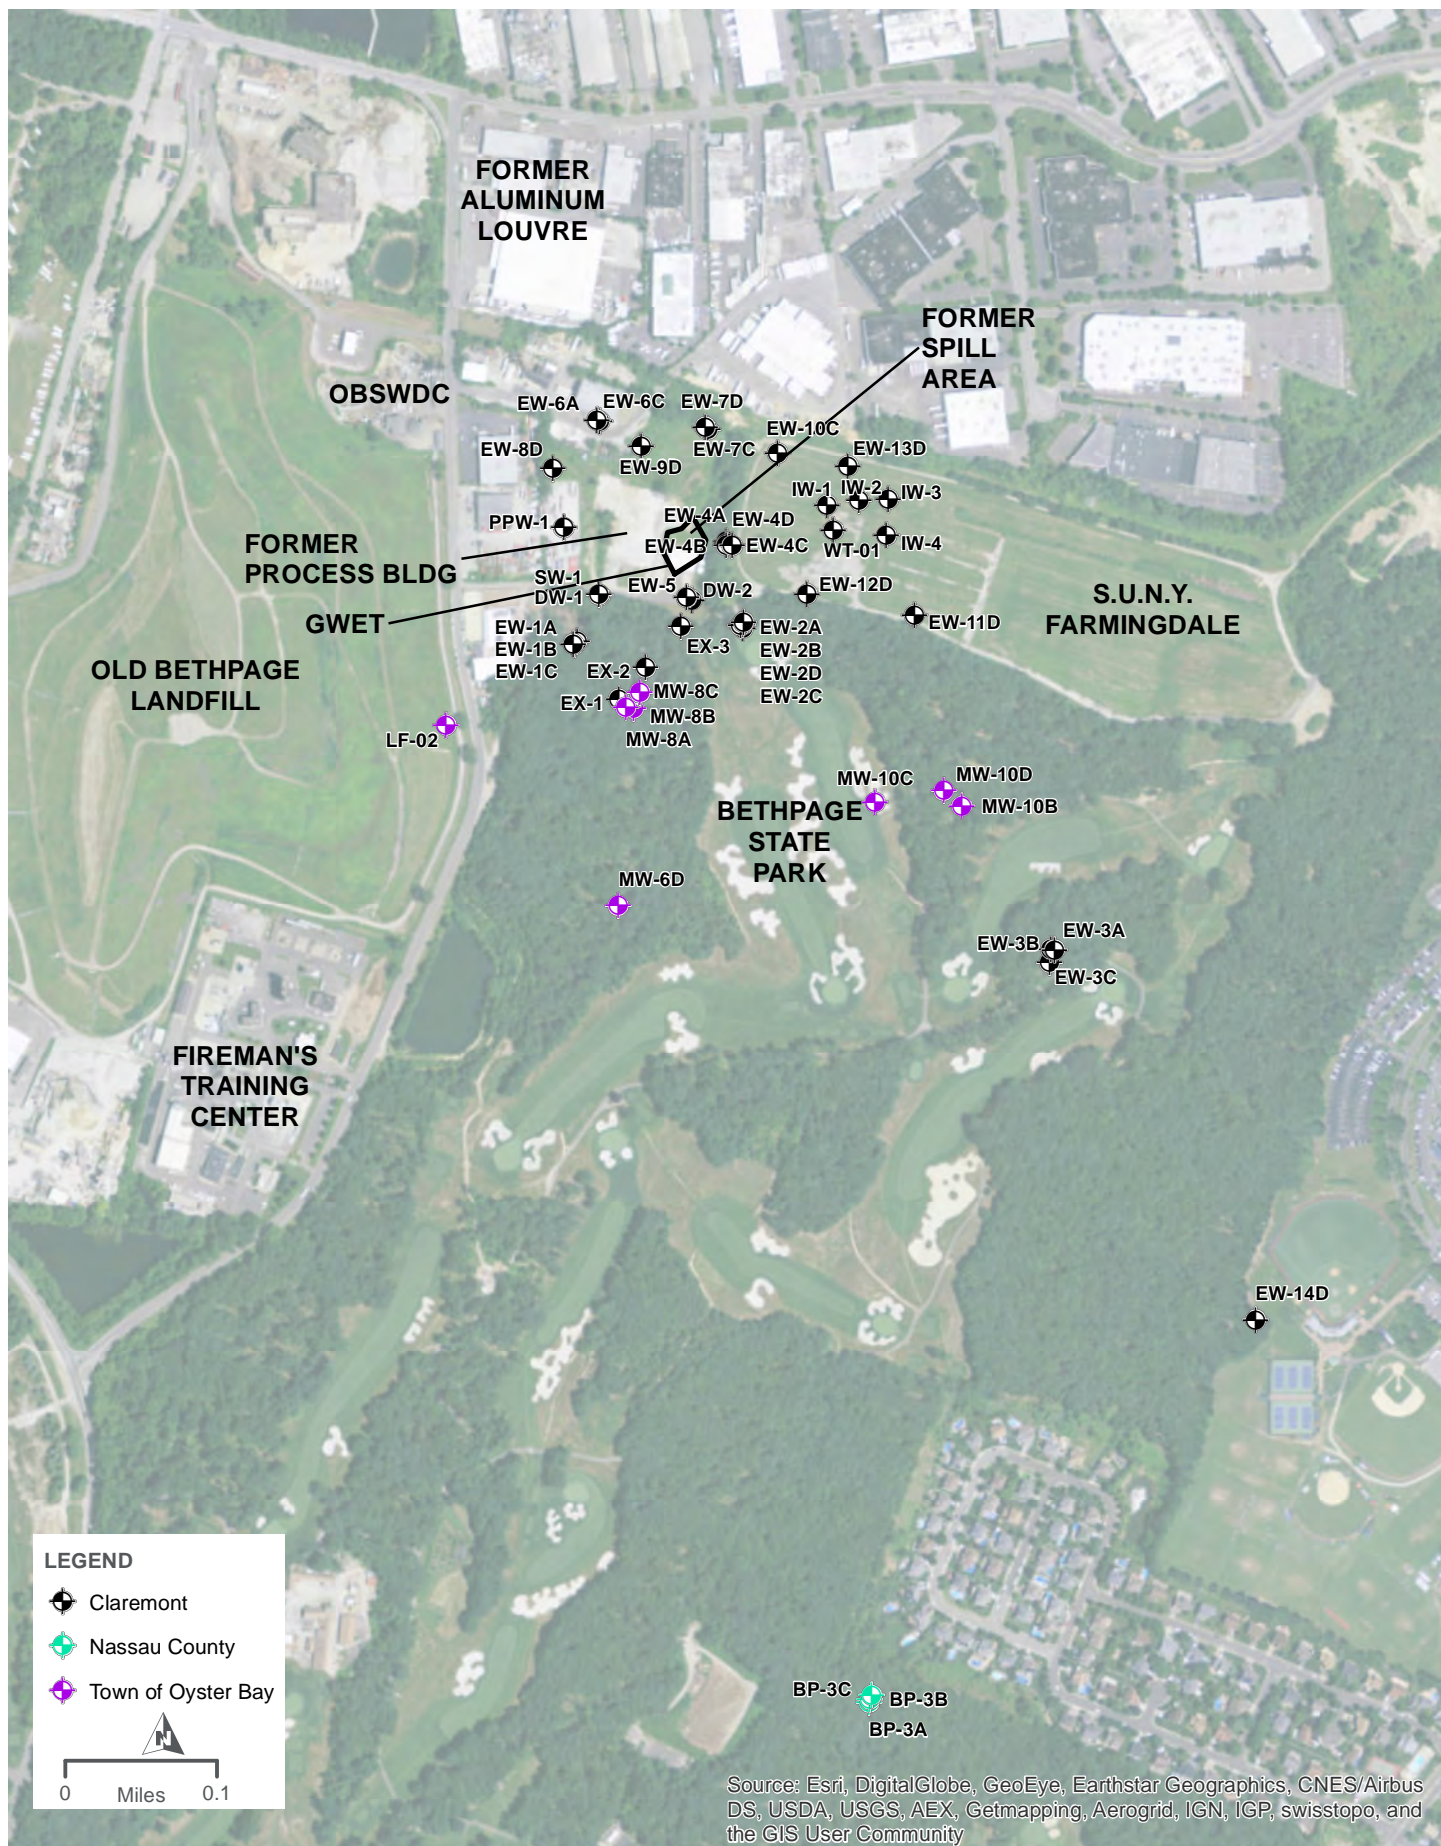
FIGURE 2

On August 24 and 25, 2015 HRP sampled a total of 41 on-site and off-site monitoring wells. On-site monitoring wells included DW-1, DW-2, EW-5, EW-7C, EW-7D, EW-8D, EW-9D, and SW-1. Off-site wells included BP-3A, BP-3B, BP-3C, EW-1A, EW-1B, EW-1C, EW-2A, EW-2B, EW-2C, EW-2D, EW-3A, EW-3B, EW-3C, EW-4A, EW-4B, EW-4C, EW-4D, EW-6A, EW-6C, EW-10C, EW-11D, EW-12D, EW-13D, EW-14D, LF-02, MW-6D, MW-8A, MW-8B, MW-8C, MW-10B, MW-10C, MW-10D, and WT-01. In addition, the three extraction wells, EX-1, EX-2, and EX-3, were sampled. The monitoring well locations are depicted on Figure 2. A description of the groundwater sampling event is provided below.

## WELL LOCATIONS CLAREMONT POLYCHEMICAL CORPORATION

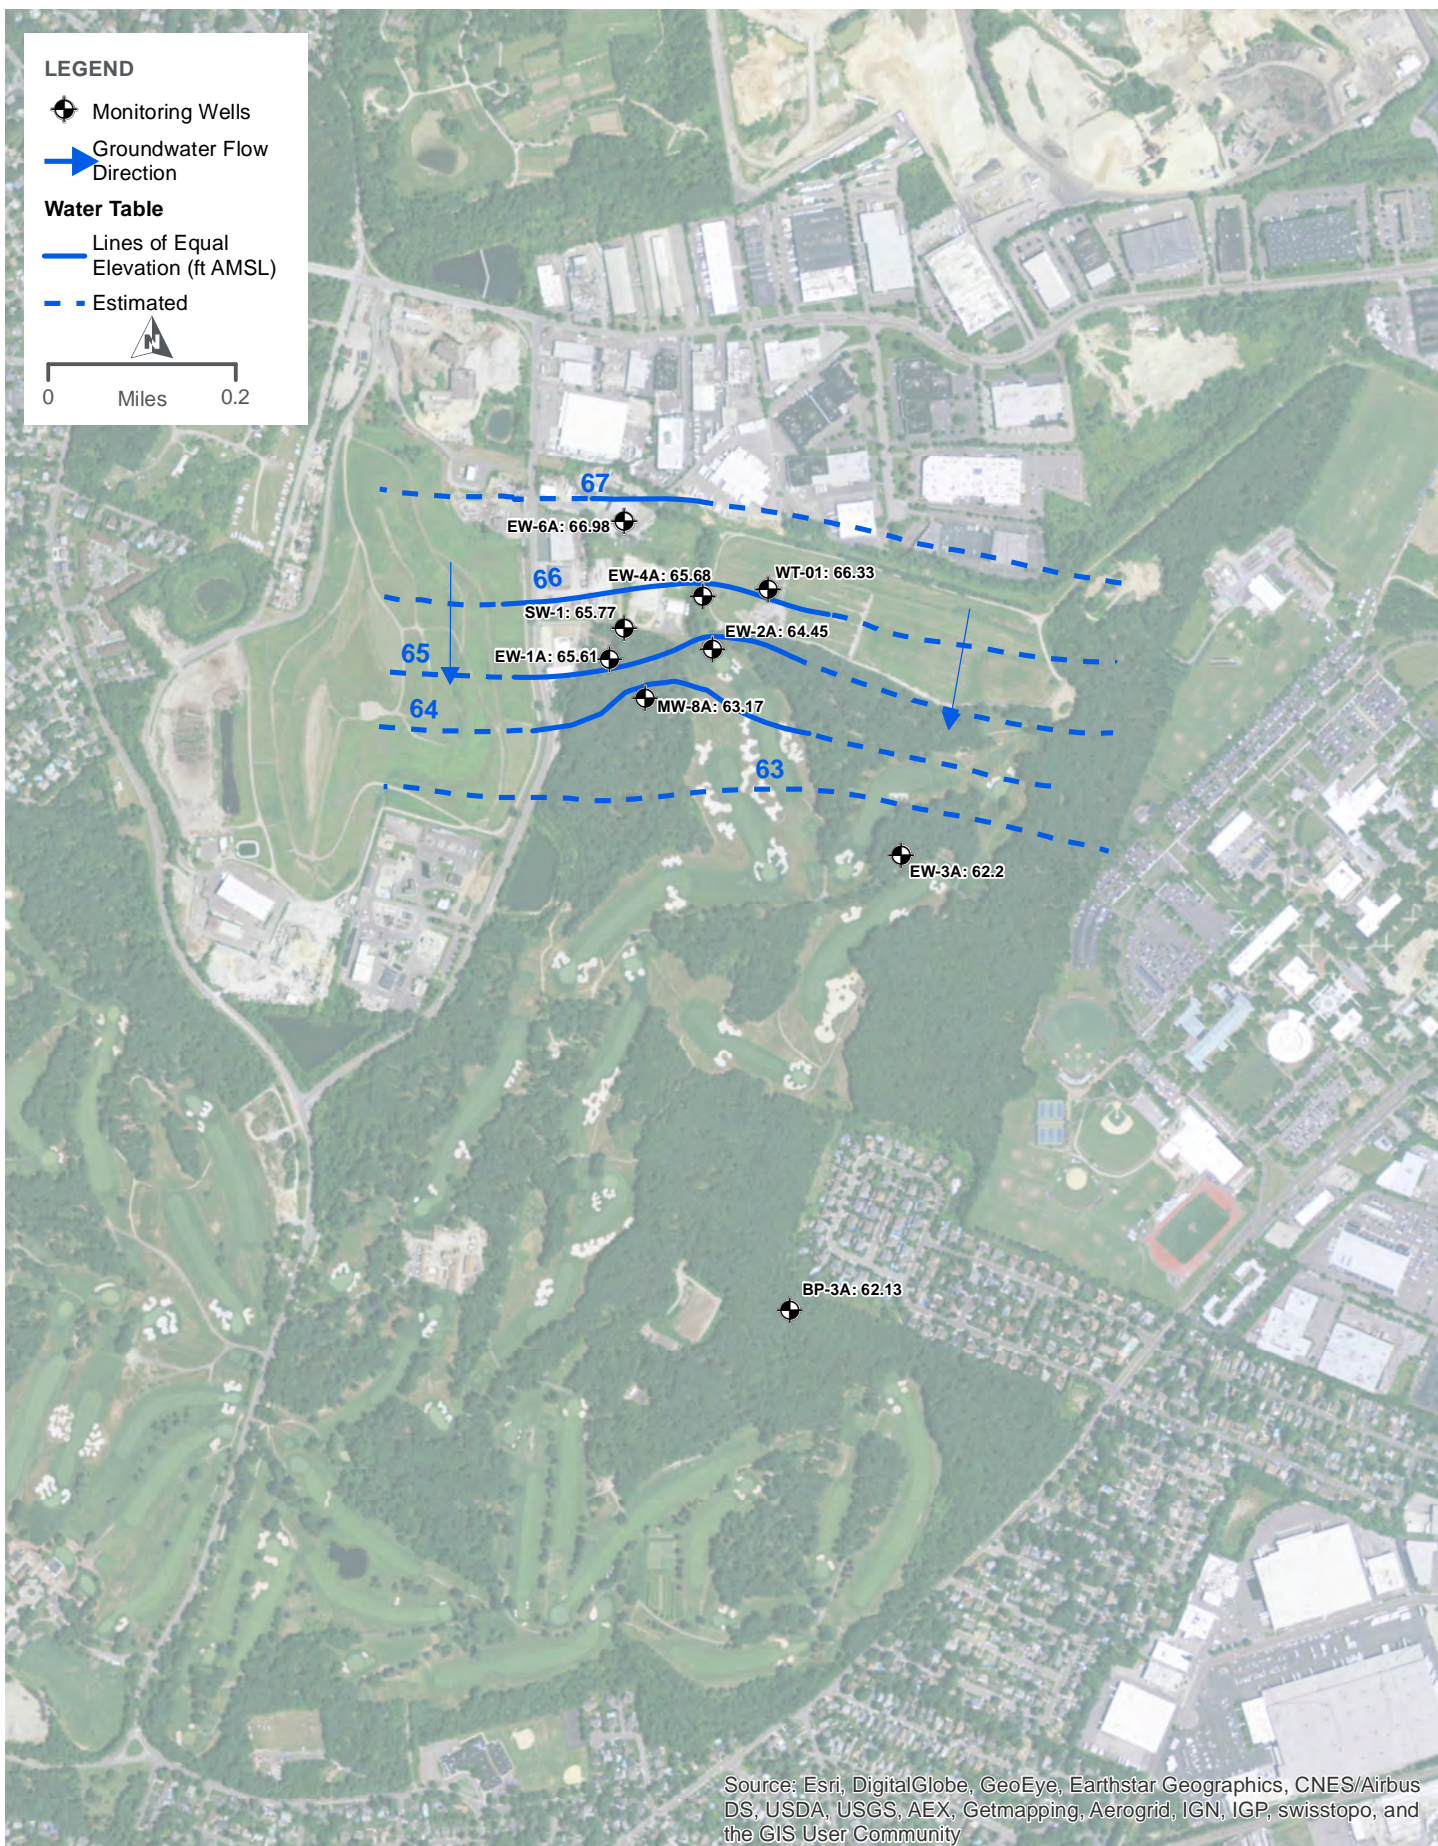
FIGURE 3

Groundwater contour maps produced from the August 2015 water level measurements show groundwater flow direction in the water table wells to be due south; and south-southwest to the east at the SUNY Farmingdale property (Figure 3). The contour map produced from wells screened in the Magothy aquifer depicts a south-southeast flow direction (Figure 4). The recent contour maps are consistent with previous maps produced from the CPC wells and from other investigations.

A synoptic round of groundwater levels were measured in 41 groundwater wells on August 21, 2015. Depth to groundwater in August 2015 ranged from 43.75 feet (EW-14D) to 102.98 feet bgs (EW-11D). Water level elevations were calculated by subtracting the depth to water from each measurement from the top of casing elevation. HDR plotted the water levels and drew the configurations of the water table and potentiometric surface in the Magothy aquifer depicting the groundwater flow directions. These data show the groundwater flow direction is due south and south-southwest at the water table (Figure 2) and south-southeast in the Magothy (Figure 3). The effect on the aquifer from pumping of the CPC extraction wells is evident from bends in otherwise straight potentiometric surface contours nearest the extraction wells. Overall, groundwater elevations and inferred groundwater flow direction based on groundwater elevation contours were consistent with previous data.

## WATER TABLE CONTOURS CLAREMONT POLYCHEMICAL CORPORATION

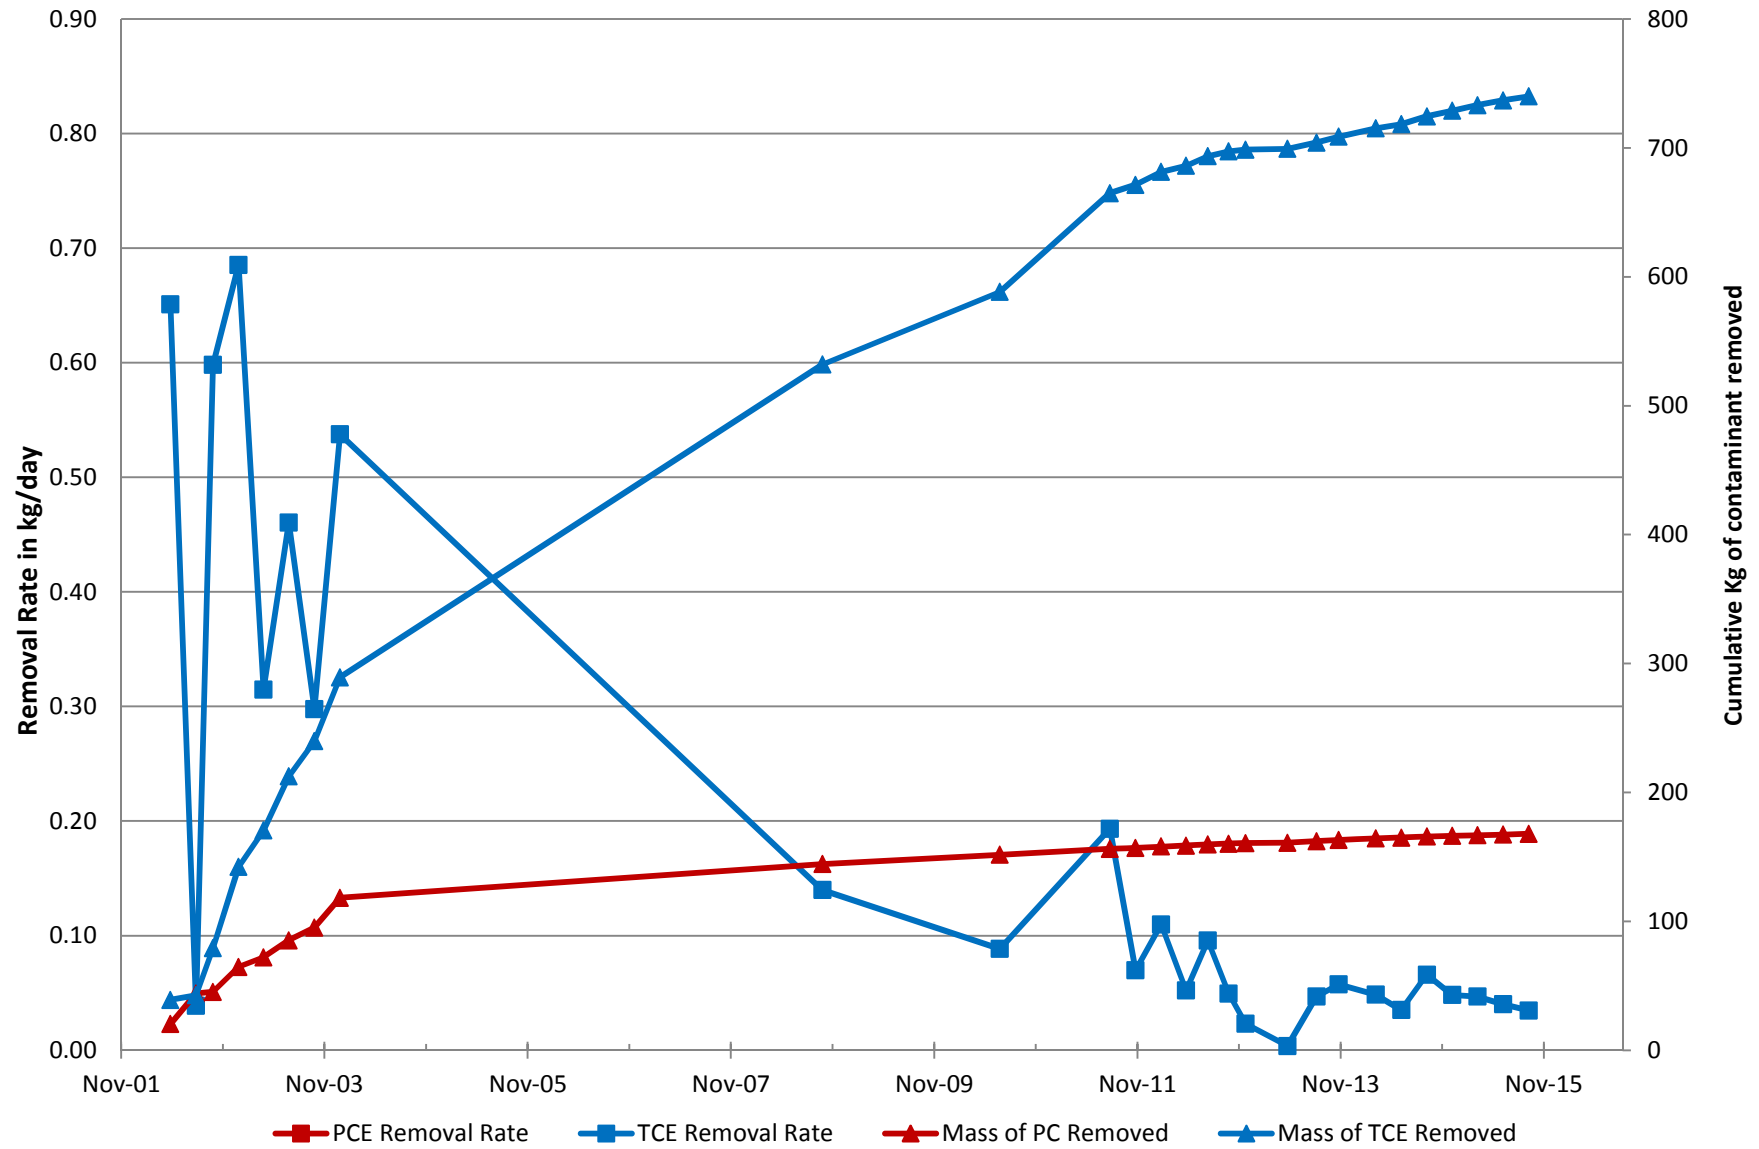
Figure 5

To evaluate the treatment system's contaminant influent removal rate, HDR reviewed available GWET system influent and effluent analytical results from monthly operation and maintenance records. Approximately 936 kilograms (2,063 pounds) of VOCs have been removed to date. Mass removal peaked in 2003 at 288 kilograms and in 2015 is 13 kilograms to date. Cumulatively, most of the mass removed has been TCE (740 kilograms) and PCE (167 kilograms). A plot of historic mass removal rates and cumulative PCE and TCE mass removal is presented as Figure 5.

## VOC Removal vs Time (PCE, TCE)

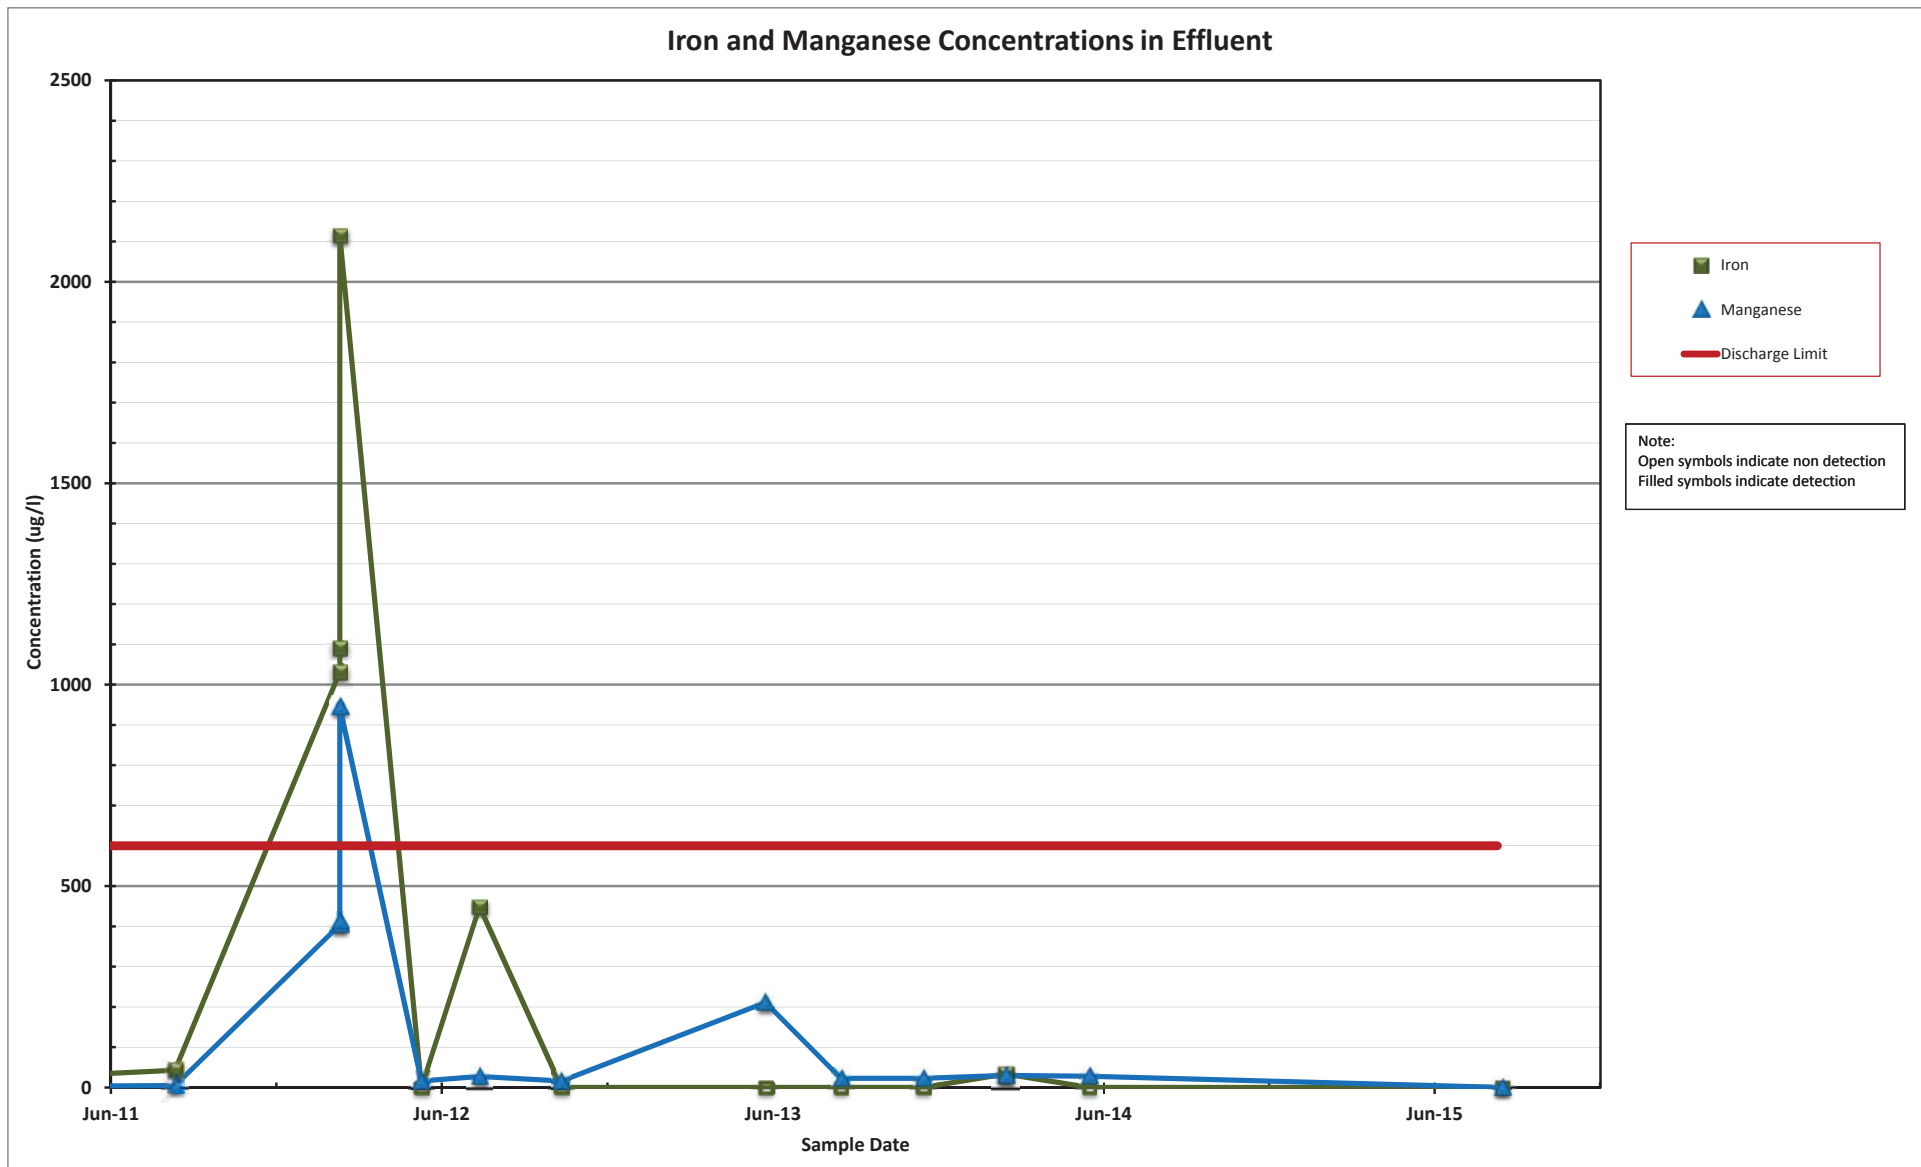
have remained below permissible discharge limit levels. Figure 7 shows that the concentrations of iron and manganese were under the permissible levels for the third quarter 2015 sampling results. Refer to the monthly O&M and the Significant Events reports for additional information on remediation system performance and daily operations.

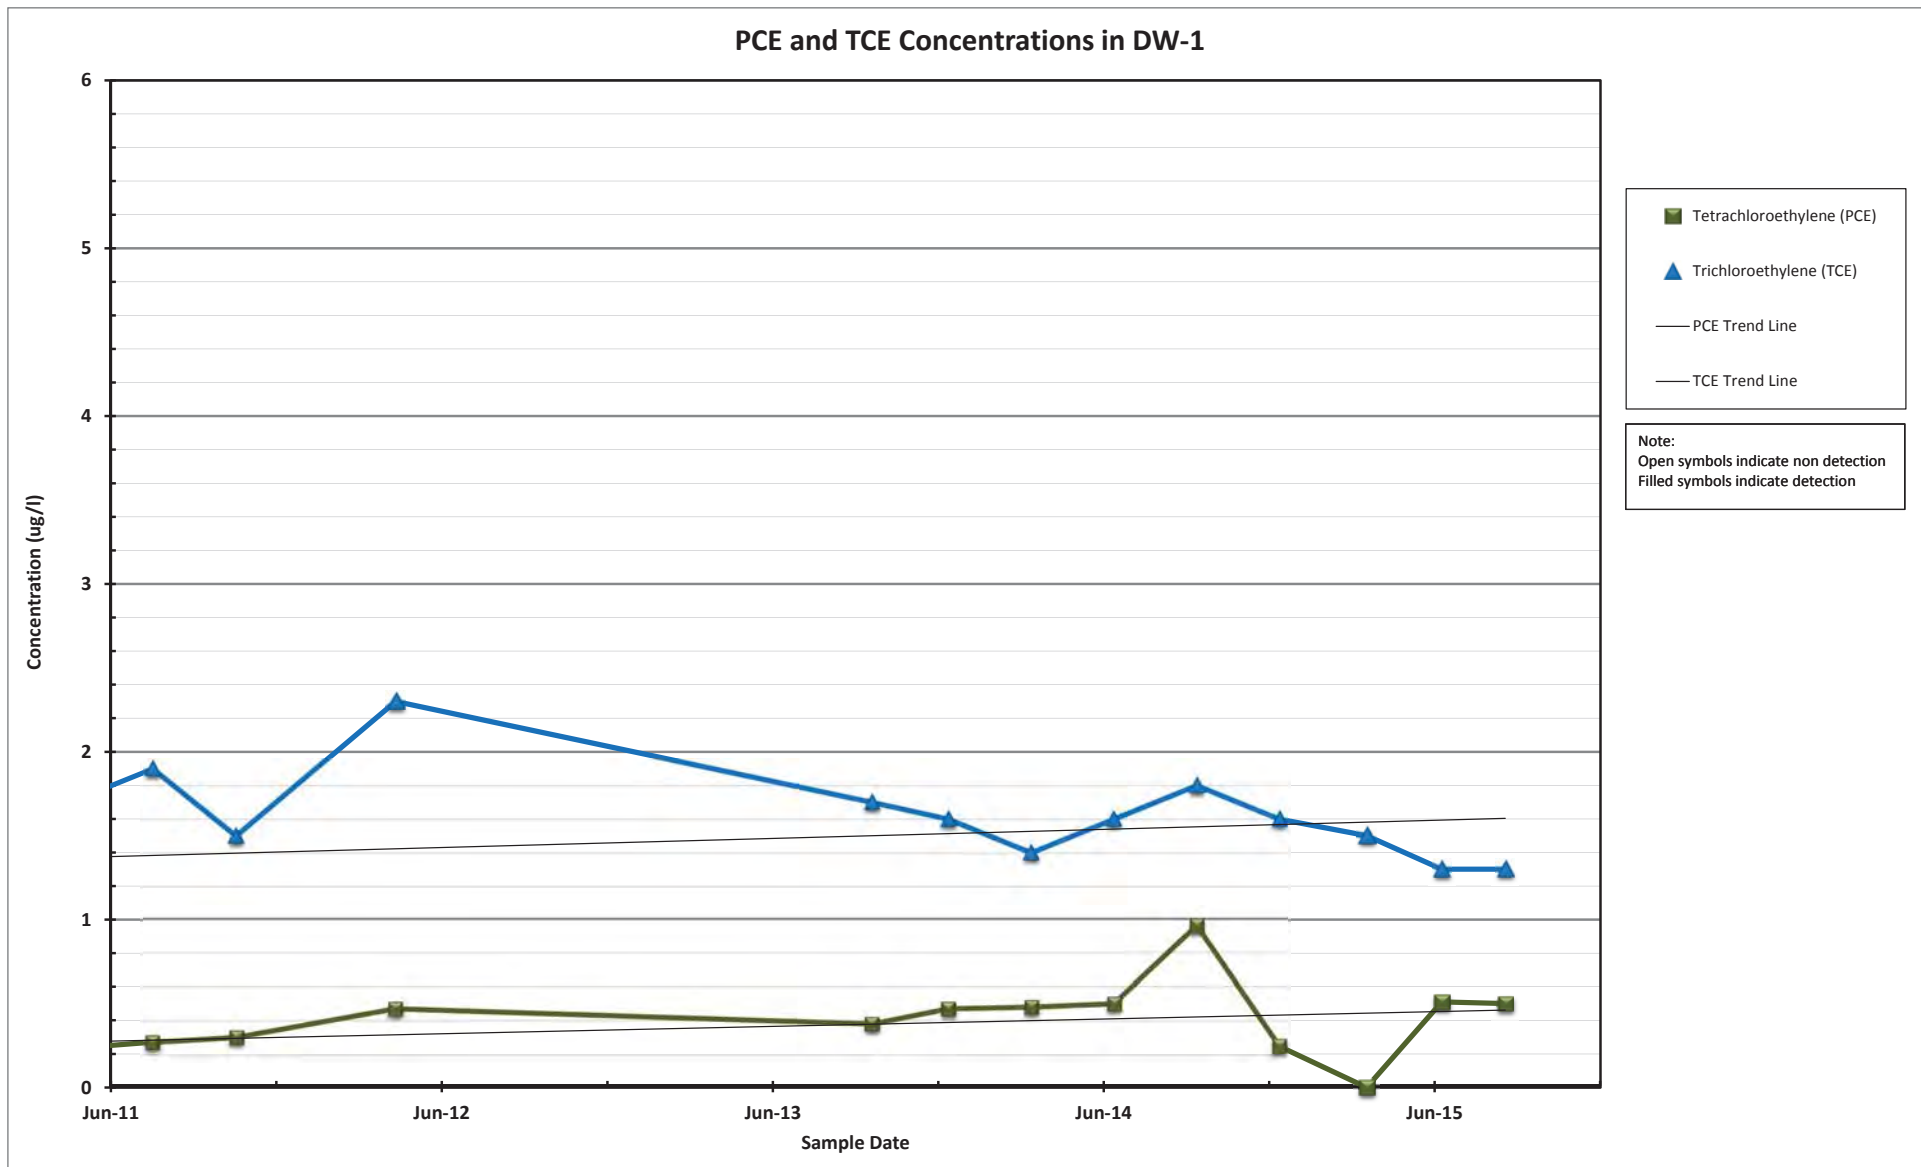
Figures 8 through 25 illustrate the historical concentration trends for PCE and TCE in multiple wells. Table 4 summarizes the concentration trends in each of the wells.

Well	Screen Depth	Location	PCE Trend	TCE Trend	Figure
<b>CPC Plume Wells</b>					
DW-1	93 - 98	South-southwest of CPC	Flat, slightly <b>increasing</b>	Flat, slightly <b>increasing</b>	Figure 8
EW-1A	65 - 75	Southwest of CPC	Decreasing	Decreasing	Figure 9
SW-1	65 - 70	Southwest, closest to CPC	<b>Increasing, by ~ 140 µg/L 2<sup>nd</sup> Q 2015</b>	Flat	Figure 10
EW-5	165 - 175	South-southeast of CPC	Flat, slightly decreasing	Decreasing	Figure 11
<b>Off-Site Plume(s) Wells</b>					
EW-4A	100 - 115	East of CPC	Decreasing	Flat, slightly decreasing	Figure 12
EW-4B	120 - 130	East of CPC	Decreasing	Flat, slightly decreasing	Figure 13
EW-4C	145 - 155	East of CPC	Flat, slightly decreasing	Decreasing	Figure 14
EW-4D	285 - 295	East of CPC	Flat, slightly decreasing	Decreasing	Figure 15
EW-7C	189 - 199	Upgradient, north of CPC	Flat	Decreasing	Figure 16
EW-7D	273 - 283	Upgradient, north of CPC	Decreasing	Flat, slightly decreasing	Figure 17

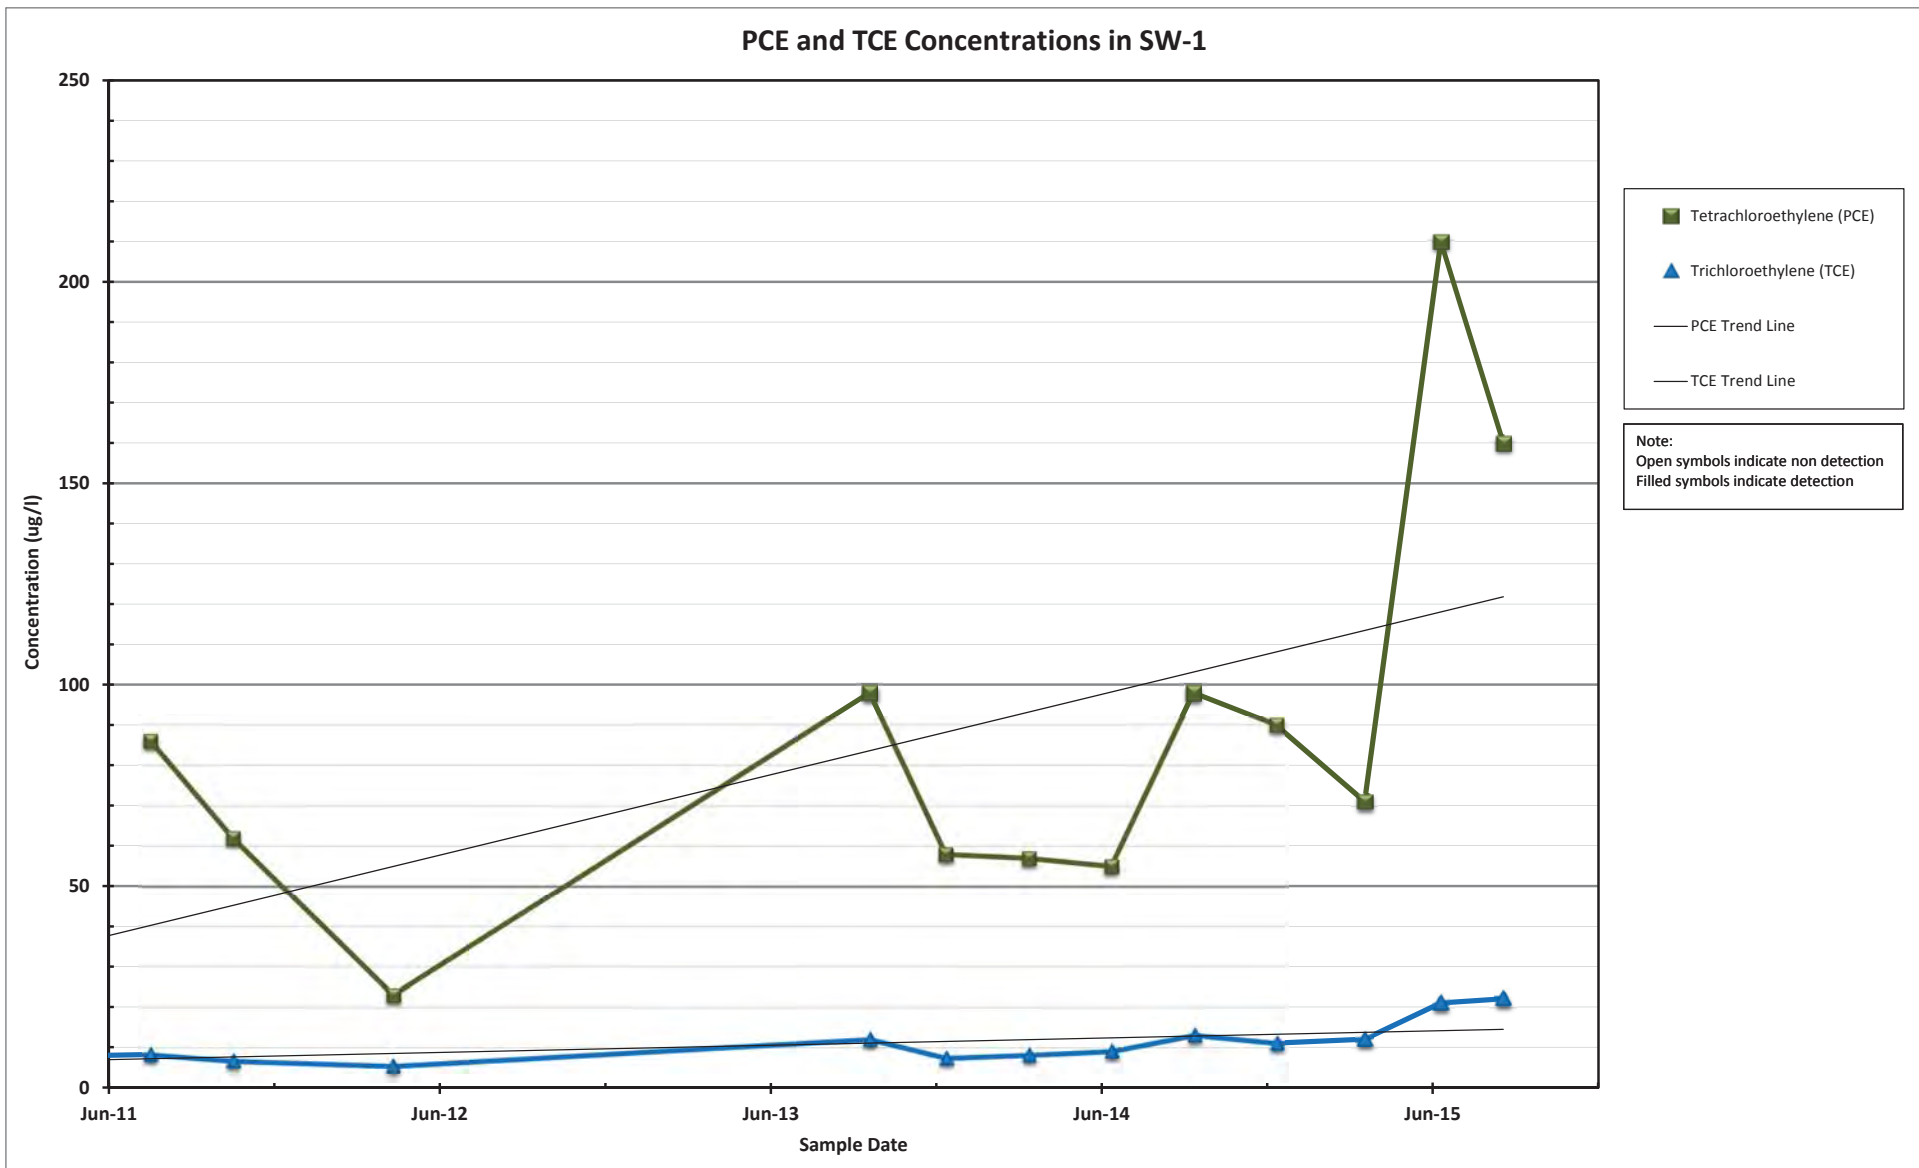
Figure 10

On-site plume. This plume originates on-site with the highest concentrations most frequently measured at well SW-1, a water table well (Figures 26 and 27). The on-site plume is predominantly PCE, with PCE concentrations typically slightly less than an order of magnitude greater than the TCE concentrations (Figure 10). PCE shows an overall increasing trend in well SW-1 and recent spikes this year with a concentration of 160 µg/L this quarter and over 200 µg/L last quarter. For the remaining wells, PCE concentrations continue to decline or are stable.

- **An increasing trend in PCE concentrations is observed at well SW-1 in the on-site plume nearest the former Process Building, particularly a recent spike in June of 2015.**

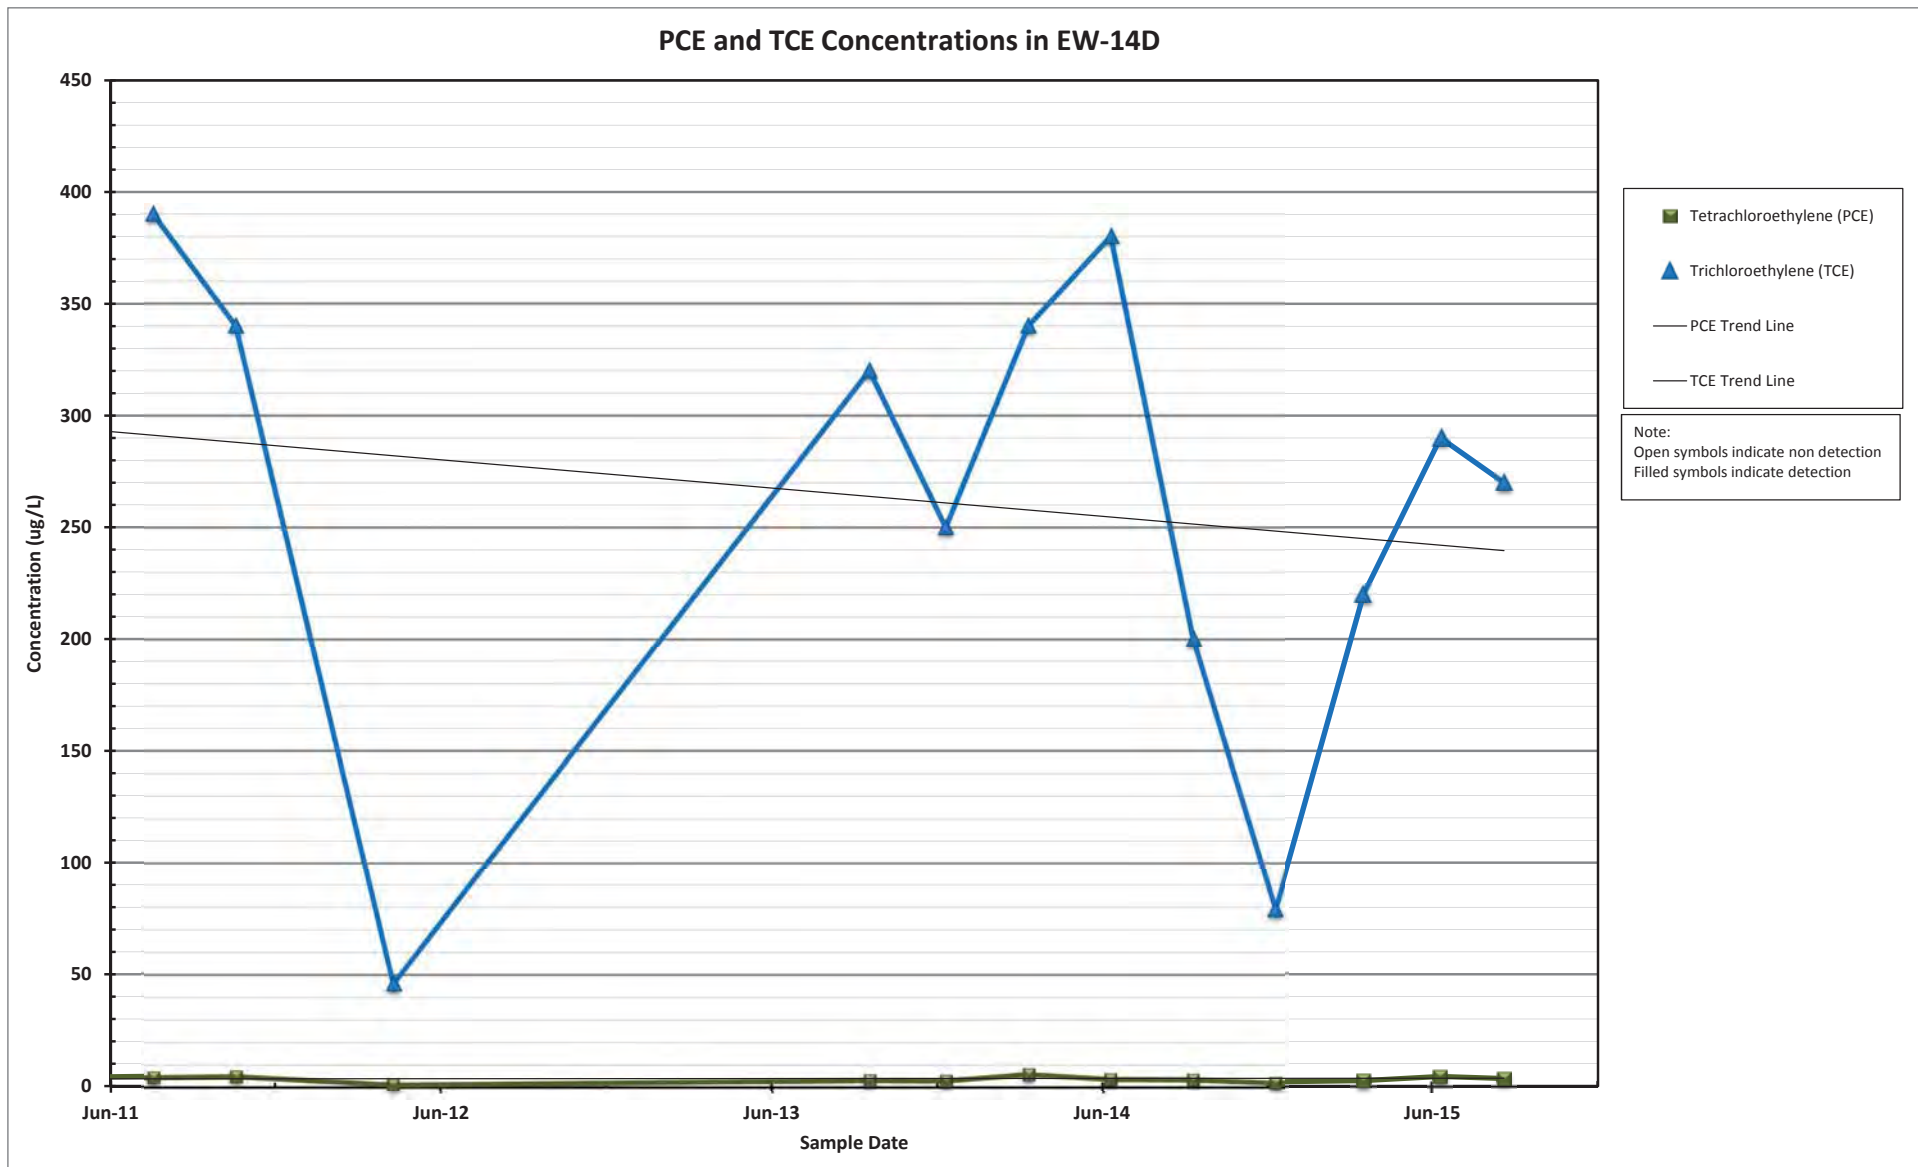
Figure 21

Well EW-14D. The groundwater contamination at EW-14D is high in TCE, similar to the off-site, upgradient plume (Figure 27). The PCE concentration is close to the criterion. Well EW-14D has the greatest variability in TCE concentrations of all of the wells evaluated for contaminant concentration trends (Figure 21).

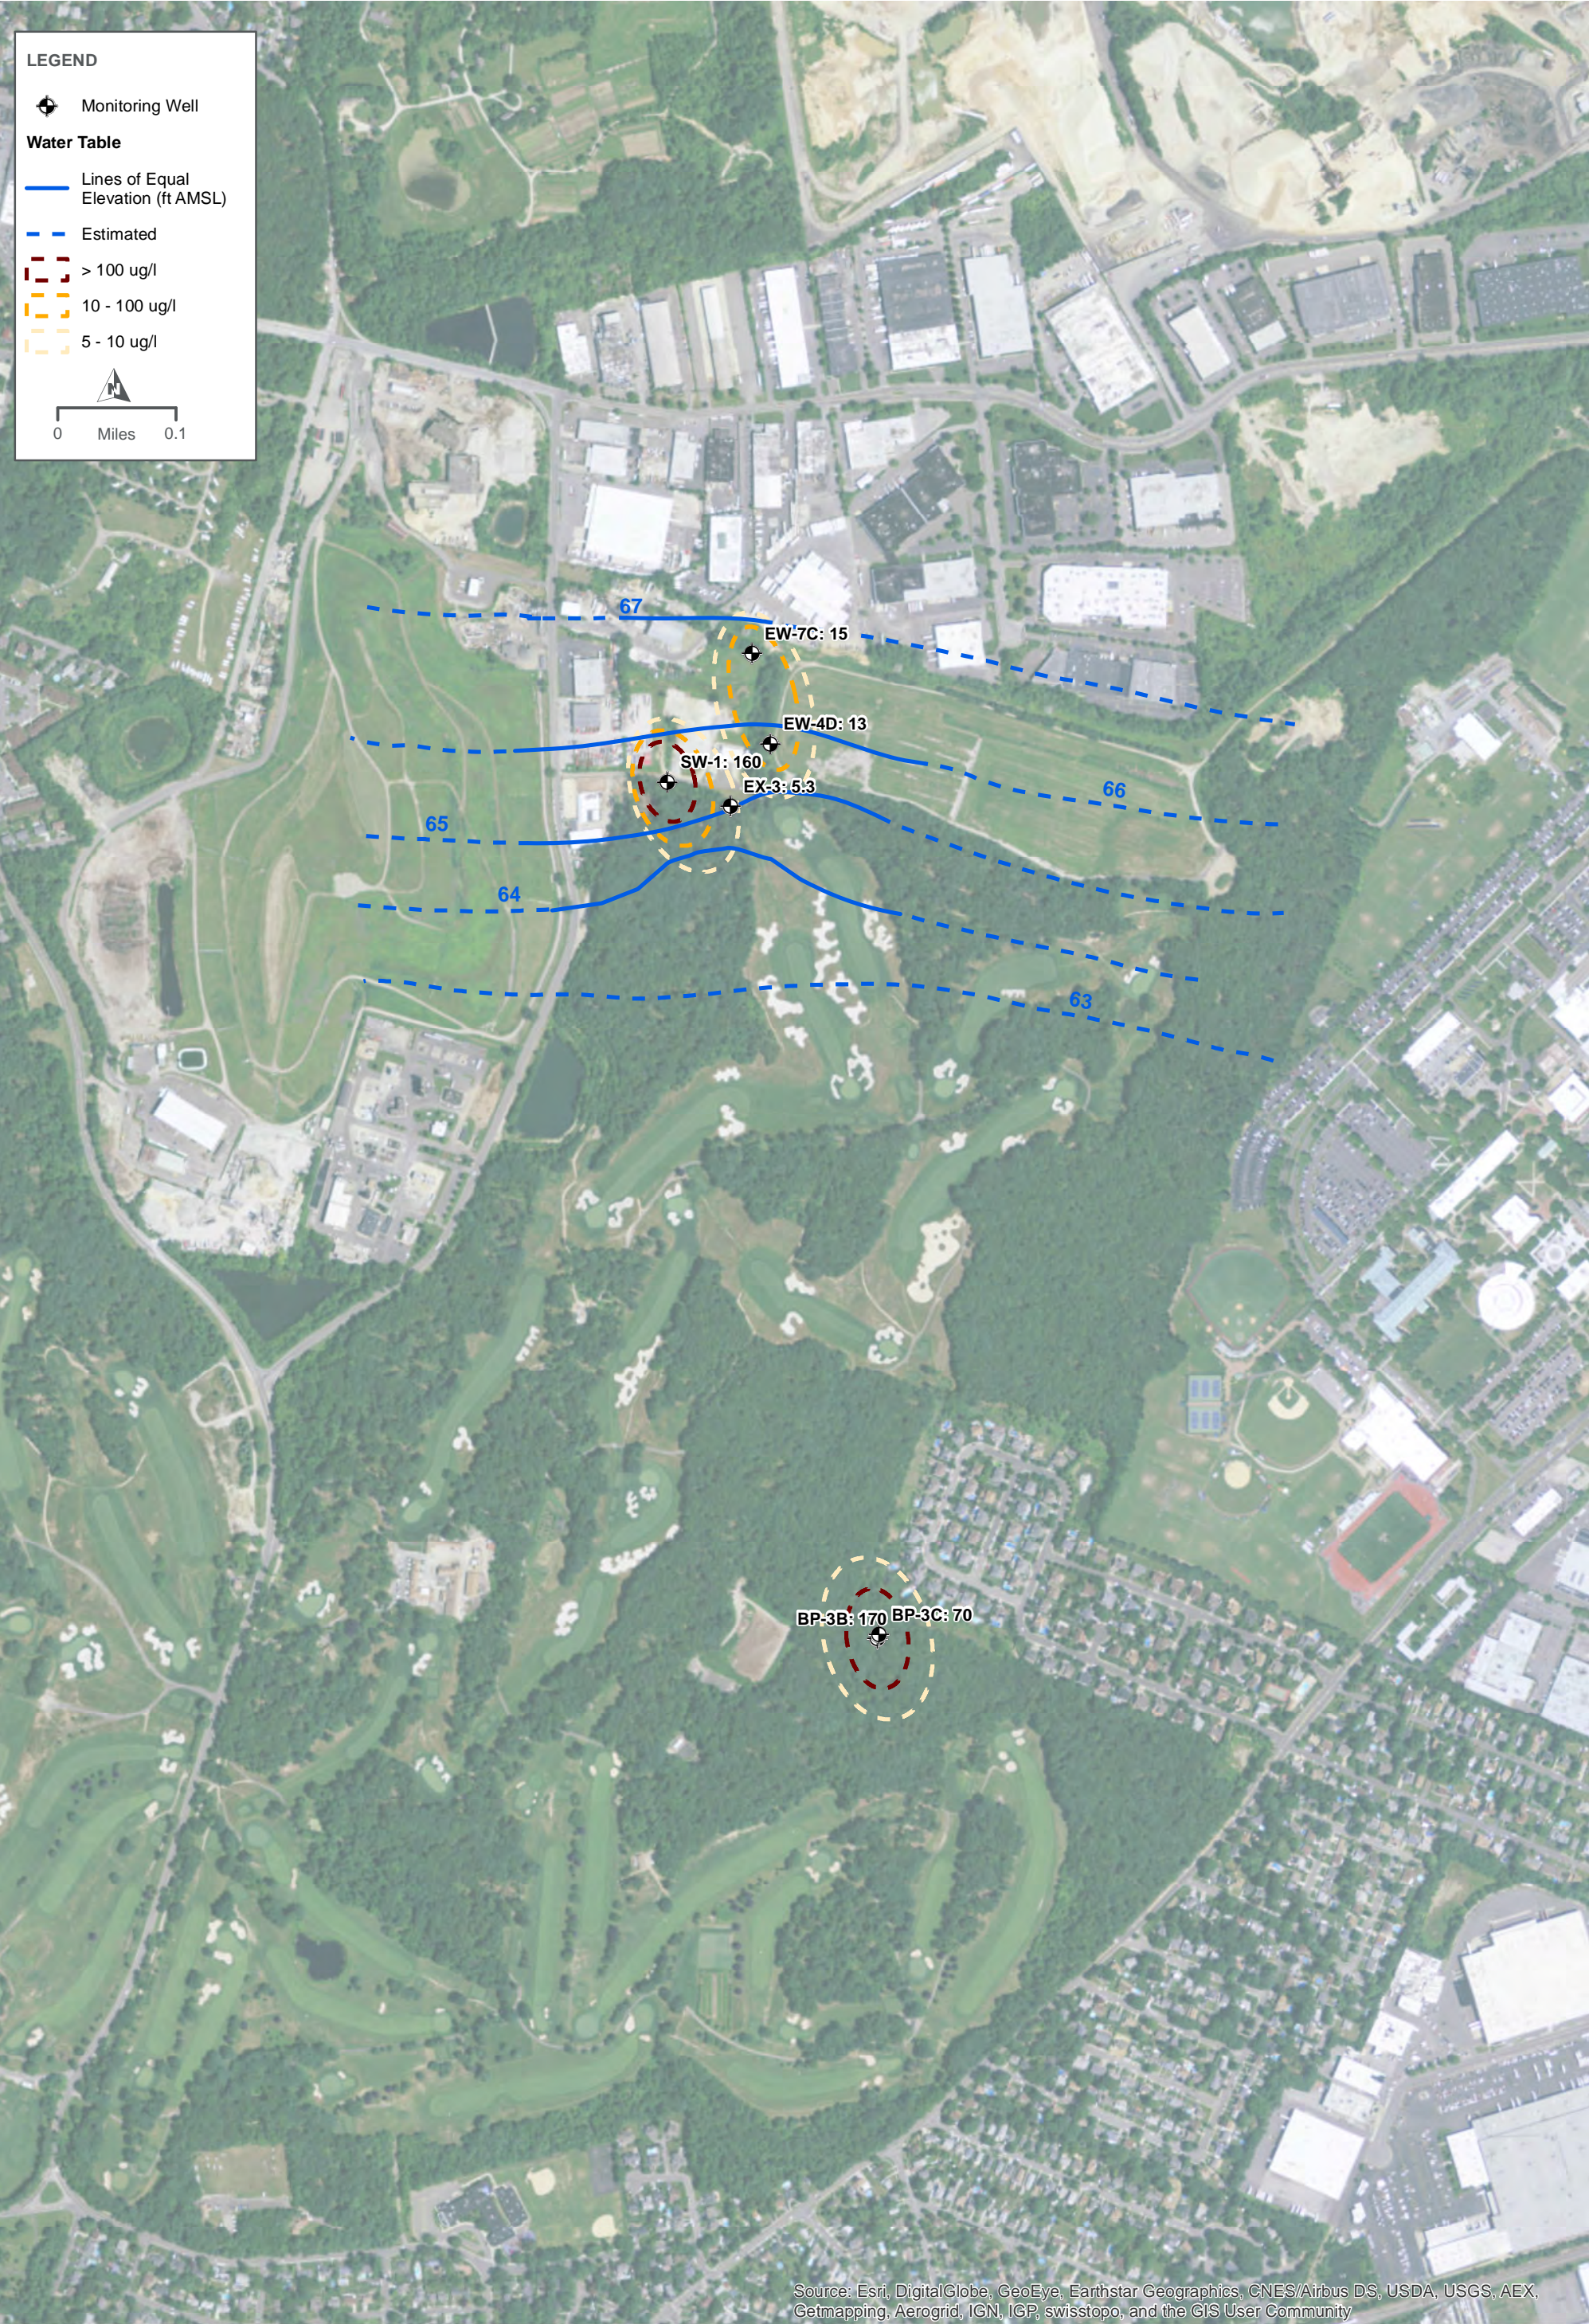
The groundwater contamination distribution was evaluated by creating sample location figures with iso-concentration lines for PCE and TCE in plan view and cross section (Figures 26 through 32).

Off-site, upgradient plume. This plume is first detected at the farthest upgradient well cluster, the EW-7 series, and flows southeast with only the western portion captured by the CPC system (Figures 26 and 27). The off-site plume is predominantly TCE, with TCE concentrations typically an order of magnitude greater than the PCE concentrations (Figure 16). TCE concentrations increased over 100 µg/L in the first two quarters of 2015 in well EW-7C, although the overall trend in TCE concentrations since 2011 is decreasing. The off-site, upgradient plume extends at least as far south-southeast as the MW-10 series wells.

Southern Area. This location is centered on the BP-3 series wells far south of the CPC site (Figures 26 and 27). The concentration of PCE is higher than the concentration of TCE by approximately an order of magnitude (Table 3). The source of groundwater contamination at the BP-3 series wells has not been investigated.

- Additional investigation to identify the source(s) of PCE and TCE detected in groundwater samples from the BP-3 series well cluster and at EW-14D.
