# 2015 Third Quarter Groundwater Monitoring Report July – September 2015

Claremont Polychemical Corporation Site

505 Winding Road  
Old Bethpage, Nassau County, New York 11804  
Contract/WA No. D007625-19; Site No. 130015

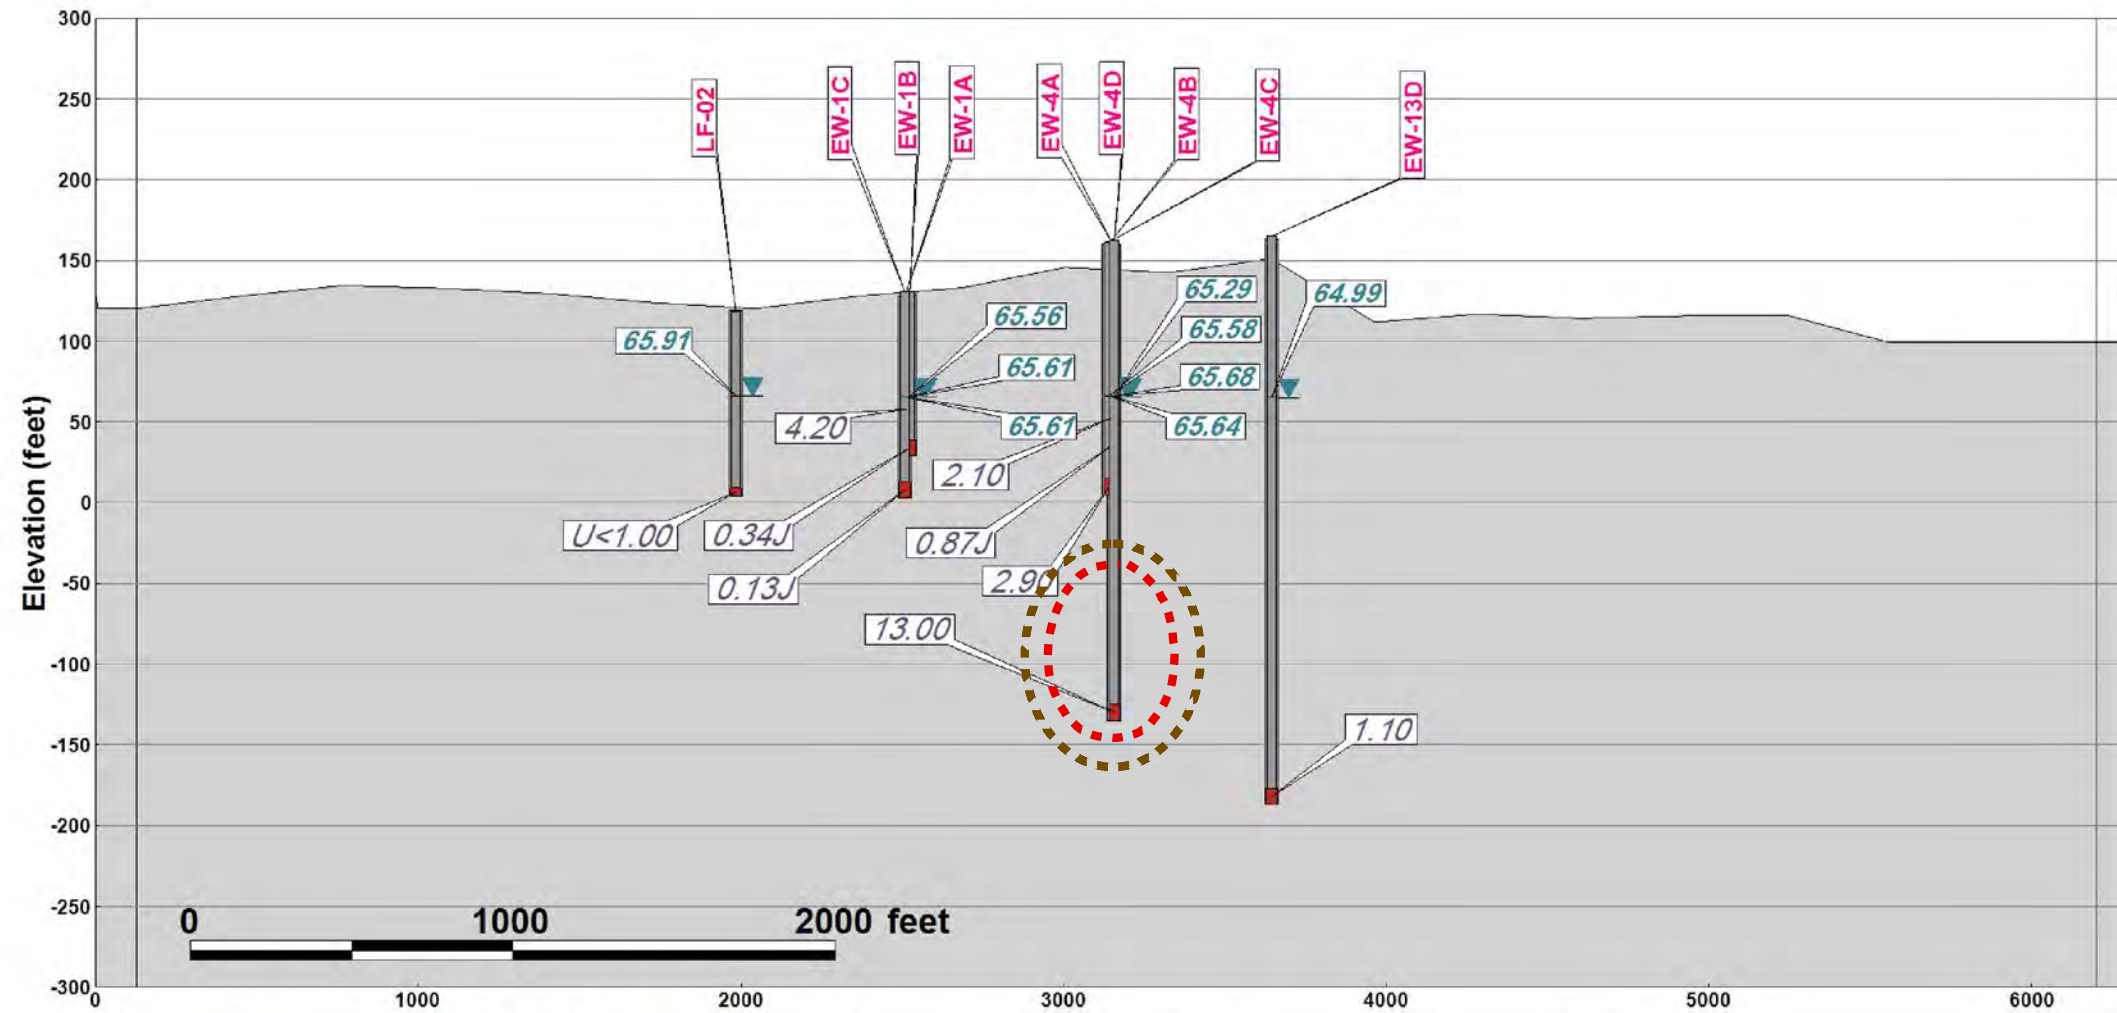
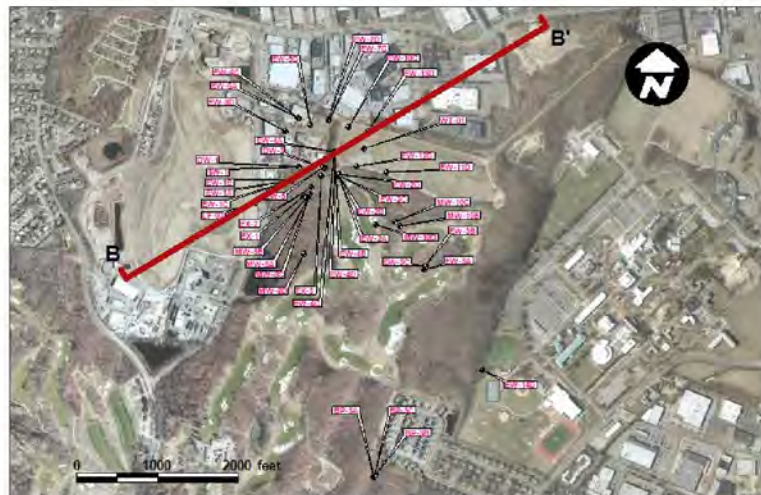
FIGURE 29

Figures 28, 29 and 30 depict PCE concentrations in wells to the east, center, and to the west of the Site and show the vertical extent of PCE. PCE was detected at 15 µg/L at 89.6 feet bgs in EW-7C (Figure 28, Cross Section A – A'); 13 µg/L at 98.6 feet bgs at EW-4D (Figure 29, Cross Section B – B'); and 160 µg/L at 65.84 feet bgs at well SW-1 (Figure 30, Cross Section C - C').

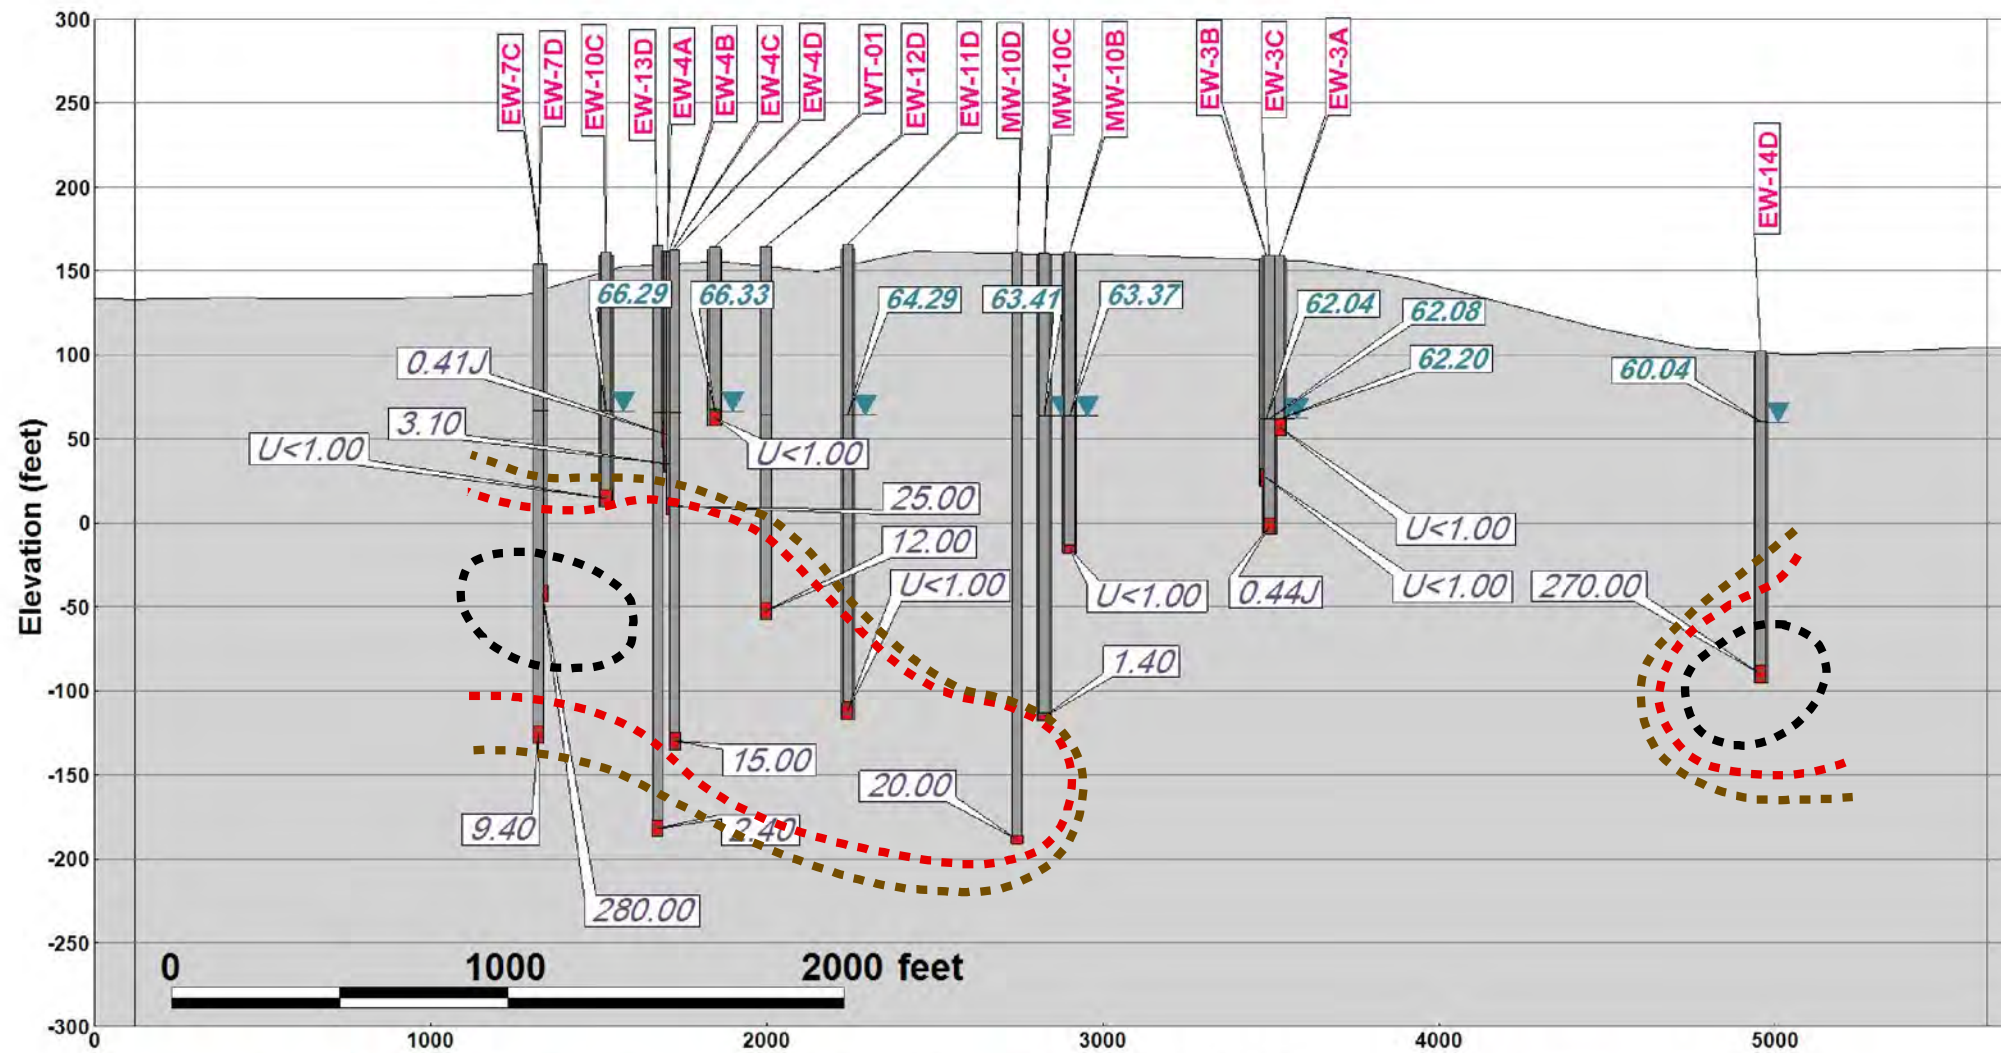
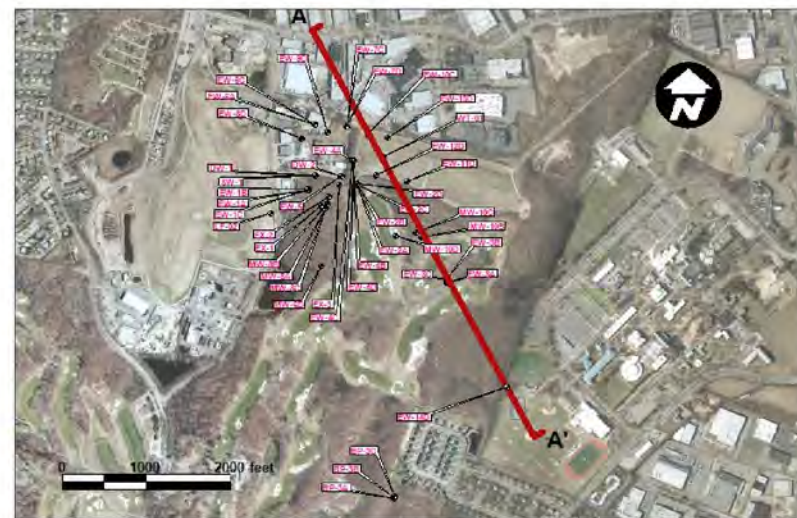
FIGURE 31

Figures 31 and 32 depict TCE concentrations in wells to the east and west of the Site and show the vertical extent of TCE. TCE was detected at 280 µg/L at 89.6 feet bgs at well EW-7C and 270 µg/L at 43.74 feet bgs at well EW-14D. TCE was not detected at concentrations above the groundwater quality standard to the west of the Site (Figure 32, Cross Section B – B').

TRICHLOROETHENE CROSS SECTION  
CLAREMONT POLYCHEMICAL CORPORATION
