2018 Second Quarter Groundwater Monitoring Report

Claremont Polychemical Corporation Site

Contract/WA No. D0076025-28; Site No. 130015

August 1, 2018

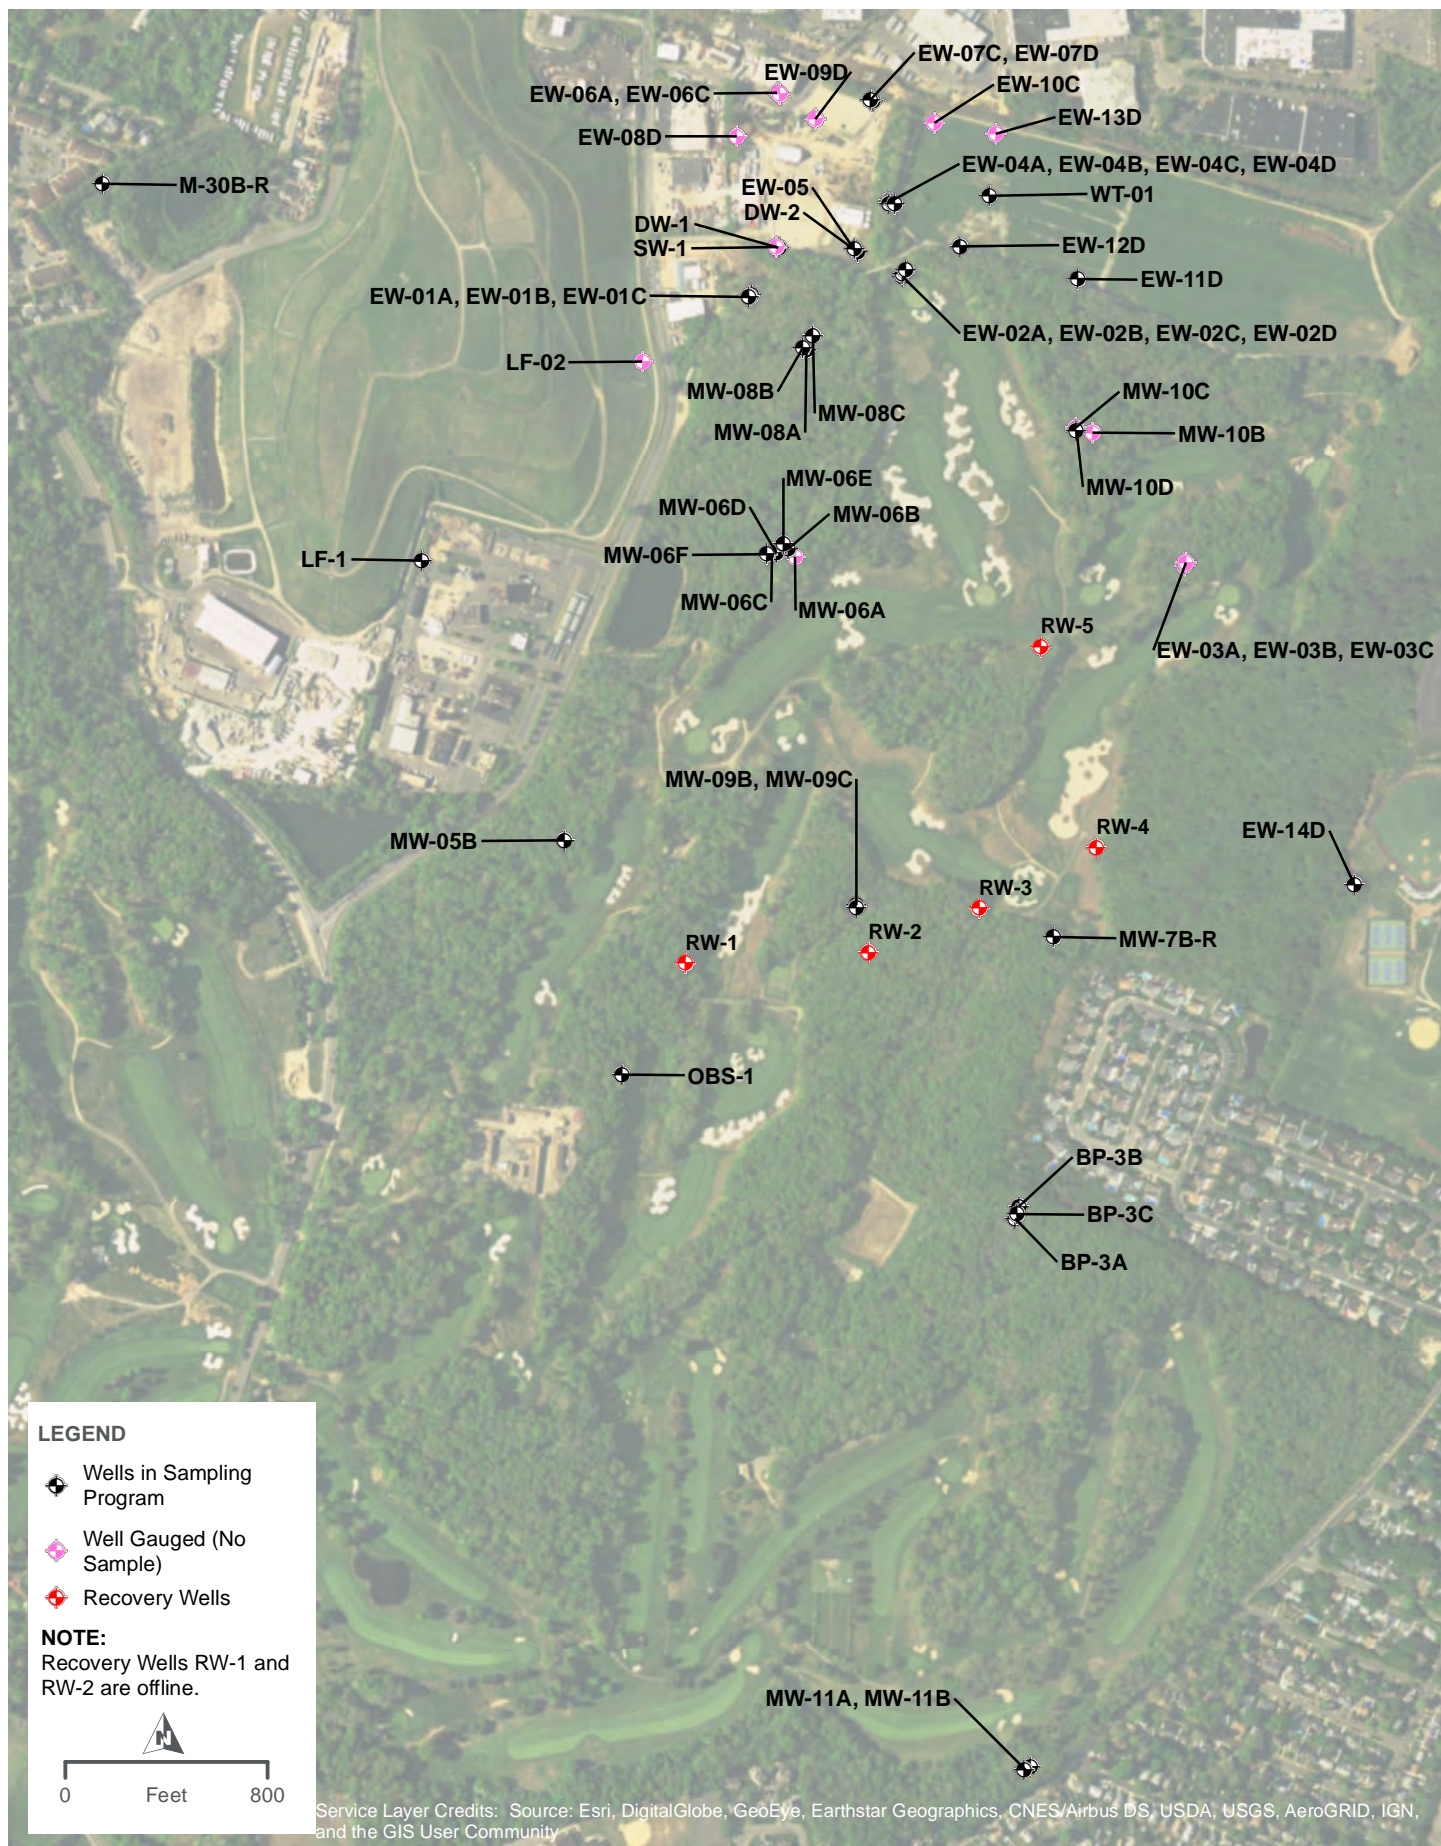
FIGURE 2

A network of 43 monitoring wells is used to monitor the groundwater quality and effectiveness of the GWE&T system (Figure 2). On March 12, 2018, HDR sampled 41 of the 43 monitoring wells (SW-1 was dry at the time of sampling, and MW-6A had insufficient water to collect a sample.). OU-4 monitoring wells sampled were DW-1, DW-2, EW-5, EW-7C, EW-7D, and WT-01. OU 5 wells sampled were BP-3A, BP-3B, BP-3C, EW-1A, EW-1B, EW-1C, EW-2A, EW-2B, EW-2C, EW-2D, EW-4A, EW-4B, EW-4C, EW-4D, EW-11D, EW-12D, EW-14D, LF-1, M-30B-R, MW-5B, MW-6B, MW-6C, MW-6D, MW-6E, MW-6F, MW-7B-R, MW-8A, MW-8B, MW-8C, MW-9B, MW-9C, MW-10D, MW-11A, MW-11B, and OBS-1. A description of the groundwater sampling event and results is provided below.

WELLS SAMPLED CLAREMONT POLYCHEMICAL CORPORATION

Sixteen wells were added to the CPC monitoring program as a result of the transition on October 1, 2016 to the OU-5 GWE&T system (Figure 2). The first quarter 2018 synoptic water level round

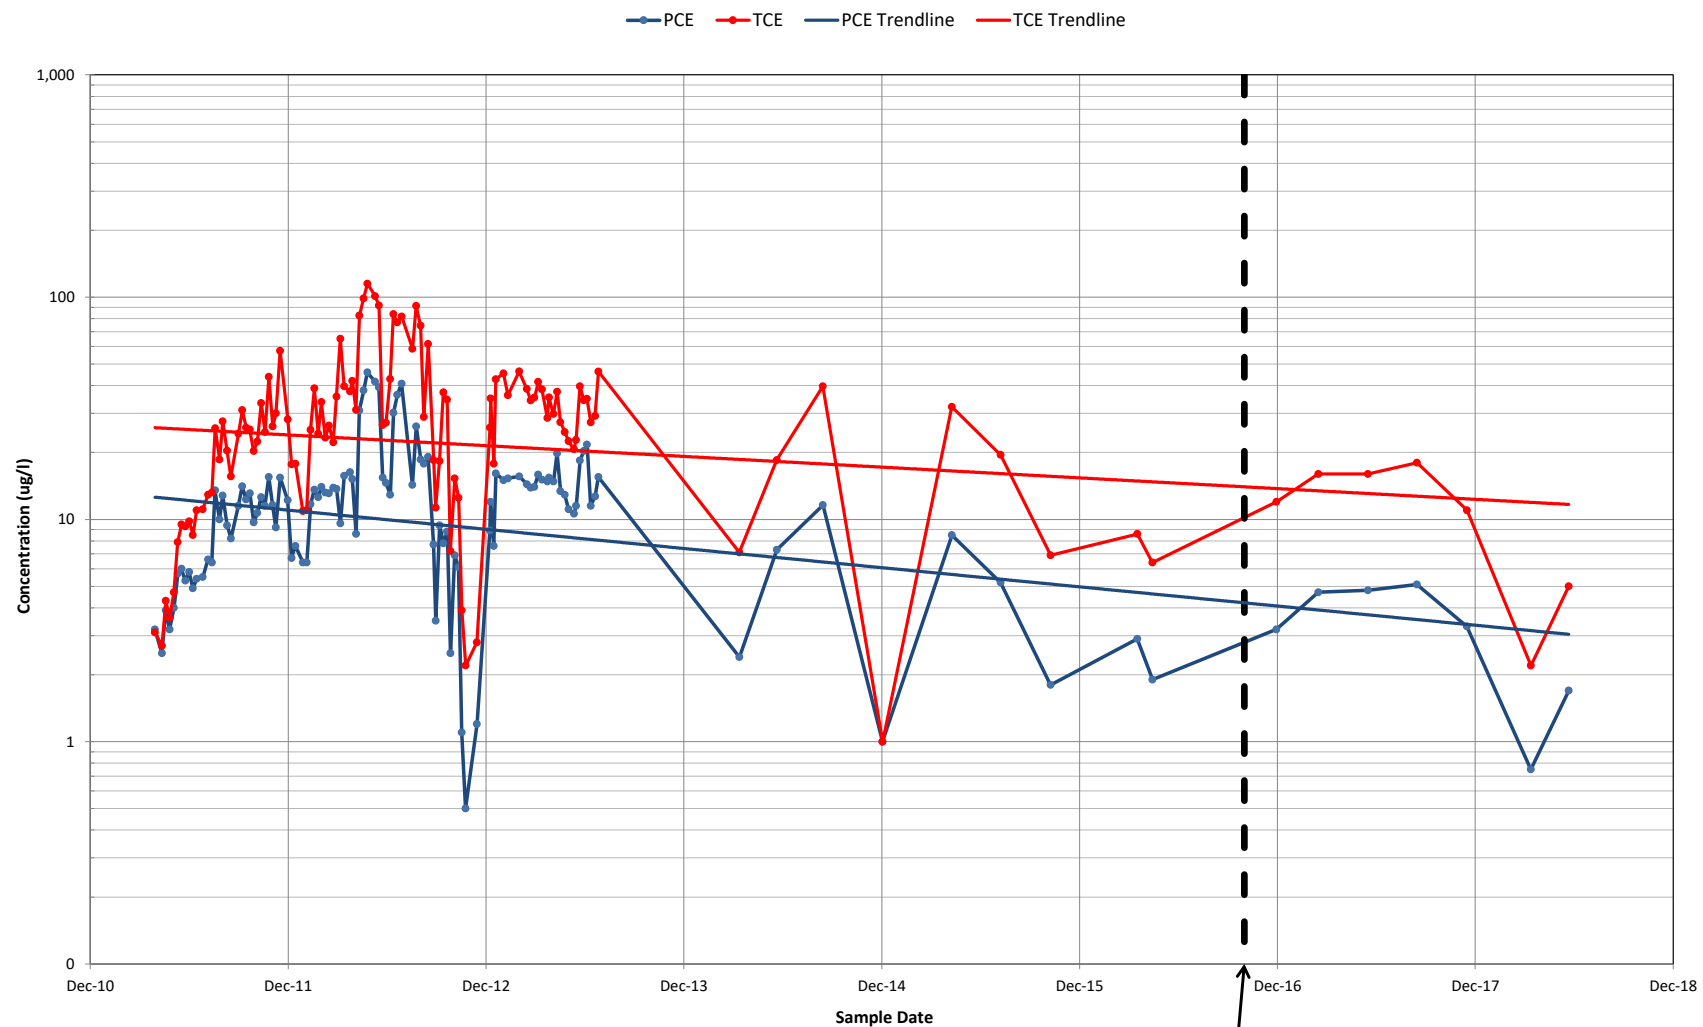
NYSDEC 703 Class GA: PCE, TCE = 5 ug/l
 Detection limits used to display non-detect results. How some reporting limits were generated is unknown.

PCE AND TCE CONCENTRATIONS
WELL RW-3
CLAREMONT POLYCHEMICAL CORPORATION OPERABLE UNIT 5
NYSDEC SITE #130015

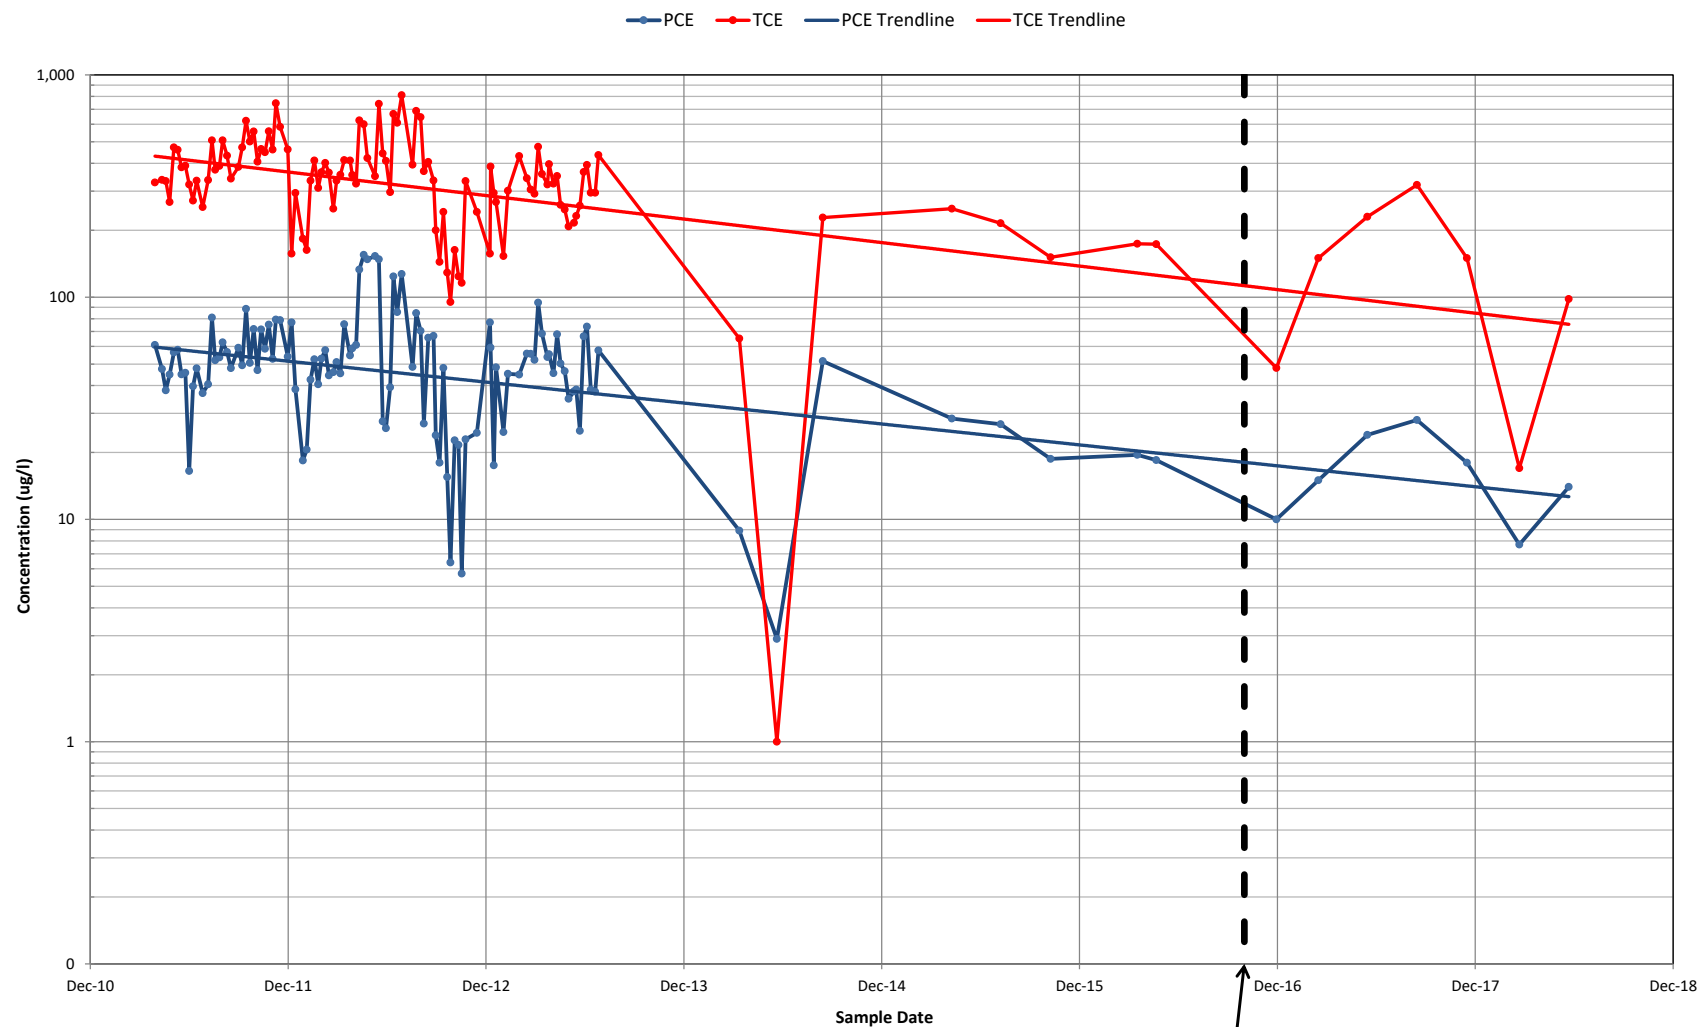
NYSDEC 703 Class GA: PCE, TCE = 5 ug/l
 Detection limits used to display non-detect results. How some reporting limits were generated is unknown.

PCE AND TCE CONCENTRATIONS
WELL RW-4
CLAREMONT POLYCHEMICAL CORPORATION OPERABLE UNIT 5
NYSDEC SITE #130015

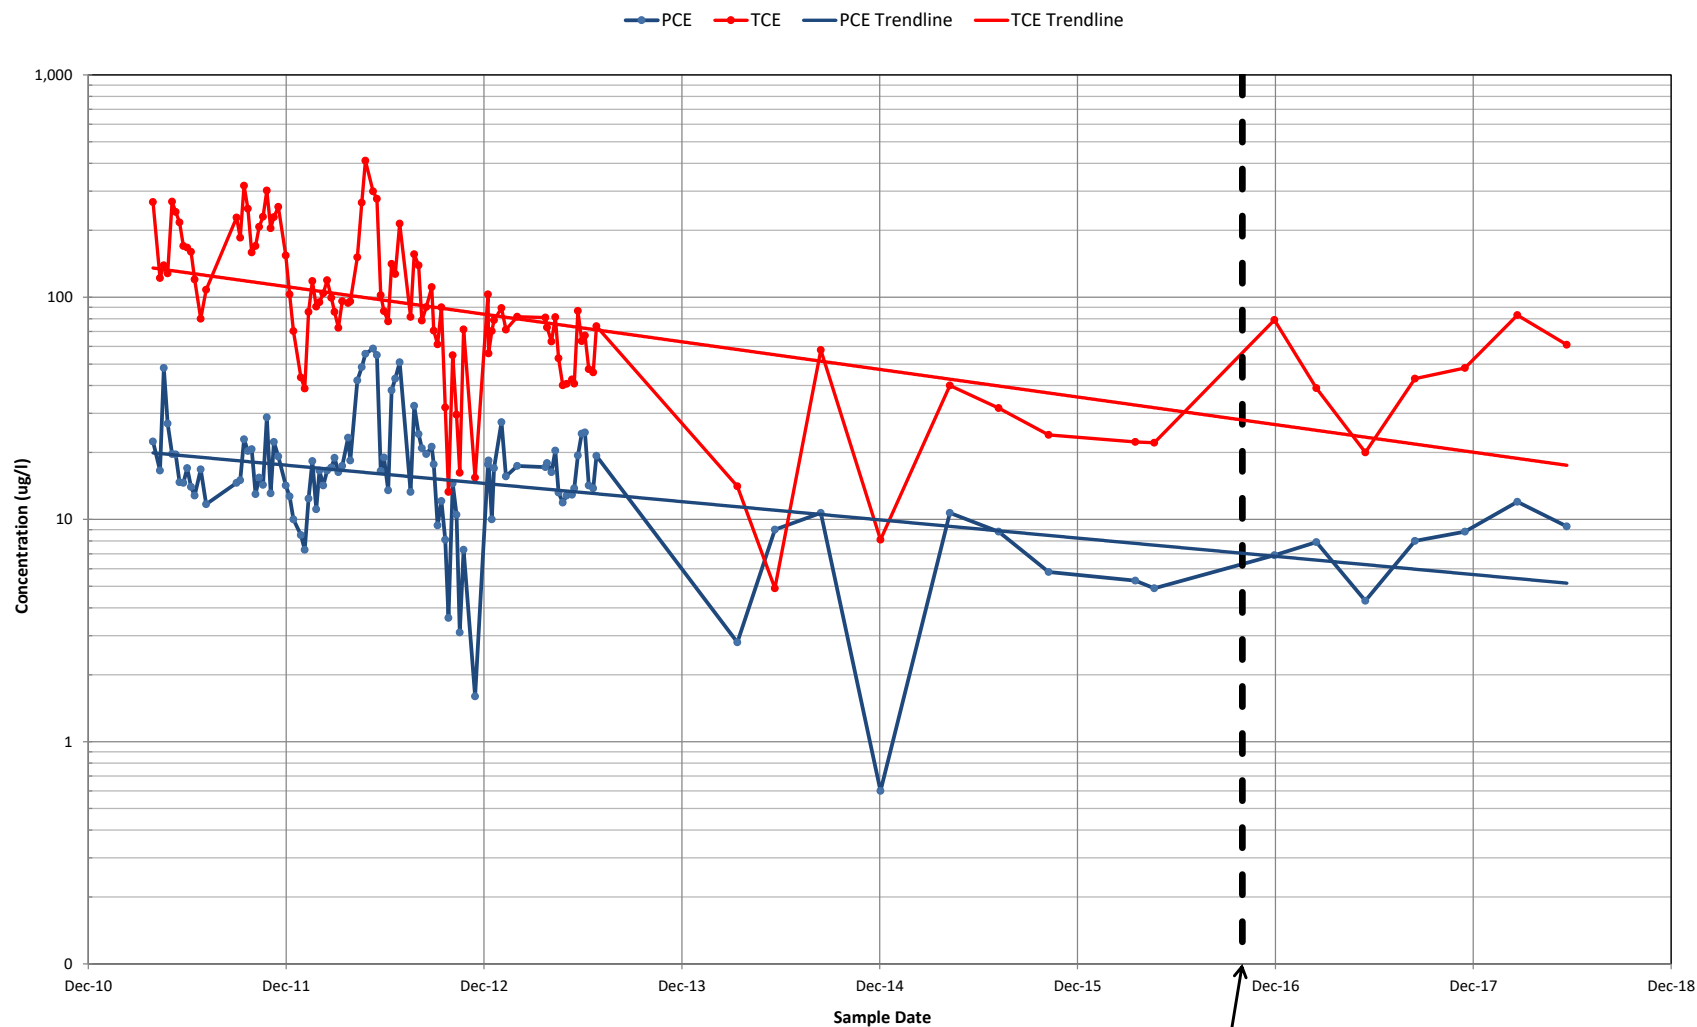
NYSDEC 703 Class GA: PCE, TCE = 5 ug/l
 Detection limits used to display non-detect results. How some reporting limits were generated is unknown.

PCE AND TCE CONCENTRATIONS
WELL RW-5
CLAREMONT POLYCHEMICAL CORPORATION OPERABLE UNIT 5
NYSDEC SITE #130015

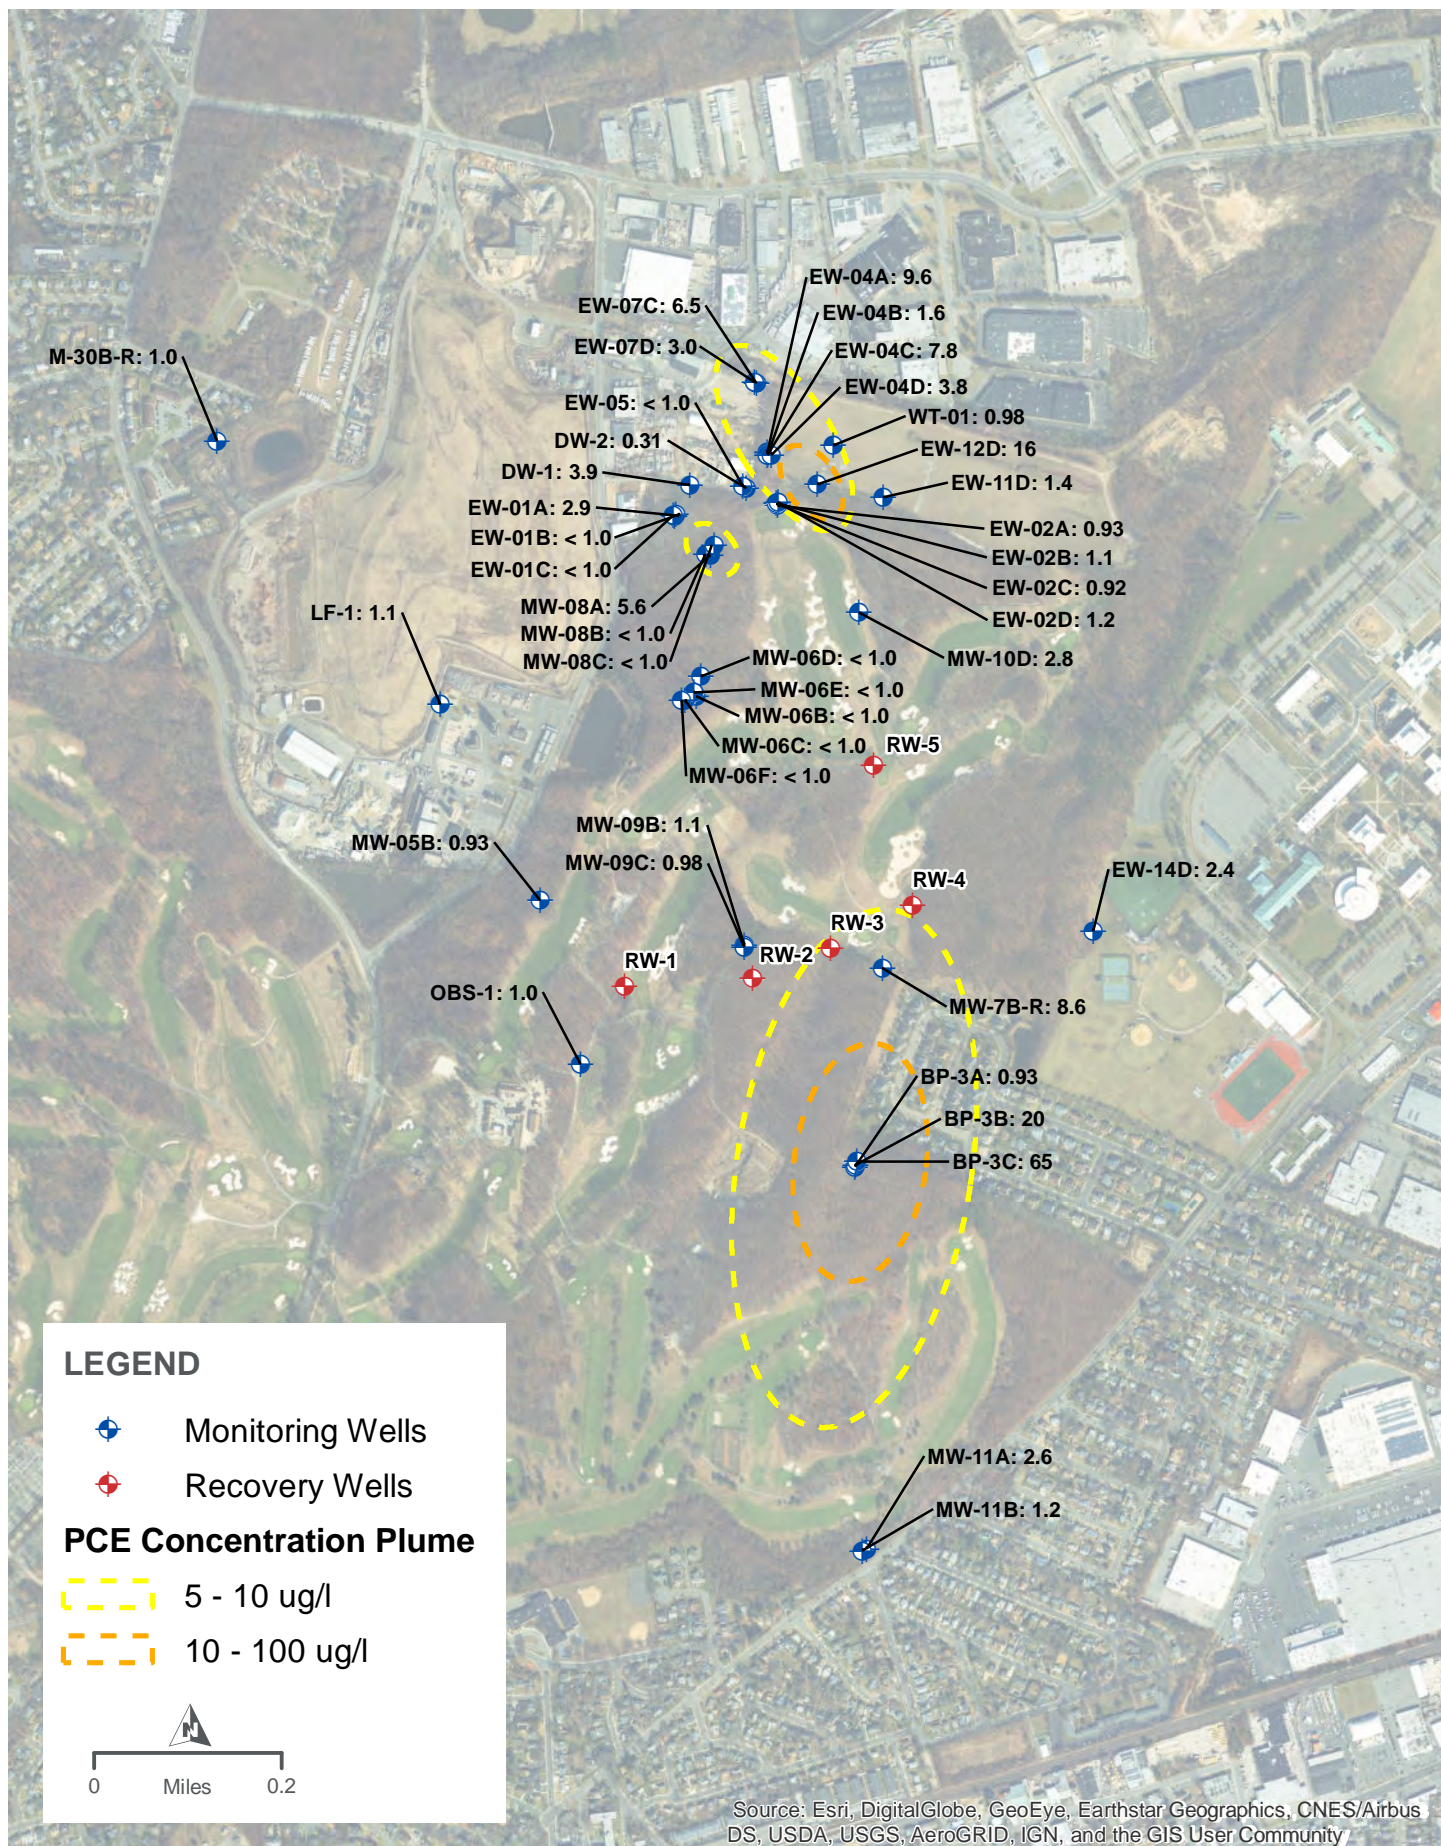
FIGURE 29

JUNE 2018 TETRACHLOROETHENE (PCE) PLUME
CLAREMONT POLYCHEMICAL CORPORATION

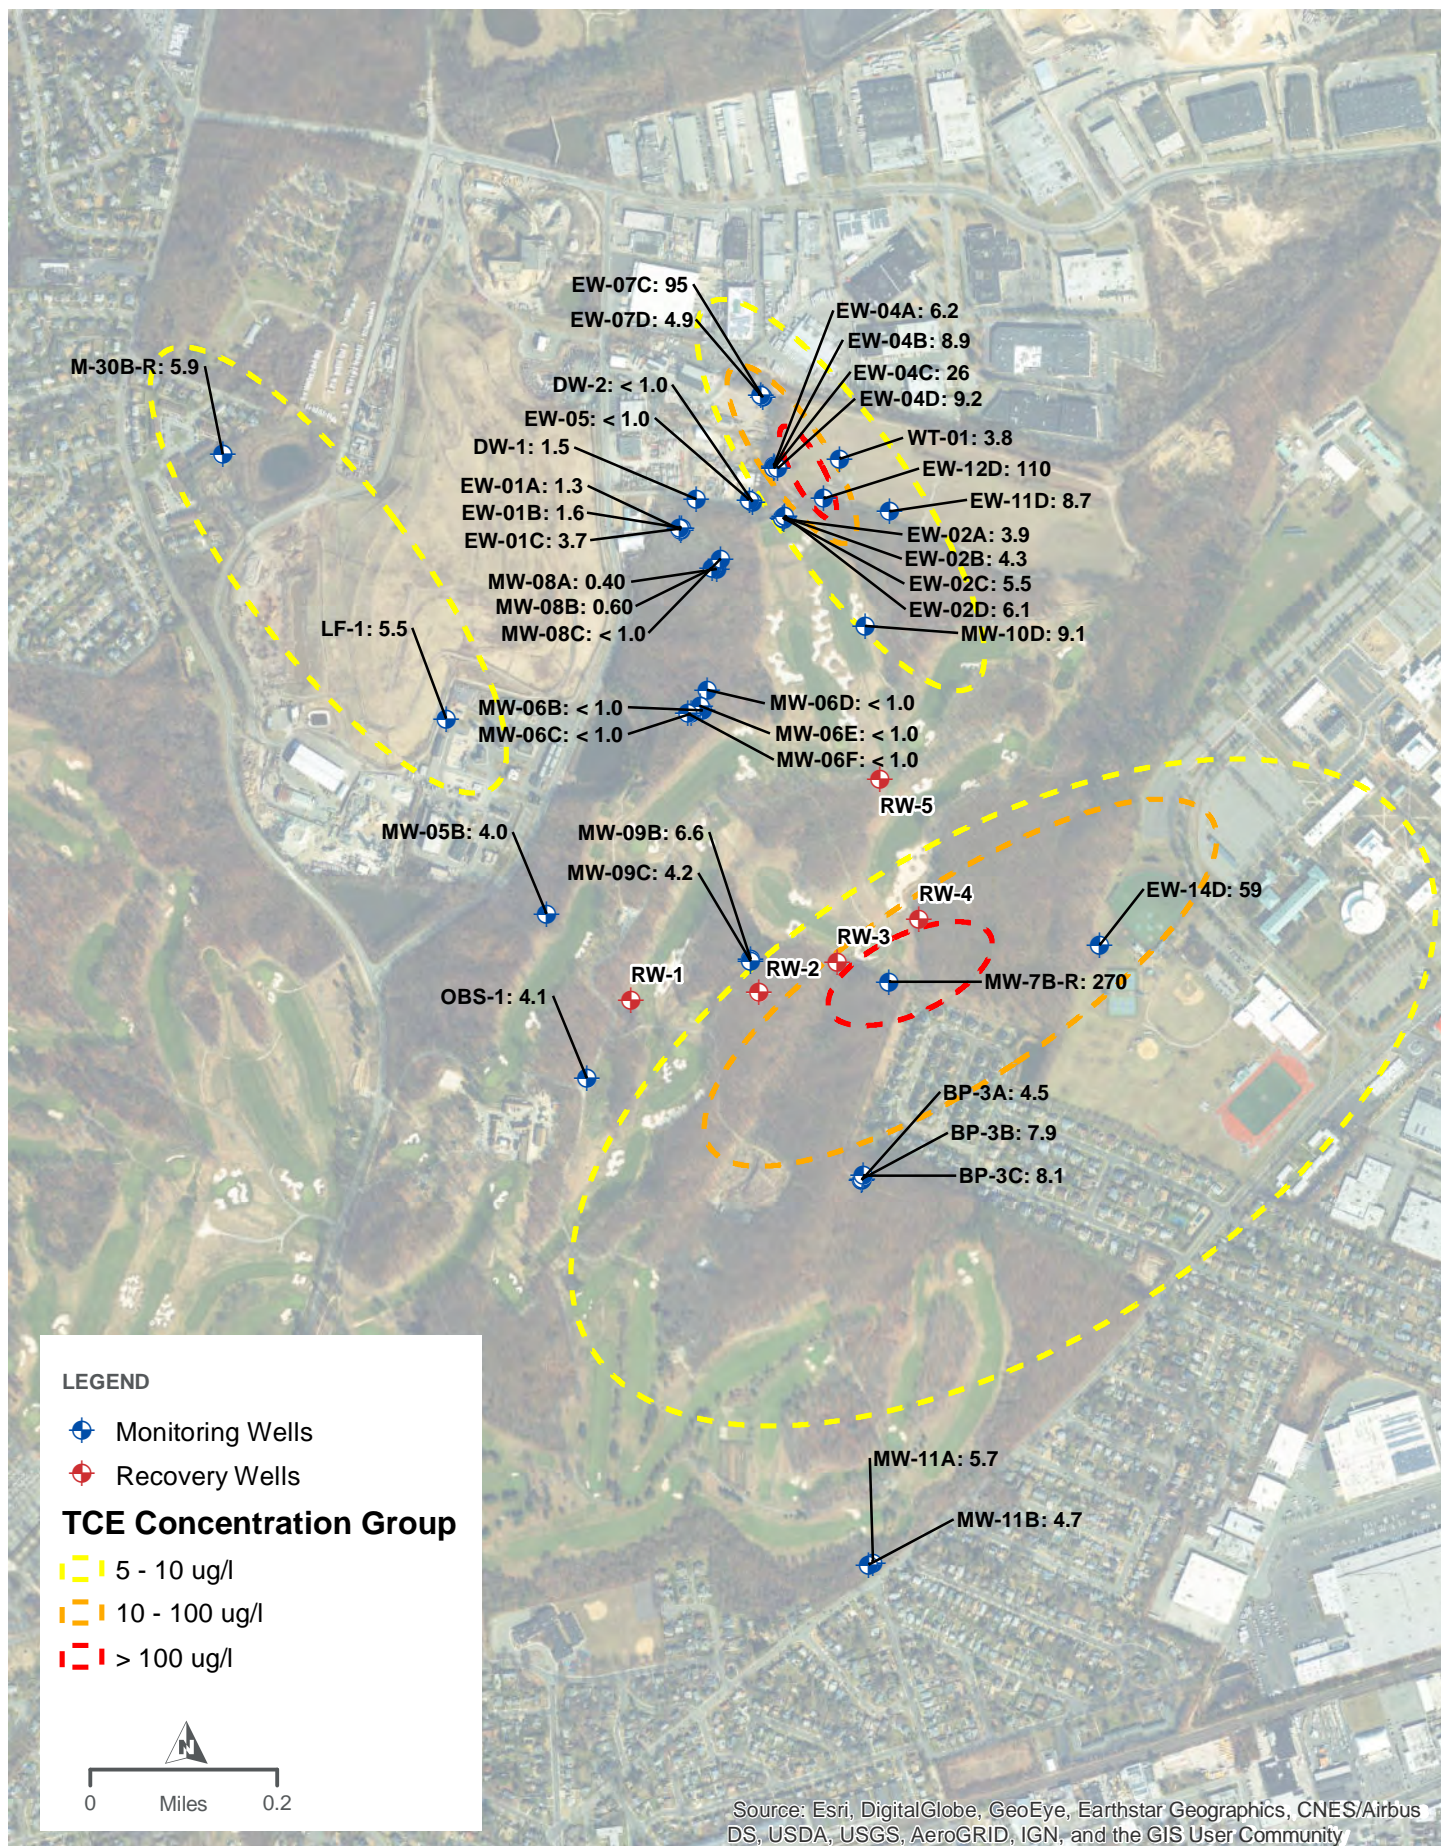
FIGURE 30

**JUNE 2018 TRICHLOROETHENE (TCE) PLUME
CLAREMONT POLYCHEMICAL CORPORATION**

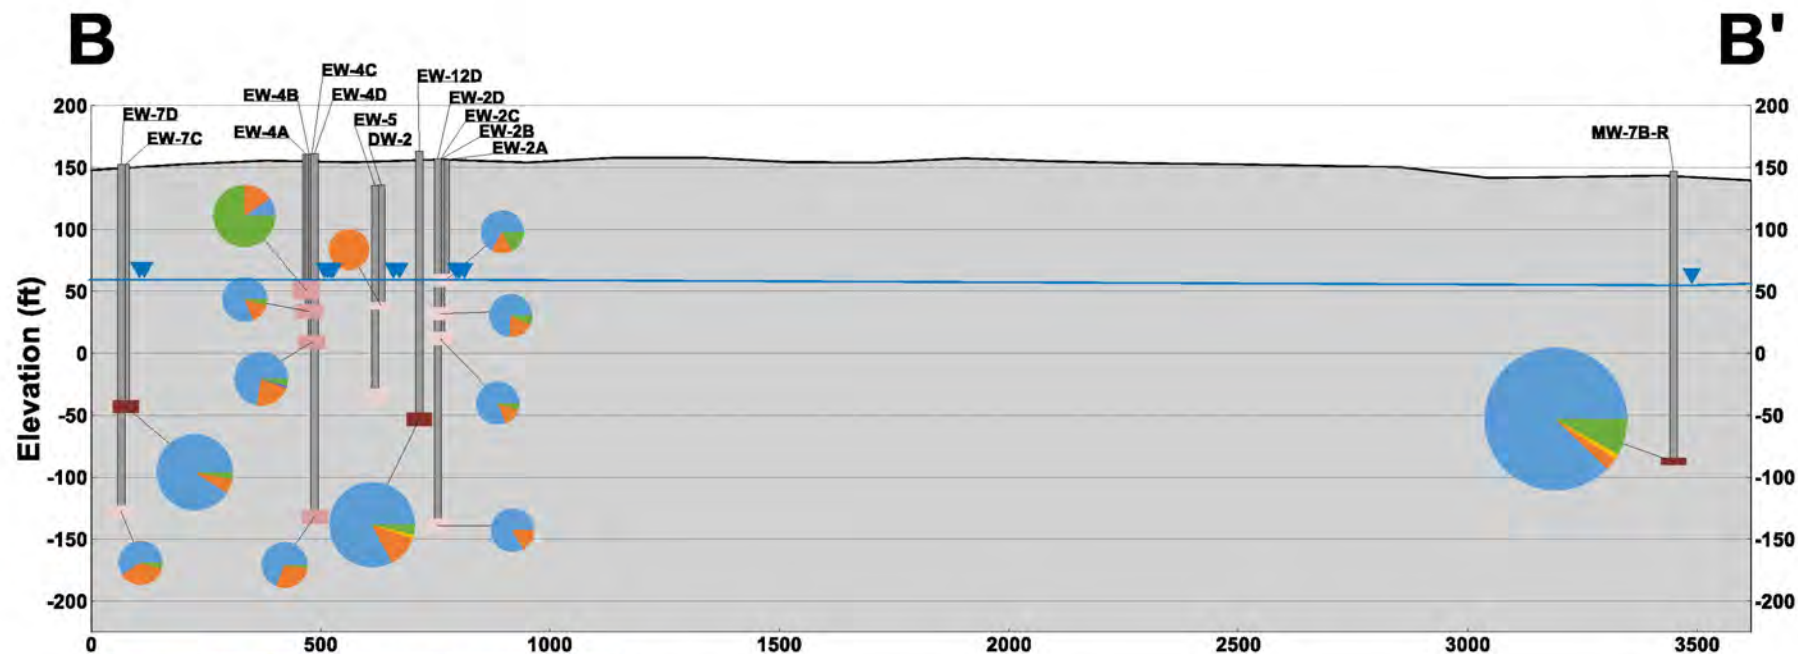
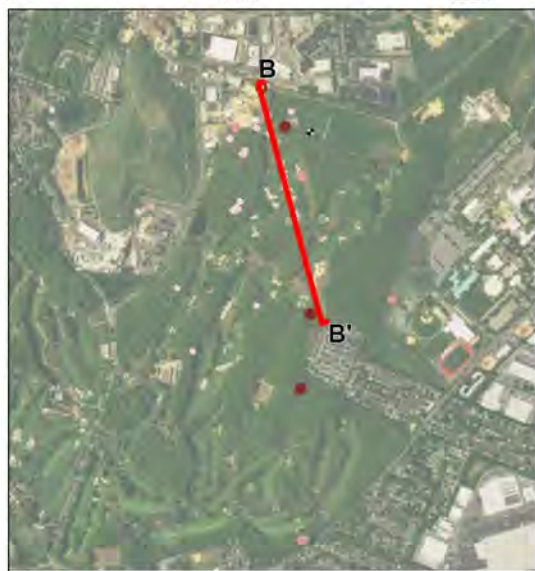
FIGURE 32

Cross section B-B' (Figure 32) begins east of A-A' at the EW-7-series wells and continues along the direction of groundwater flow to well MW-7B-R. PCE concentrations observed in wells in this cross section are below the 5 µg/l standard in the EW-2 series, DW-2, EW-05, EW-04B, EW-04D, and EW-07D.

CROSS SECTION TRANSECT B
 CLAREMONT POLYCHEMICAL CORPORATION
