## 2019 Third Quarter Groundwater Monitoring Report

July – September 2019

Claremont Polychemical Corporation Site

*Contract/WA No. D0076025-28; Site No. 130015*

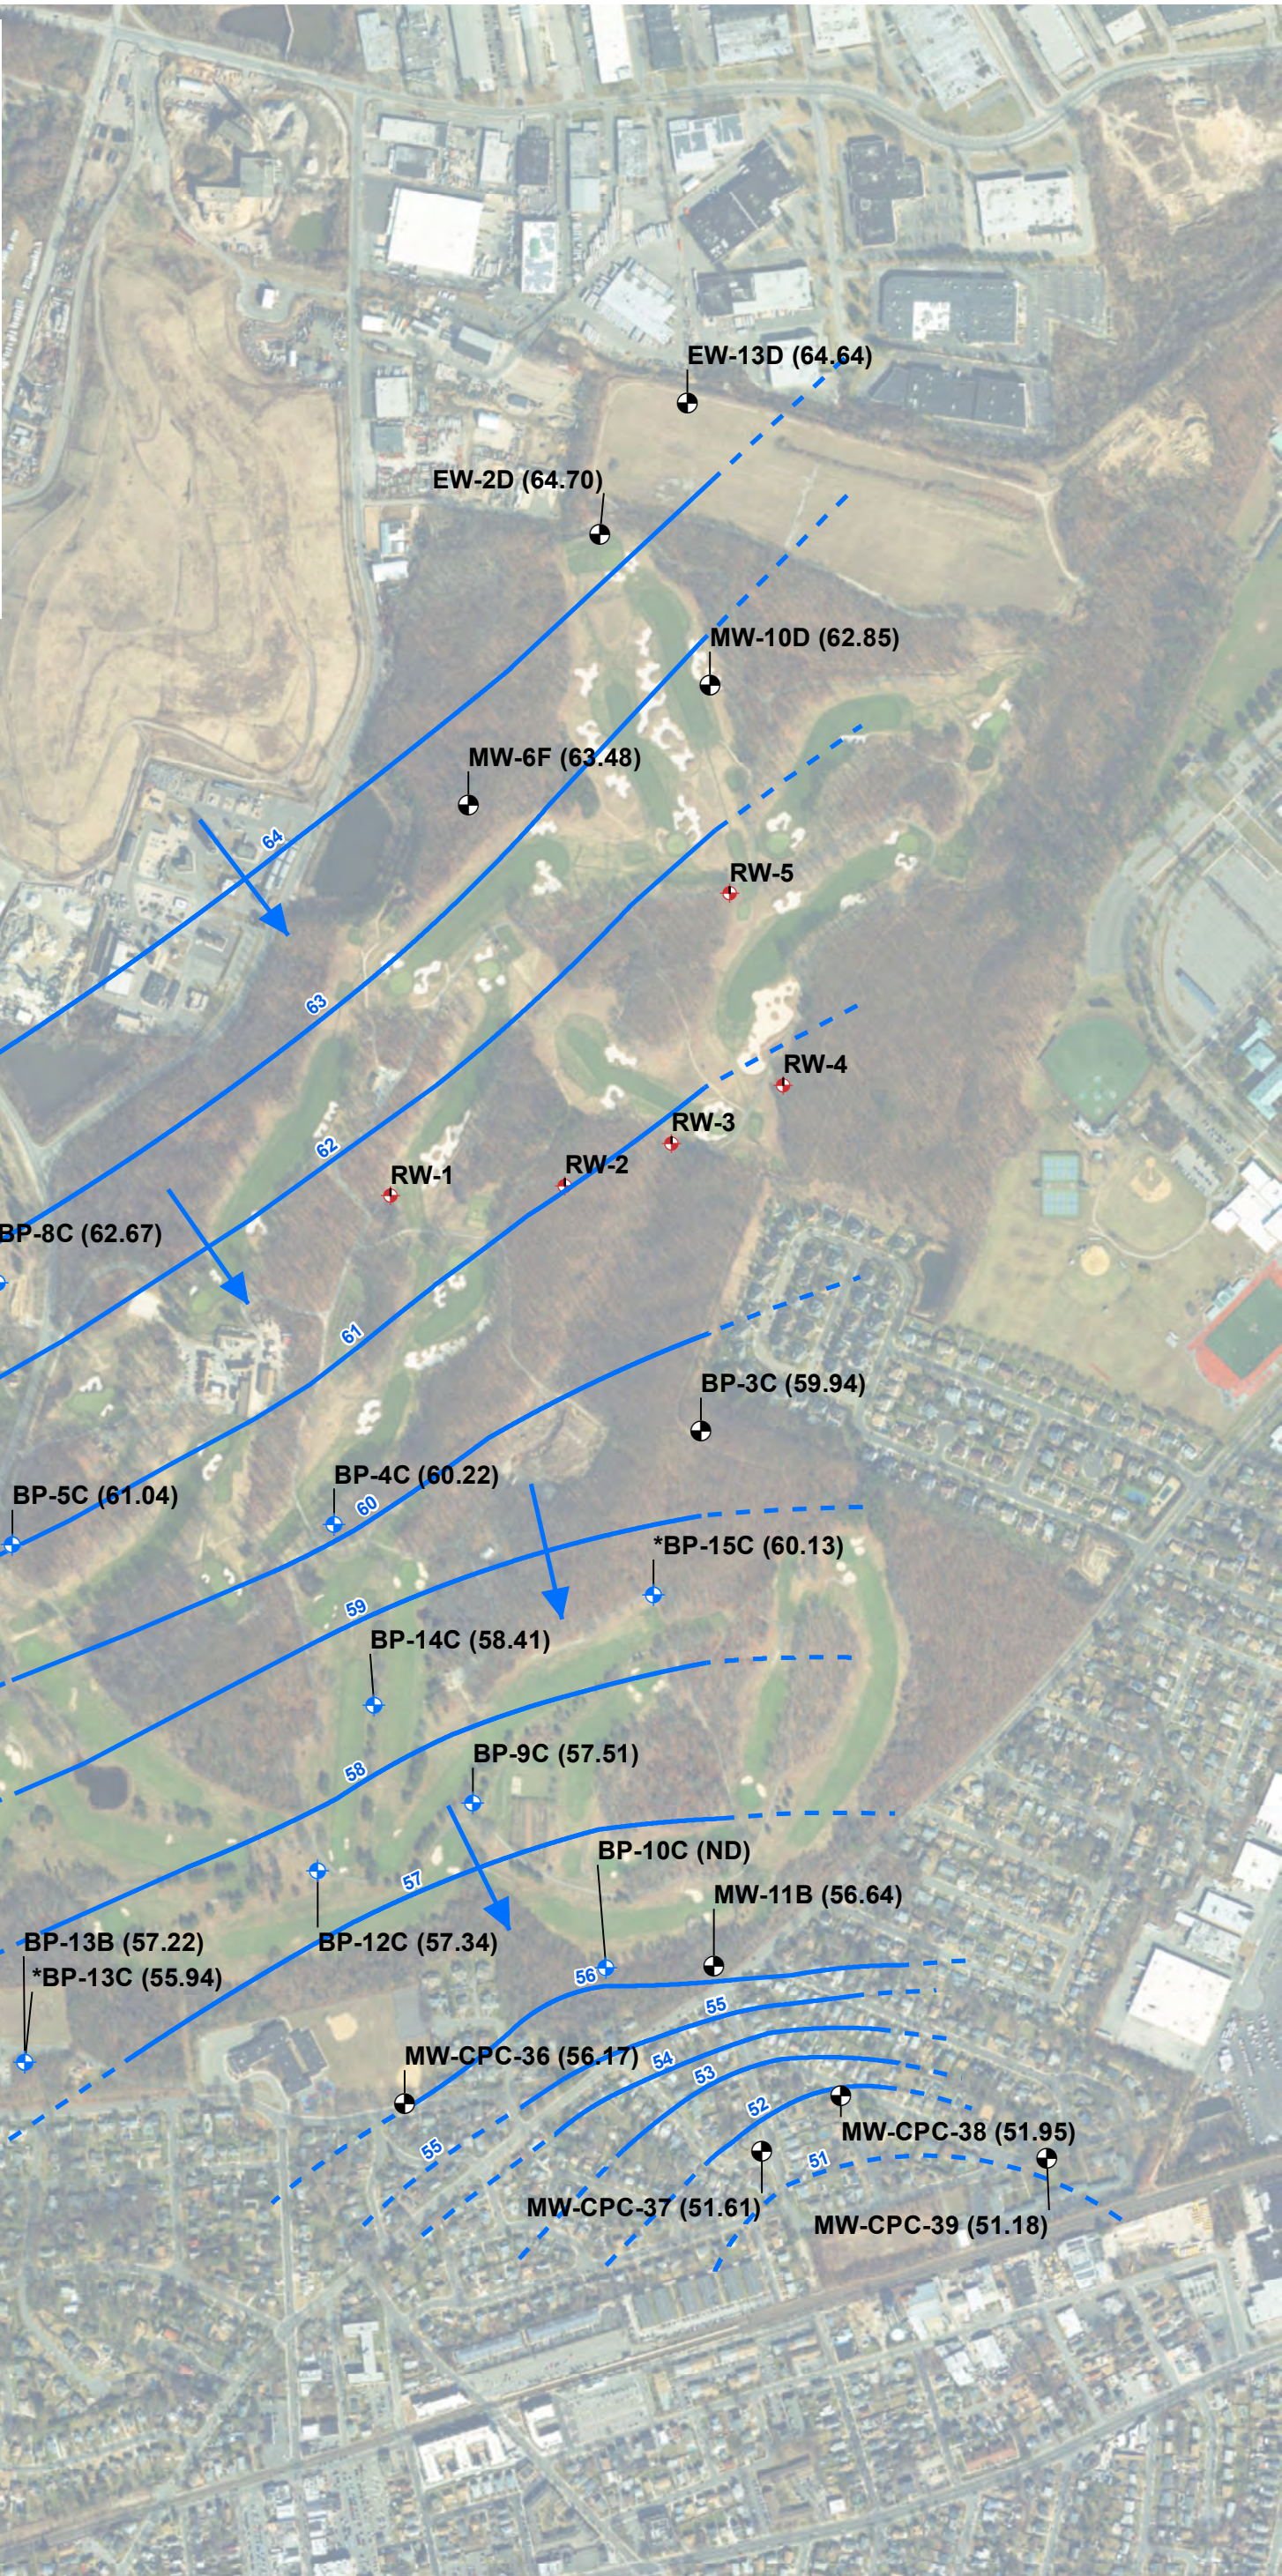
**SEPTEMBER 2019 POTENTIOMETRIC SURFACE - LOWER MAGOTHY**  
**DEEPER THAN -131 FT (NAVD 88)**  
**CLAREMONT POLYCHEMICAL CORPORATION**  
**FIGURE 5**

The contour maps produced from wells screened in both the upper glacial aquifer and the deeper Magothy aquifer depict a south-southeast flow direction (Figure 3, 4 and 5). The recent contour maps are generally consistent with previous maps produced from the CPC wells and from investigations by others.

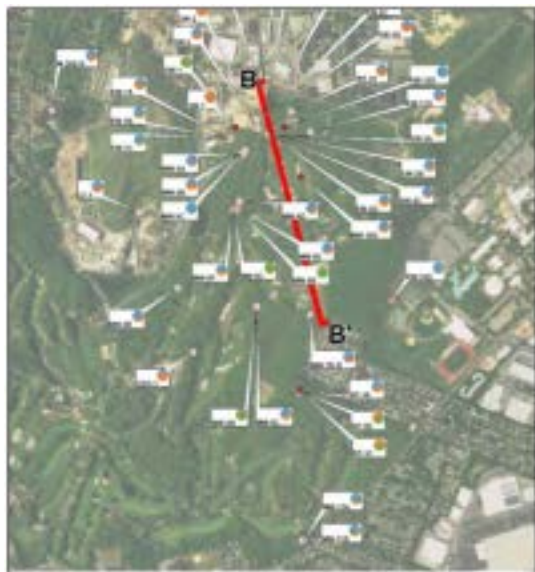
**FIGURE 32**

Cross section B-B' (Figure 32) begins east of A-A' at the EW-7-series wells and continues along the direction of groundwater flow to well MW-7B-R. PCE concentrations observed in wells in this cross section are below the 5 µg/L standard in the EW-2 series wells and at wells DW-2, EW-5, EW-4B, EW-4C, EW-4D, EW-7D, and MW-7B-R. TCE concentrations observed in wells in this cross section are below the 5 µg/L standard in the EW-2 series wells and at wells DW-2, EW-4A, EW-4B, EW-4D, EW-5, and EW-7D.

**CROSS SECTION TRANSECT B  
CLAREMONT POLYCHEMICAL CORPORATION**
