Monthly Report of the Operations & Maintenance Activities

Claremont Polychemical Operable Unit 5
Groundwater Treatment System

Old Bethpage, New York
August 2019

NYSDEC Standby Engineering Contract
Work Assignment #D0076025-28

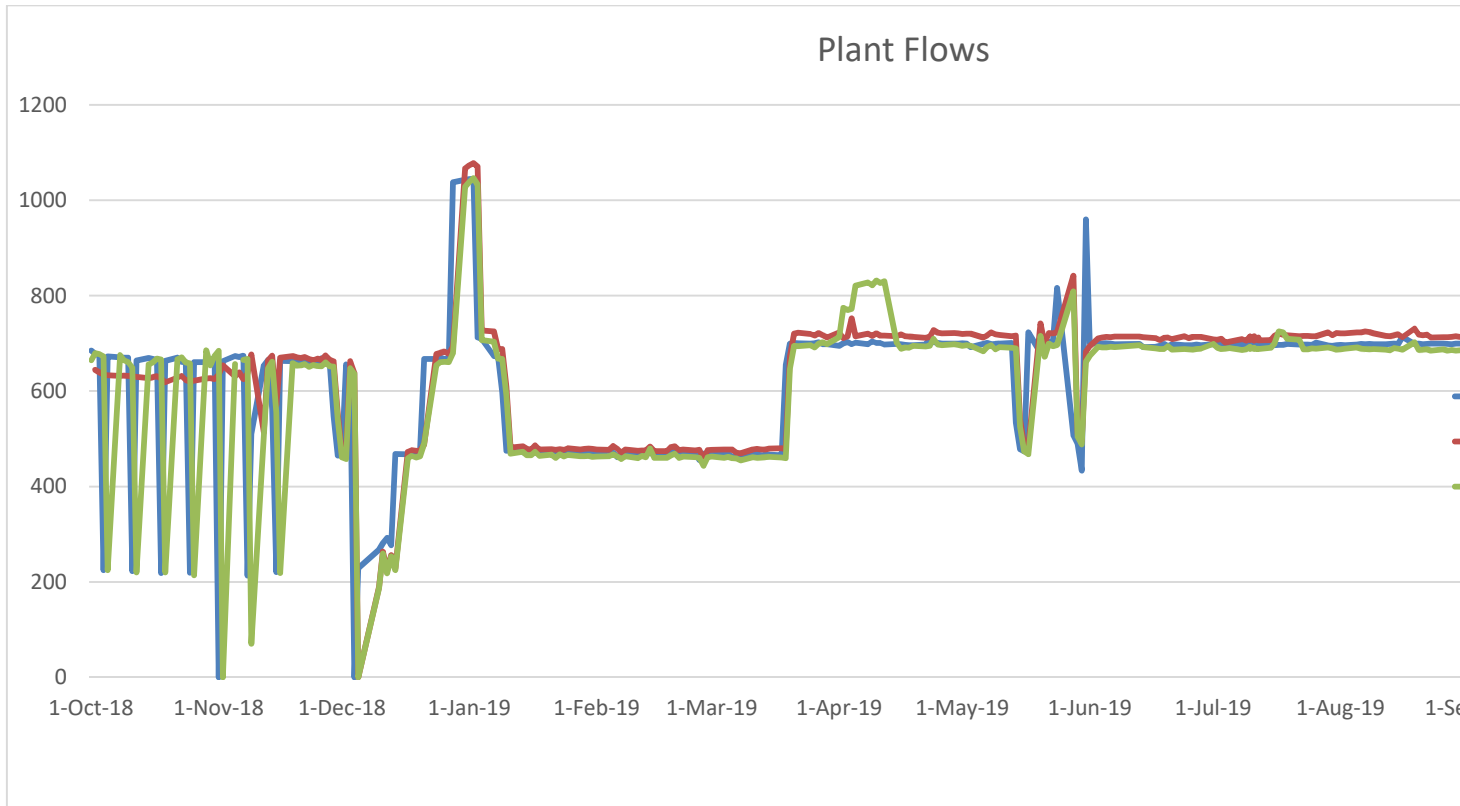
Figure 1 – Plant Discharge Daily Flow

The total volume of treated water discharged from 0730 hours on August 1, to 0730 hours on September 1, was ~30,782,000 gallons. The data in Table 1 shows recent historic flows discharged from the plant.

A graphic representation of the system's daily plant discharge output is provided in Figure 1 and the daily plant totalizer readings for August are provided in Table 4, both following the text of this
