Monthly Report of the Operations & Maintenance Activities

Claremont Polychemical Operable Unit 5
Groundwater Treatment System

Old Bethpage, New York
February 2020

NYSDEC Standby Engineering Contract
Work Assignment #D0076025-28

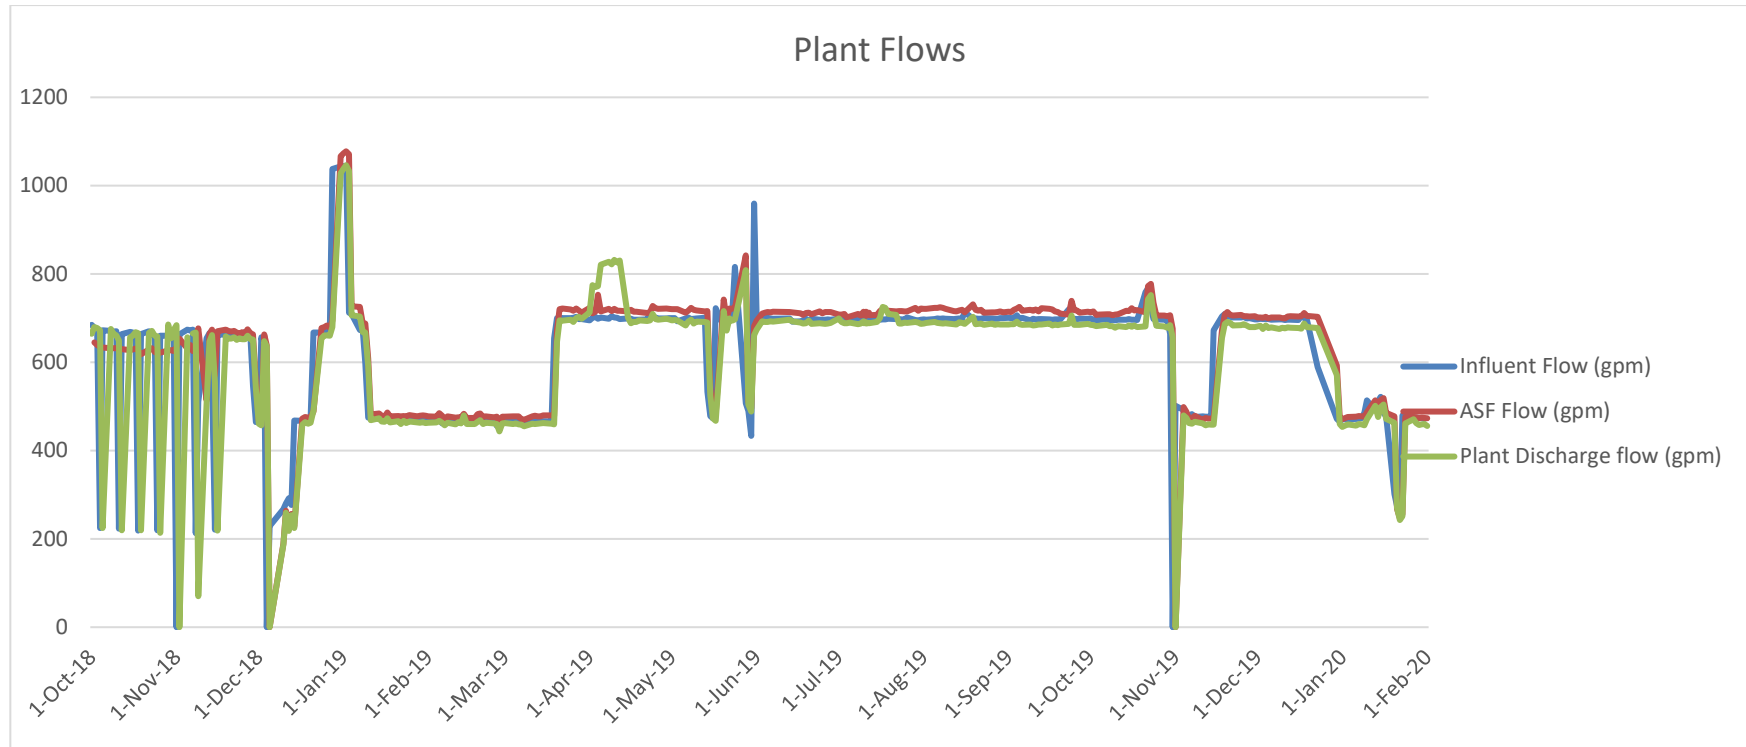
Figure 1 – Plant Discharge Daily Flow

The volume of treated water discharged by the treatment plant to the selected recharge basin is generally determined daily from readings of the plant effluent flow meter output. During the February period, the HMI readings were recorded. The plant continued to operate in the auto mode. The treatment system experienced an alarm condition which shut it down. The system was restarted after 316 minutes of downtime.

The total volume of treated water discharged from 0730 hours on February 1, to 0730 hours on March 1, was approximately 19,562,000 gallons. The data in **Table 1** shows selected monthly flows discharged from the plant.

A graphic representation of the system's daily plant discharge output is provided in **Figure 1** and the daily plant totalizer readings for February are provided in **Table 4**, both following the text of this report.
