# Monthly Report of the Operations & Maintenance Activities

Claremont Polychemical Operable Unit 5  
Groundwater Treatment System

*Old Bethpage, New York*  
March 2020

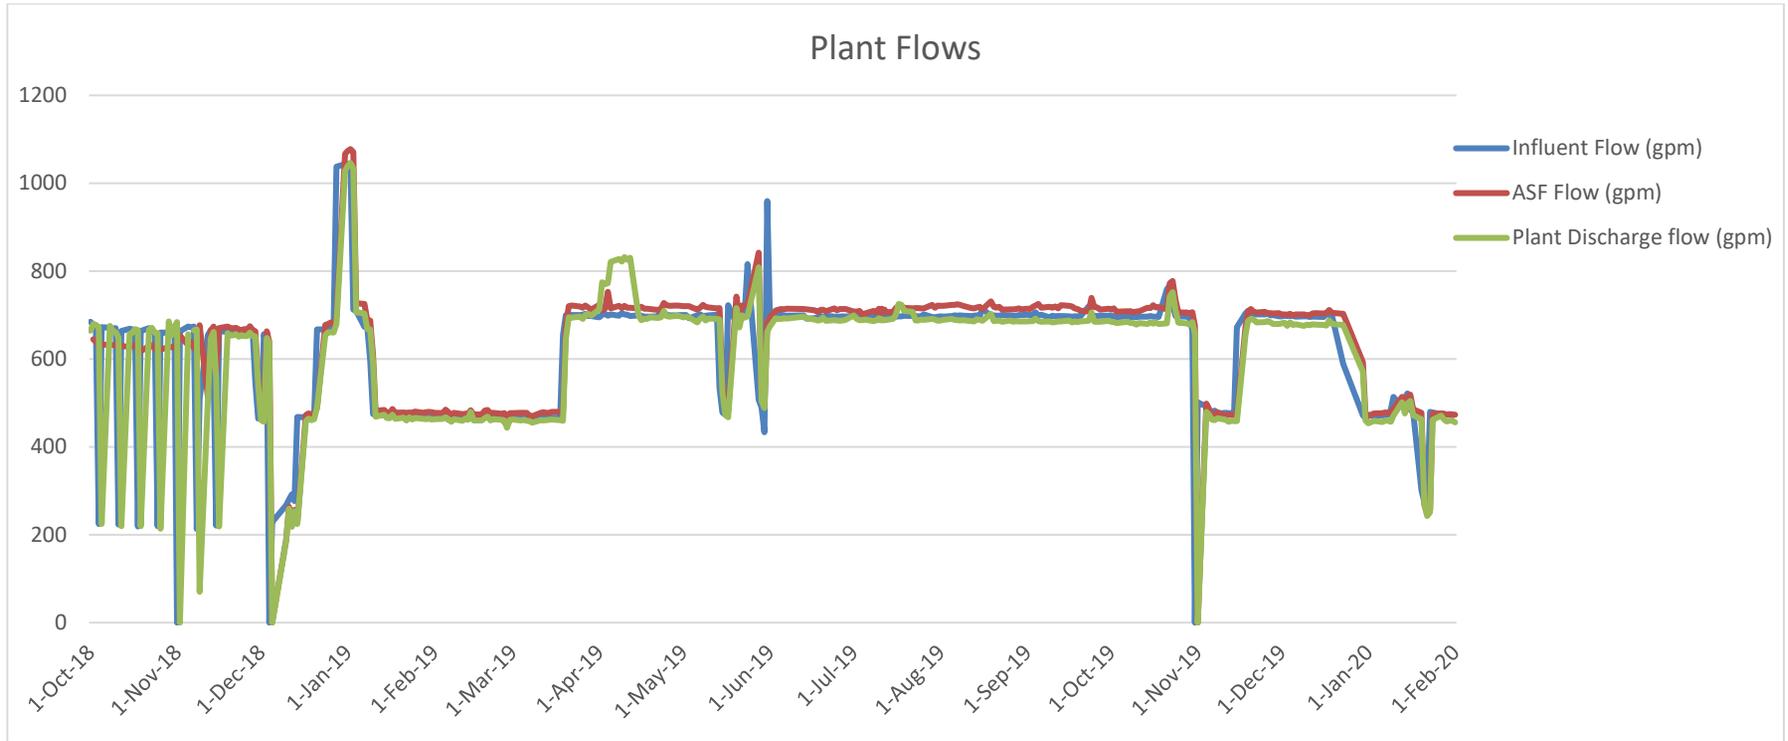
Figure 1 – Plant Discharge Daily Flow

A graphic representation of the system's daily plant discharge output is provided in **Figure 1** and the daily plant totalizer readings for March are provided in **Table 4**, both following the text of this report.

The total volume of treated water discharged from 0730 hours on March 1, to 0730 hours on April 1, was approximately 22,925,000 gallons. The data in **Table 1** shows selected monthly flows discharged from the plant.
