Monthly Report of the Operations & Maintenance Activities

Claremont Polychemical Operable Unit 5
Groundwater Treatment System

Old Bethpage, New York
December, 2020

NYSDEC Standby Engineering Contract
Work Assignment #D0076025-28

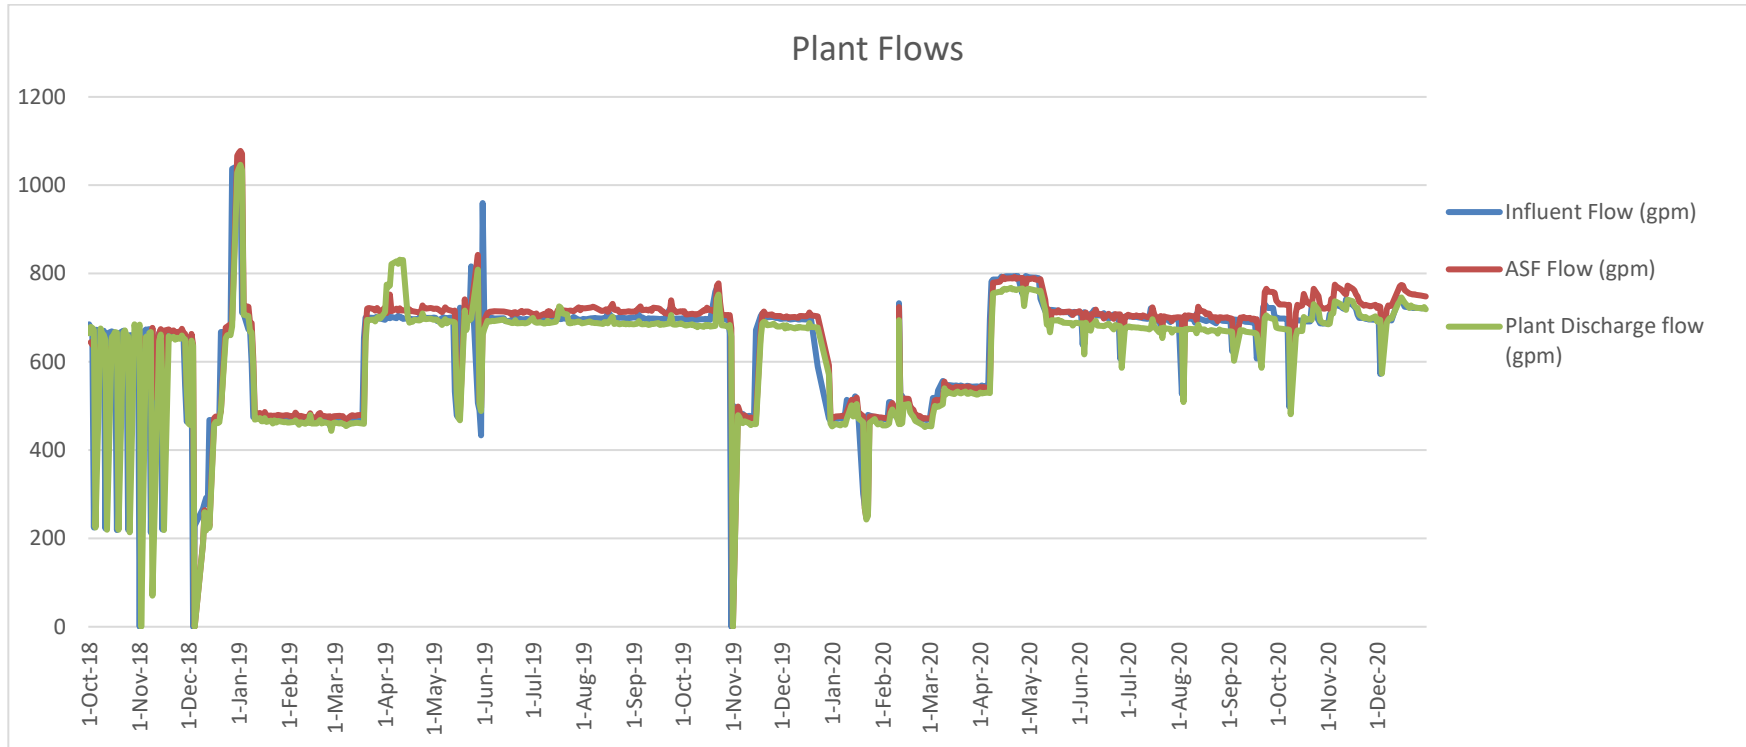
Figure 1 – Plant Discharge Daily Flow

The total volume of treated water discharged from ~0830 hours, December 1 to ~0830 hours January 1, was approximately 31,344,000 gallons. The plant discharge is now directed to Recharge Basin No. 1. The data in **Table 1** shows selected monthly flows discharged from the plant.

A graphic representation of the system’s daily plant discharge output is provided in **Figure 1** and the daily plant totalizer readings for December are provided in **Table 4**, both following the text of this report.
