Monthly Report of the Operations & Maintenance Activities

Claremont Polychemical Operable Unit 5
Groundwater Treatment System

Old Bethpage, New York
March, 2021

NYSDEC Standby Engineering Contract
Work Assignment #D0076025-28

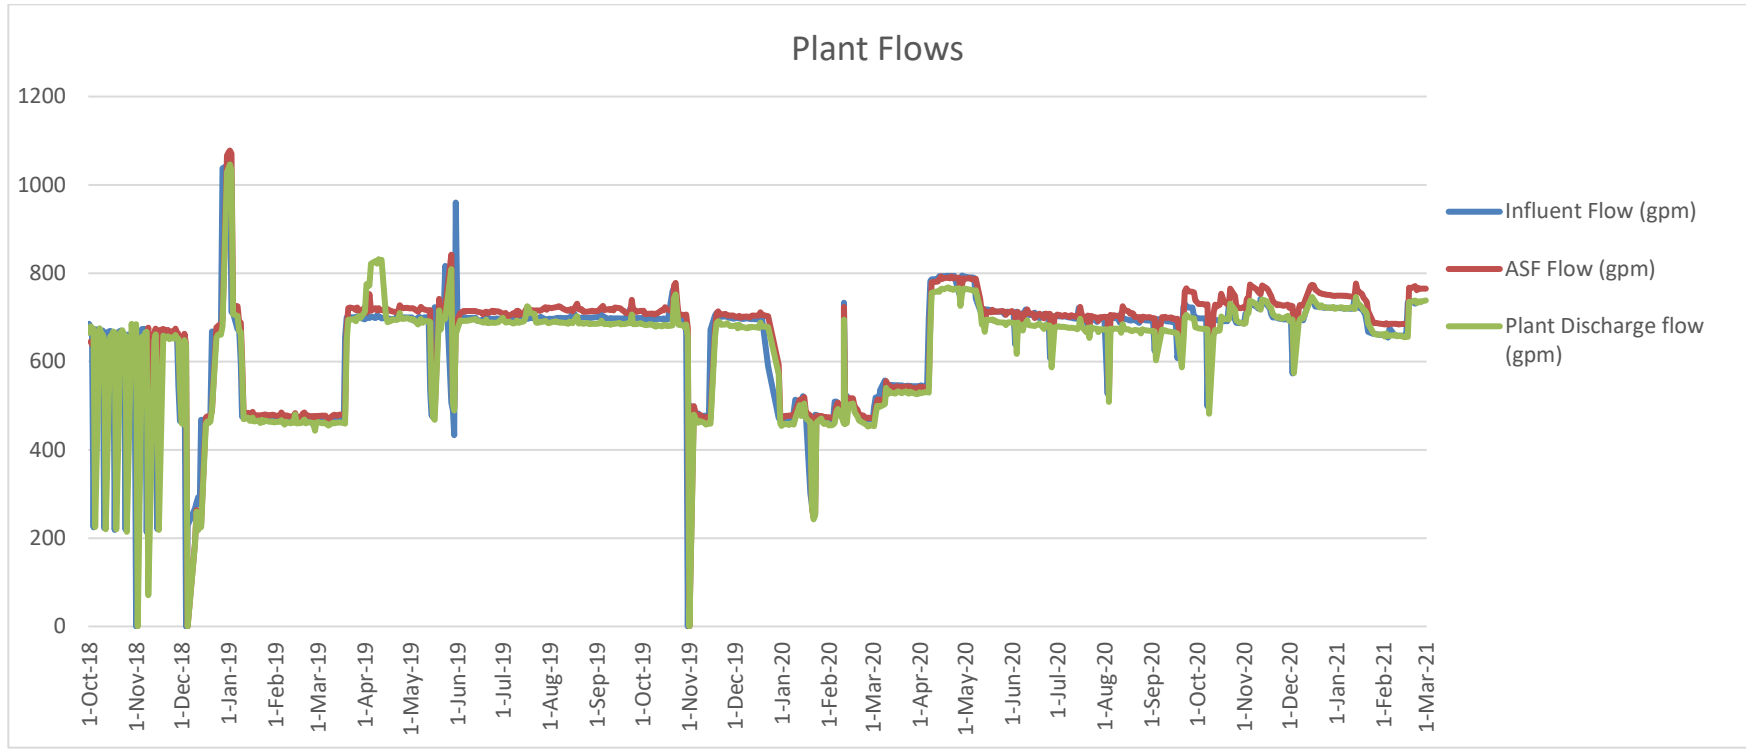
Figure 1 – Plant Discharge Daily Flow

A graphic representation of the system’s daily plant discharge output is provided in **Figure 1** and the daily plant totalizer readings for March are provided in **Table 4**, both following the text of this report.

The total volume of treated water discharged from ~0830 hours, March 1 to ~0830 hours April 1, was approximately 32,514,000 gallons. The plant discharge is currently directed to Recharge Basin No. 1. The data in **Table 1** shows selected monthly flows discharged from the plant.
