# **PRE-DESIGN REMEDIAL INVESTIGATION SUMMARY REPORT**

**Konica Minolta Graphic Imaging U.S.A., Inc.  
71 Charles Street  
Glen Cove, New York**

**NAEVA Geophysical Report**

**Results of Geophysical Investigation  
Former Manufacturing Facility  
71 Charles Street, Glen Cove, New York**

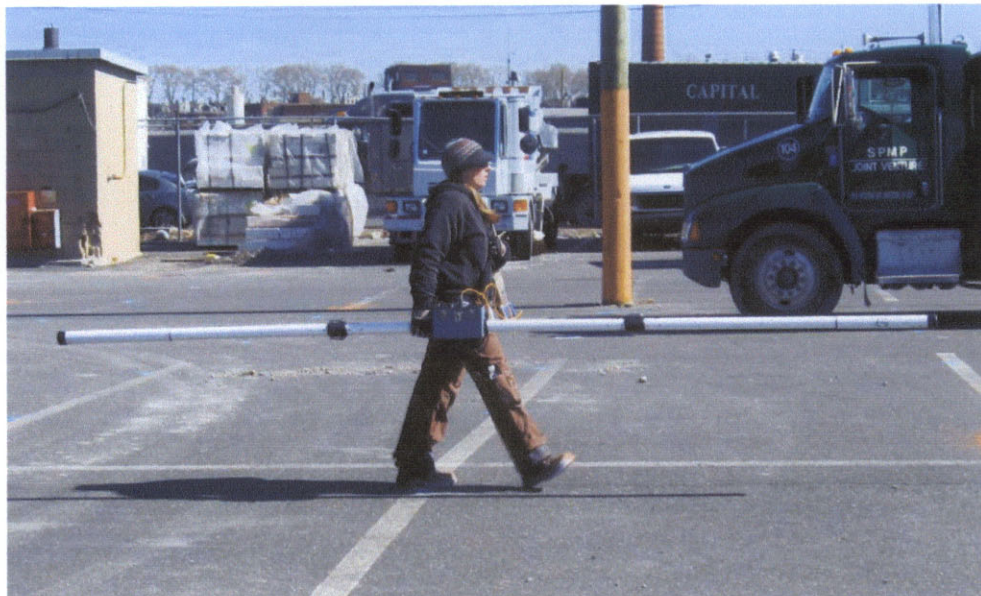
The EM31 consists of boom-mounted coplanar electromagnetic transmitter and receiver coils fixed at a distance of 12 feet to one another with an operating frequency of 9.8 kHz. The electronic processing and control unit is located at the midpoint of the boom. Data is stored in a digital data recorder attached to the instrument. A current applied to the transmitter coil produces a time-varying magnetic field, which induces small secondary currents within the earth. These currents, in turn, generate a secondary magnetic field, which is detected along with the primary field by the receiver coil. The secondary signal has the same frequency as the primary signal but has a phase shift. The phase shift of the secondary signal is linearly proportional to the apparent conductivity.

Geonics EM31 terrain conductivity meter

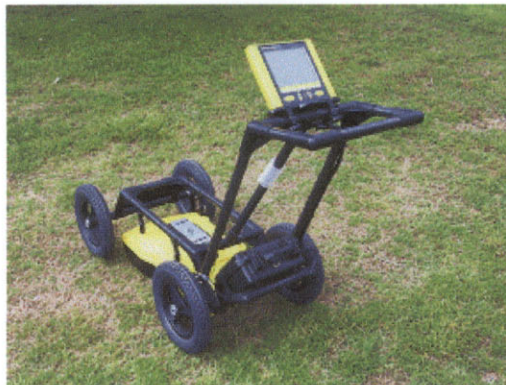
The Sensors & Software Smart Cart GPR system utilizing a 250 MHz antenna was selected to investigate EM anomalies and the 18 PEBSSs. The GPR antenna radiates short pulses of electromagnetic energy into the ground. Whenever these pulses strike an interface having variant dielectric properties, part of the wave is reflected back and detected at the surface. These GPR data profiles are then examined in real-time for parabolic reflections that could be interpreted as representing subsurface utilities, underground storage tanks, or former excavations.

**Sensors and Software GPR system with a 250 MHz antenna**

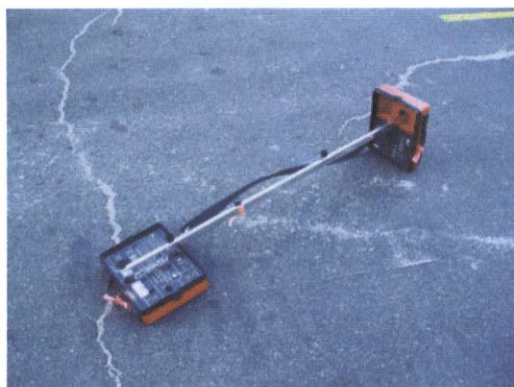
The Fisher TW-6 Pipe and Cable Locator, also known as the M-Scope, is a type of hand-held electromagnetic metal-detector. The instrument consists of a transmitter coil and a receiver coil mounted at opposite ends of a 4-foot horizontal staff. The transmitter is fixed in a vertical

**TW-6 hand-held metal-detector**

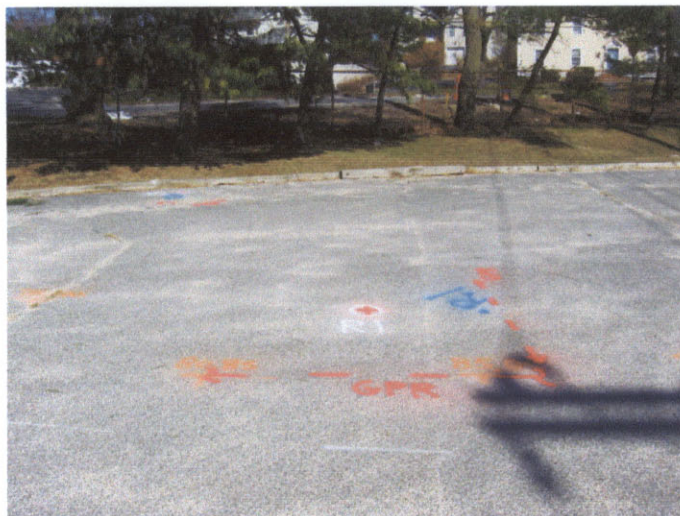
Photograph 1: View looking north toward PEBS R-SB-1 with two linear GPR anomalies.

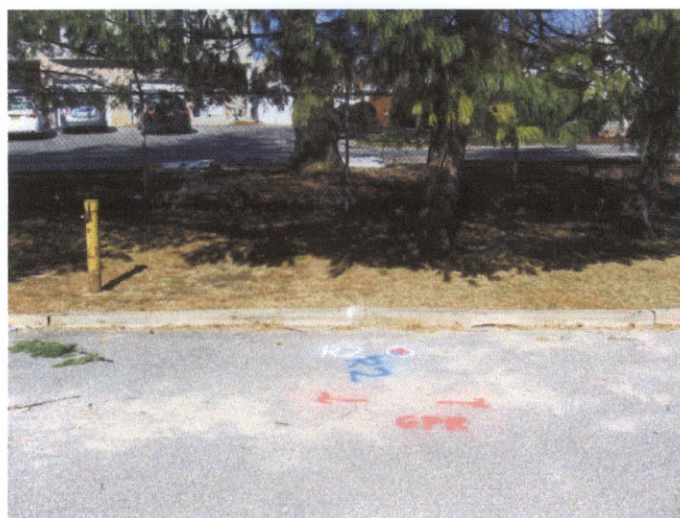
Photograph 2: View looking north toward PEBS R-SB-2 with small GPR anomaly.

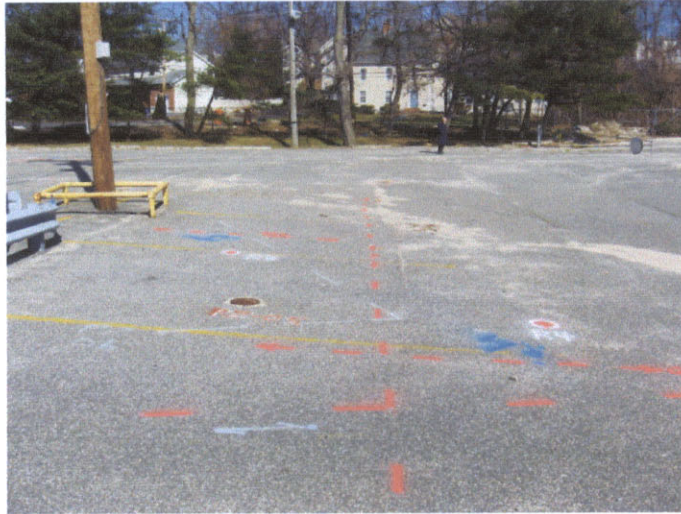
Photograph 3: View looking north toward PEBS R-SB-3 and R-SB-4. A suspected utility is visible in a north to south orientation. A second suspected utility and a linear GPR anomaly are visible in an east-west orientation.

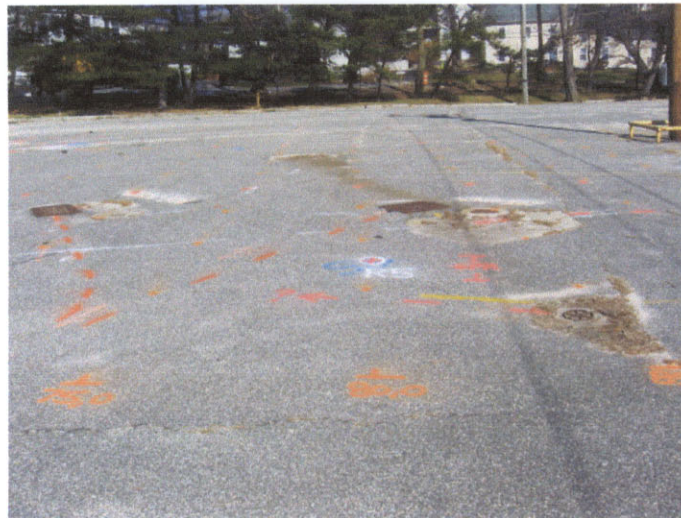
Photograph 4: View looking north toward PEBS R-SB-5. Electric lines are visible extending south from two electric vaults and a suspected utility is visible extending west immediately south of the PEBS.

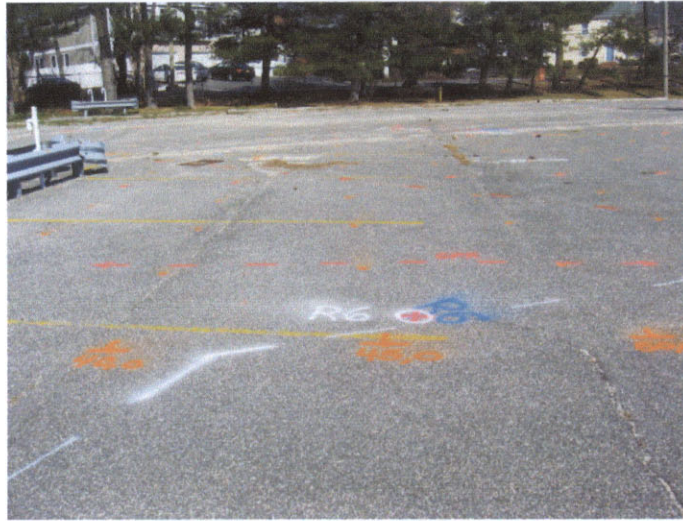
Photograph 6: View looking north toward R-SB-6 with liner GPR anomaly visible immediately north of the PEBS.

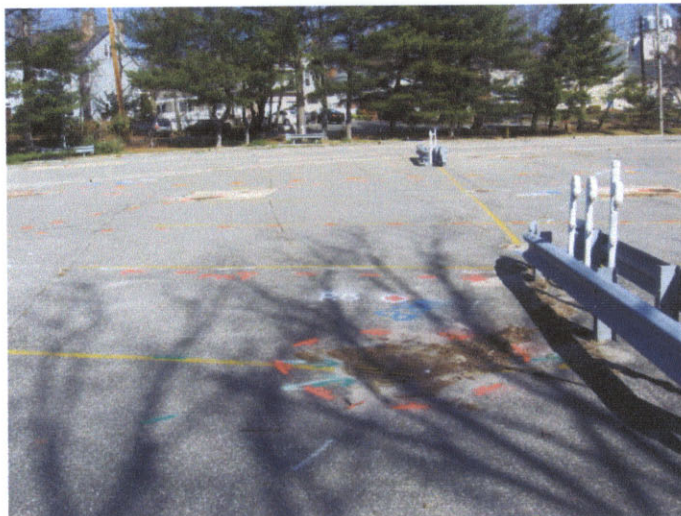
Photograph 8: View looking north toward R-SB-8. A suspected PVC line is visible extending west immediately north of the PEBS.

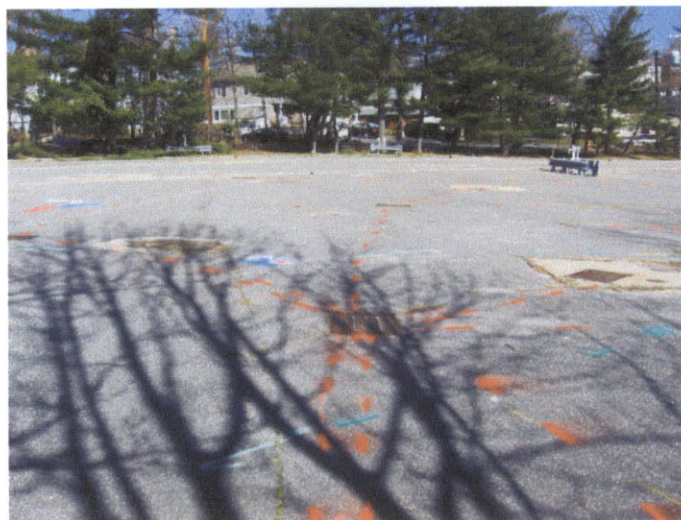
Photograph 9: View looking north toward R-SB-9 which is located to the northwest of the electric vault at the center of the photograph.

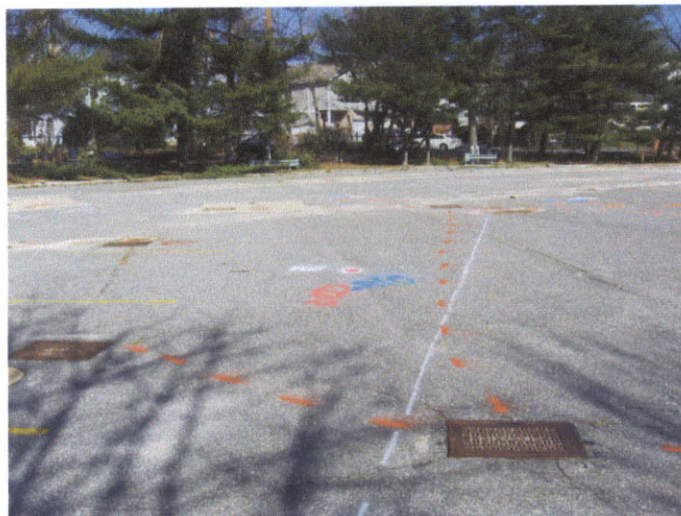
Photograph 10: View looking north toward R-SB-10. Electric lines are visible extending between the electric vaults and a small metal anomaly is visible immediately south of the PEBS.

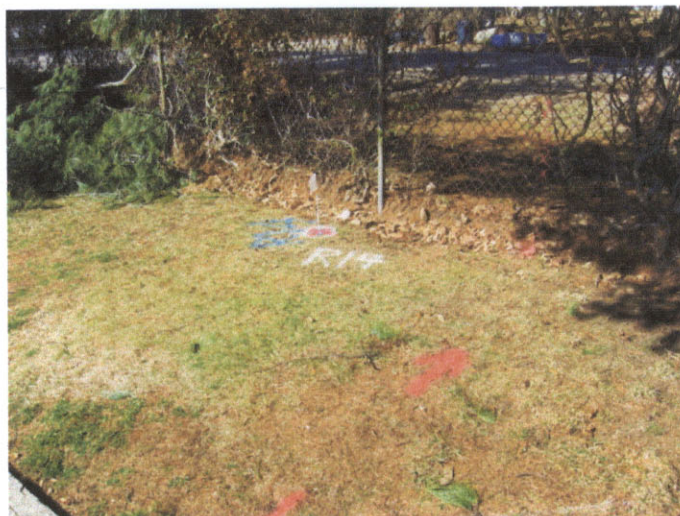
Photograph 14: View looking northwest toward R-SB-14. The suspected electric line extends under the chain-link fence to an adjacent electric vault.

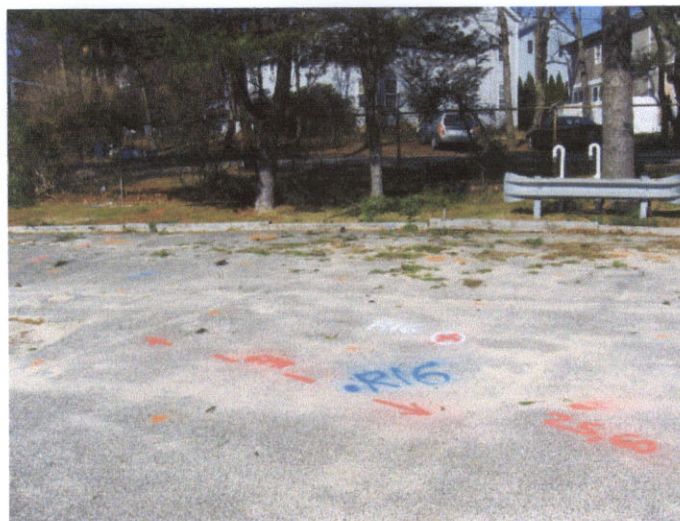
Photograph 16: View looking northwest toward R-SB-16. A linear GPR anomaly is visible immediately south of the PEBS.

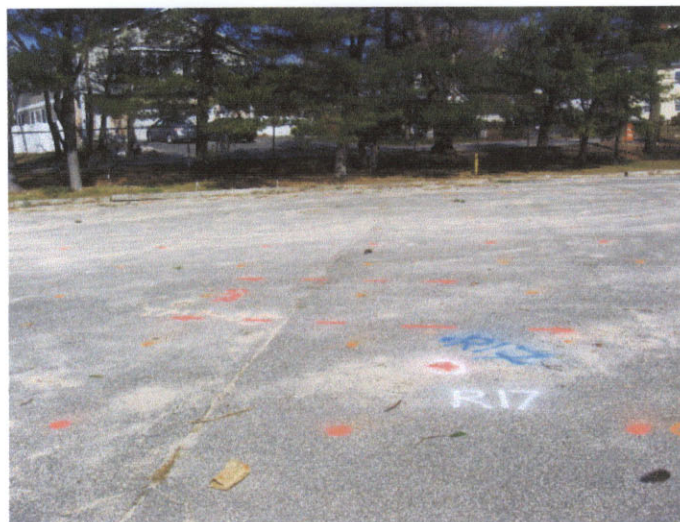
Photograph 17: View looking north toward R-SB-17. Two linear GPR anomalies are visible immediately north of the PEBS in an east west orientation.
