# **NEW YORK STATE SUPERFUND CONTRACT**

## **MULTISITE PSA TASK 4 REPORT**

New Cassel Industrial Area Site  
North Hempstead, Nassau County

Work Assignment No. D002676-12B-1

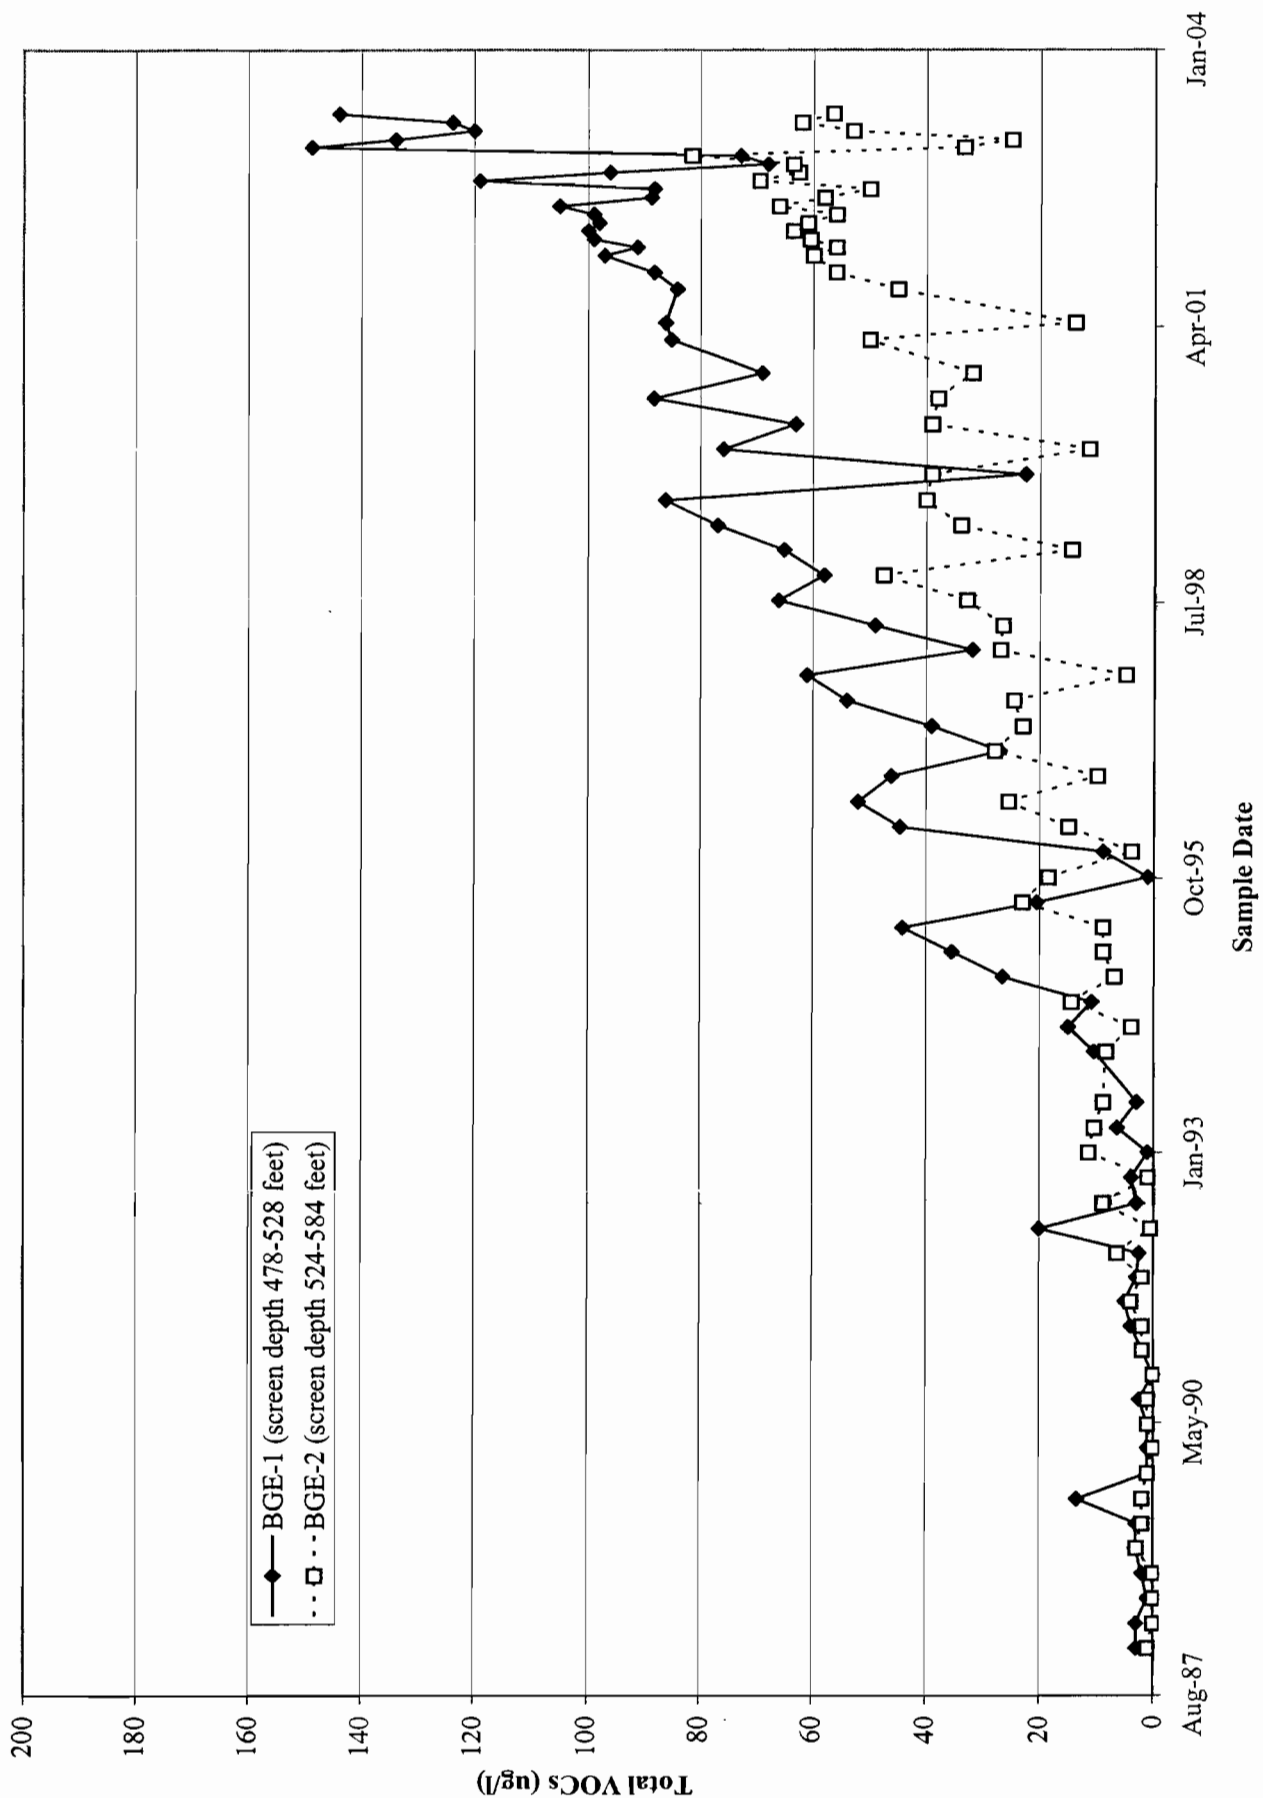
TOTAL VOCs IN BOWLING GREEN ESTATES WATER SUPPLY WELLS  
(1988-2003)
