**DRAFT**  
**VAPOR INTRUSION INVESTIGATION REPORT**  
**NEW CASSEL INDUSTRIAL AREA**  
**SITE # 130043**

**WORK ASSIGNMENT NO. D004434-31**

**New York State Department of Environmental Conservation**  
**Albany, New York**

**MACTEC Engineering and Consulting, P.C.**  
**Portland, Maine**

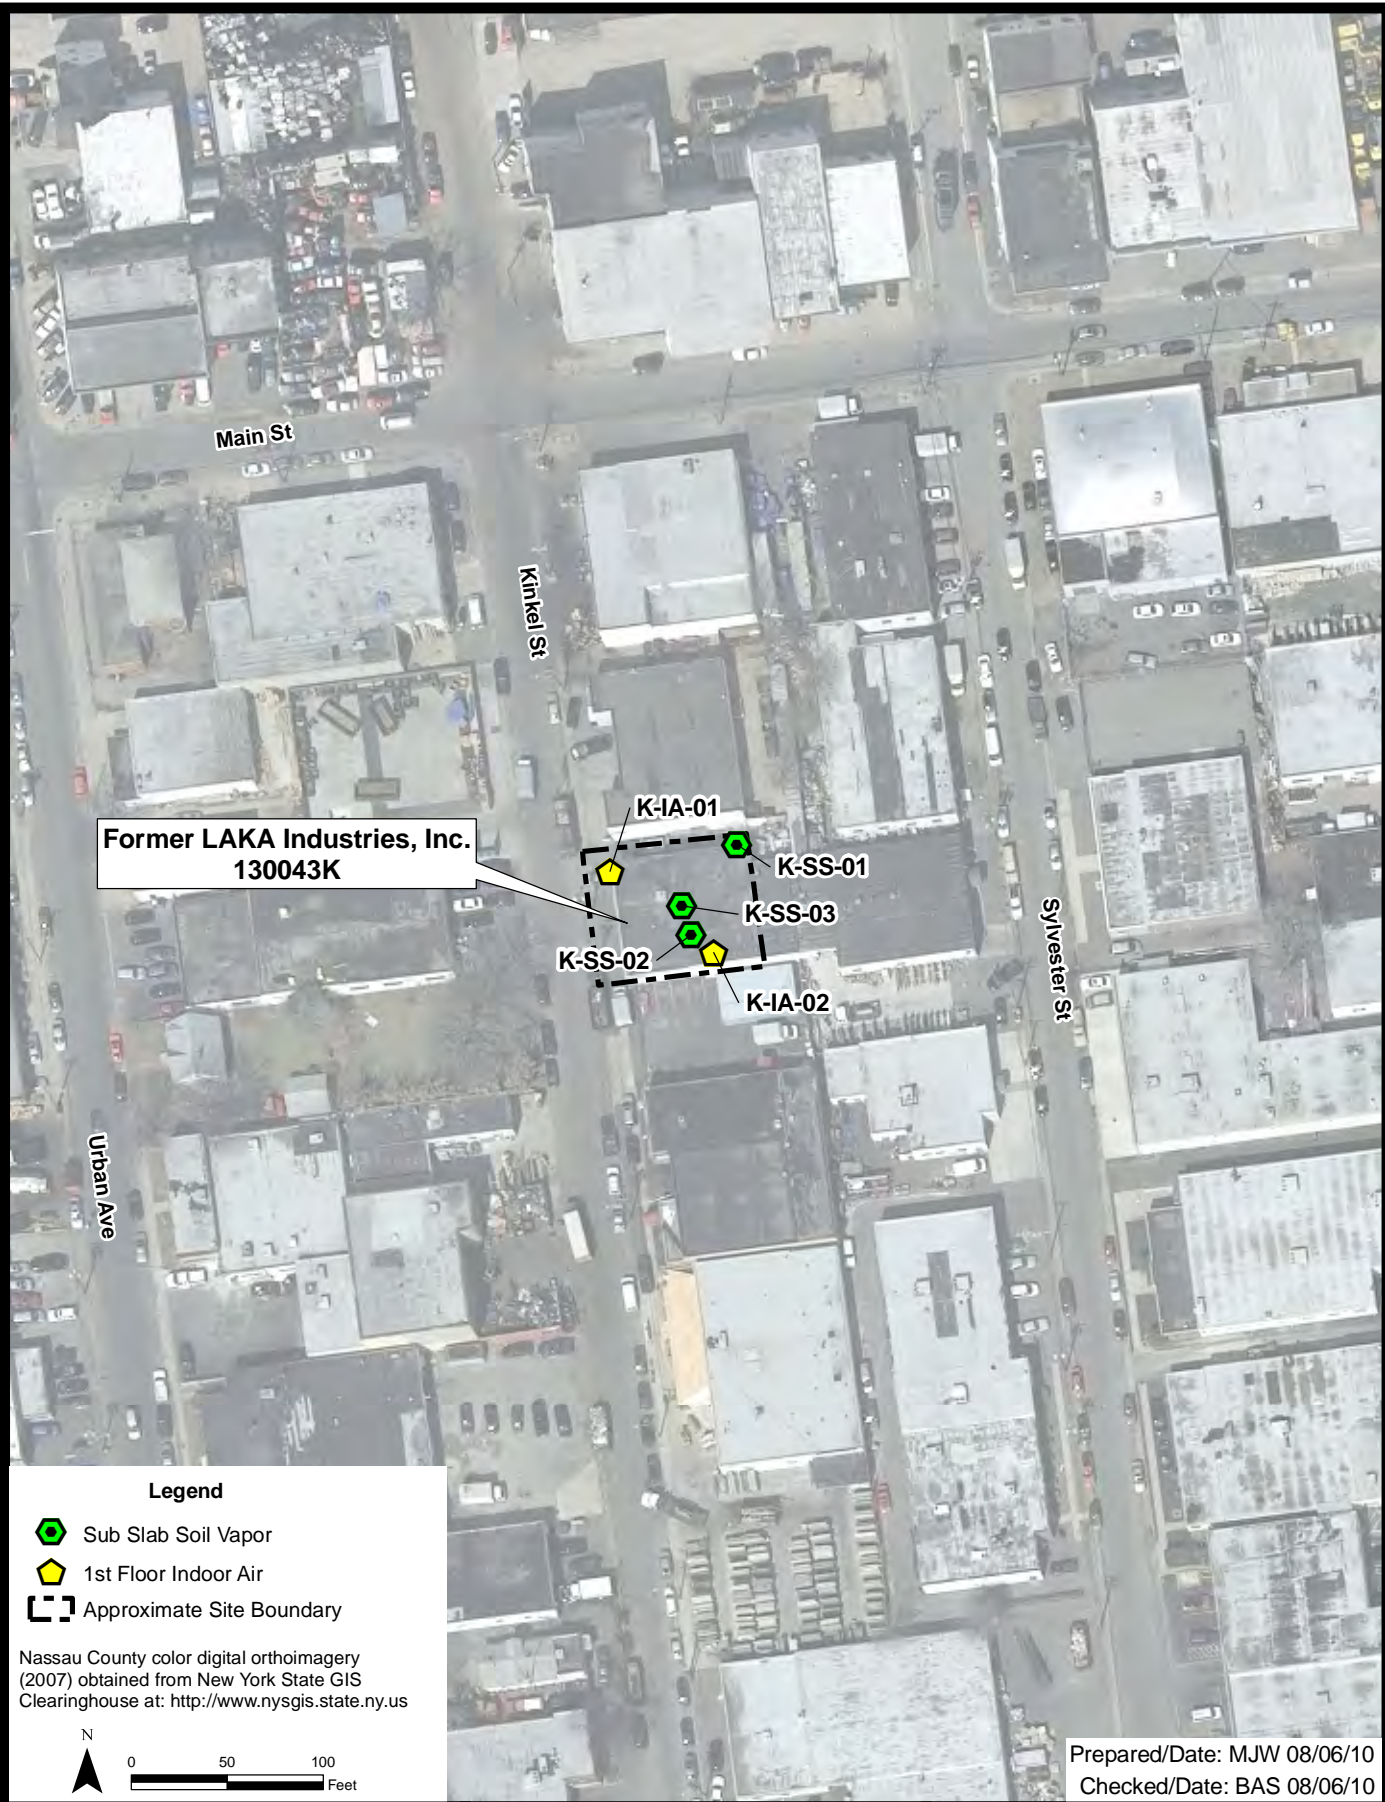
VI Sample Locations  
Former LAKA Industries, Inc. (130043K)  
Project 3612-09-2127  
Figure 3.4

**Former LAKA Industries, Inc.  
130043K**

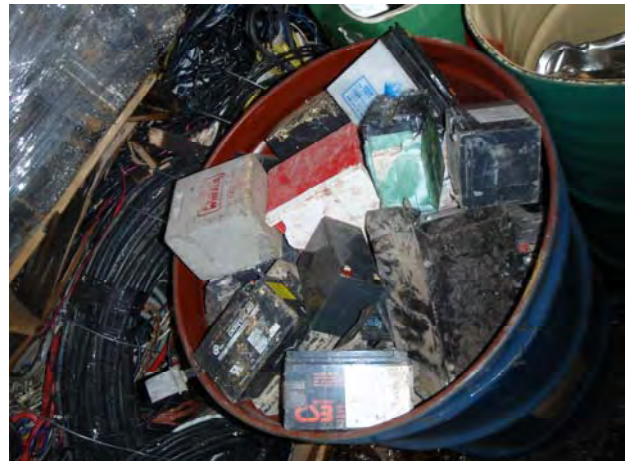
Southern Storage Batteries 2

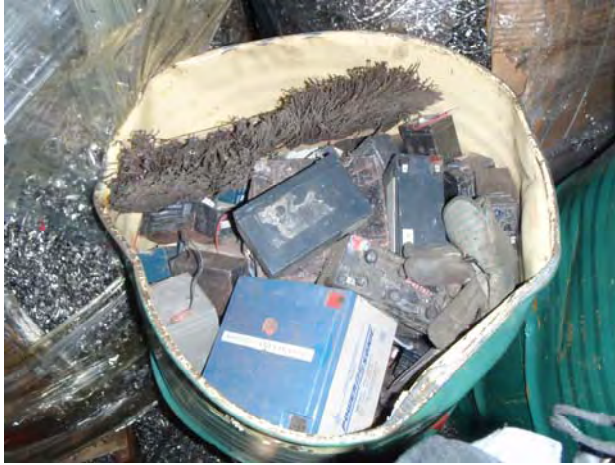
Southern Storage Batteries 3

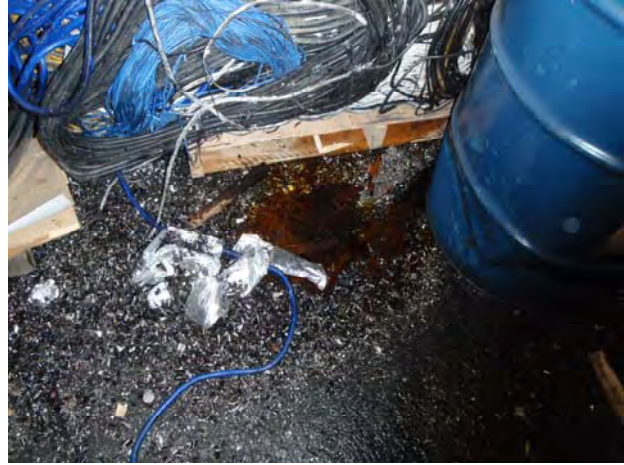
Southern Storage Oil Spill
