## **Site Closure Report**

Atlas Graphics, Inc.  
567 Main Street  
Westbury, NY 11590  
VCP Site # 01-30-034B

**Site Closure Report  
Atlas Graphics Inc.  
Table of Contents**

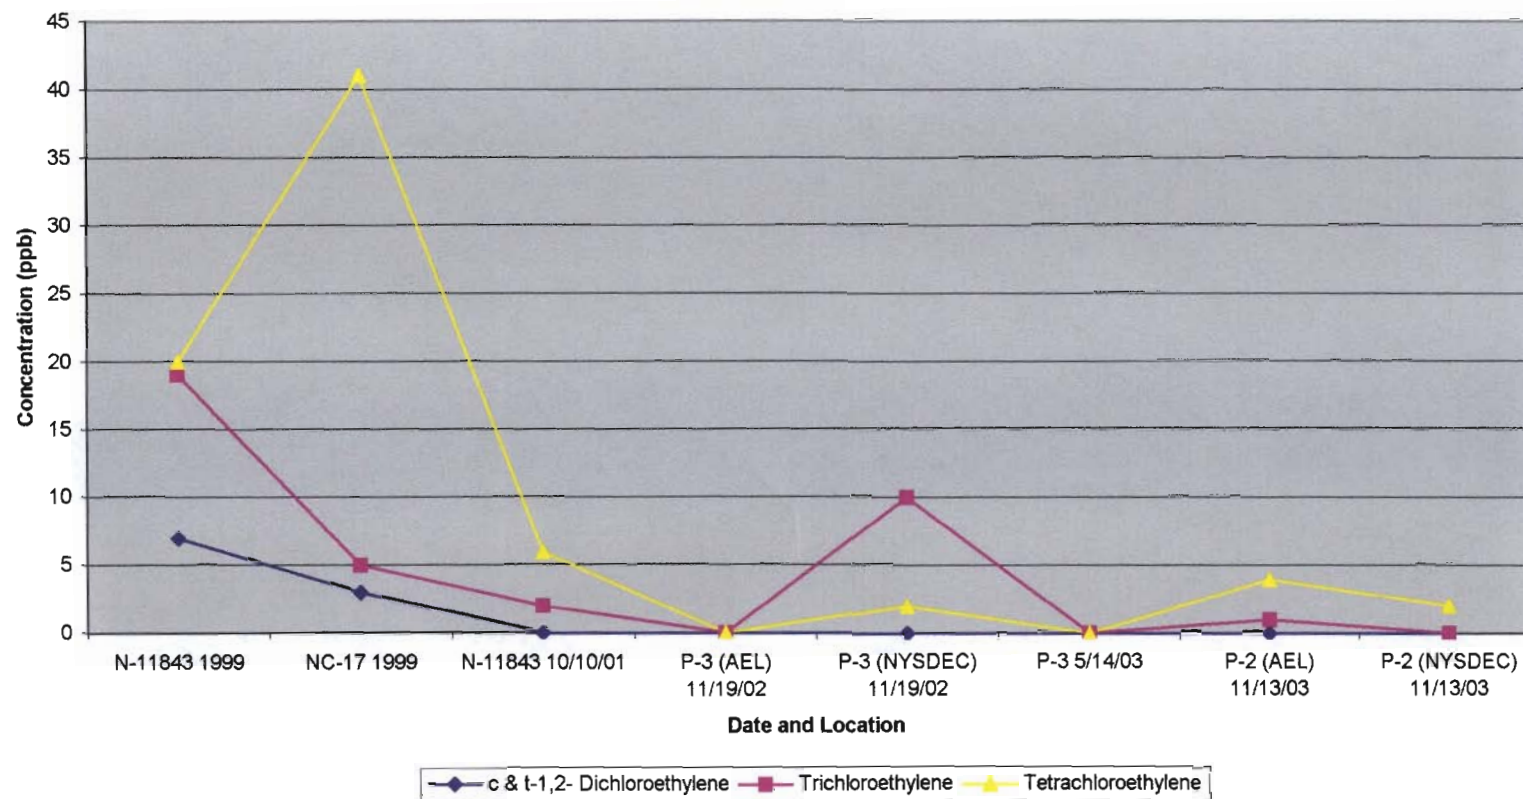
Upgradient water samples were collected from various wells and piezometers located within a 20-foot radius of each other due to the availability of water in the wells during the sampling events.

**Atlas Graphics  
Laboratory Analytical Data Up Gradient Groundwater Monitoring**

Based on the above sampling events, the on-site and down gradient groundwater are either below the New York State Department of Health Technical and Operation Guidance Series (TOGS) 1.1.1 standards or have reached an asymptotic condition. The below tables and graphs show the trend in the up gradient and down gradient monitoring wells.

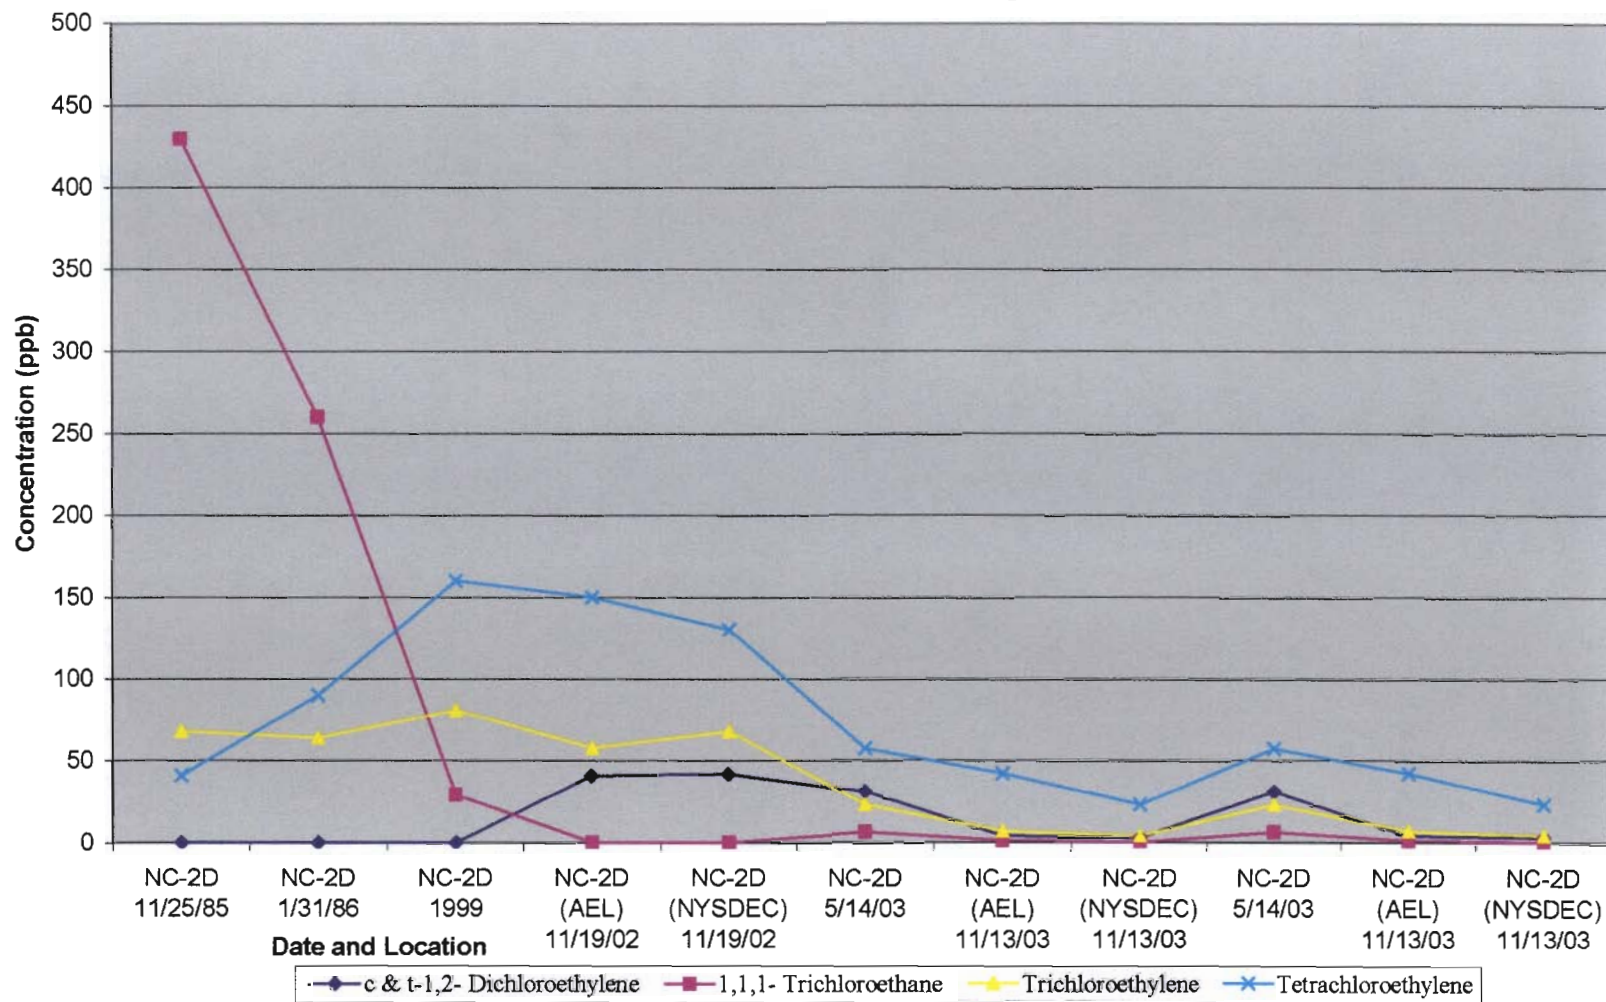
**Atlas Graphics**  
**Laboratory Analytical Data NC-2D Downgradient Well**

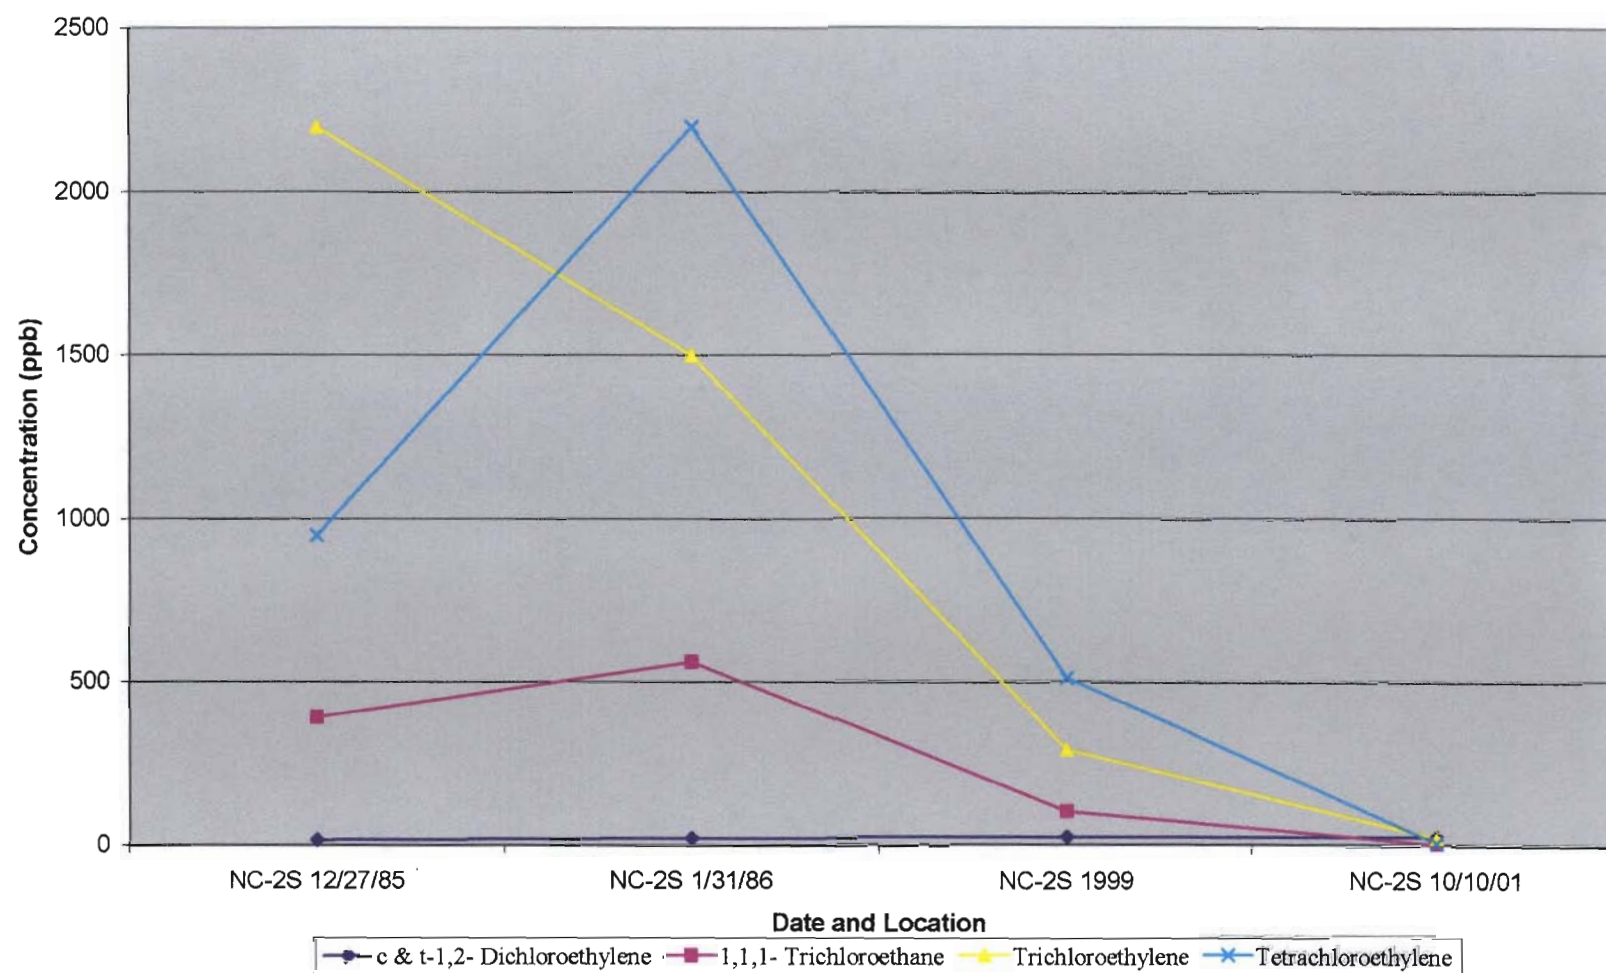
**Atlas Graphics  
Laboratory Analytical Data NC-2S Downgradient Well**

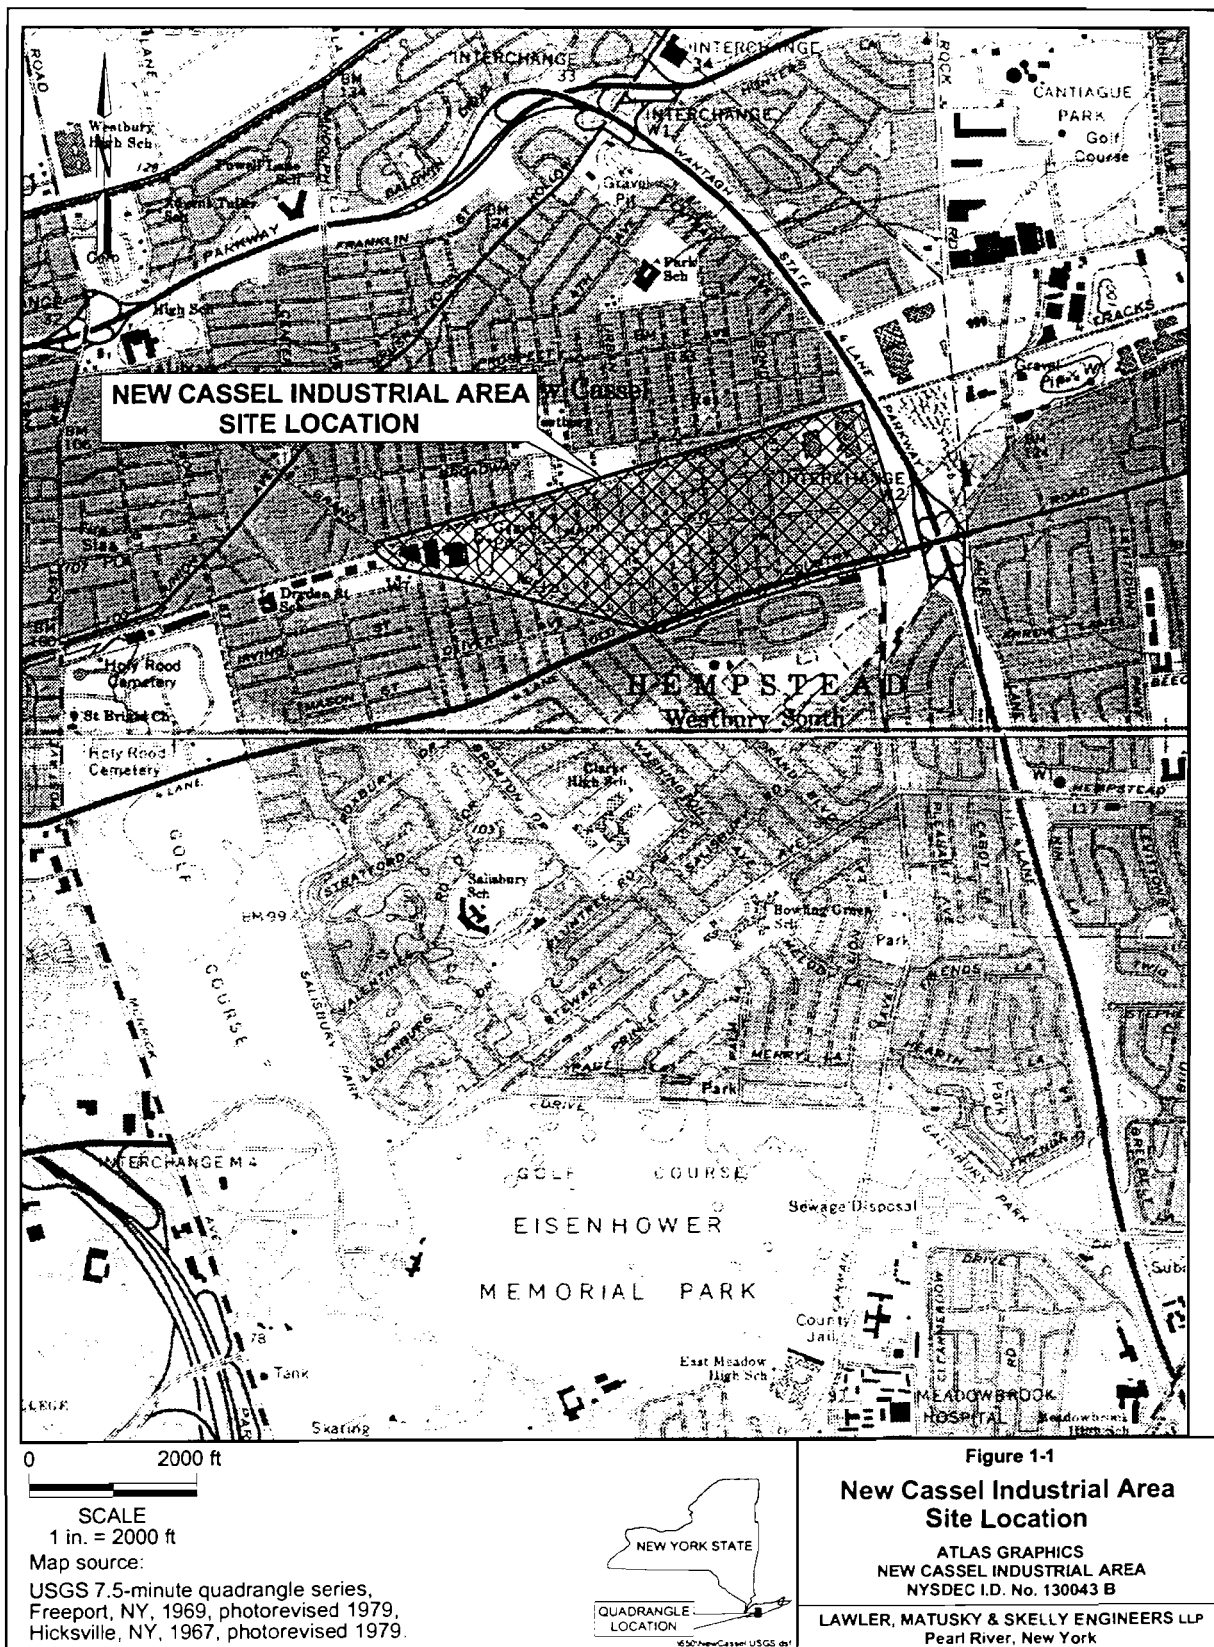
Figure 1-2  
**Atlas Graphics  
 Site Location**

The Atlas Graphics Site, (NYSDEC Site No. 1-30-143B on the New York State Registry of Inactive Hazardous Waste Sites) is located at 567 Main Street in the New Cassel Industrial Area (NCIA), Town of North Hempstead, Nassau County, New York (Figure 1-2). The site is comprised of approximately 8000 square feet which is bounded by a Swalm Avenue to the west, commercial buildings and parking lots to the north and east, and Main Street to the south. The property is currently a active printing and graphics operation which occupies the small two story commercial building on the site.

The New Cassel Industrial Area (NCIA) is located in the unincorporated village of Westbury in the Town of North Hempstead, Nassau County, New York (Figure 1-1). Approximately 200 industrial or commercial businesses occupy this 170-acre site (Figure 1-2). Due to extensive halogenated volatile organic contamination of groundwater beneath the site, the New York State Department of Environmental Conservation (NYSDEC) classified the entire industrial area as a hazardous waste site in 1988. Based on the results of a Site Investigation (SI) and Preliminary Site Assessment (PSA) conducted by Lawler, Matusky & Skelly Engineers LLP (LMS) the individual facilities responsible for the contamination were identified as Class 2 sites on the New York State Registry of Inactive Hazardous Waste Disposal Sites. The Atlas Graphics Site was identified as one of these facilities.

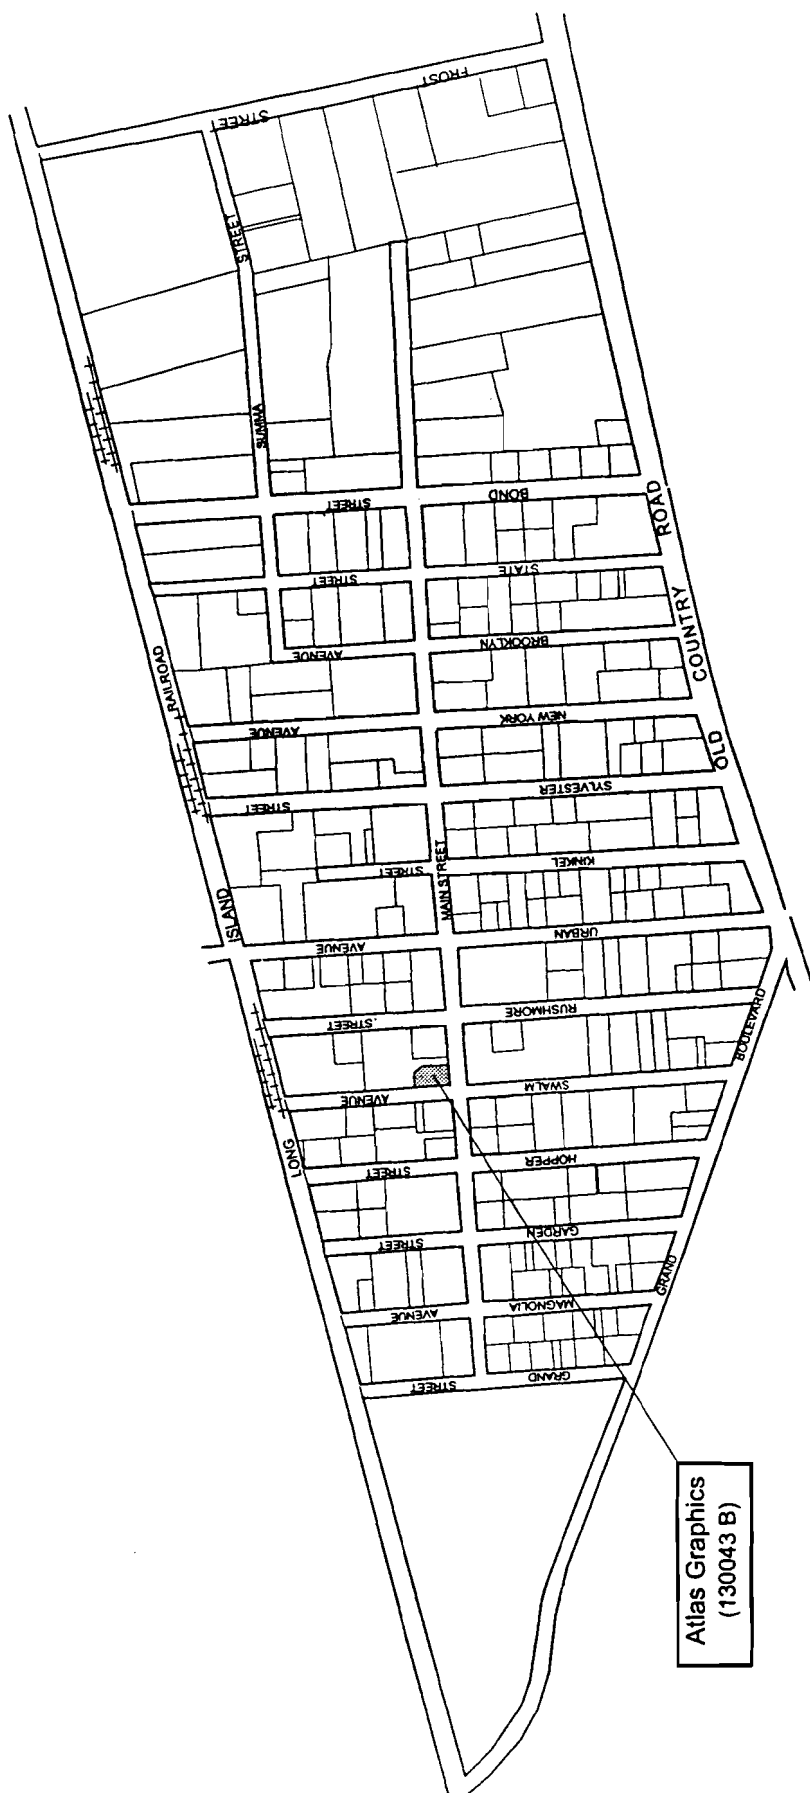
ATLAS GRAPHICS  
 NEW CASSEL INDUSTRIAL AREA  
 NYSDEC I.D. No. 130043

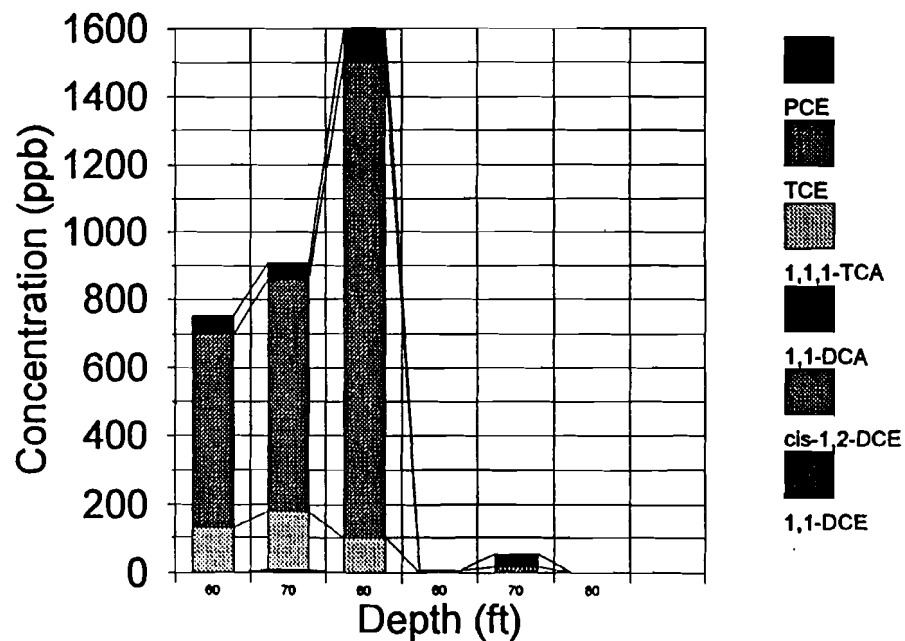
Figure 3-1  
Hydropunch Results

ATLAS GRAPHICS SITE  
NEW CASSEL INDUSTRIAL AREA  
NYSDEC I.D. No. 130043

depth (76-80 ft) (Table 3-2). Target compounds found at the shallow depth (56-60 ft) in excess of the Class GA groundwater standards include 1,1-DCE (2 µg/l), 1,1-DCA (8 µg/l), 1,1,1-TCA (47 µg/l), TCE (310 µg/l), and PCE (30 µg/l). Other compounds found at the shallow depth include acetone (16 µg/l) and 1,1,2-TCA (3 µg/l). Target compounds found at the intermediate depth (66-70 ft) in excess of the Class GA groundwater standards include TCE (16 µg/l), and PCE (6 µg/l). Other compounds found at the intermediate depth include 1,1,1-TCA (1 µg/l), and 1,2-DCE (3 µg/l). The only target compound found at the deepest depth (76-80 ft) in excess of the Class GA groundwater standards was PCE (40 µg/l). Toluene (3 µg/l) was also detected at the deepest depth. The only trend noted in the data from the AGGW-03 is a decreasing concentration of TCE with depth. The presence of high concentrations of TCE at the shallow depth suggest an on-site source of TCE. However, similar concentrations of TCE were noted in the upgradient sampling point (NC-17).

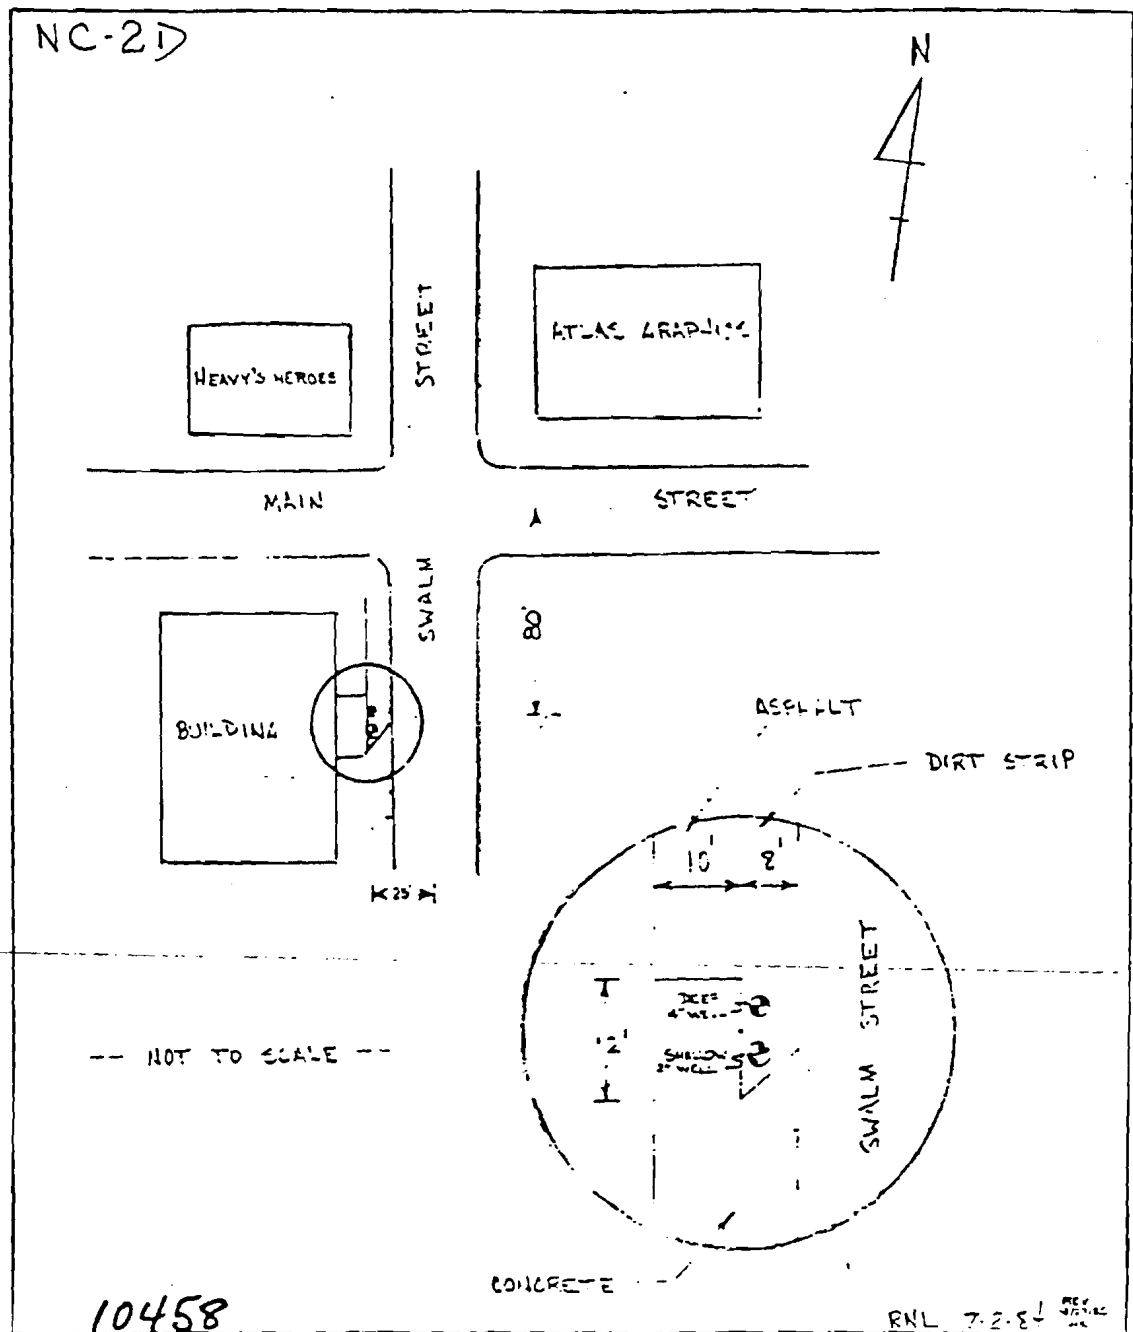
NASSAU COUNTY WELL No: NC-2d

APPROX. DEPTH TO WATER: 48

DRILLER: Moretrench American Corp.

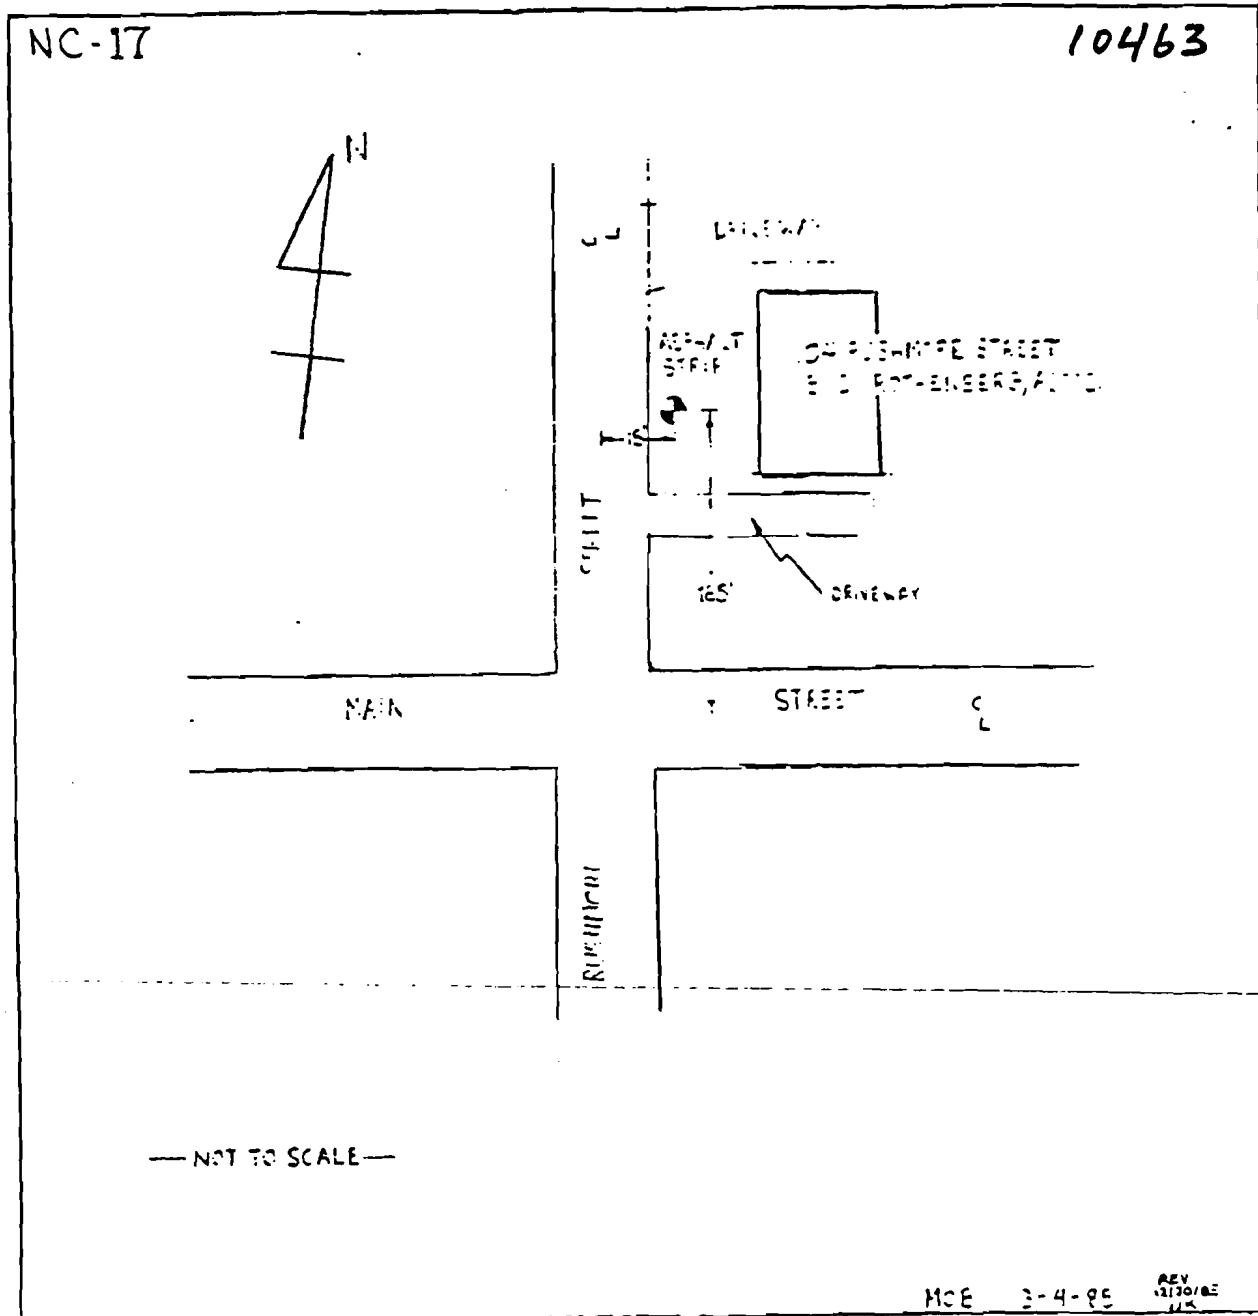
NASSAU COUNTY WELL No: NC-17 LOCATION: New Cassel  
N.Y. STATE No: 10463 INSTALLED: 8/30/85  
TOTAL DEPTH: 64' MEAS. POINT: Top of Casing  
DIAMETER: 2" Schedule 80 PVC ELEV. MEAS. PT: 122.12  
APPROX. DEPTH TO WATER: 48 DRILLER: Moretrench American Corp.
