**DRAFT**  
**VAPOR INTRUSION INVESTIGATION REPORT**  
**NEW CASSEL INDUSTRIAL AREA**  
**SITE # 130043**

**New York State Department of Environmental Conservation**  
**Albany, New York**

**MACTEC Engineering and Consulting, P.C.**  
**Portland, Maine**

**AUGUST 2010**

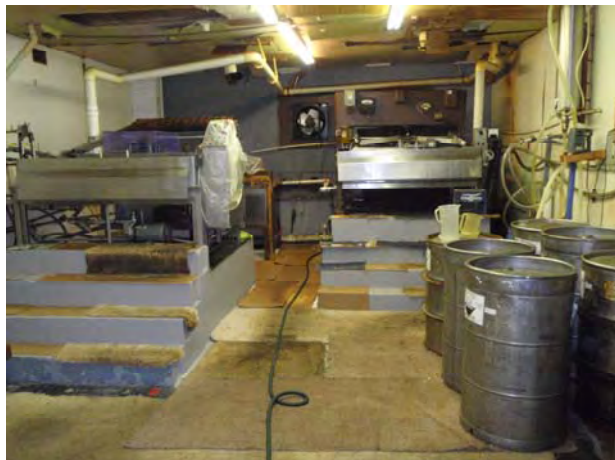
Etching Room

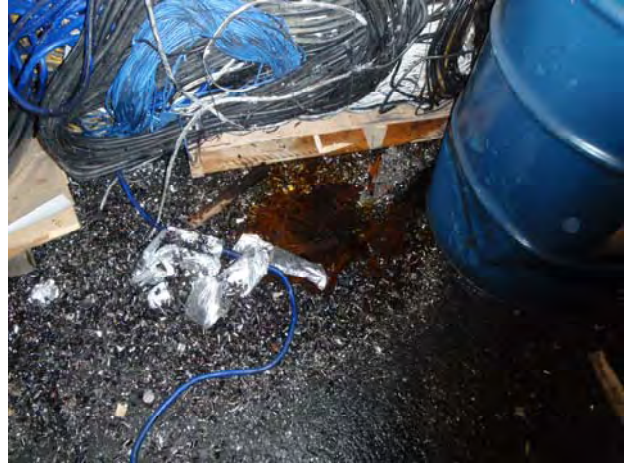
Southern Storage Oil Spill
