**DRAFT**  
**VAPOR INTRUSION INVESTIGATION REPORT**  
**NEW CASSEL INDUSTRIAL AREA**  
**SITE # 130043**

**WORK ASSIGNMENT NO. D004434-31**

**MACTEC Engineering and Consulting, P.C.**  
**Portland, Maine**

**AUGUST 2010**

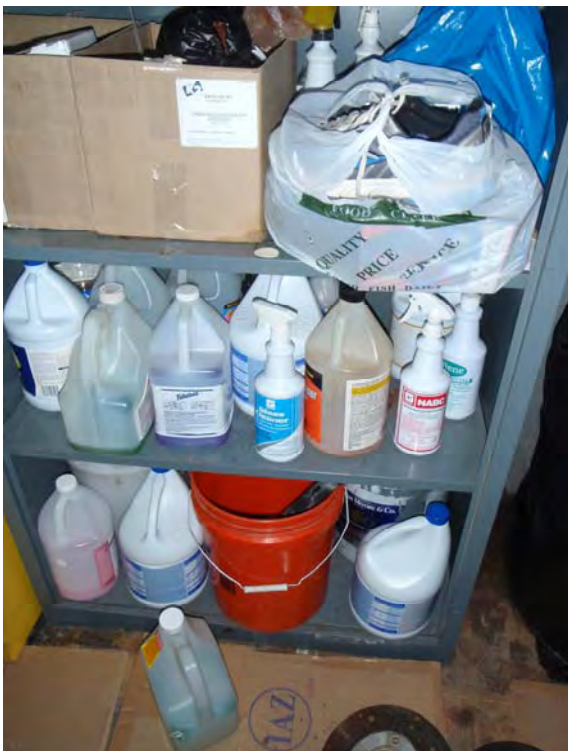
Chemical Storage 1st Floor 1

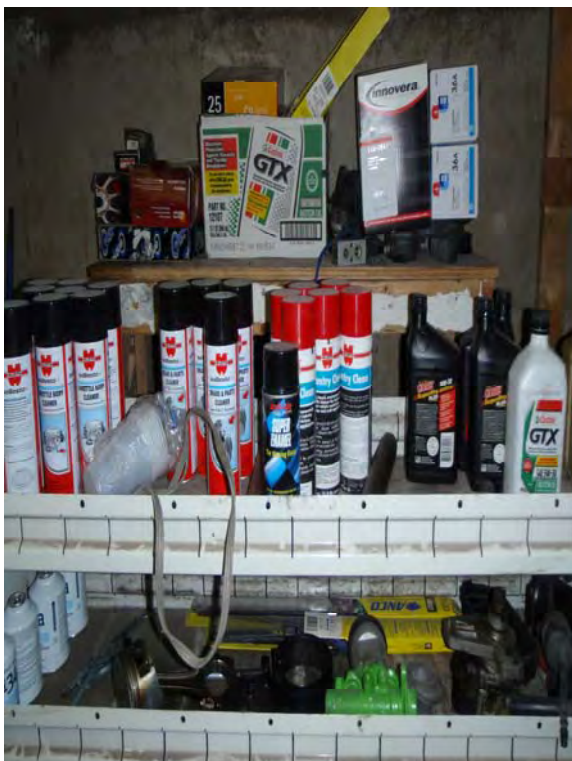
Chemical Storage Basement 1
