**DRAFT**  
**VAPOR INTRUSION INVESTIGATION REPORT**  
**NEW CASSEL INDUSTRIAL AREA**  
**SITE # 130043**

**WORK ASSIGNMENT NO. D004434-31**

**New York State Department of Environmental Conservation**  
**Albany, New York**

**MACTEC Engineering and Consulting, P.C.**  
**Portland, Maine**

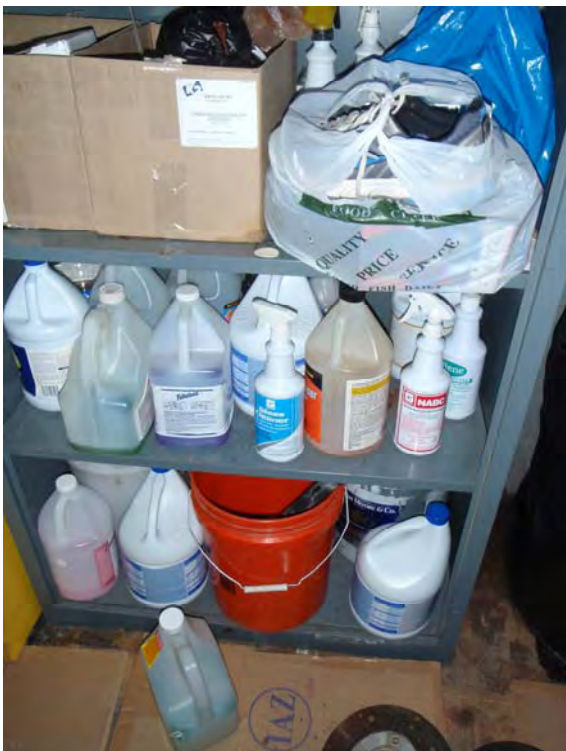
Chemical Storage 1st Floor 1

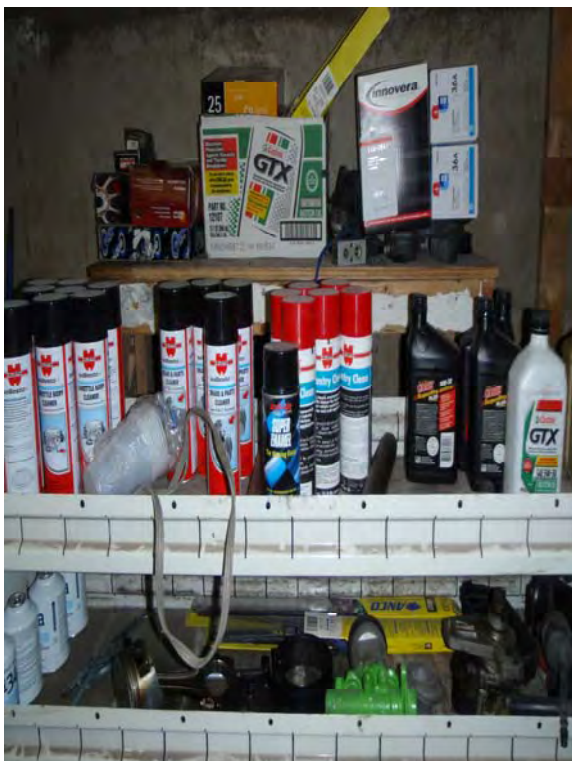
Chemical Storage Basement 1

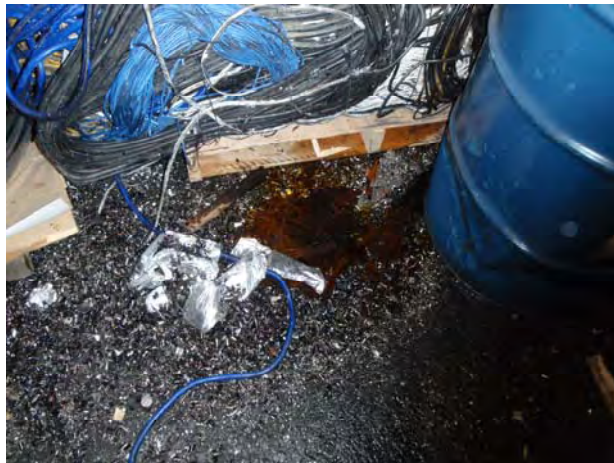
Southern Storage Oil Spill
