**DRAFT**  
**VAPOR INTRUSION INVESTIGATION REPORT**  
**NEW CASSEL INDUSTRIAL AREA**  
**SITE # 130043**

**WORK ASSIGNMENT NO. D004434-31**

**New York State Department of Environmental Conservation**  
**Albany, New York**

**MACTEC Engineering and Consulting, P.C.**  
**Portland, Maine**

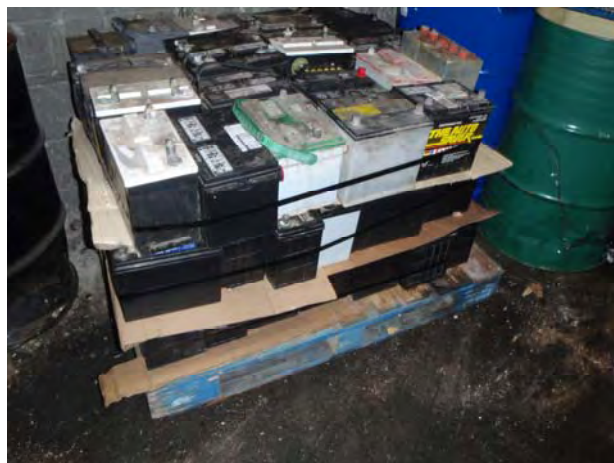
Southern Storage Batteries 1
