**Focussed Remedial Investigation  
Report**

299 Main Street Site  
Westbury, New York  
(Site Code 1-30-043S)

The New York State  
Department of Environmental Conservation

September 2000

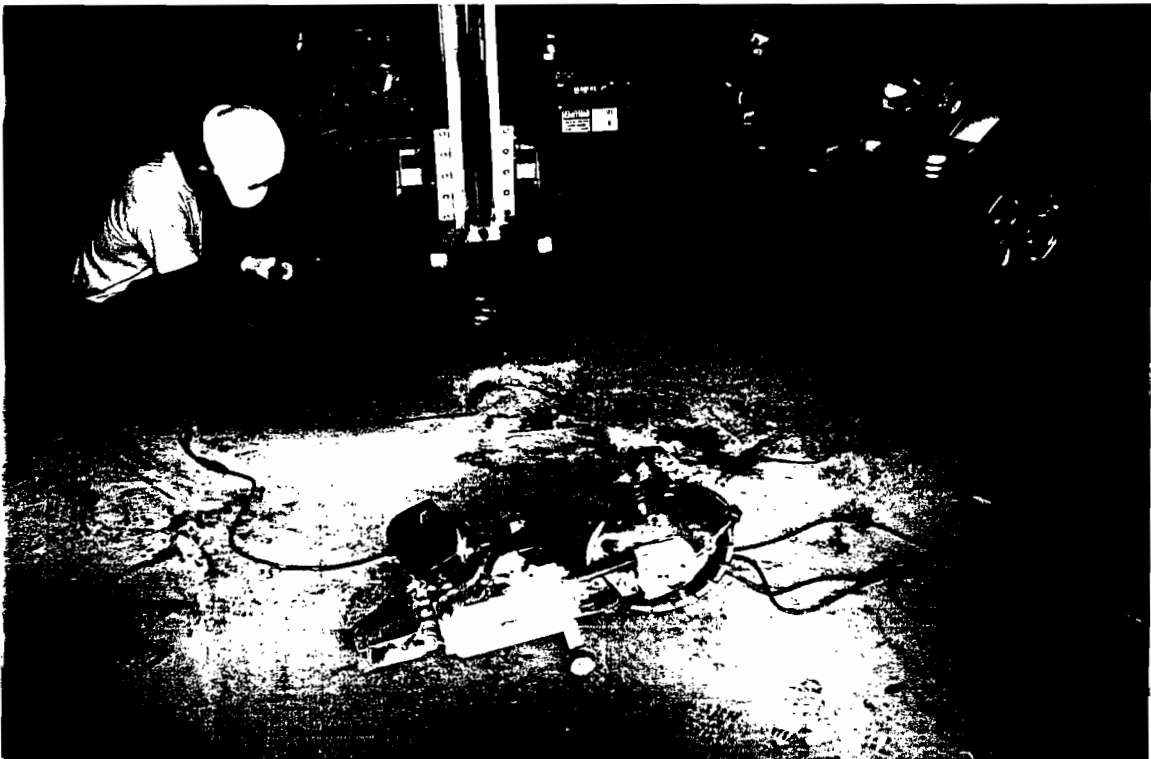
Photograph 5

#### Tentative Pollution Source B – Photograph 6

With respect to TSP-B, said feature was accessed with a hydraulic probing tool. The tool penetrated the feature to its base (6 feet below grade) which was determined to be solid (likely concrete). The feature was determined to contain standing water as evidenced by observations of liquid on the probe rods (see Photograph 9). This feature was determined to function as a semi-permeable storage tank. As such, it was identified as a confirmed non-point pollution source.
