DRAFT
VAPOR INTRUSION INVESTIGATION REPORT
NEW CASSEL INDUSTRIAL AREA
SITE # 130043

WORK ASSIGNMENT NO. D004434-31

New York State Department of Environmental Conservation
Albany, New York

MACTEC Engineering and Consulting, P.C.
Portland, Maine

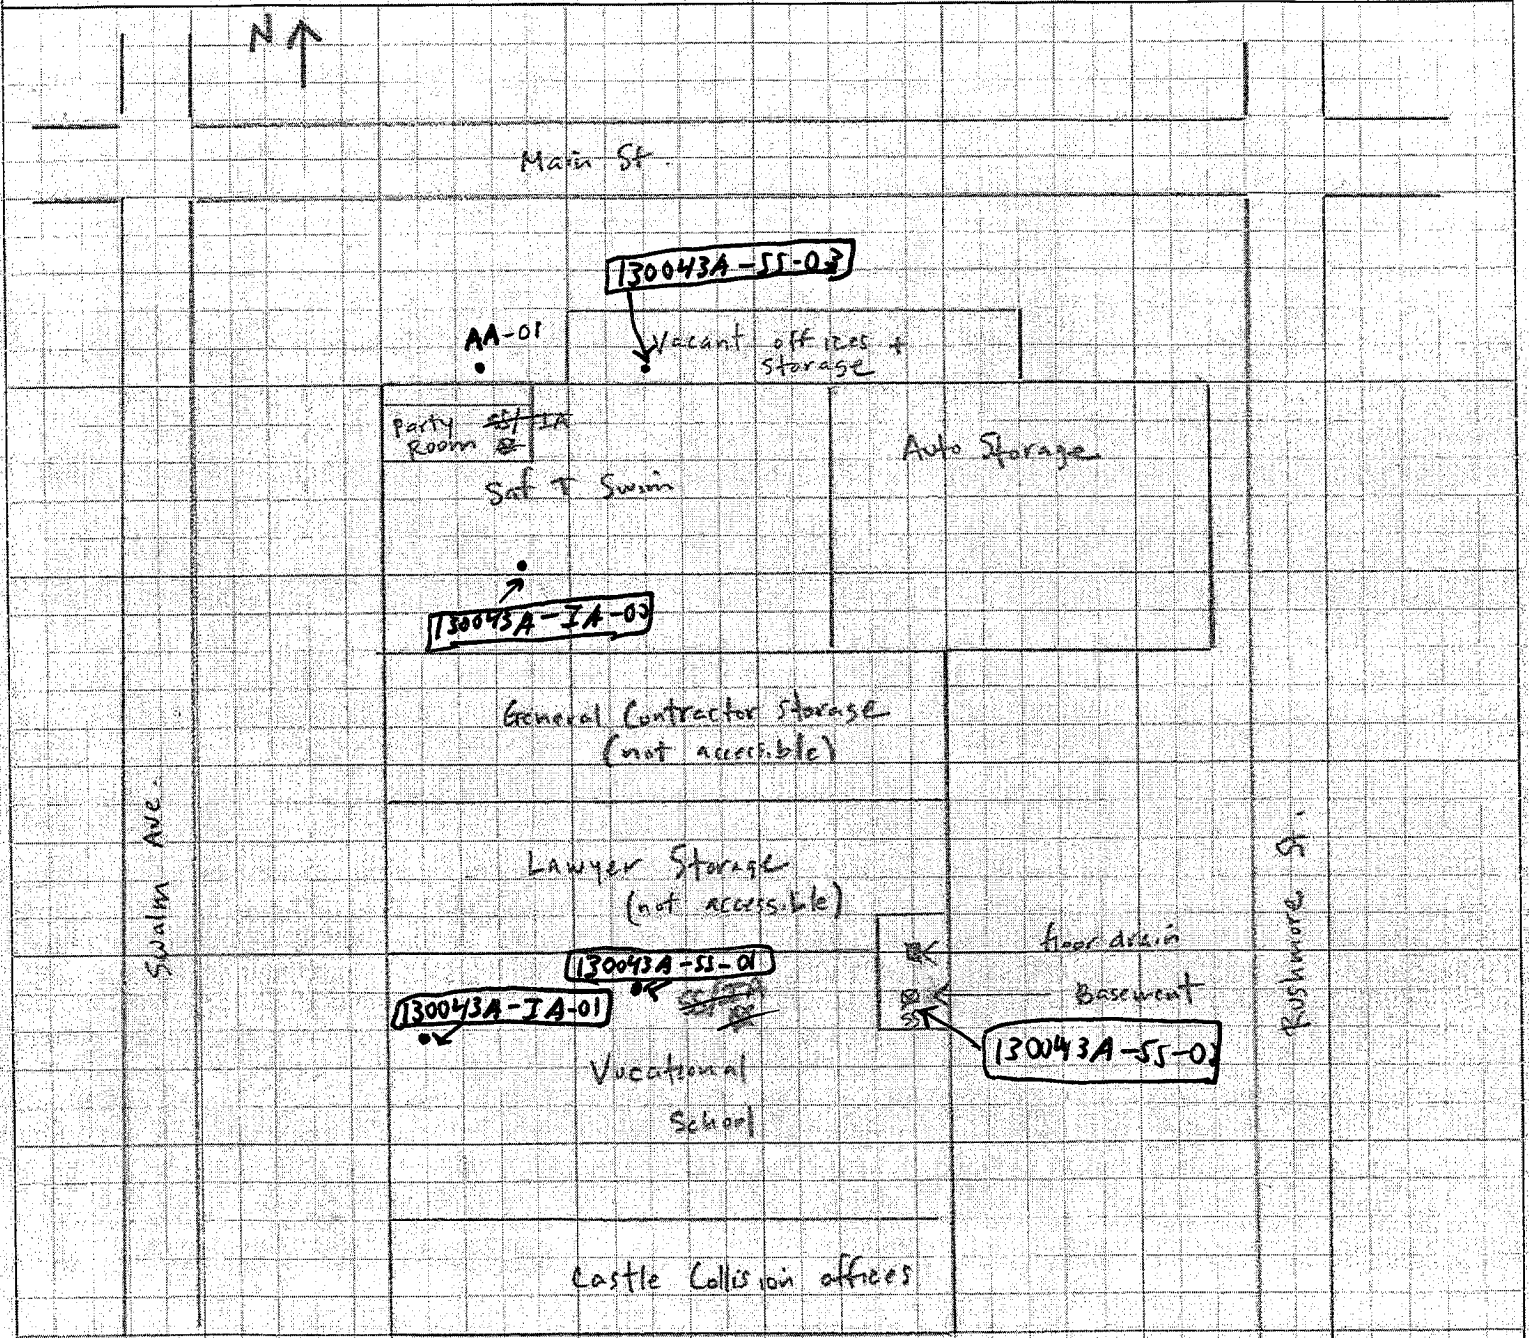
JOB NO. NCA SHEET 1 OF 1
 PHASE 3612092127 TASK 01.01
 JOB NAME 570 Main St.
 BY PJM DATE 12-29-09
 CHECKED BY _____ DATE _____

Notes: Bob Scarpelli demands that MACTEC/DEC contact IML Magnetics before testing. Contact is Lance Turxley Mason, OH (513) 459-9677. Also, contact Chris Ramsley (603) 924-4100 at Hill + Assoc. - they performed clean-up. Syl Lamarca is owner's rep.

Vocational School is large and any convenient sub-slab point is appropriate.
 SS - proposed sub-slab soil vapor sampling point.
 IA - proposed indoor air sampling location.
