## 2021 PERIODIC REVIEW REPORT FRANKLIN CLEANERS SITE NYSDEC SITE NO. 130050

WORK ASSIGNMENT NO. D009809-18

MACTEC Engineering and Geology, P.C. Portland, Maine

**JUNE 2021**

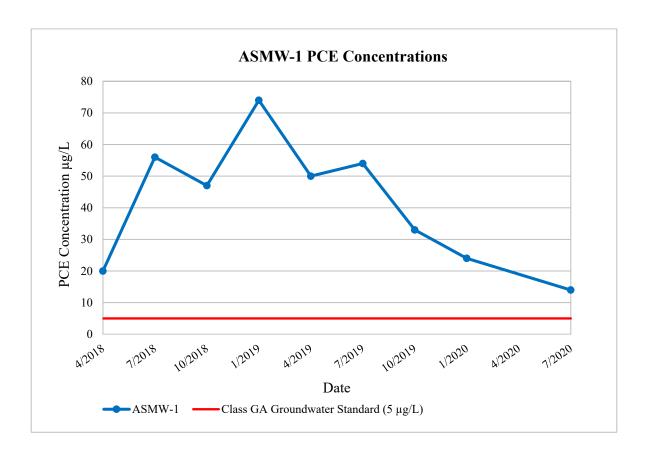
ASMW-1: PCE was detected at concentrations ranging from 14  $\mu$ g/l (July 2020) to 74  $\mu$ g/l (January 2019) during the reporting period. PCE concentrations in ASMW-1 exhibited an overall decreasing trend throughout the reporting period and historically since 2003. A graph depicting PCE concentrations in ASMW-1 during the reporting period compared to the Class GA Standard for PCE (5  $\mu$ g/l) is included below.

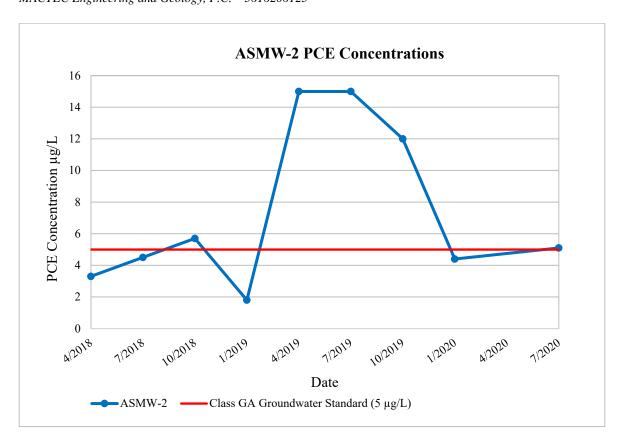
ASMW-2: During the reporting period, PCE was detected at concentrations ranging from 1.8  $\mu$ g/l (January 2019) to 15  $\mu$ g/l (April and July 2019). Overall, PCE concentrations have exhibited an increasing trend throughout the reporting period and an overall decreasing trend since 2003. A graph depicting PCE concentrations in ASMW-2 during the reporting period compared to the Class GA Standard for PCE (5  $\mu$ g/l) is included below.

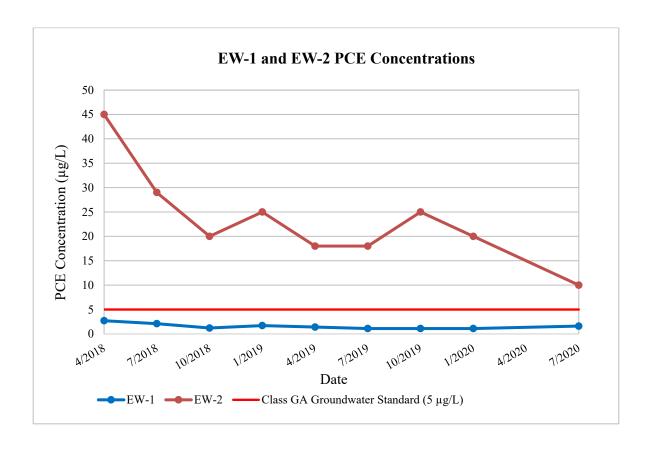
<u>EW-2</u>: PCE concentrations ranged from 10 μg/l (July 2020) to 45 μg/l (April 2018) during the reporting period. Overall, PCE concentrations have exhibited a decreasing trend throughout the reporting period and a decreasing trend since start-up of the treatment system in September 2004. A graph depicting PCE concentrations in EW-2 during the reporting period compared to the Class GA Standard for PCE is included below.
