## TECHNICAL MEMORANDUM

**SUBJECT:** Groundwater Monitoring Well Decommissioning  
Franklin Cleaners Site  
NYSDEC Site Number (No.) 130050  
Contract/Work Assignment No. D009806-34  
EA Project No. 16025-34-00-CP

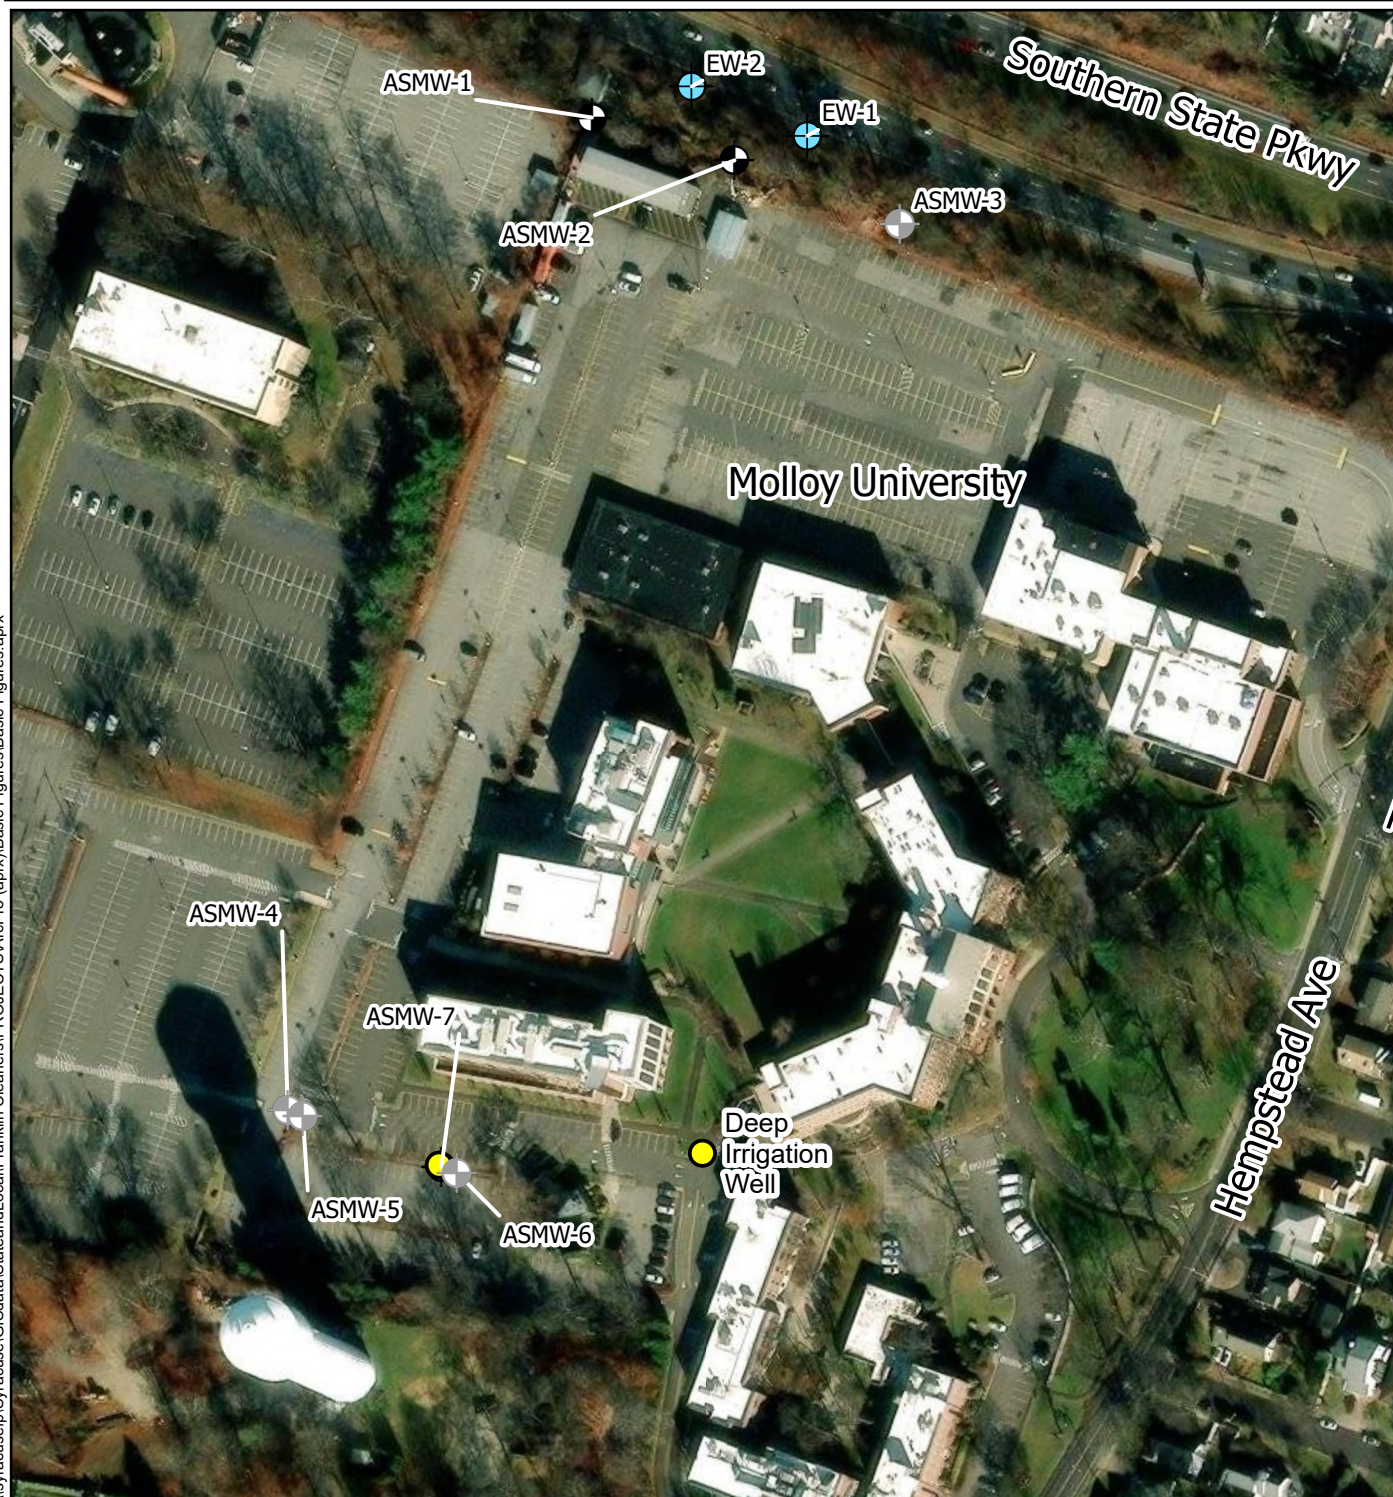
Figure 1.

### Monitoring Well Locations

Franklin Cleaners (NYSDEC Site No. 130050)  
Molloy University, 1000 Hempstead Avenue,  
Rockville Centre, Nassau County, New York

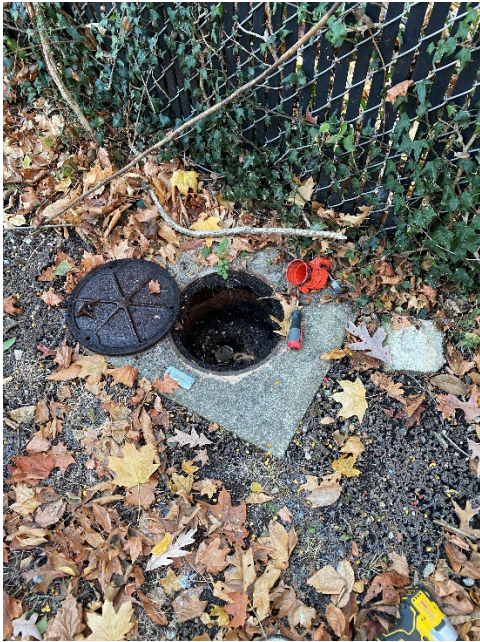
| Site Photographs (Descriptions Below) |
|---|
| ASMW-1 Opened |

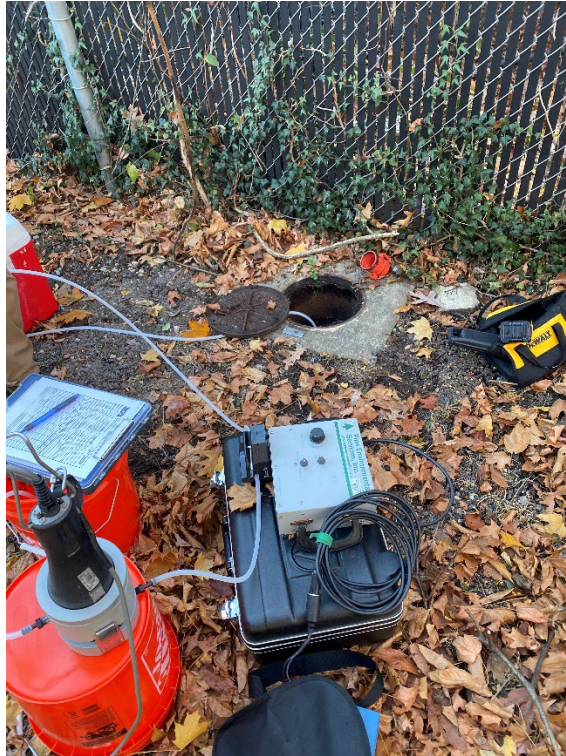
Setup on ASMW-1

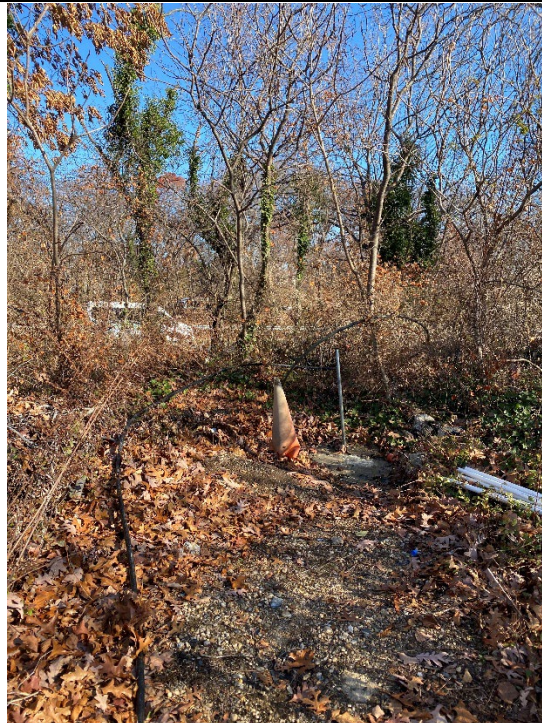
ASMW-3 grout in progress

- Well Grouting—Grout was mixed in batches according to NYSDEC well-decommissioning protocol (90 gallons of water with 9 bags of Portland cement type I-II). Each well was grouted in place, up to 1 to 2 feet below grade. Grout was placed in wells using a tremie pipe from the bottom of the well to the ground surface. Each location was inspected 24 hours following grout placement to ensure the grout settled and grout line was above the groundwater table. Once it was determined the well casing was sufficiently grouted, each PVC casing was cut bgs.

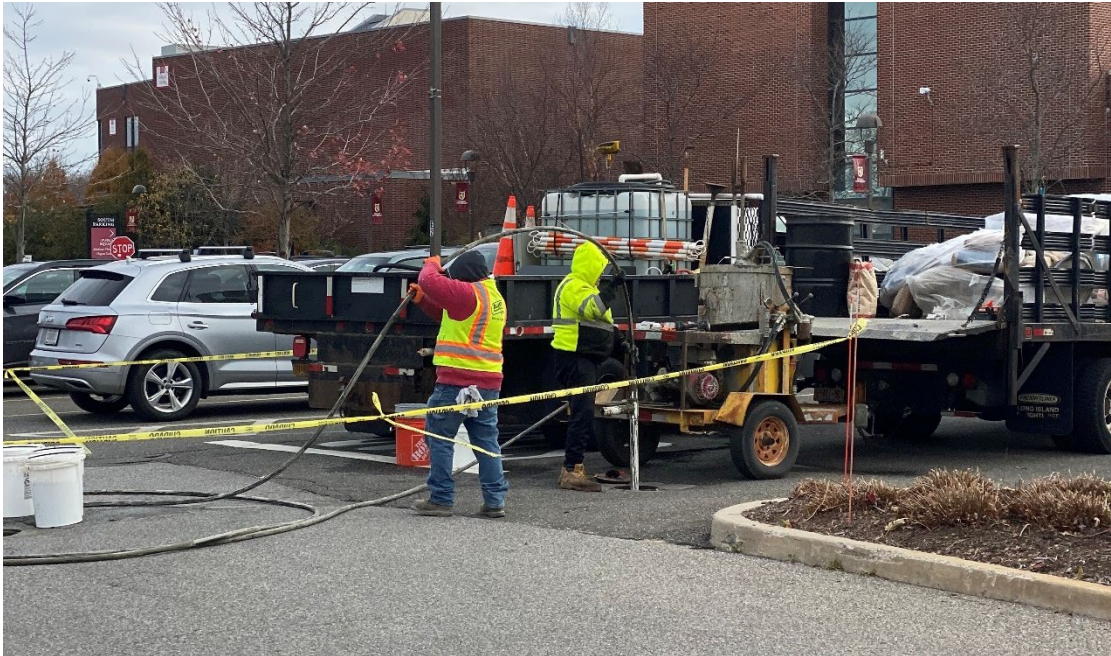
| Site Photographs (Descriptions Below) |
|---|
| Grout setup at ASMW-4 & ASMW-5 |

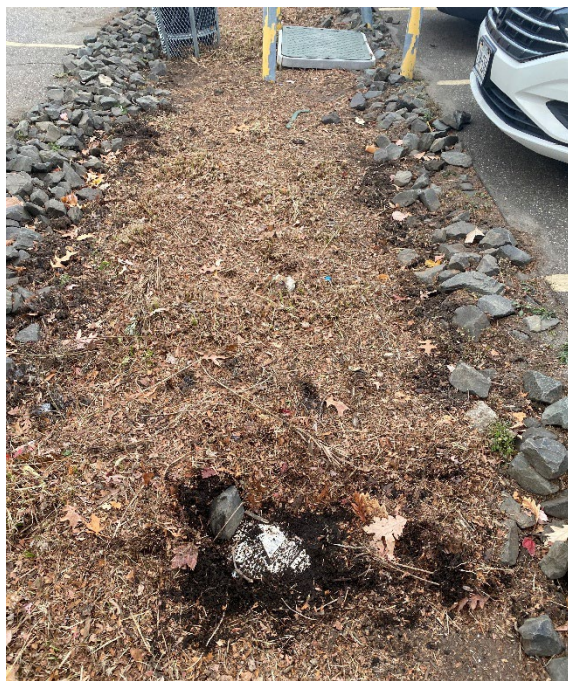
ASMW-6 closed

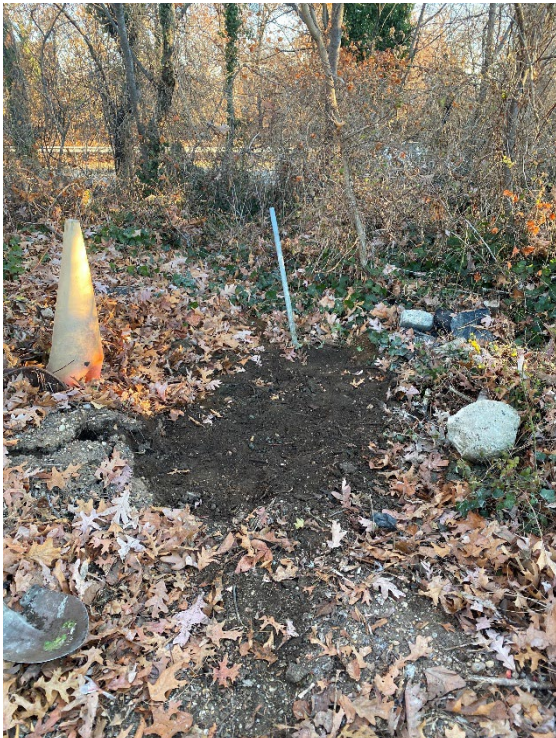
| Site Photographs (Descriptions Below) |
|---|
| ASMW-3 following monitoring well abandonment |

- Well Pad Removal—Concrete well pads and road boxes were jackhammered and removed from the ground surface.
- Restoration—After well grouting and removing well pads, surface restoration was completed using similar soil and topsoil in grassy areas and asphalt in paved areas.

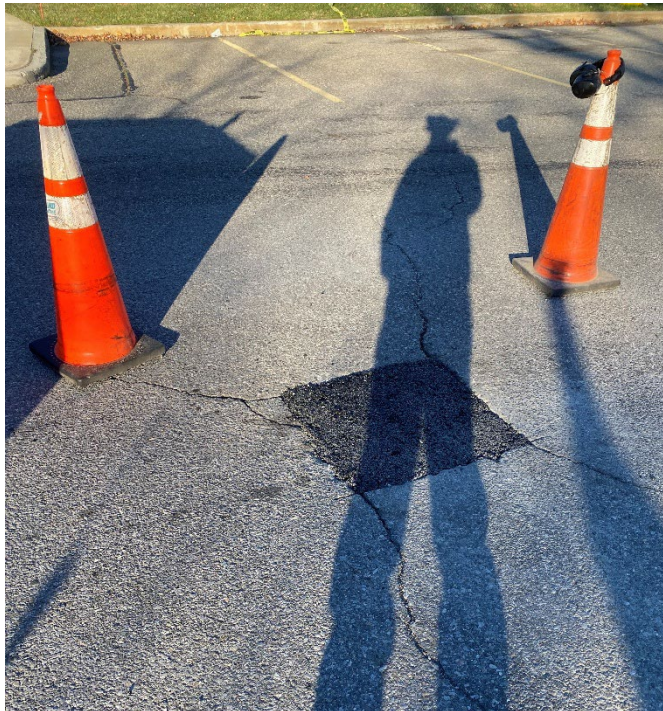
ASMW-4 following monitoring well abandonment

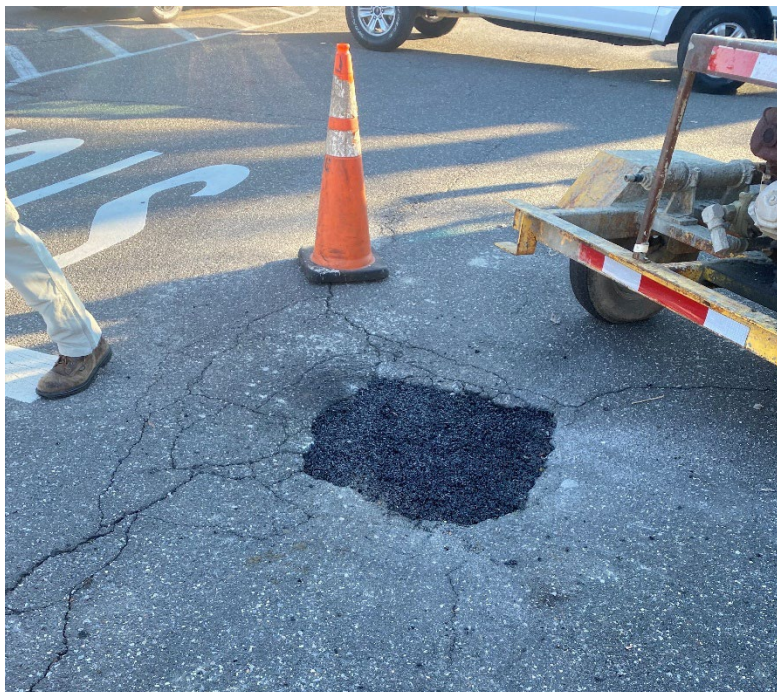
ASMW-5 following monitoring well abandonment

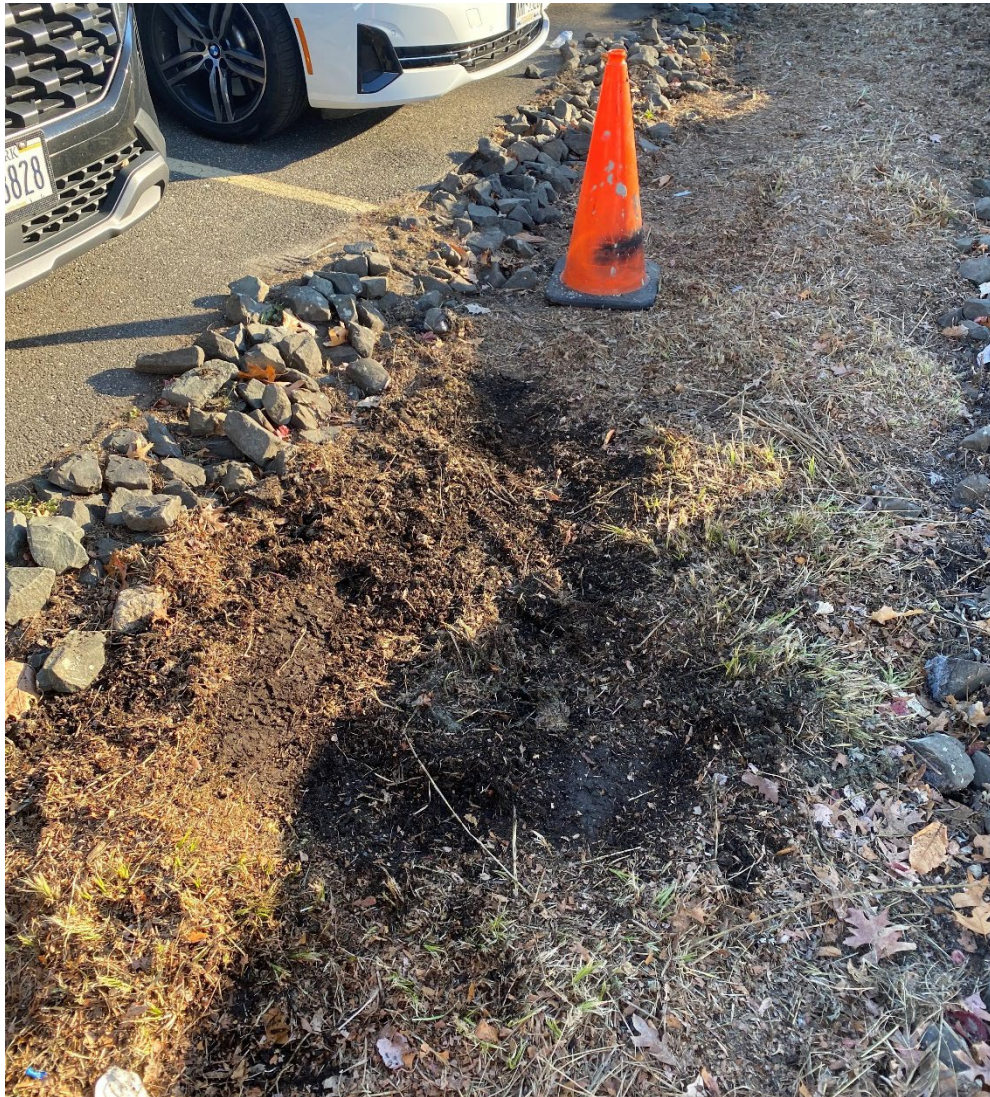
ASMW-6 following monitoring well abandonment

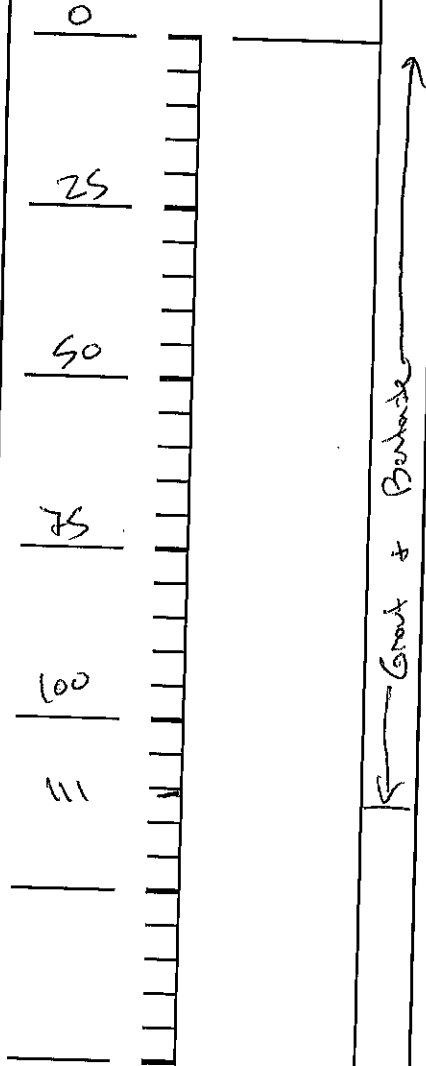
**WELL SCHEMATIC\***

\* Sketch in all relevant decommissioning data, including:  
interval overdrilled, interval grouted, casing left in hole,  
well stickup, etc.
