TS-PIC-20502367S
April 2005

**AERIAL PHOTOGRAPHIC ANALYSIS OF
OLD ROOSEVELT FIELD
CONTAMINATED GROUNDWATER AREA
Garden City, New York**

AERIAL PHOTOGRAPHIC ANALYSIS OF
OLD ROOSEVELT FIELD CONTAMINATED GROUNDWATER AREA

Garden City, New York

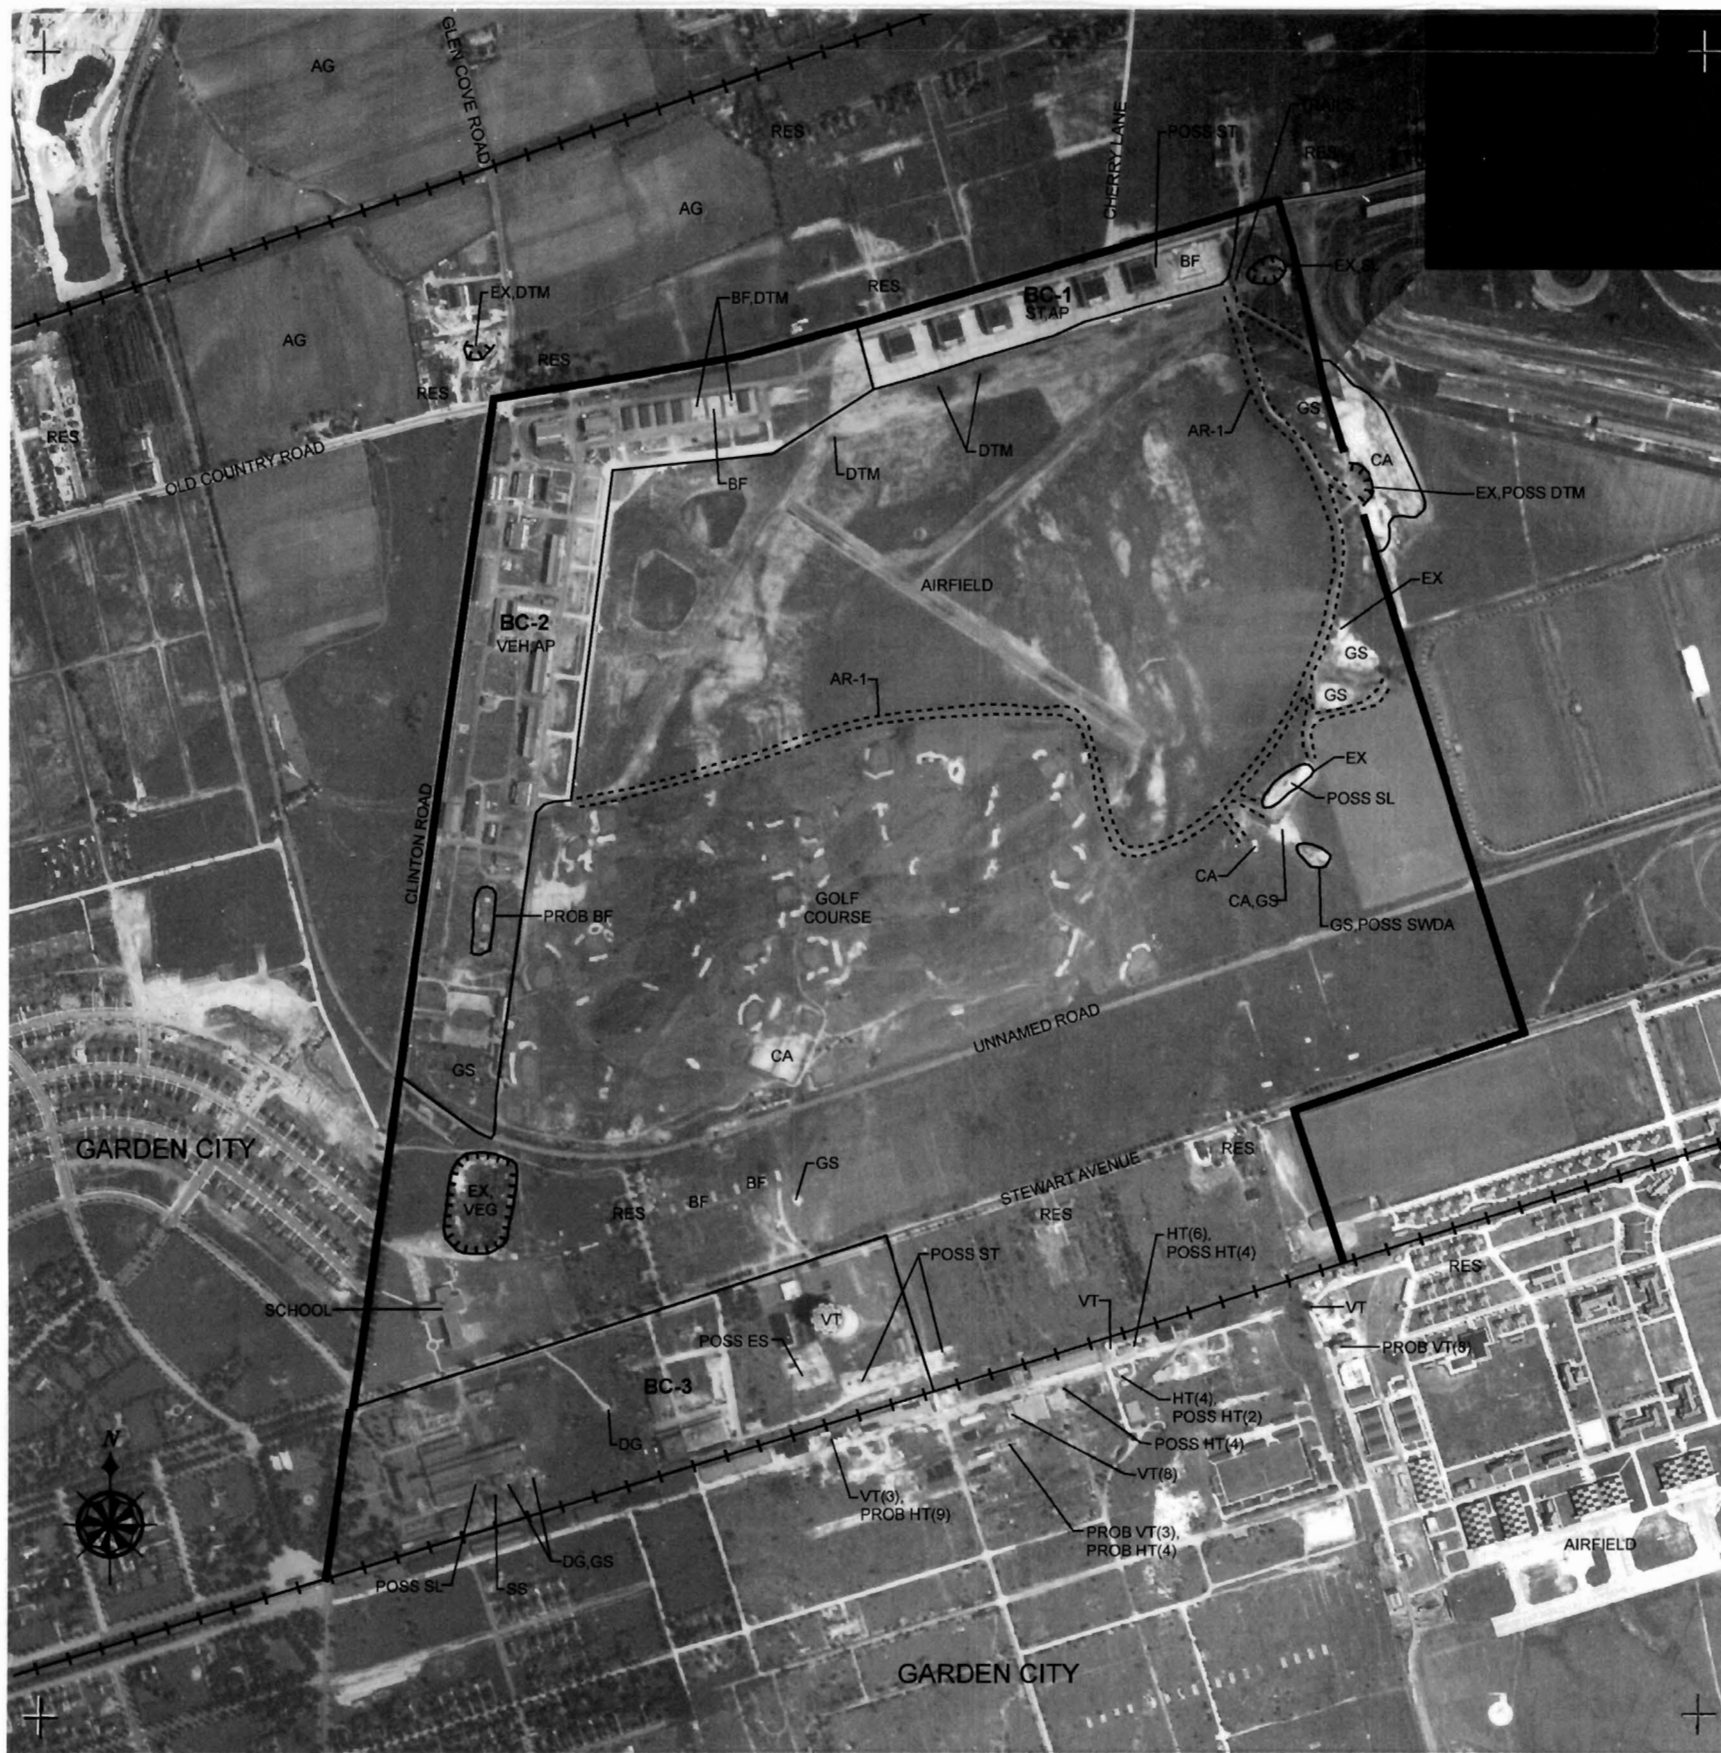
Building Complex-1 (BC-1) is located along Old Country Road in the northern part of the Old Roosevelt Field Contaminated Groundwater Area ("the site") and is mainly comprised of six large, square-shaped buildings (not annotated), a building foundation (BF), and a section of the airfield tarmac (not annotated). The size, shape, and location of these buildings relative to the tarmac and to the airfield to the south suggest these buildings are hangars used for storage, repair, and maintenance of airplanes (AP; not individually annotated) visible nearby. Stains (ST; not individually annotated) and a possible stain are also noted. Just to the east of this building complex, there are several trails that extend to the east toward an excavation (EX) containing standing liquid (SL). South and southwest of this complex, a total of three patches of dark-toned material (DTM) are noted.

Building Complex-2 (BC-2) is located in the northwestern and western parts of the site, adjacent to Old Country and Clinton roads. Several buildings of various sizes, probably used for maintenance and repair of airplanes, and offices (buildings not annotated) comprise this complex. Numerous vehicles (VEH; partially annotated) are noted near several of the buildings, and airplanes are visible near the tarmac (not annotated). Three building foundations, two of which are showing dark-toned material on their surface, are noted along Old Country Road in the northern portion of this building complex. Probable building foundations and ground scars (GS), possibly related to building removal, are visible in the southern portion of this complex adjacent to Clinton Road. Access Road-1 (AR-1) connects this building complex to the far-eastern portion of Building Complex-1, and also separates the airfield from

the golf course to the south, where a cleared area (CA) is noted near an unnamed road. Adjacent to this access road, several road spurs are visible. Near this access road and the spurs there are several cleared areas and ground scars. The southernmost ground scar appears to be used as a possible solid waste disposal area (SWDA). Two excavations are also visible. The southernmost excavation contains possible standing liquid. Abutting the eastern boundary of the site, there is a large cleared area. An excavation containing possible dark-toned material is noted.

In the southwestern part of the site, just south of Building Complex-2, a third excavation is observed. Only the northwestern corner of the excavation appears active, indicated by the light-toned material (not annotated) on its surface. The remaining section of the excavation is covered with vegetation (VEG) and does not appear to have been recently disturbed. East of the excavation, there are approximately ten residences (RES), several building foundations (partially annotated), and a ground scar. A school is observed south of the excavation. The school will continue to be annotated on subsequent overlays, but will no longer be discussed in the text unless changes of environmental significance are observed.

In the southwestern part of the site Building Complex-3 (BC-3) is observed along Clinton Road, Stewart Avenue, and the railroad. A light-industrial facility (not annotated) is noted in the extreme western portion of this building complex. Possible standing liquid, a smokestack (SS), small patches of disturbed ground (DG), and ground scarring are visible at this facility. To the east there are a possible electrical substation (ES), a large vertical storage tank (VT), and a possible stain. Another stain is noted just east of Building Complex-3, as are two small groupings of residences adjacent to Stewart Avenue.

Immediately northwest of the site, there is an excavation and dark-toned material in a residential area adjacent to agricultural fields (AG). South of the site and proximal to the railroad, there are a total of 13 vertical storage tanks, 11 probable vertical storage tanks, 10 horizontal storage tanks (HT), 13 probable horizontal storage tanks, 10 possible horizontal storage tanks, and an airfield.

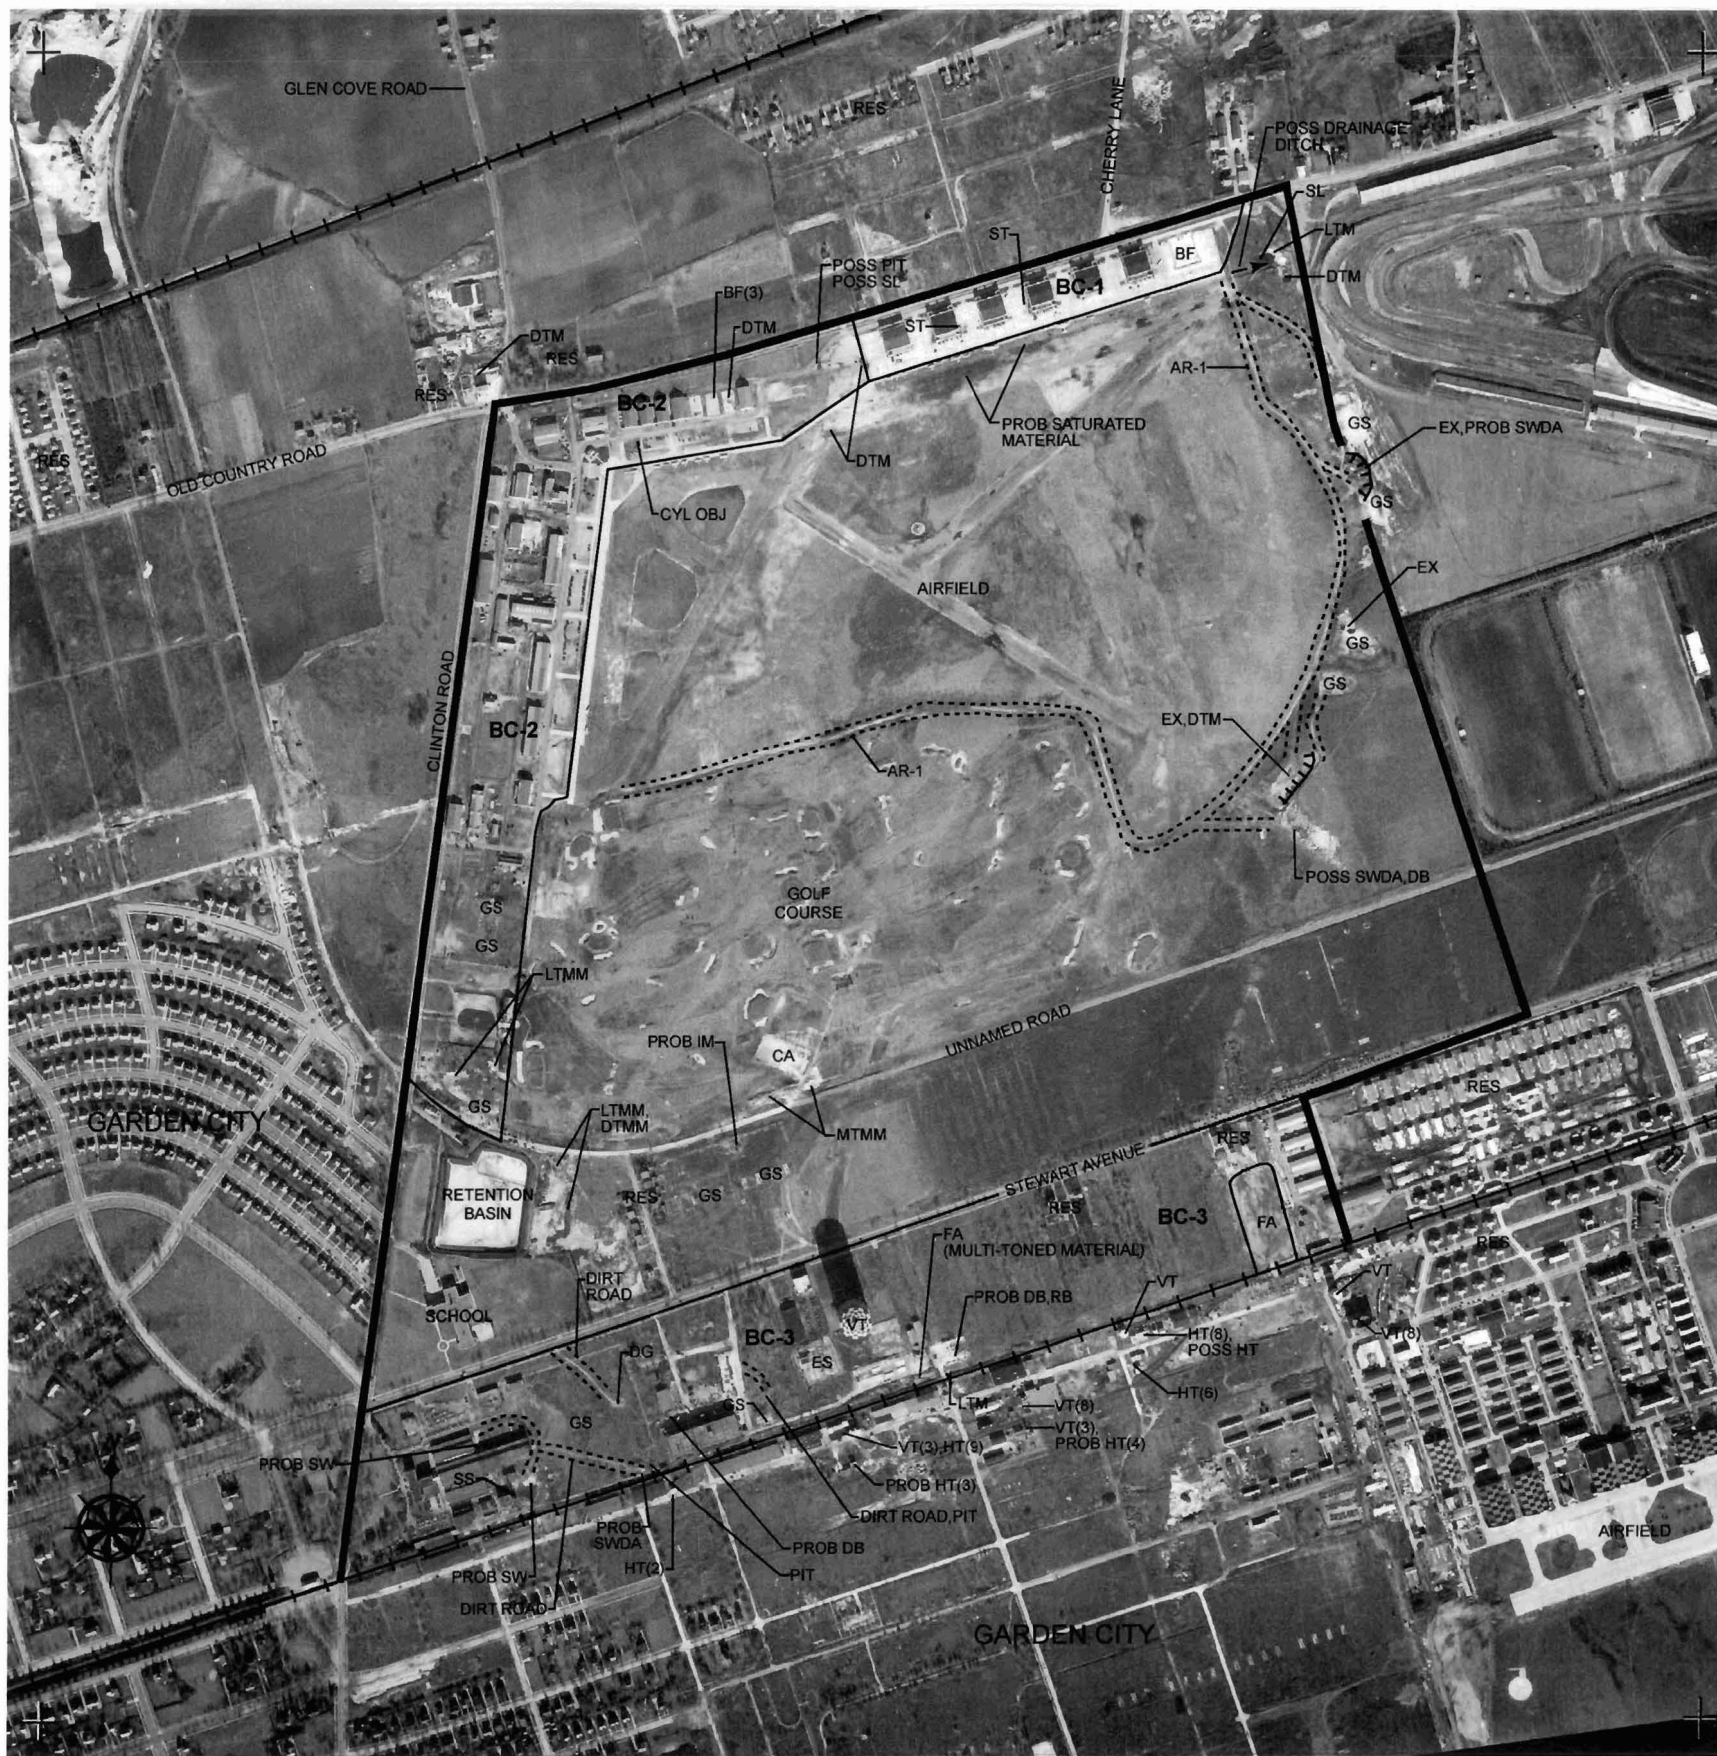
The six square-shaped buildings (hangars), several stains (not individually annotated), a building foundation, and several airplanes and vehicles (not annotated) remain noted at Building Complex-1 in the northern part of the site. Immediately to the east of this building complex, a dirt road (not annotated) extends east to a pool of standing liquid. A possible drainage ditch extends east from the corner of the tarmac and connects to the standing liquid. Near the pool of liquid there are dark-toned material and light-toned material (LTM). This light-toned material may indicate additional excavated material from the excavation seen in the 1938 photograph, but due to the lack of stereo coverage for this part of the site, this cannot be confirmed. South of this building complex, there are large areas of probable saturated material where dark-toned material was previously noted.

At Building Complex-2 numerous aircraft and vehicles (neither feature annotated) are located proximal to several buildings and the tarmac. Dark-toned material remains visible on one of the three building foundations along Old Country Road, as does a cylindrical-shaped object (CYL OBJ). To the east there are a possible pit containing possible standing liquid and a patch of dark-toned material. Another patch of dark-toned material is observed just to the south of the building complex. In the southern portion of this complex, adjacent to Clinton Road, numerous ground scars (possibly related to building removal) and light-toned mounded material (LTMM) are noted.

possible solid waste disposal area in which debris (DB) is observed, as well as connecting to an excavation where dark-toned material is noted. South of the golf course, the cleared area seen in 1938 remains visible. Two mounds of medium-toned material (MTMM) are located between the cleared area and the unnamed road.

In the southwestern part of the site, south of Building Complex-2, a dry retention basin is observed. The areal extent of the basin is larger than the excavation seen in this location in 1938. Materials that may have been removed to enlarge the basin are noted to the east in the form of piles of uniform light- and dark-toned material (LTMM, DTMM). East of the retention basin there are approximately ten residences and numerous ground scars (partially annotated) likely resulting from the removal of former buildings. North of these ground scars, adjacent to the unnamed road, a small, dry rectangular-shaped probable impoundment (IM) is observed.

and a pile of probable debris and rubble (RB). On the east side of the building complex a small residential area and an individual residence front Stewart Avenue. An extensive fill area is now located south of the single residence and four new buildings (not annotated) are observed just to the east.

Immediately northwest of the site, dark-toned material is noted at a light-industrial facility (not annotated). South of the site, proximal to the railroad, a total of 24 vertical storage tanks, 25 horizontal storage tanks, 7 probable horizontal storage tanks, and 1 possible horizontal storage tank are noted.

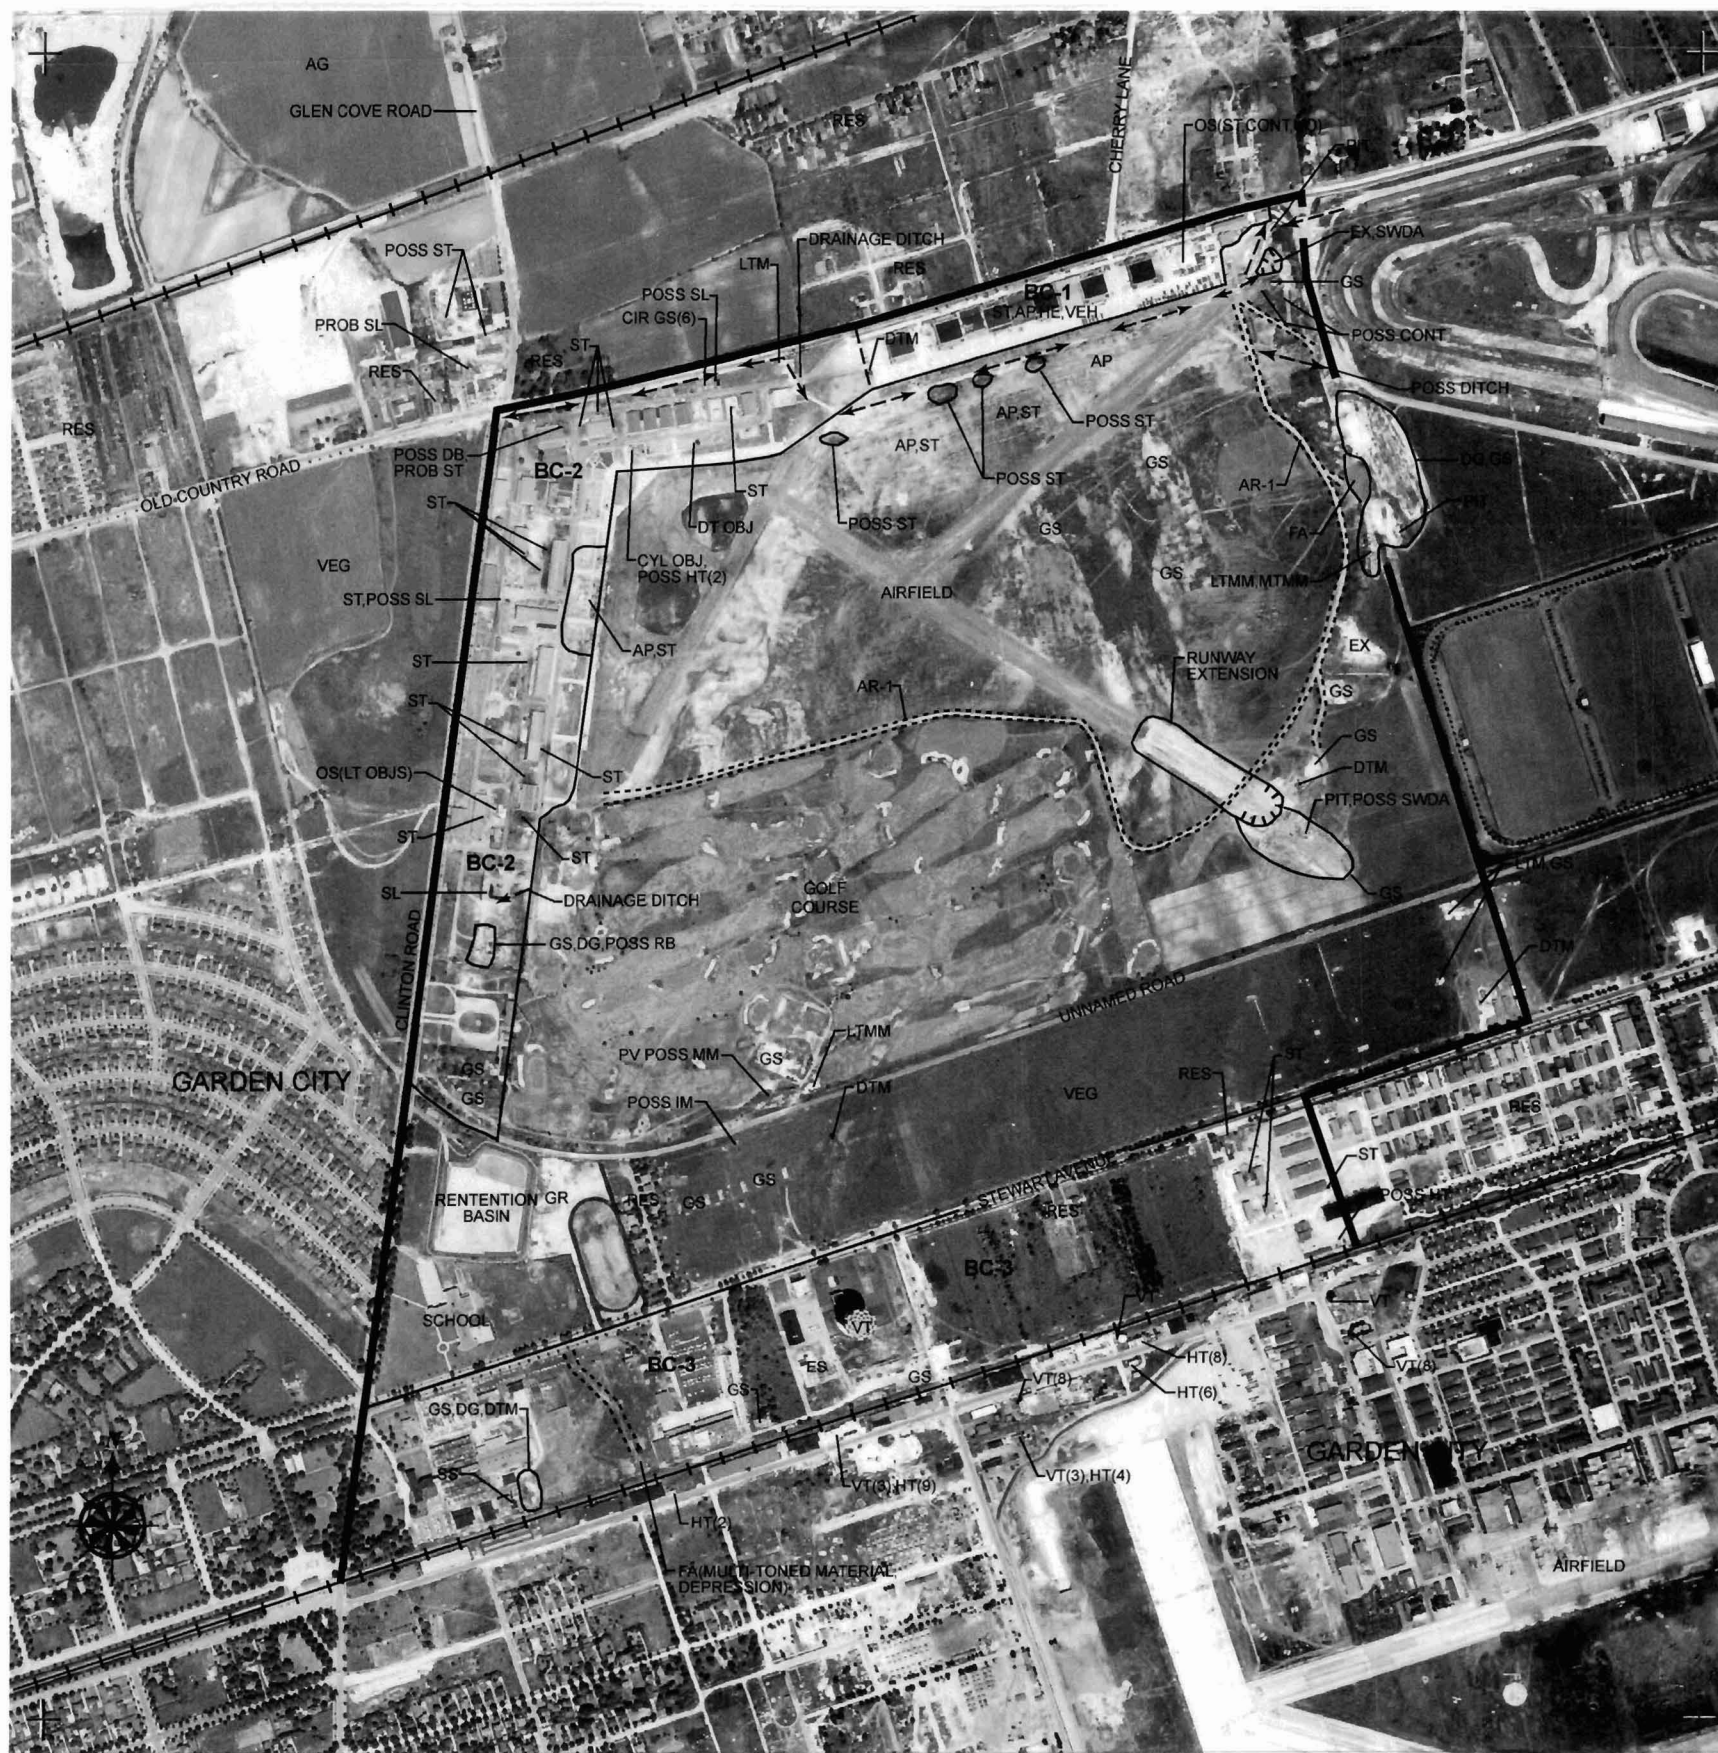
Building Complex-1 in the northern part of the site remains active. A large number of airplanes, vehicles, heavy equipment (HE), and stains are visible near the six square-shaped buildings (hangars) and tarmac (features are not individually annotated). Since 1940 several smaller buildings (not annotated) have been constructed in the eastern portion of the building complex. In addition, the building foundation noted in previous photographs has been converted to a large open storage area (OS) comprised of large containers (CONT) and unidentified objects (UO). Scattered stains are also visible. Immediately to the east of this building complex, the large excavation seen in 1938 (stereo coverage was not available for 1940) is again visible and is being utilized for solid waste disposal. However, unlike the 1938 and 1940 photographs where standing liquid was noted in this location, the excavation is now dry. This is possibly because of an extensive east-west oriented drainage ditch that may be diverting surface drainage, which traverses the northern portion of the site, into Building Complex-2. In addition, a possible drainage ditch is noted south of the excavation. A small pit, a ground scar, two possible containers, and two possible containers are also observed in this location. South of Building Complex-1, there are three areas of stained ground and a large assemblage of airplanes and associated stained ground.

Building Complex-2 also remains active, as numerous airplanes (partially annotated), vehicles (not annotated), and stains are located proximal to several of the buildings and the tarmac (not annotated). In the northern portion of this complex, adjacent to Old Country Road, there is a drainage ditch, a patch of dark-toned material, light-toned material, possible standing liquid, six circular (CIR)-shaped ground scars, a dark-toned object (DT OBJ), possible debris, and a probable stain. The cylindrical-shaped object seen in 1940 remains visible, adjacent to which are two possible horizontal storage tanks. Possible standing liquid is observed near Clinton Road and in the southern portion of the building complex, there is a small pool of standing liquid and associated drainage ditch. Farther south are ground scars, disturbed ground, and possible rubble.

Access Road-1 continues to connect Building Complex-2 to the far-eastern part of Building Complex-1, as well as to separate the golf course from the airfield. Several ground scars are noted on the eastern portion of the airfield. Two road spurs continue to connect the access road to a large area of disturbed ground and ground scars along the eastern site boundary. Within this area a pit and numerous, dump-truck-sized mounds of light- and medium-toned material are noted. These mounds are devoid of vegetation, suggesting recent deposition. Also visible is a graded fill area where, in 1940, an excavation and solid waste deposition were identified. The northwest-southeast oriented runway is in the process of being extended across Access Road-1, where several spurs (partially annotated) remain noted. Connected to the runway is a large ground scar where a pit is being utilized for possible solid waste deposition. Smaller ground scars and a collection of small piles of dark-toned material are noted near the access road. Material has also been removed from the excavation area and may have been transported and used for runway extension and/or for filling and covering the pit to the south. To the southwest, south of the golf course, a large ground scar is located near the unnamed road where, in 1940, a cleared area was visible. A grouping of dump-truck-sized mounds of uniform light-toned material is also observed. These mounds are devoid of vegetation, suggesting recent deposition. Possible mounded material is located in the same location where, in 1940, medium-toned mounded material was identified. The ground surface of the possible mound appears partially vegetated (PV), suggesting the material has not been disturbed for several years.

In the southwestern part of the site, south of Building Complex-2, the dry retention basin, approximately ten residences, a patch of dark-toned material, and numerous ground scars likely resulting from the removal of former buildings are observed. In 1940 uniform light- and dark-toned materials were observed just east of the basin. These materials are no longer visible, and the area is now graded (GR) and mostly devoid of vegetation. Adjacent to the unnamed road, there is a possible impoundment where, in 1940, a small rectangular-shaped probable impoundment was observed.

In the southern part of the site, the light-industrial facility (not annotated) with a smokestack remains in the western portion of Building Complex-3. On the east side of the facility, there is an area composed of ground scars, disturbed ground, and small patches of dark-toned material. In the open field (not annotated) to the east, one of the two dirt roads noted on the 1940 photograph is visible. This dirt road, which terminated at a patch of disturbed ground in 1940, now extends farther southeast to a depression and the fill area comprised of multi-toned material. A probable solid waste disposal area was noted in this location in 1940. Farther east, near the central portion of this building complex, the grouping of rectangular-shaped ground scars, electrical substation, and large vertical storage tank remain. The short dirt road and pit noted in 1940 are no longer discernible. Southeast of the vertical storage tank, a ground scar is noted where, in 1940, a fill area composed of multi-toned material was located. The small patch of light-toned material and pile of probable debris and rubble noted nearby in 1940 cannot be discerned. Continuing to the east, the small grouping of residences and the single residence adjacent to Stewart Avenue remain. Numerous stains are associated with buildings (not annotated) constructed on the former fill area since 1940. In the far-eastern part of the site, between the unnamed road and Stewart Avenue, there are areas of light-toned material and ground scars, as well as a patch of dark-toned material.

Immediately northwest of the site, probable standing liquid and possible stains are noted at the light-industrial facility (not annotated). South of the site and proximal to the railroad, there are a total of 24 vertical storage tanks, 30 horizontal storage tanks, and one possible horizontal storage tank.

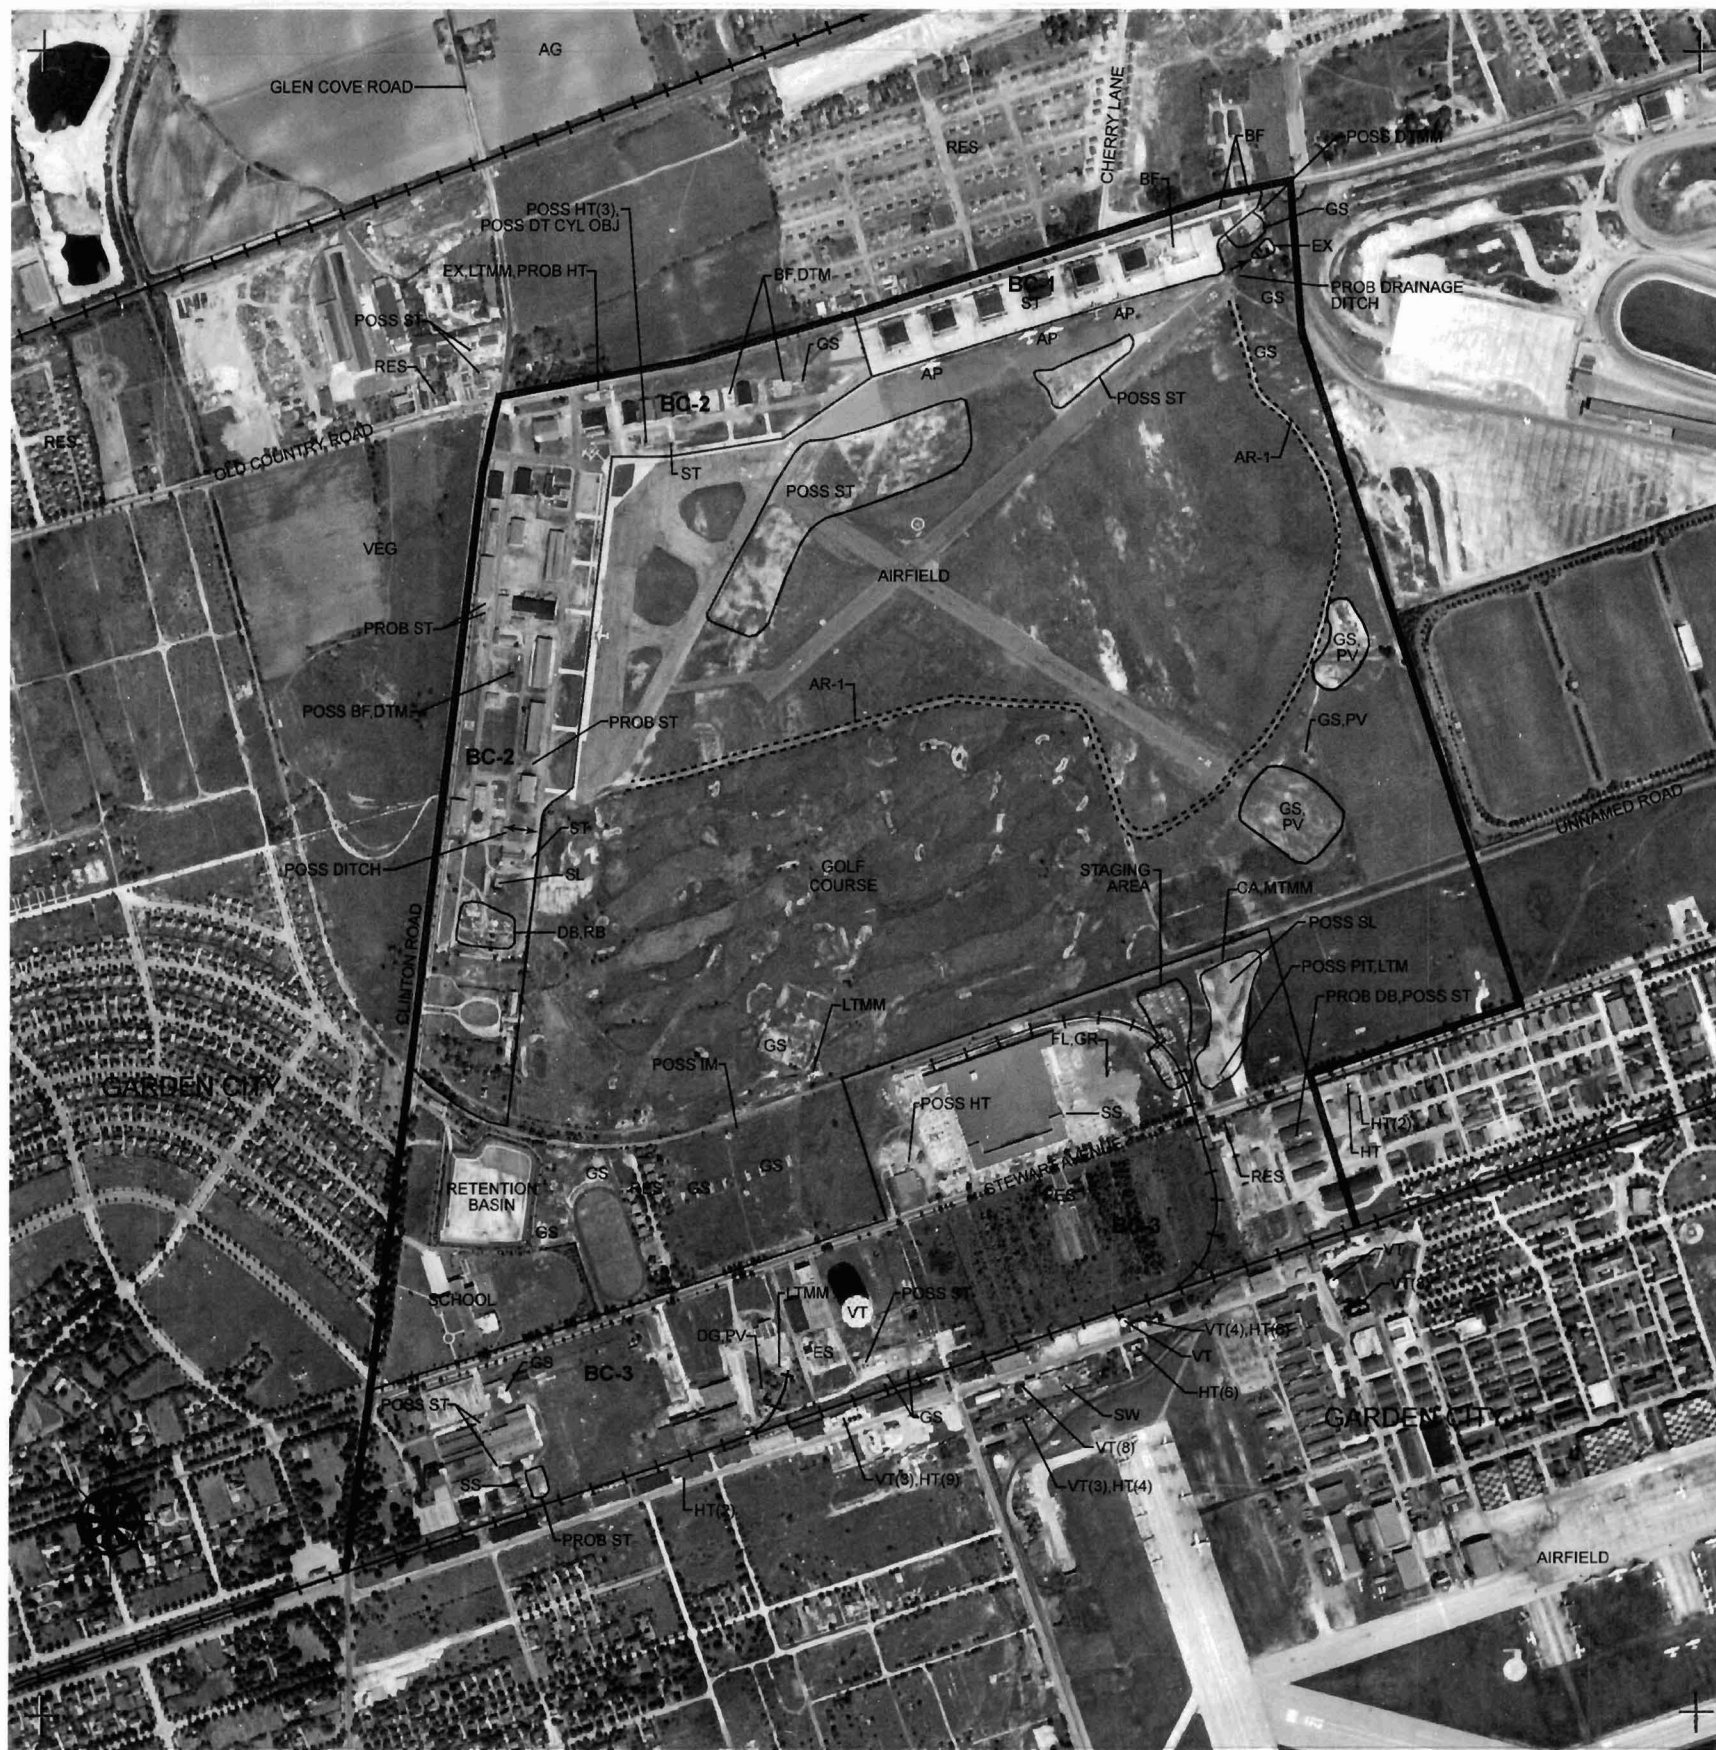
Building Complex-1 in the northern part of the Old Roosevelt Field Contaminated Groundwater Area remains active; however, the number of airplanes and vehicles have been greatly reduced since 1943. Stains (not individually annotated) remain visible adjacent to several of the six square-shaped buildings, tarmac (not annotated), and building foundation. The building foundation converted into an open storage area on the 1943 photograph is no longer being used for that purpose and all stored materials have been removed. East of this building complex, possible dark-toned mounded material, ground scars (not individually annotated), and the excavation are noted. The areal extent of the excavation, as compared to 1943, has been reduced. A probable drainage ditch located between the tarmac and the excavation now appears to channel runoff into the excavation, although no standing liquid is noted in it. A faint linear ground scar (not annotated) is located where an extensive east-west oriented drainage ditch was discerned in 1943. In the airfield to the south of Building Complex-1, numerous possible stains are located where, in 1943, a large assemblage of airplanes was apparent.

Building Complex-2 remains active; however, the number of airplanes and vehicles (features not annotated) are greatly reduced as compared to the 1943 photograph. Stains, probable stains, standing liquid, a ground scar, and a possible ditch are noted scattered throughout the complex. In the northern portion of this complex, two building foundations remain, one of which contains dark-toned material on its surface. Adjacent to Old Country Road, a probable horizontal storage tank is located alongside an excavation of similar size. Uniform light-toned mounded material is noted adjacent to the excavation. The lack of vegetation atop this mound suggests earthmoving activities have been recent. Just to the south are three possible horizontal storage tanks and a possible dark-toned cylindrical-shaped object. In the central portion of this complex are a possible building foundation and the outer walls (not annotated) of a former structure. Within these walls dark-toned material is noted. Near Clinton Road, in the southern portion of this building complex, there is a large area comprised of debris and rubble.

Access Road-1 connects Building Complex-2 to the far-eastern part of Building Complex-1, as well as separates the golf course from the airfield. The southeast extension of the runway noted in 1943 has been completed. Two sizable and another smaller partially vegetated ground scars are located proximal to the access road. Excavation activity observed at the northernmost ground scar has slowed or ceased. The southernmost ground scar is visible in the former location of the possible solid waste disposal area noted on the 1943 photograph. Between the golf course and the unnamed road to the south, the ground scar and uniform light-toned mounded material noted in the 1943 photograph remain. Vegetation cannot be discerned on the surface of the mound of light-toned material, suggesting recent deposition activity. The possible mounded material noted previously is no longer noted.

In the southwestern part of the site, south of Building Complex-2, the dry retention basin, approximately ten residences, numerous ground scars, and the possible dry impoundment are observed.

The northern limits of Building Complex-3 have been expanded to incorporate new activity. The light-industrial facility (not annotated) with a smokestack remains in the western portion of this building complex. Proximal to the facility, a large ground scar and possible and probable stains are noted. In the open field (not annotated) to the east, the depression and fill area noted on the 1943 photograph can no longer be discerned. Near the central portion of this building complex, a new railroad spur has been constructed and a small patch of partially vegetated disturbed ground, light-toned mounded material, the electrical substation, a large vertical storage tank, a possible stain, and ground scars are noted. Ground scars remain in the location where a fill area composed of multi-toned material was previously observed. Farther east there are the small grouping of residences, the individual residence, probable debris, and possible stains. To the north, between Stewart Avenue and the unnamed road, a large U-shaped railroad spur has been constructed which extends to a new building (not annotated) with a smokestack. Proximal to the building a possible horizontal storage tank and a large, graded fill area are noted. To the east there is a large staging area likely comprised of building construction materials. In an adjacent, extensive cleared area there are several large piles of medium-toned material (not individually annotated)

possibly composed of vegetation and earth (not annotated), possible standing liquid, and a possible pit containing light-toned material. Off site, immediately southeast of this cleared area, there are three horizontal storage tanks.

Immediately northwest of the site, possible stains remain at the light-industrial facility (not annotated). South of the site, proximal to the railroad are a total of 28 vertical storage tanks and 27 horizontal storage tanks.

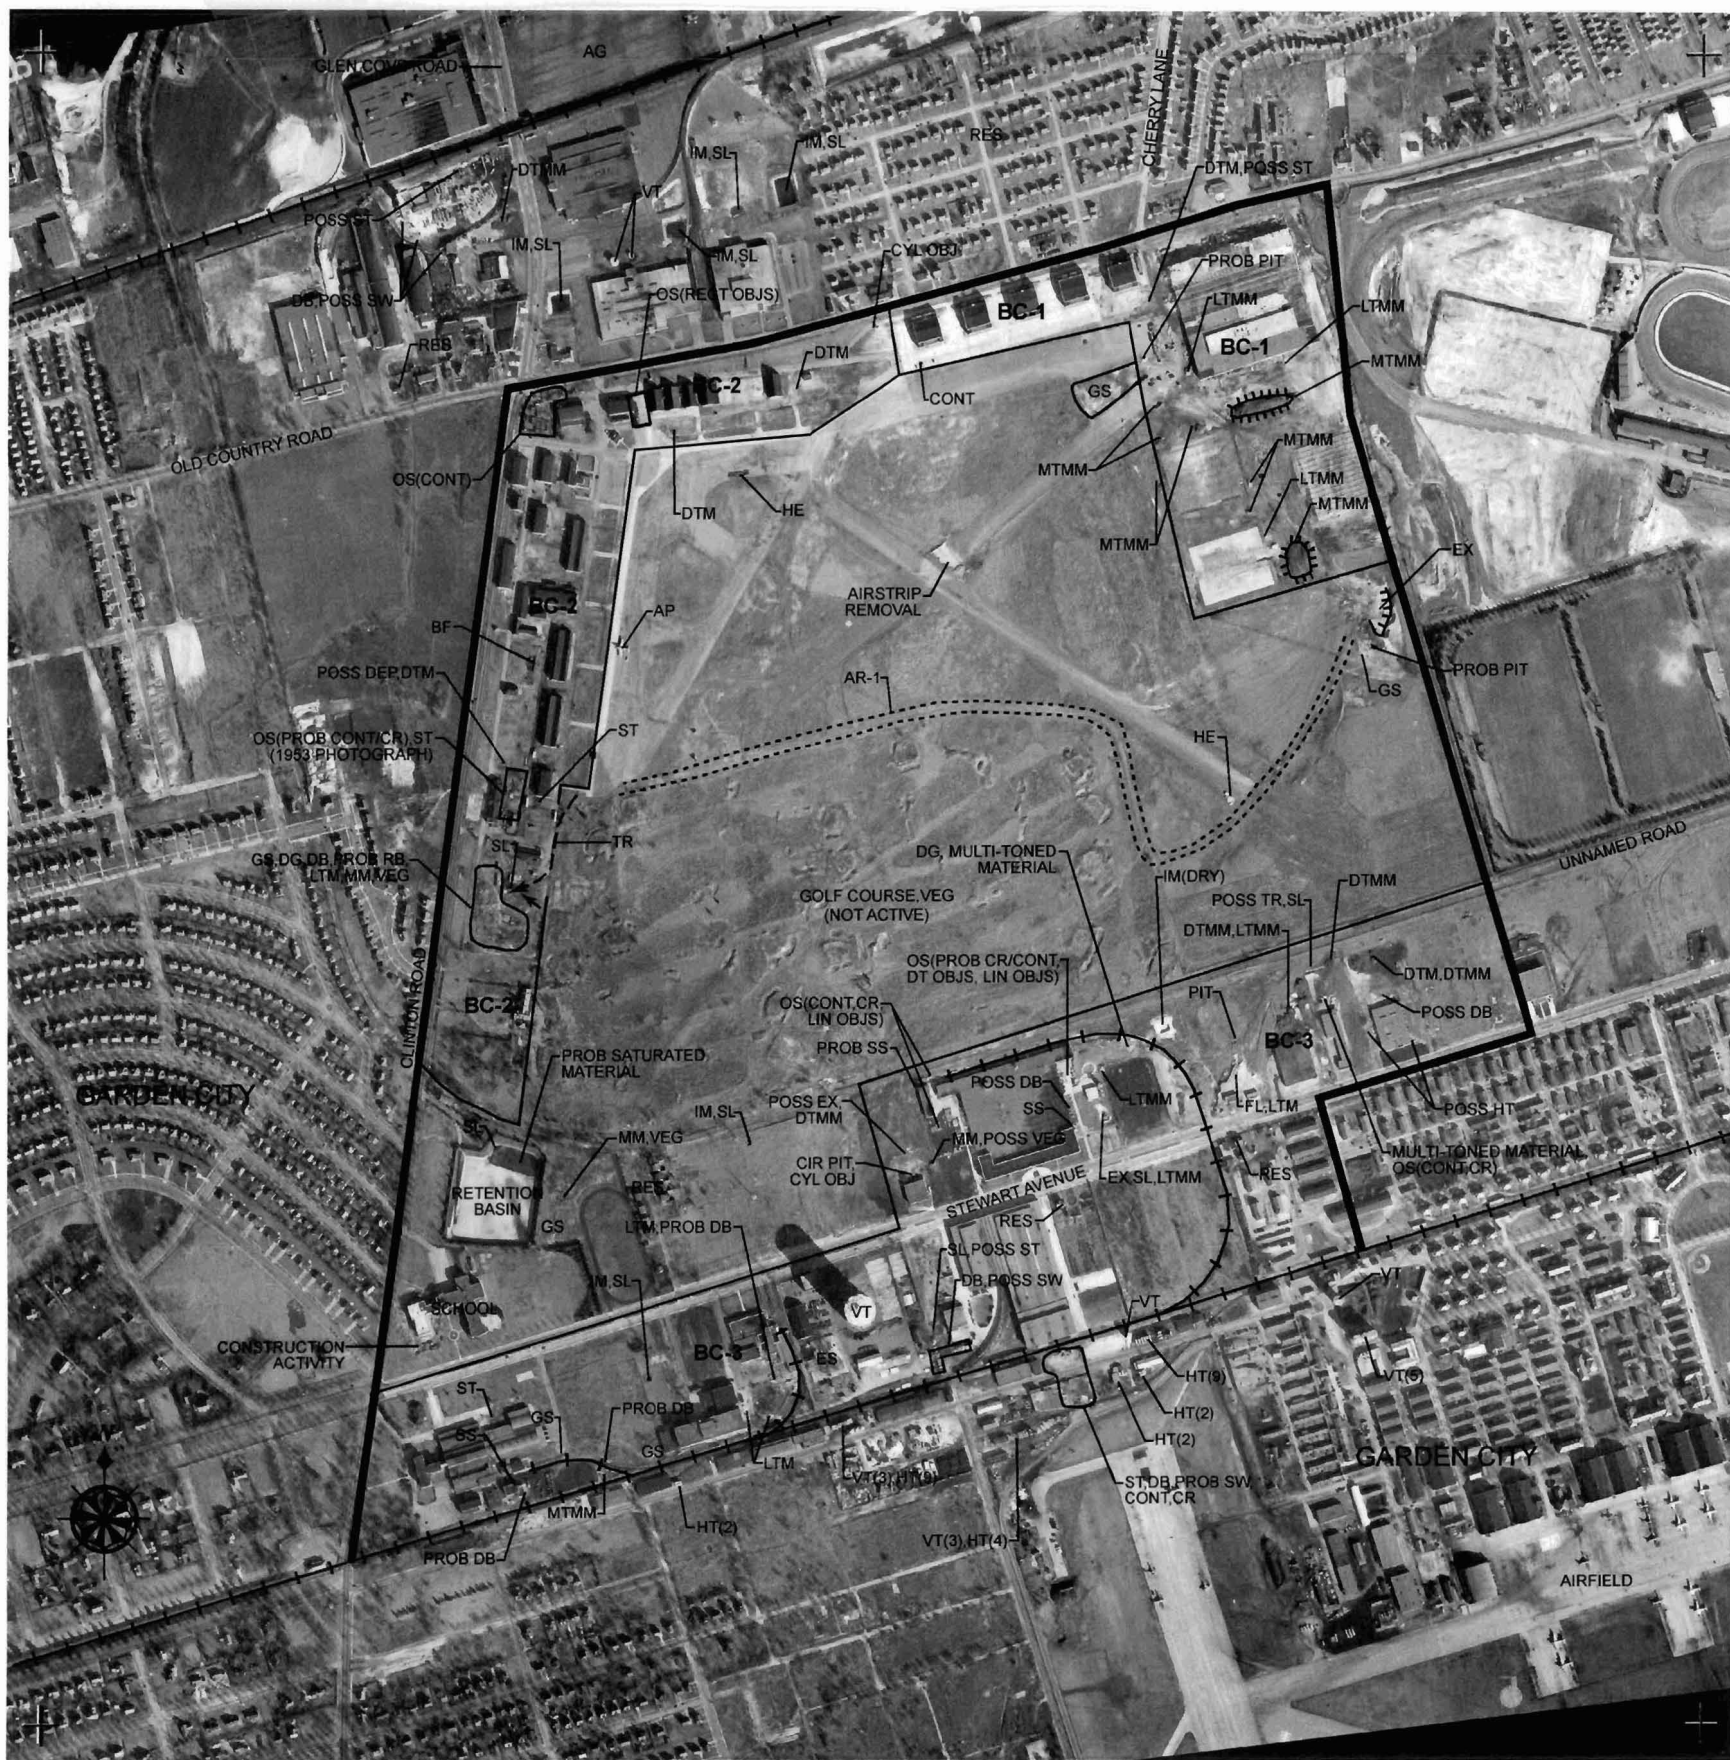
Figure 7. Old Roosevelt Field Contaminated Groundwater Area, February 10, 1952. Approximate scale 1:11,105.

The limits of Building Complex-1 have been expanded to the east and south to incorporate new activity. However, the building complex no longer appears to be used for the maintenance and repair of aircraft, as no airplanes are present. A large container is observed on the tarmac (not annotated) south of the westernmost of the five remaining square-shaped buildings. Dark-toned material, possible stains, and a probable pit are located adjacent to a large building (not annotated) under construction in the northeast portion of the complex. Numerous mounds composed of uniform light- and medium-toned material are scattered throughout the central and southern portions of the complex. Immediately west of the complex, there is a grouping of ground scars.

Only one airplane is visible at Building Complex-2 and, similar to Building Complex-1, this complex no longer appears to be engaged in large-scale aircraft maintenance and repair activities. In the northern part of this complex, adjacent to Old Country Road, there are two open storage areas. The easternmost storage area is enclosed and is comprised of unidentified rectangular-shaped (RECT) objects. Numerous large containers comprise the westernmost storage area. Two patches of dark-toned material and a cylindrical-shaped object are noted to the east. In the southern portion of the building complex, stains are visible at a third open storage area, which is also comprised of small probable containers/crates. This information was gathered from photographs acquired in 1953 which are not included in this report (see References section). In the central portion of the complex are the outer walls of a former structure (annotated as BF). The base of the former structure has been removed or has deteriorated, suggesting an older building had been present at this location. Farther south are a probable depression (DEP) containing dark-toned material and a large stain adjacent to a building (not annotated). Also noted is a deep trench (TR) that directs runoff from the tarmac (not annotated) into a depression (not annotated) containing standing liquid. This liquid was also present on previous photographs. Immediately to the south, there is large area comprised of ground scars, disturbed ground, debris, light-toned material, probable rubble, and mounded material covered with vegetation.

Access Road-1 appears to connect Building Complex-2 to Building Complex-1 as well as to separate the golf course from the airfield. This access road terminates just south of Building Complex-1, where numerous tire tracks and ruts (not annotated) are visible on the surface of an excavation that did not appear active in 1947. Immediately south of the excavation, a probable pit and a ground scar are observed. The golf course is overgrown with vegetation and appears to be inactive. A paved section of the airfield is in the process of being removed, indicating that the northeast-southwest oriented runway will no longer be utilized for air transportation. Heavy equipment is also visible and is further indication of future changes to the site.

In the southwestern part of the site, south of Building Complex-2, standing liquid and probable saturated material are observed in the extreme northern part of the retention basin. In the field (not annotated) immediately east of the retention basin, ground scars are noted as are several small mounds of material covered with vegetation (Note: due to photographic scale limitations, features are not individually annotated). The mounds do not appear to have recently been disturbed. Farther east approximately ten residences and an impoundment containing standing liquid are observed. South of the retention basin, construction activity is noted at the school.

The limits of Building Complex-3 have again been expanded to the northeast to incorporate new activity. The light-industrial facility (not annotated) with a smokestack remains in the western portion of this complex. On the north side of the facility is stained ground and just south of the smokestack is probable debris. A new east-west oriented rail spur connects the eastern section of the facility to the main railroad. Proximal to the rail spur there are medium-toned mounded material, probable debris, and ground scars. The easternmost ground scar is located where a fill area was observed in 1943. In the open field (not annotated) east of this industrial facility, there is a small impoundment containing standing liquid, the north-south oriented rail spur, and three areas of light-toned material. Probable debris is noted adjacent to one of the three areas of light-toned material where construction activity (not annotated) is also observed. East of the north-south oriented rail spur are the electrical substation and the large vertical storage tank. Standing liquid, possible stains, debris, and possible solid waste are observed

adjacent to buildings (not annotated) constructed since 1947. Several residences remain along Stewart Avenue. To the north, between Stewart Avenue and the unnamed road, several new buildings (not annotated) have been constructed since 1947. A smokestack remains visible at the large building located at the terminus of the U-shaped rail spur. Adjacent to this building, possible debris and three open storage areas comprised of large containers, crates (CR), probable crates/containers, dark-toned objects, and linear (LIN) - shaped objects are noted. A probable smokestack appears attached to one of the smaller buildings (not annotated) immediately to the west. Also visible to the west are a small possible excavation, dark-toned mounded material, mounded material covered with possible vegetation, and a circular-shaped pit containing cylindrical-shaped object. Between the building and the rail spur to the east, a small excavation containing standing liquid is observed. Adjacent to the excavation is light-toned mounded material. Just to the north are uniform light-toned mounded material and an area of disturbed ground where multi-toned material is also noted.

Most of the new development within Building Complex-3 has occurred east of the rail spur, near to where a square-shaped dry impoundment is under construction. Uniform, light-toned mounded material (not annotated) is located on the south side of the future impoundment. Farther east there is a small pit and two new buildings (not annotated) located on a new fill area composed of uniform light-toned material. Proximal to other new buildings (not annotated) constructed since 1947, there are uniform light- and dark-toned mounded material, dark-toned material, multi-toned material, a possible trench containing standing liquid, two possible horizontal storage tanks, possible debris, and a small open storage area in which containers and crates are visible.

Northwest of the site, between the railroad line and Old Country Road, possible stains, dark-toned mounded material, debris, and possible solid waste are noted at the light-industrial facility (not annotated). To the east there are several impoundments containing standing liquid and two vertical storage tanks. South of the site, proximal to the railroad, a total of 13 vertical storage tanks and 28 horizontal storage tanks are observed. In addition, an area comprised of stains, debris, probable solid waste, containers, and crates remains visible.
