TS-PIC-20502367S
April 2005

**AERIAL PHOTOGRAPHIC ANALYSIS OF
OLD ROOSEVELT FIELD
CONTAMINATED GROUNDWATER AREA
Garden City, New York**

AERIAL PHOTOGRAPHIC ANALYSIS OF
OLD ROOSEVELT FIELD CONTAMINATED GROUNDWATER AREA

Garden City, New York

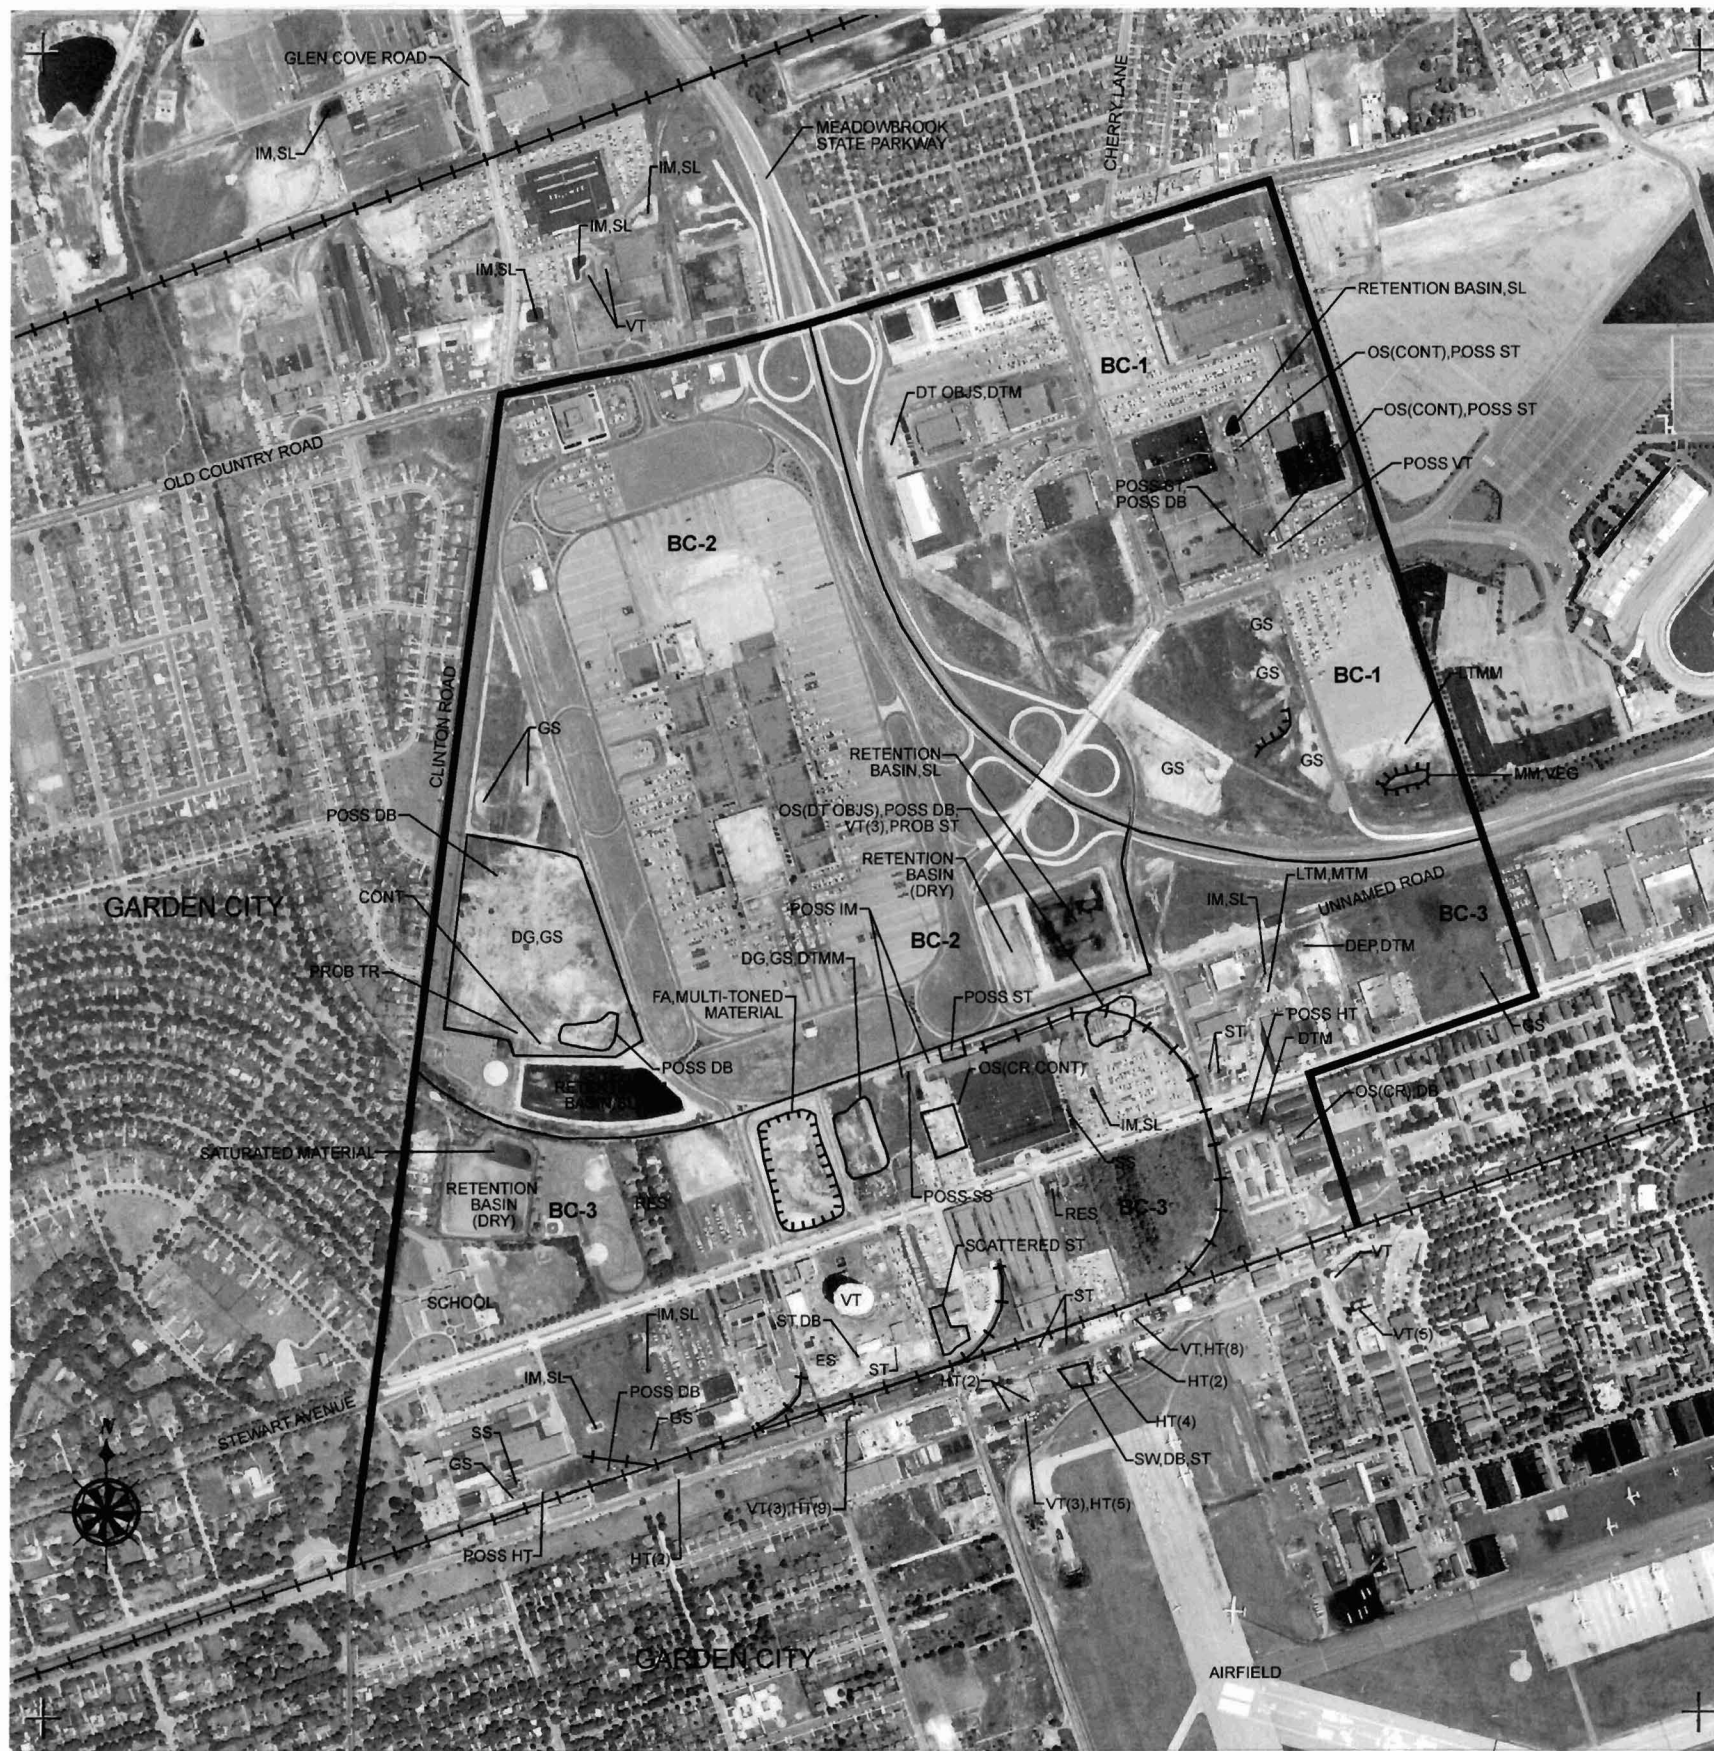
JUNE 24, 1959 (FIGURE 8)

Due to large-scale construction activity since 1952, which included the building of Meadowbrook State Parkway, the areal extent and limits of all three building complexes have significantly changed since 1952 and collectively comprise the entire Old Roosevelt Field Contaminated Groundwater Area. Building Complex-1 encompasses the northeast part of the site east of the Parkway, Building Complex-2 the northwest part of the site basically west of the Parkway, and Building Complex-3 the entire southern part of the site basically south of the unnamed road. These new complex boundaries will remain consistent throughout the remainder of the analysis period.

Since 1952 numerous buildings and parking areas (features are not annotated) have been constructed within Building Complex-1. Dark-toned objects are noted near dark-toned material in the northwestern portion of this building complex. To the east there are a retention basin containing standing liquid, two open storage areas each comprised of crates and possible stains, a possible vertical storage tank, and a small area where possible stains and possible debris are noted. Farther south several ground scars, uniform light-toned mounded material, and a large east-west oriented mound covered with vegetation are noted. The scars are likely the result of the new construction activity.

North of Stewart Avenue in the western portion of Building Complex-3, saturated material is observed in the northern end of the retention basin. To the east there are approximately ten residences, an expansive fill area composed of multi-toned material, a patch of disturbed ground and ground scars

where dark-toned mounded material is noted, and an open storage area. Crates and containers are visible within the open storage area, which appears associated with a large building (not annotated) with a smokestack in the north-central portion of this complex. North of the open storage area is a small building (not annotated) where a possible smokestack is noted. On the north side of these two buildings, there are two possible impoundments in which no liquid is observed, and possible stained ground. East of the large building are the small impoundment containing standing liquid seen on the 1952 photograph and an open storage area. Within this open storage area, dark-toned objects, probable stains, possible debris, and three vertical storage tanks are noted. East of the rail spur, there are stains, a small impoundment containing standing liquid, light- and medium-toned material, a depression containing dark-toned material, and ground scars.

South of Stewart Avenue, the light-industrial facility (not annotated) with a smokestack remains in the western portion of Building Complex-3. South of the smokestack, a ground scar and a possible horizontal storage tank are noted. Between the east-west oriented rail spur and the main railroad line is possible debris. East of the industrial facility, there are ground scars and two impoundments containing standing liquid. In 1952 only one impoundment was observed at this location. Farther east the electrical substation and the large vertical storage tank remain. In addition, nearby are two patches of stained ground, one where debris is noted, and another area of widely scattered staining. A single residence remains along Stewart Avenue. East of the large U-shaped rail spur, a possible horizontal storage tank, dark-toned material, and a small open storage area containing crates are noted. Near the open storage area is a small pile of debris.

Immediately northwest of the site, at a light-industrial facility (not annotated) there are several impoundments containing standing liquid and two vertical storage tanks. South of the site, proximal to the railroad, there are a total of 13 vertical storage tanks and 34 horizontal storage tanks. In addition, solid waste, stains, and debris are visible.

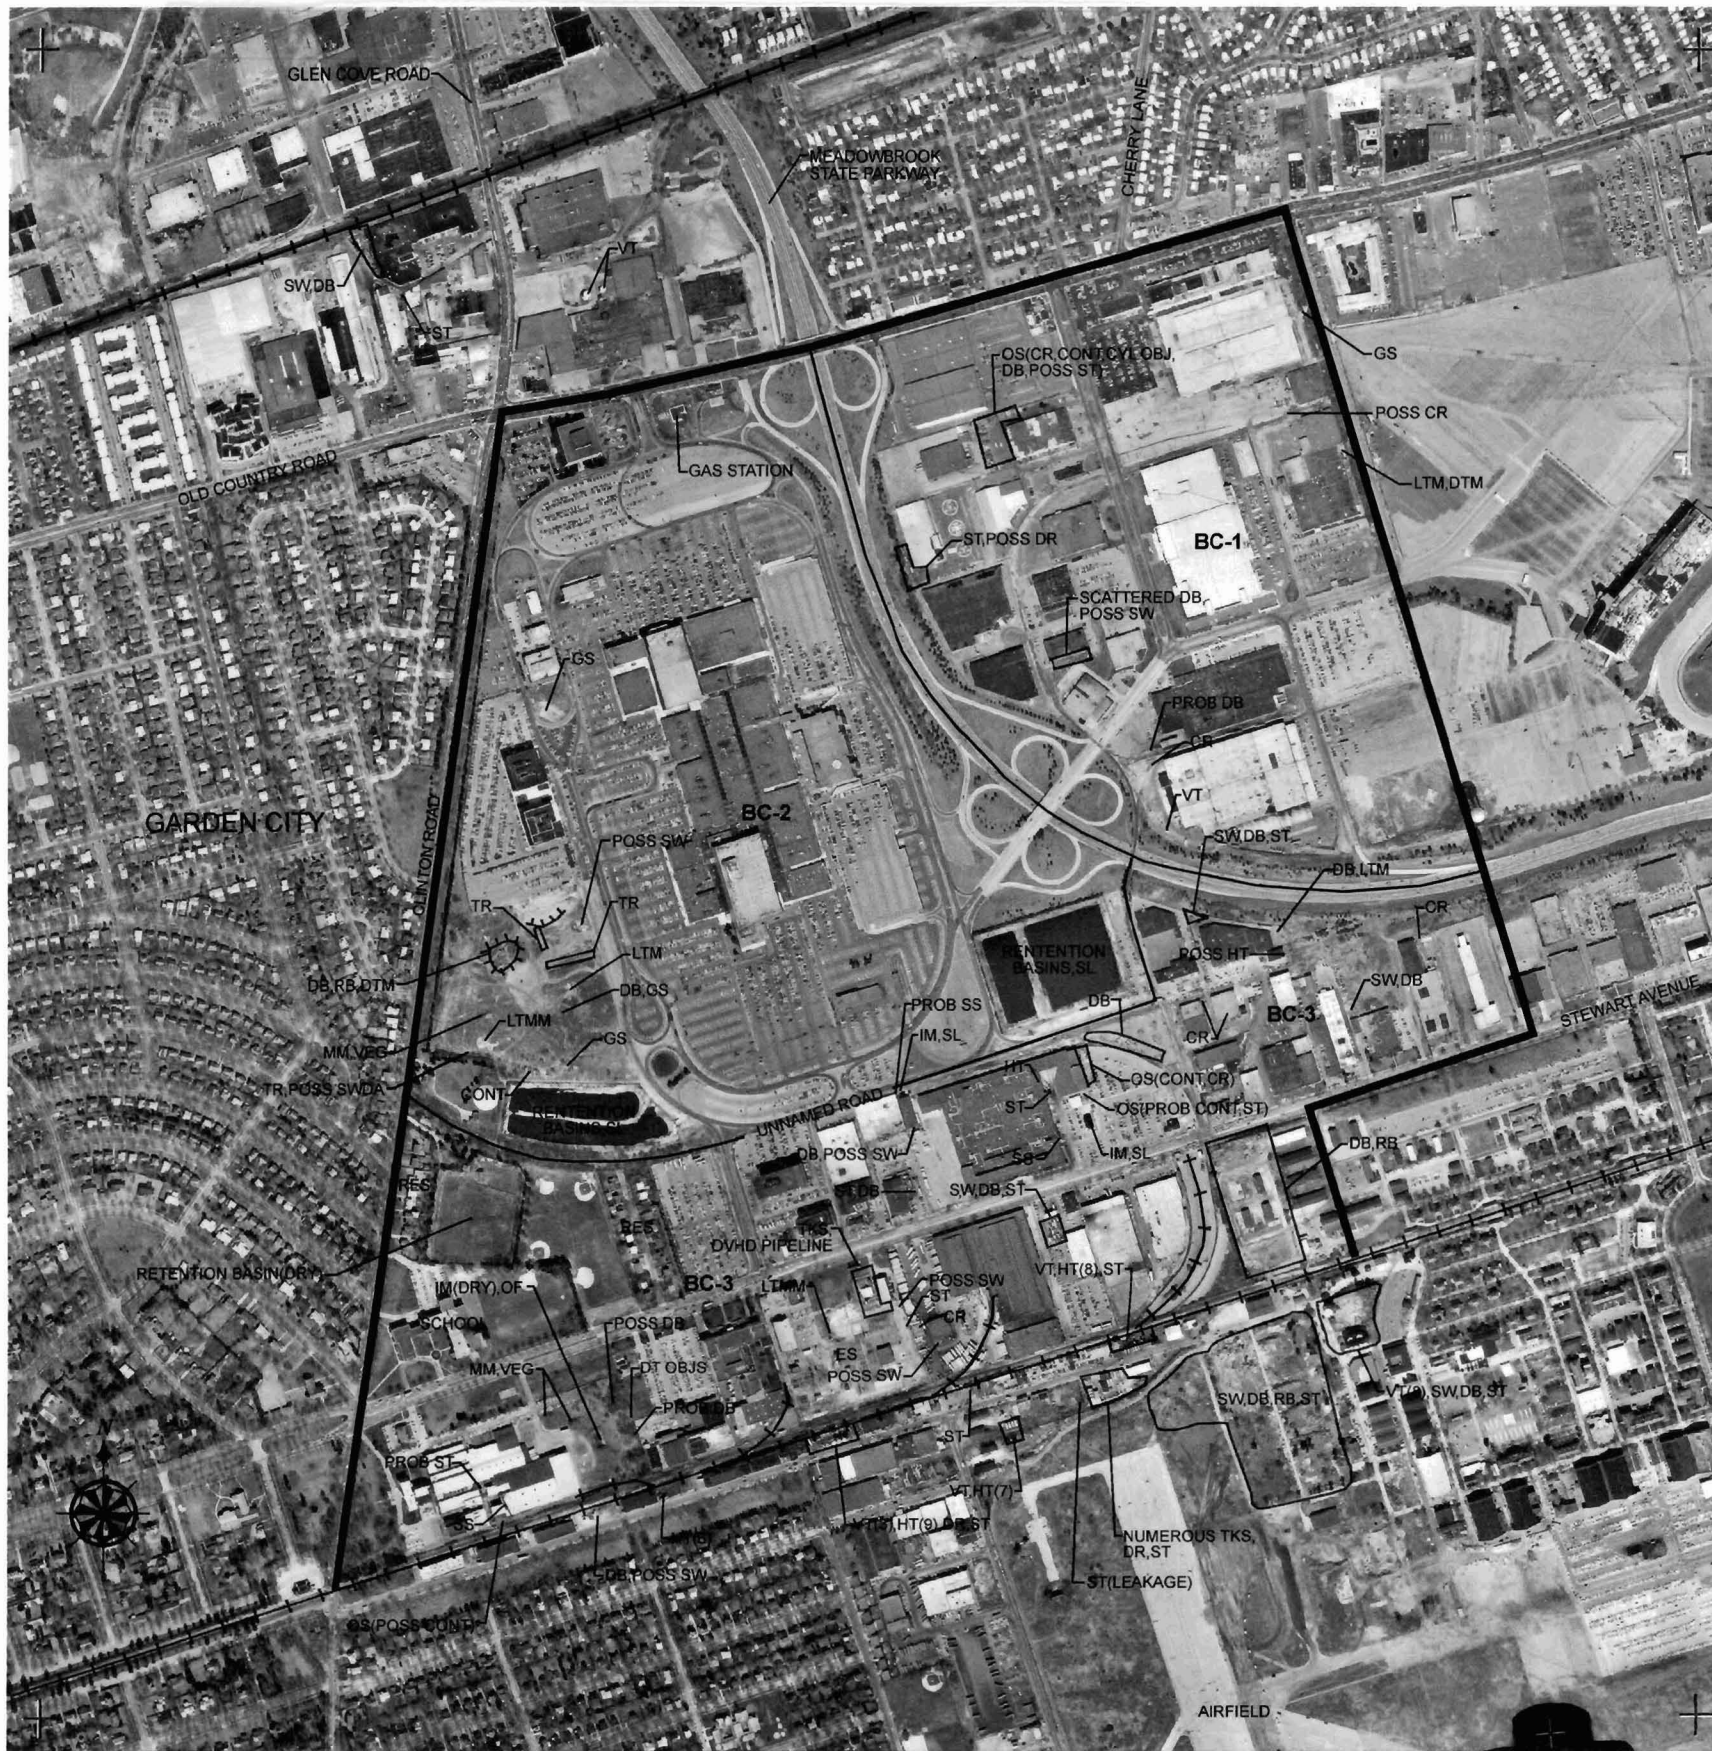
In the northern portion of Building Complex-1, near Meadowbrook State Parkway, possible drums (DR) and stains are observed along the southwest side of a building (not annotated). To the northeast there is an open storage area comprised of numerous crates, containers, cylindrical-shaped objects, debris, and possible stains. Near the eastern site boundary, a ground scar, several possible crates, and a small area consisting of light- and dark-toned material are noted. In the west-central portion of this building complex, scattered debris and possible solid waste are observed adjacent to a building (not annotated). In the southern portion of the complex, a vertical storage tank, a small pile of probable debris, and several crates are discerned.

A gas station (first identified on the 1962 photographs; see References section) is noted in the northern portion of Building Complex-2. Land in the extreme southwestern portion of the complex remains undeveloped; however, this area continues to be active. Several trenches are visible, the southernmost of which is being utilized as a possible solid waste disposal area. An area comprised of debris, rubble, and patches of dark-toned material, indicating possible liquid deposition, is noted near Clinton Road. Also visible are possible solid waste, a small pile of debris, ground scars, light-toned material, light-toned mounded material, mounded material covered with vegetation, and the containers first noted on the 1959 photograph. Two side-by-side, east-west oriented retention basins are now visible. The large retention basin seen in this location on previous photographs was drained by 1966 (see References section) at which point an east-west oriented berm (not annotated) was constructed in the middle of the basin to separate it into northern and southern halves. Both of these retention basins now contain standing liquid, as do the two retention basins in the southeast corner of this building complex.

North of Stewart Avenue in the western portion of Building Complex-3, there are two small groupings of residences between which is a dry retention basin. To the east there are a small stain, debris, and the large building (not annotated) with a smokestack noted on previous photographs. Immediately west of this building, there is a small building (not annotated) and a probable smokestack. Adjacent to the south side of this small building, debris and possible solid waste are observed, and an impoundment containing standing liquid is visible along the north side of the building. A second possible impoundment seen on the 1959 photograph is no longer evident and appears to have been filled. Proximal to the east side of the large building, there is a horizontal storage tank, patch of stained ground, large swath of debris, and an impoundment containing standing liquid. In addition, two small open storage areas are also visible. Collectively, these open storage areas are comprised of containers, probable containers or crates, and stains. Farther east, between Stewart Avenue and the unnamed road, solid waste, debris, and crates are visible. To the north, between the unnamed road and Meadowbrook State Parkway, solid waste, debris, stains, light-toned material, and a possible horizontal storage tank are evident.

South of Stewart Avenue, the light-industrial facility (not annotated) with a smokestack remains in the western portion of Building Complex-3. A small open storage area comprised of possible containers is noted alongside the facility, as is a probable stain. East of the facility, there are two mounds of material covered with vegetation, possible and probable debris, dark-toned objects, and a dry impoundment. An outfall (OF), oriented toward the industrial facility, is observed within the impoundment. Farther east, near the electrical substation, there are light-toned mounded material, several storage tanks (TKS) connected by overhead (OVHD) pipelines, a pile of possible solid waste, a stain, and several crates. The large vertical storage tank seen in previous photographs has been removed. Farther east solid waste, debris, and stains are apparent. Near the easternmost rail spur (formerly identified as the U-shaped rail spur, much of which has been removed), one of a grouping of four buildings (not annotated) has been demolished. Piles of debris and rubble are scattered throughout this portion of the building complex.

Immediately to the northwest of the site, there are two vertical storage tanks, solid waste, debris, and stains at a light-industrial facility (not annotated). South of the site, proximal to the railroad, there are a total of 13 vertical storage tanks and 30 horizontal storage tanks, as well as a large collection of storage tanks, drums, stains, solid waste, possible solid waste, rubble, and debris. One area of staining may be the result of leakage.

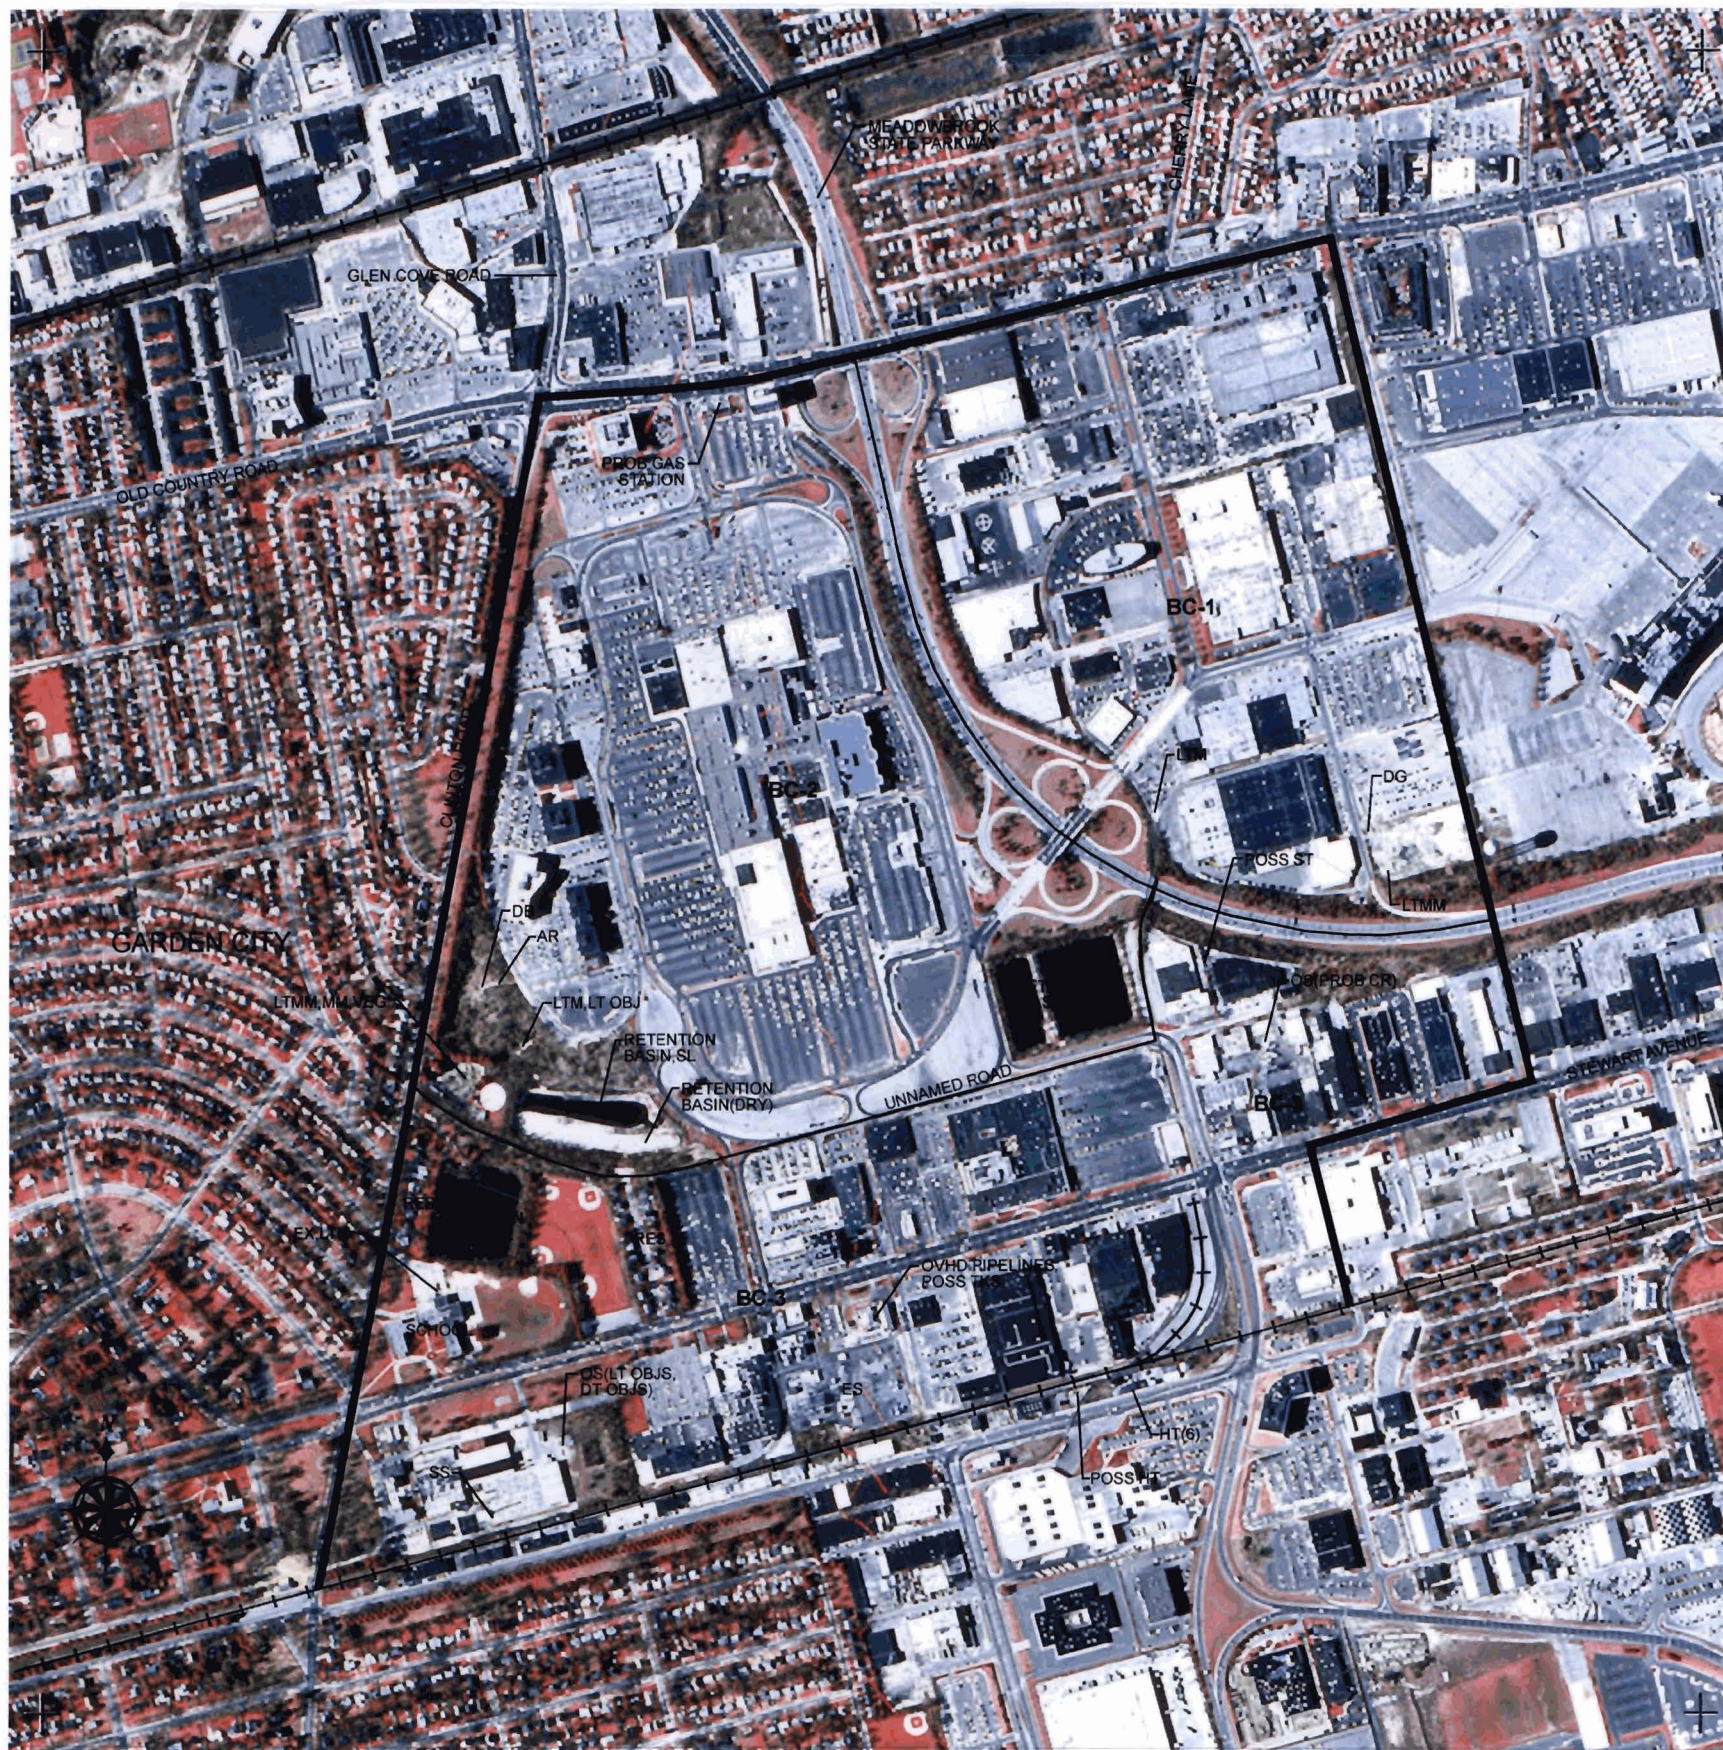
Within Building Complex-1, disturbed ground, light-toned mounded material, and light-toned material are observed.

A probable gas station remains noted in the northern portion of Building Complex-2. Land in the extreme southwestern part of the complex remains undeveloped and is covered with unkempt vegetation (not annotated). A patch of debris is visible at the terminus of an access road (not annotated). Light-toned material, light-toned mounded material, mounded material covered with vegetation, and light-toned objects are also noted in this portion of the building complex. Only one of the two retention basins on the 1976 photograph in this portion of the complex is filled with standing liquid. In the southeast portion of this complex, the two retention basins, also noted in 1976, continue to hold standing liquid.

North of Stewart Avenue, in the western portion of Building Complex-3, the two small groupings of residences remain, as does the retention basin containing standing liquid situated between the residences. Immediately south of the retention basin, there is a small excavation and a pile of light-toned material alongside the school. To the east, proximal to Meadowbrook State Parkway, there are a possible stain and an open storage area comprised of probable crates.

South of Stewart Avenue, in the western portion of Building Complex-3, the light-industrial facility (not annotated) with a smokestack remains. An open storage area consisting of light- and dark-toned objects is visible just east of this facility. Farther east is the electrical substation and a grouping of overhead pipelines connecting possible tanks.

Contrary to all previous analysis years, no environmentally significant activity is observed northwest of the site. South of the site, proximal to the railroad, there are six horizontal storage tanks and one possible horizontal storage tank.
