Final Remedial Action Report

**Old Roosevelt Field Contaminated
Groundwater Area Superfund Site
Remedial Action**

Garden City, New York

September 25, 2015

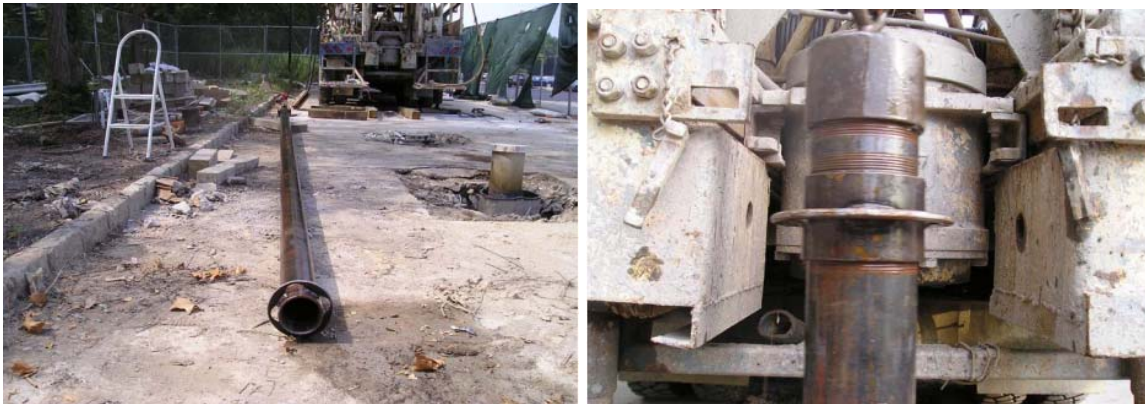
UTD tested each extraction well for plumbness and alignment immediately prior to development to ensure proper construction. Plumbness testing consisted of suspending a plumb bob centered in the well casing from a cable fixed 10 feet above the top of the well. The plumb bob was lowered into the well and the displacement was measured, at 10-foot intervals, from the ground surface to the top of the well screen. Displacement was measured between the cable and the well casing on the northern and eastern sides of the well using a folding ruler. CDM Smith calculated the casing drift using the displacement measurements. The American Water Works Association (AWWA) allows a drift of two-thirds the ID of the well per 100 feet of depth (AWWA 2006). A maximum deflection of 3/8 inch was noted; therefore, the drift for each well was within the acceptable AWWA limits.

Photographs 3-1 and 3-2: Plumbness and alignment testing device, total length view (left) and top view (right).

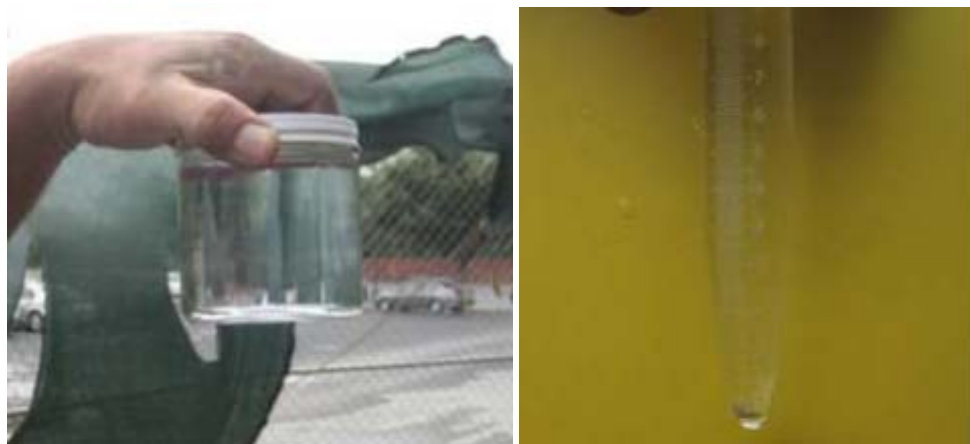
Following completion of air lift/swabbing, a submersible pump was lowered into each well and a flow meter/totalizer and Rossum Sand Tester were attached to the purge water discharge hose. The pumps were provided by UTD, along with a trailer-mounted diesel generator to supply power. The submersible pumps were activated, and UTD monitored the flow rate and sand content of the purge water. EW-1D was pumped at a rate of 157 gpm and EW-1I and EW-1S were pumped at 72 gpm to complete well development.

Photographs 3-3 and 3-4: EW-1I sand content sample (left) and 0.05 mg/L of sand deposited into vial (right).

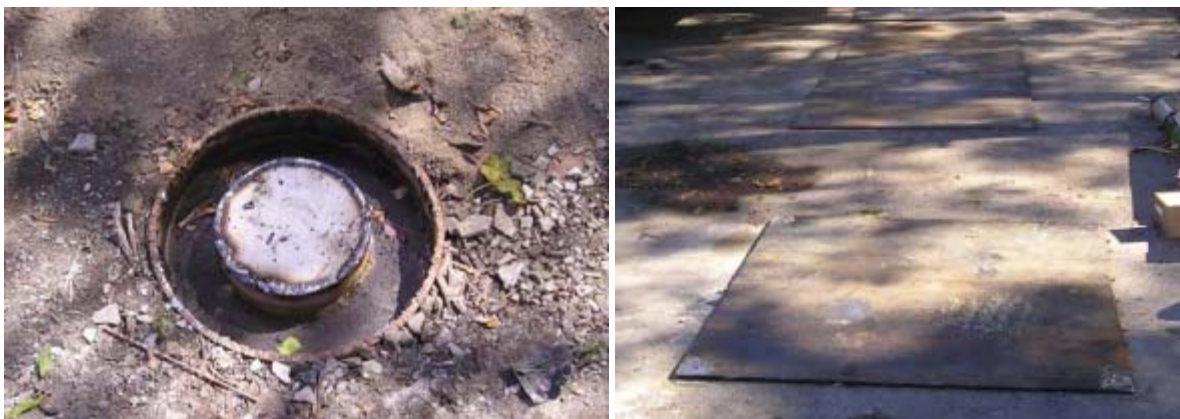
A stainless steel lid was welded onto the top of each extraction well. Sand was then placed around the well and a 24-inch by 24-inch stainless steel plate was installed by securing it with rebar at each corner, driven 2 feet into the ground.

Photographs 3-5 and 3-6: Extraction well welded stainless steel cover (left) and steel plates (right).

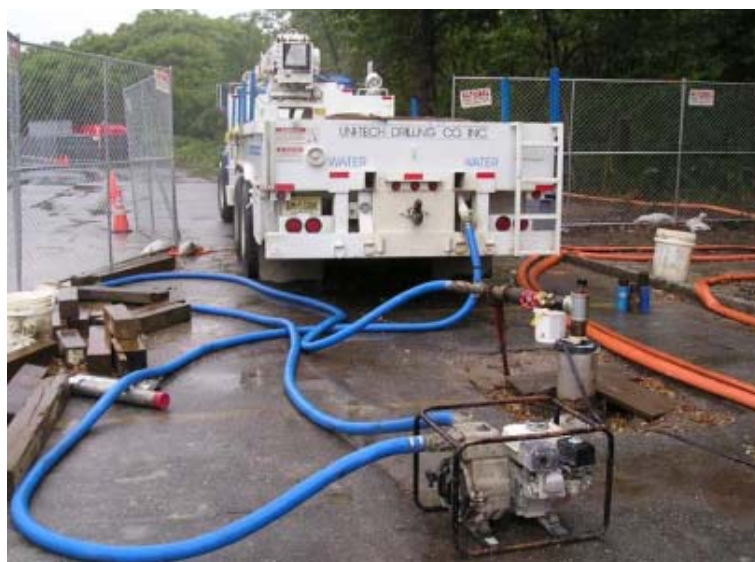
The extraction wells were disinfected after well development, aquifer testing, and sampling using calcium hypochlorite granules mixed with city water. After a minimum period of 24 hours following injection of calcium hypochlorite solution, the extraction wells were purged using a submersible pump to remove the chlorine solutions from the wells. The purge water was tested for residual chlorine using a chlorine test kit. Water was purged until the extraction wells were free of chlorine. Purged water was neutralized in the influent frac tanks by adding Johnson Screens NW-500 chlorine neutralizer before pumping the water into the temporary GWTS. Well disinfection details and purge water test results are included in the Phase 1 Bi-weekly Report No. 10 (**Appendix F**).

Photograph 3-7: Well disinfection setup.

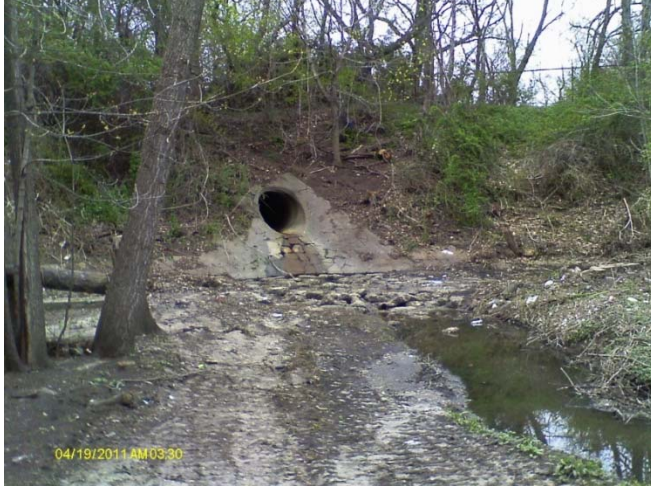
In accordance with the Contract Documents, ACI refurbished the recharge basin prior to discharging treated effluent to the storm sewer. The existing access road into the basin was overgrown and in need of maintenance. ACI removed trees and shrubs from the road and placed 3 to 4 inches of commercial-grade recycled concrete aggregate (RCA) over the existing road to provide a stable surface. ACI also cleared and grubbed trees in a 2,500-square-foot area near the storm sewer outfall. Finally, approximately 26 tons of 5-inch riprap was placed below the existing outfall in the recharge basin for added stabilization to accommodate the increased flow.

Photograph 3-8: Recharge Basin #124, facing north.

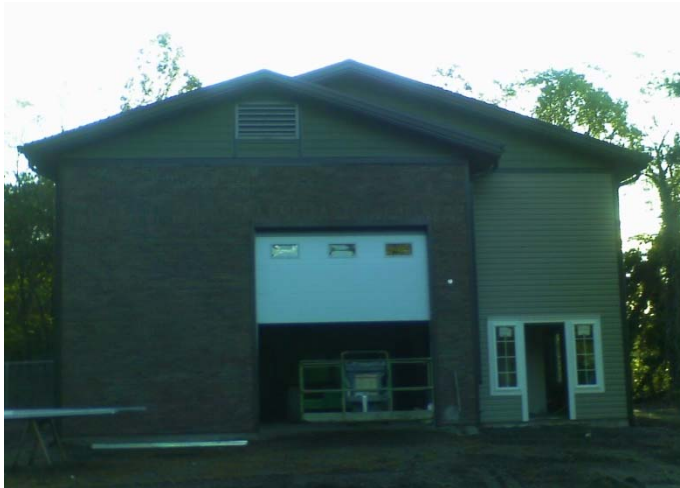
Photograph 3-9: View of treatment building facing east.

The building has dimensions of approximately 40 feet by 50 feet, with approximately 2,000 square feet of floor space and a 20-foot eave height. The following are key features of the treatment building:

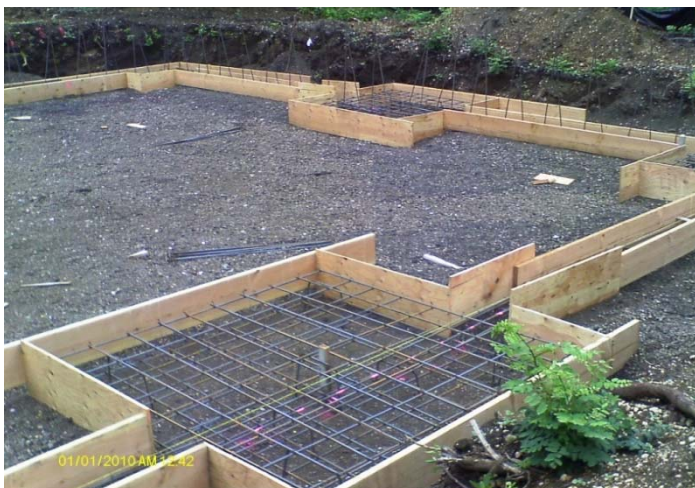
The building foundation consists of reinforced concrete with spread footings. The building foundation extends 4 to 5 feet below the finished grade to prevent frost heave and foundation movement.

Photograph 3-10: View of treatment building footings facing northeast.

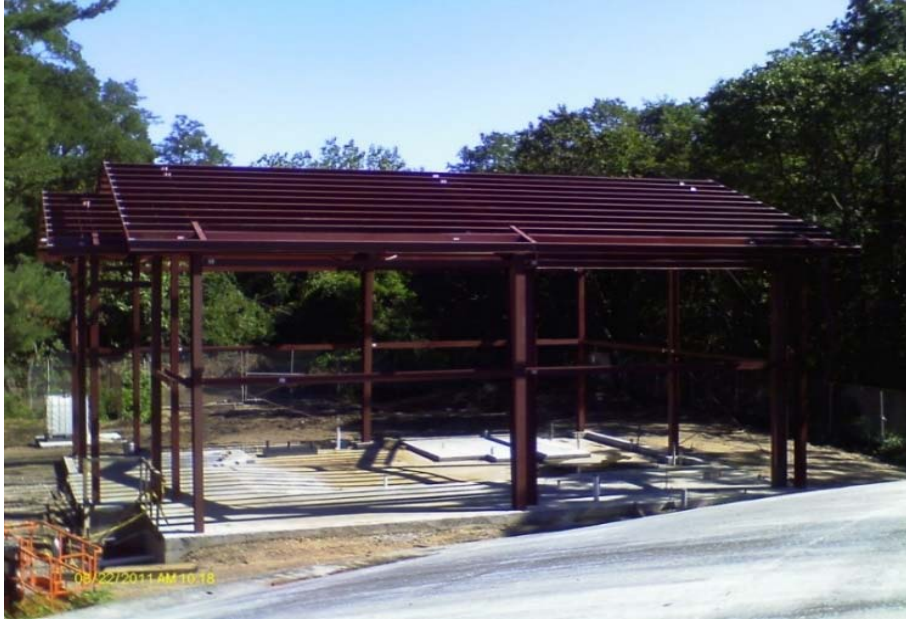
ACI subcontracted erection of the treatment building structural steel frame to Racanelli and Metal-Bilt Construction. Installation of exterior wall framing, insulation, and wall and roof sheathing was subcontracted to Racanelli and Long Island Building Systems Inc. (LIBS).

Photograph 3-11: View of the building frame during construction, facing north.

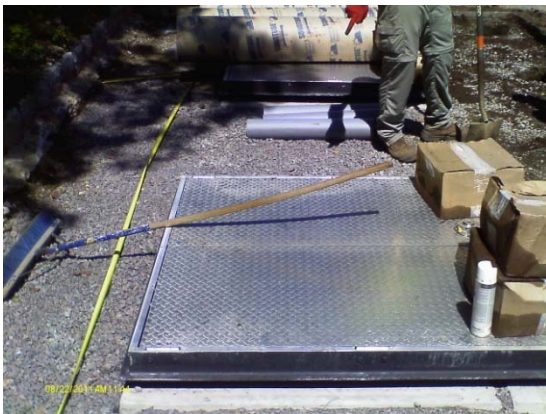
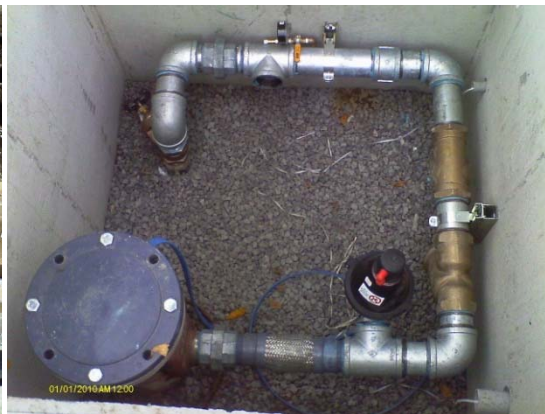
A series of extraction wells, EW-1S, EW-1I, and EW-1D, were installed by CDM Smith during Phase 1. Installation and development of the extraction wells is discussed in detail in **Section 3.1.5**. A 4-foot-long by 4-foot-wide by 4-foot-deep, bottomless, pre-cast concrete well vault was installed for each well. Wellheads were completed in accordance with approved design and shop drawings, including installation of a gate valve, air release valve, check valve, y-strainer, and sample tap/pressure gauge. A submersible pump was installed in each extraction well to pump water at the combined design flow rate of 250 gpm. A level transducer was installed in each well to provide continuous water level readings to the PLC and HMI and allow flow control via motorized globe valves located inside the GWTS.

Photographs 3-12 and 3-13: Extraction well vault cover (left) and the typical piping inside the vault (right).

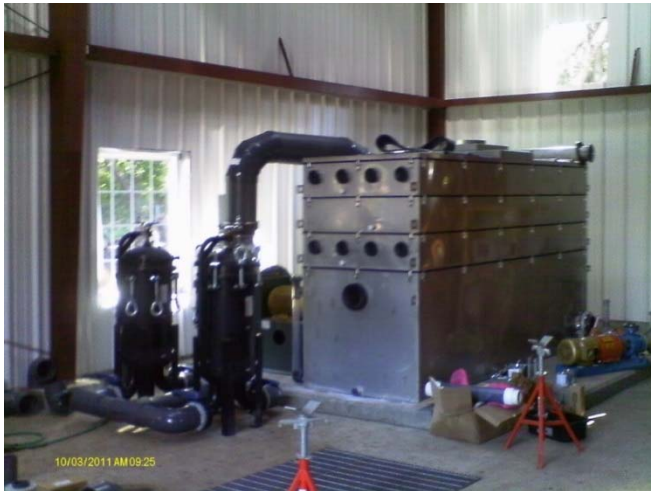
Photograph 3-14: Bag filter housing and air stripper in place, facing northeast.

ACI installed a NEEP ShallowTray Model 41231 air stripper consisting of three trays. This model is capable of treating VOCs to less than 5 µg/L at a maximum flow rate of 250 gpm with three trays, and can be expanded up to six trays to handle a maximum flow rate of 550 gpm, if additional future treatment capacity is required.

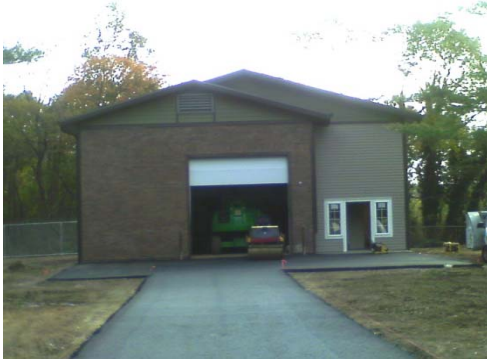
The sub-base for the road and parking area was constructed with geotextile fabric and a minimum 6-inch layer of commercial-grade RCA, used as DGA. The existing soil and DGA were compacted using a vibratory plate compactor. ACI enlisted the services of CM Testing, a local geotechnical testing firm, for in-place density testing of native soil and DGA prior to paving the access road and parking area. In-place soil density testing results are included in **Appendix P**. The access road and parking area were paved with a 4-inch asphalt binder course followed by a 2-inch asphalt surface course.

Photograph 3-15: Access road running from the Clinton Road entrance to the GWTS, facing east.

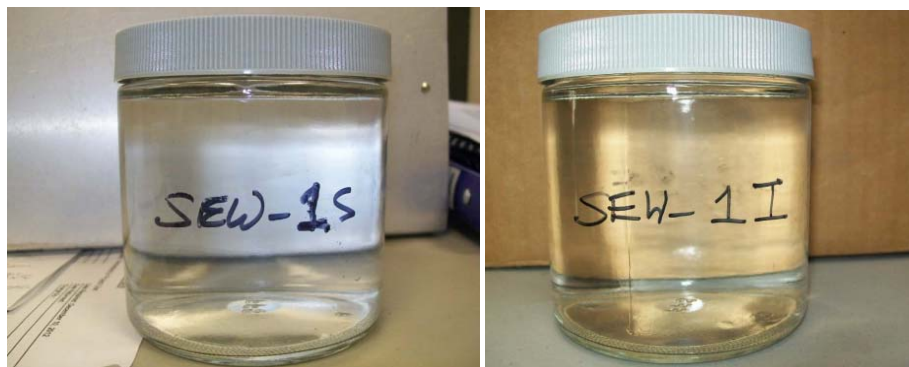
Extraction wells were developed between February 19, 2013 and March 5, 2013 using a combination of air lift/swabbing and constant rate pumping to remove fine-grained material from the wells, stabilize the filter packs, and repair damage to the formation caused by drilling as described in **Section 3.1.5.4**. Following completion of air lift/swabbing, SEW-1D was pumped at 168 gpm for 3 hours, SEW-1I was pumped at 165 gpm for 2 hours, and SEW-1S was pumped at 165 gpm for 3 hours to complete well development. Pumping continued until water quality parameters (pH, temperature, specific conductivity, DO, ORP, and turbidity) stabilized to within 10 percent over three consecutive readings, the turbidity was less than 10 NTU, and sand content was less than 5 mg/L. Purge water was pumped

Photographs 3-16 and 3-17: SEW-1S (left) and SEW-1I (right) final purge water.

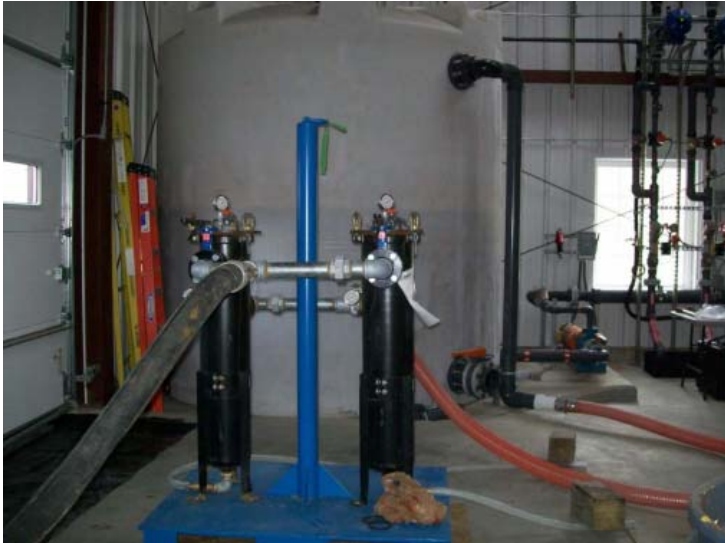
Purge water was discharged directly into UTD's container during field activities. UTD transferred the water from this container into four 21,000-gallon tanks located near the extraction wells using trash pumps. Seacoast transported the water from these tanks into the 21,000-gallon tank placed at the Village of Garden City Pumping Station and subsequently pumped the water from this tank through a portable 10-micron filter housing unit into the holding tank of the onsite treatment system. The water IDW was ultimately processed through the treatment system and discharged to Recharge Basin #124. Approximately 300,000 gallons of purge water was treated at the onsite treatment system during this phase of the project.

Photograph 3-18: Portable filter housing system.

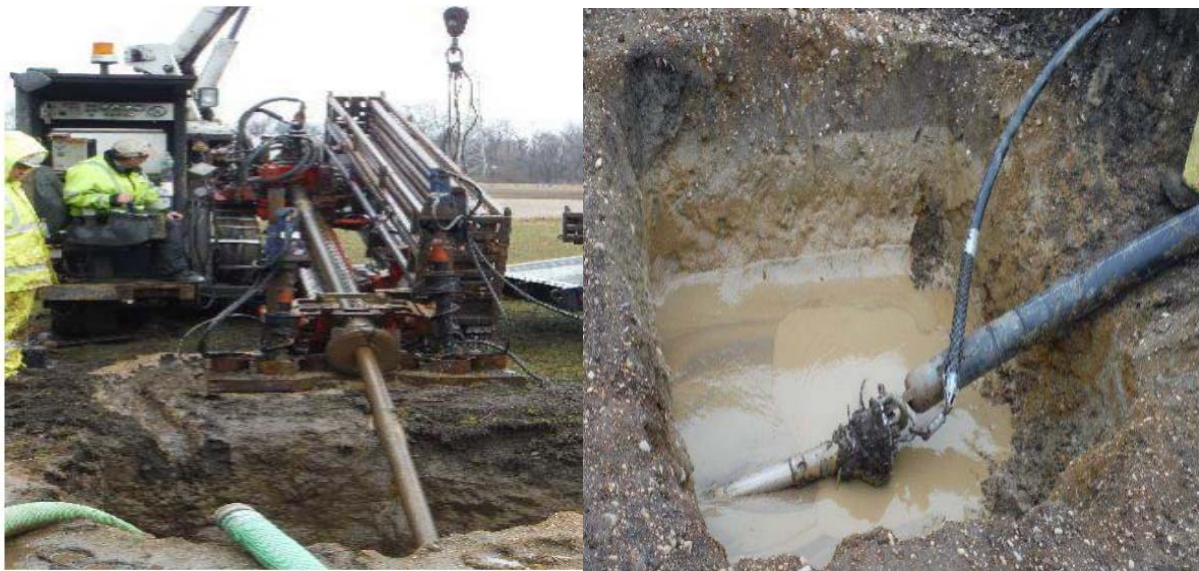
The HDD was completed on March 25 and 26, 2015 by HDB using an American Augers DD-6 directional drill and MPR-6000 drilling fluid mixing/pumping system. During advancement of the bore, the location and depth of the drill lead bit was monitored using a walk-over locating receiver. The depth and angle of the bore head was recorded at 15-foot intervals during the entire bore advancement and marked at the surface with white paint, which was surveyed by the surveyor. This information was incorporated into the as-built drawings indicating the actual bore alignment compared to the design location. Refer to **Appendix M** for the as-built drawings. No problems were encountered during installation of the piping and all work was completed in accordance with the approved plan and permit.

Photographs 3-19 and 3-20: HDD rig (left), and 2-inch and 6-inch HDPE pipe pulled by drill rig.

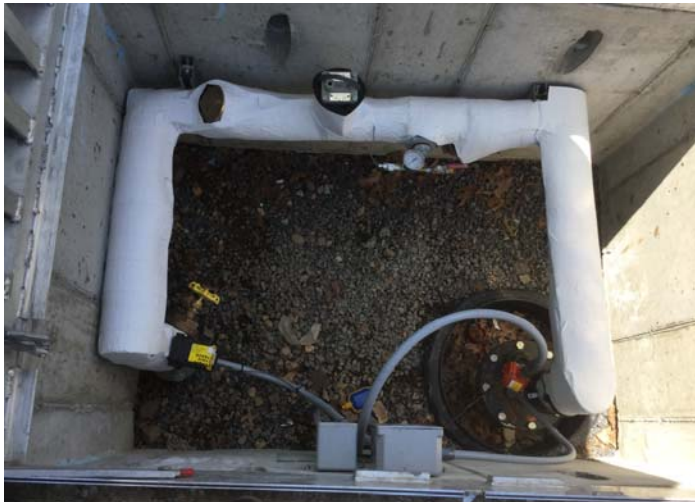
Each extraction well vault contains discharge piping, valves, and instrumentation necessary to operate the well. All discharge piping is 3-inch diameter Schedule 40 galvanized steel with y-strainer, check valve, air release valve, sample tap, pressure gauge, and isolation valves constructed of brass. All piping is insulated and contains heat trace for freeze protection. Refer to **Appendix M** for as-built drawings detailing well vault construction.

Photograph 3-22: Southern extraction well vault.

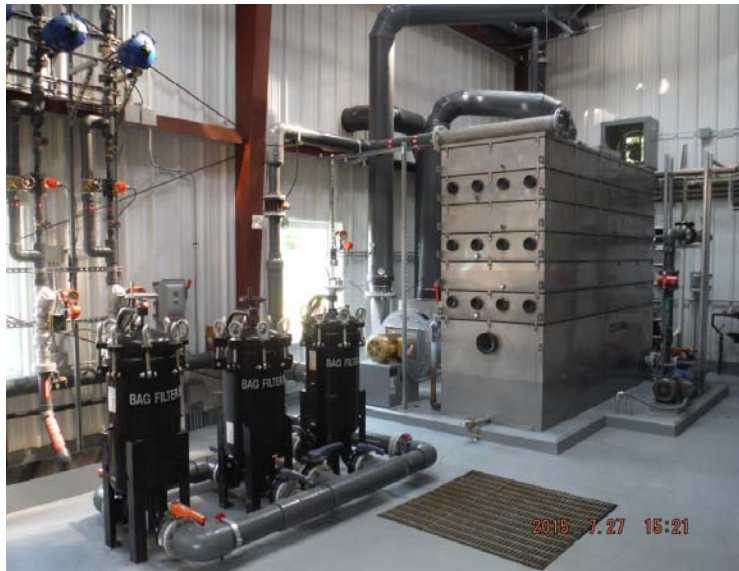
- Added three NEEP Model 41231 trays to the existing air stripper, and completed all duct piping. The duct piping was changed from forced-air operation to an induced draft configuration.

Photograph 3-23: Upgraded air stripper, bag filter housing, and duct pipe.
