**CONSTRUCTION COMPLETION REPORT
SUB-SLAB DEPRESSURIZATION SYSTEM**

**COLUMBIA CEMENT COMPANY SITE
159 HANSE AVENUE
FREEPORT, NEW YORK
SITE NO. 130052**

October 21, 2020

Project No: 60481767

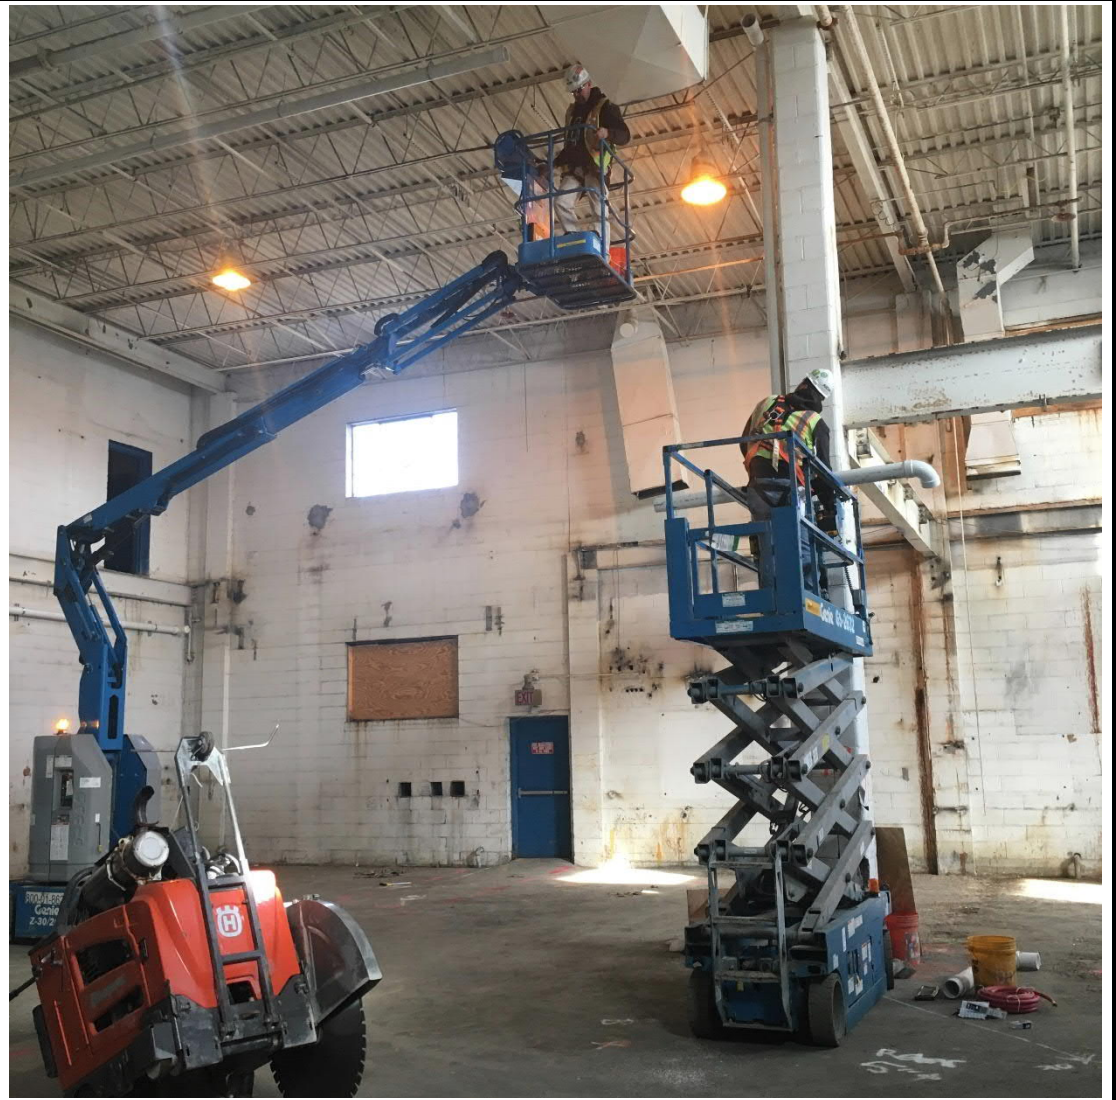
Description:
Installing overhead
piping in Room 2.

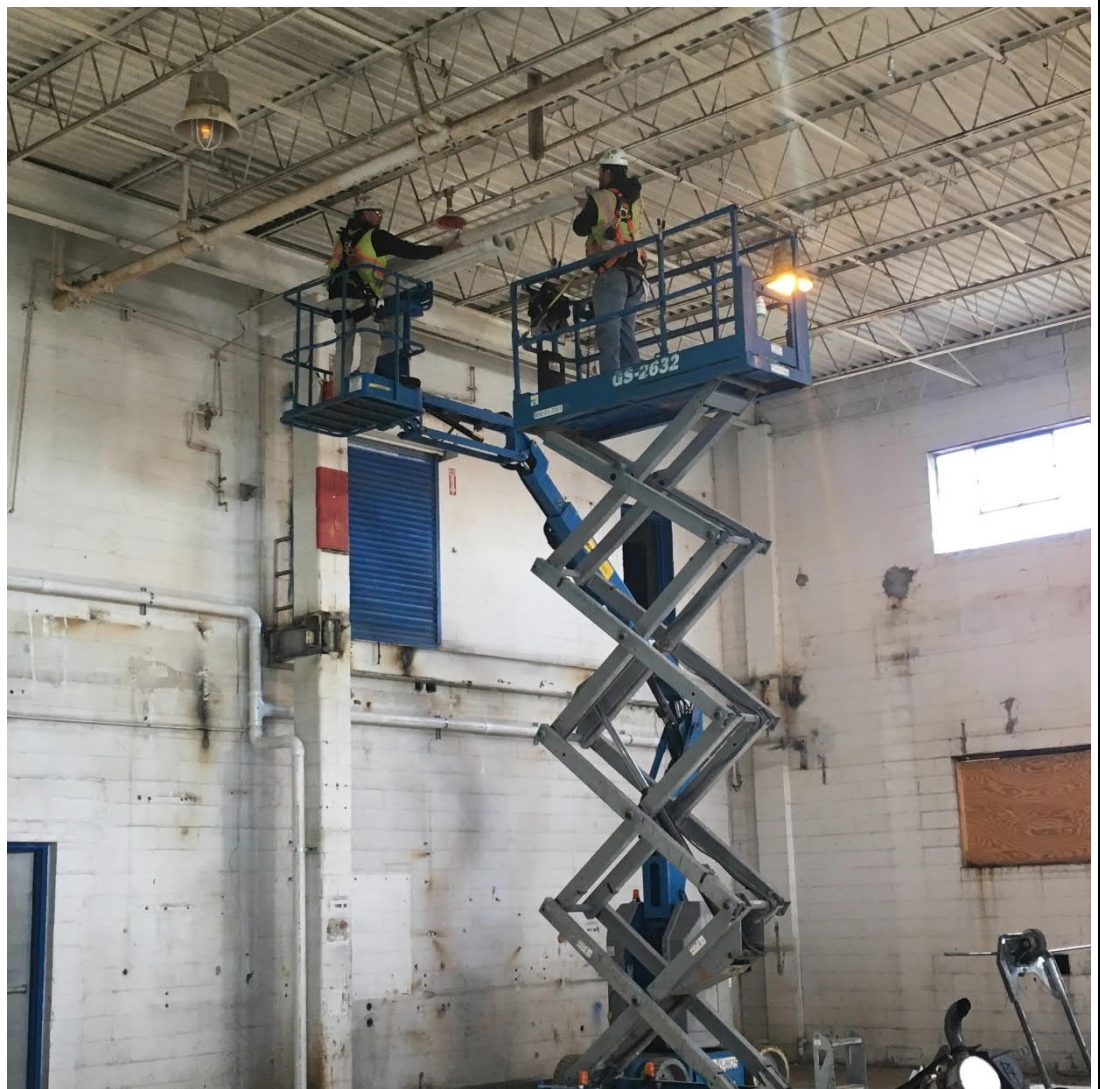
Description:
Installing overhead
piping in Room 2.

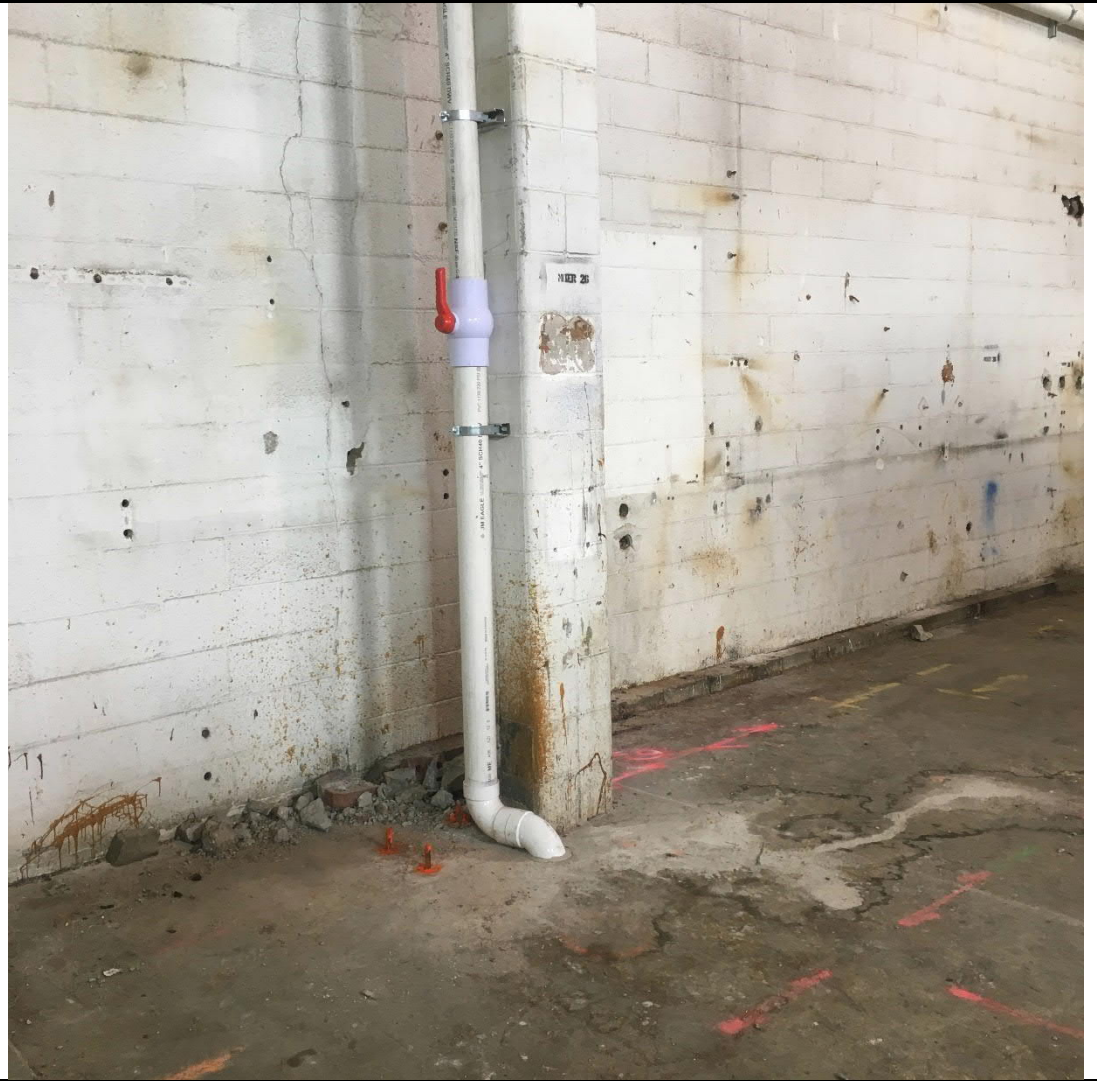
Description:
Extraction point EP-09.

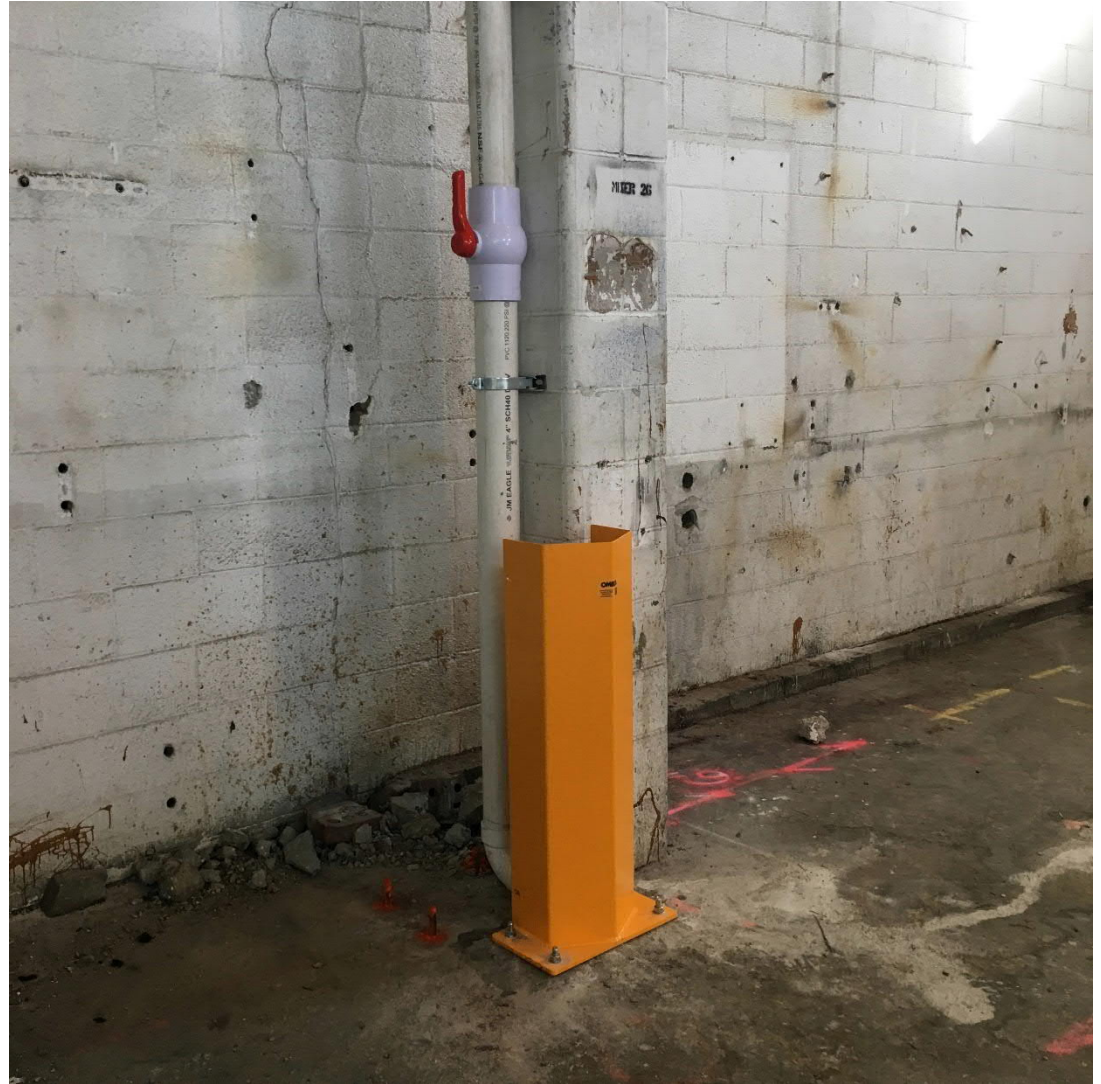
Description:
Extraction point EP-09
with pipe protector.

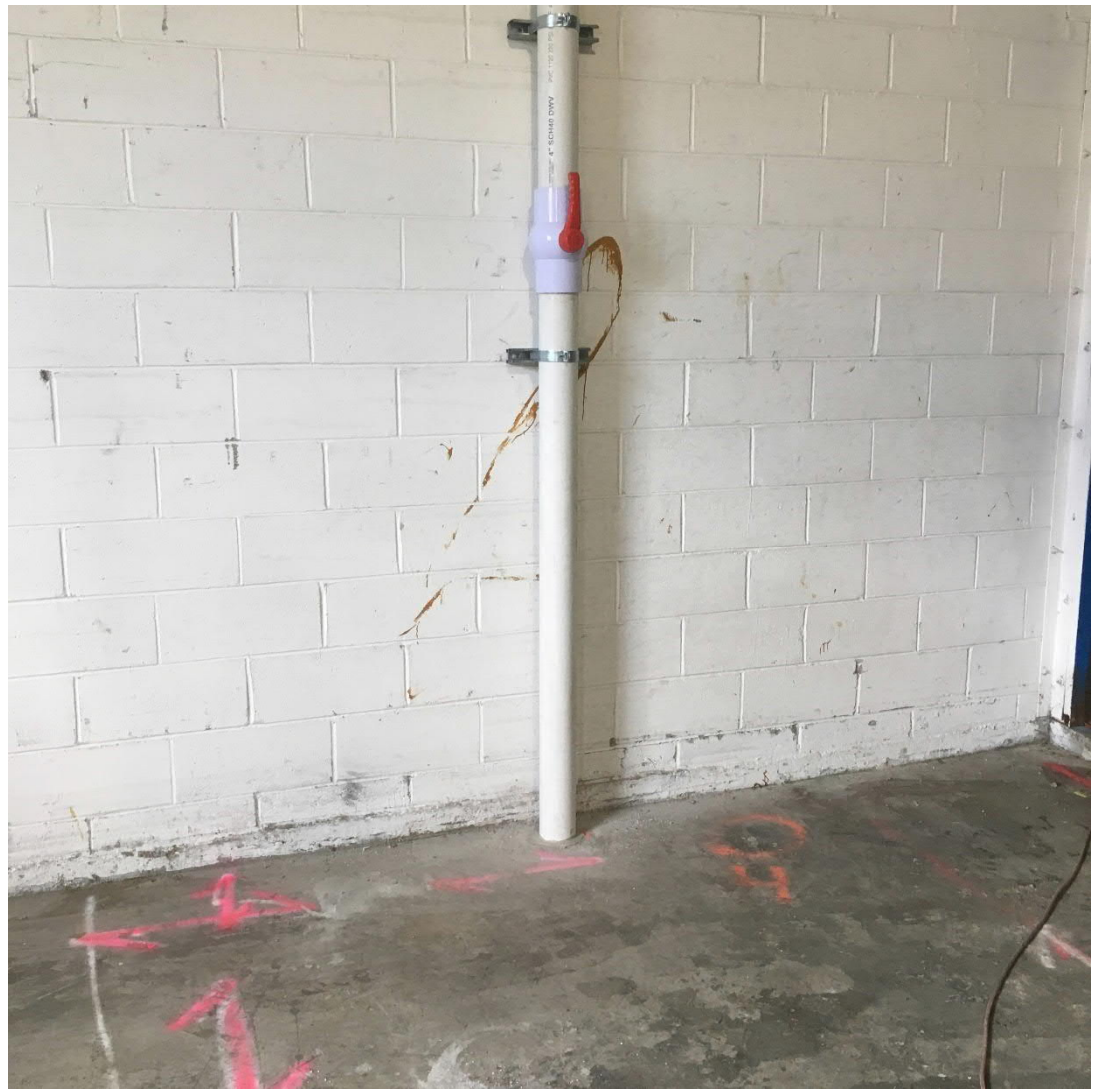
Description:
Extraction point EP-04.

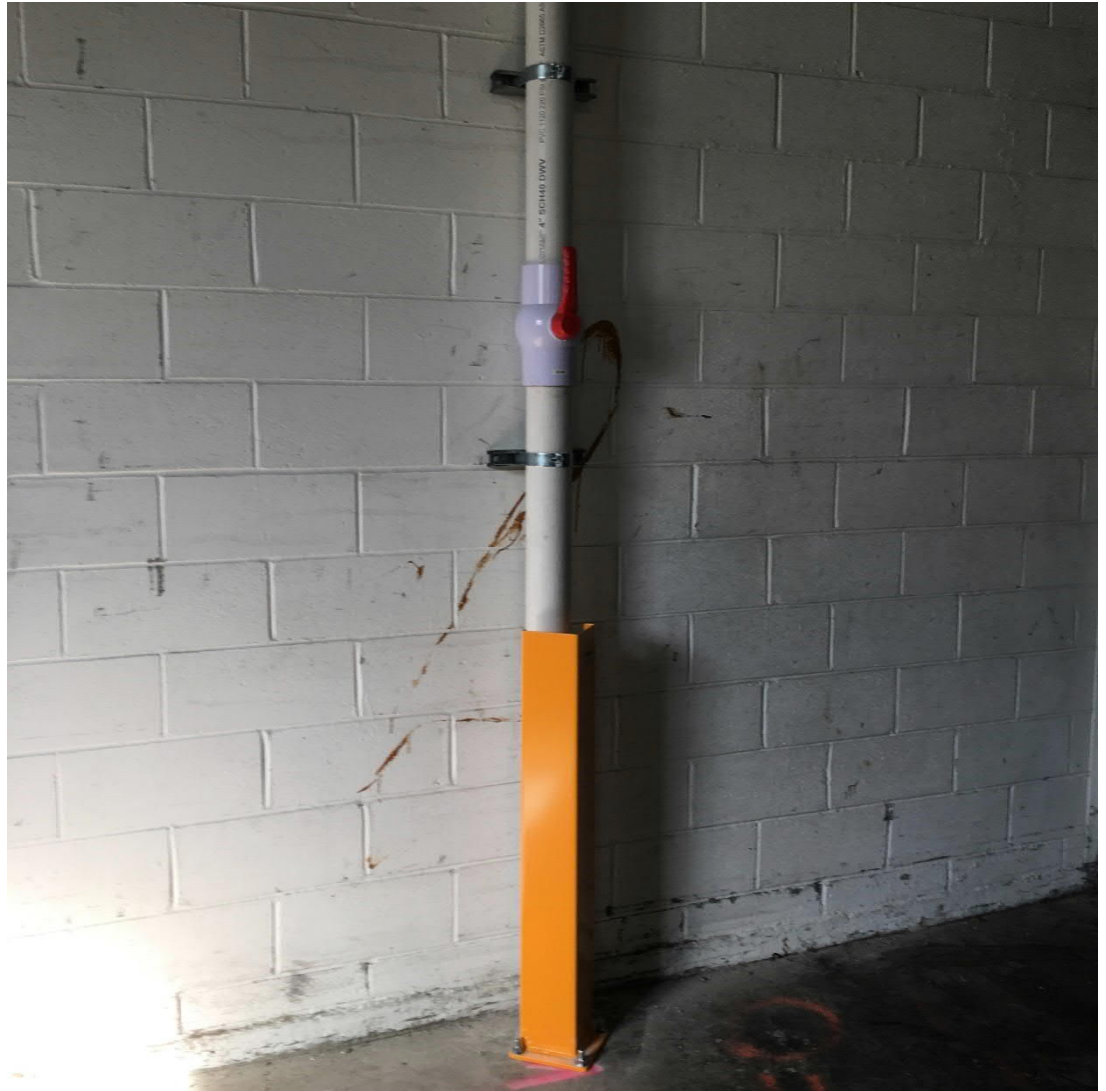
Extraction point EP-04
with pipe protector.

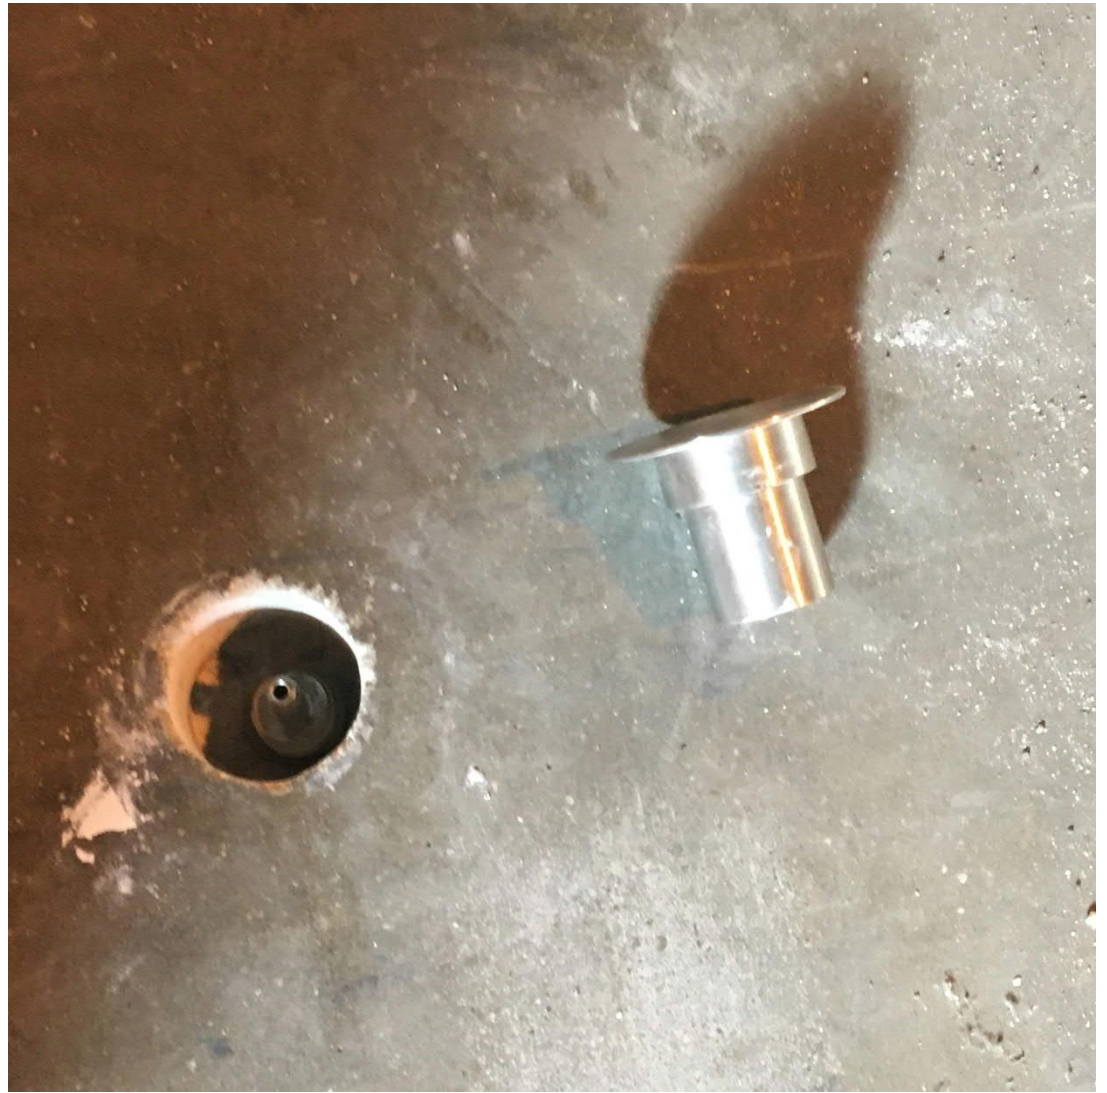
Vacuum monitoring
point with protective
cover.

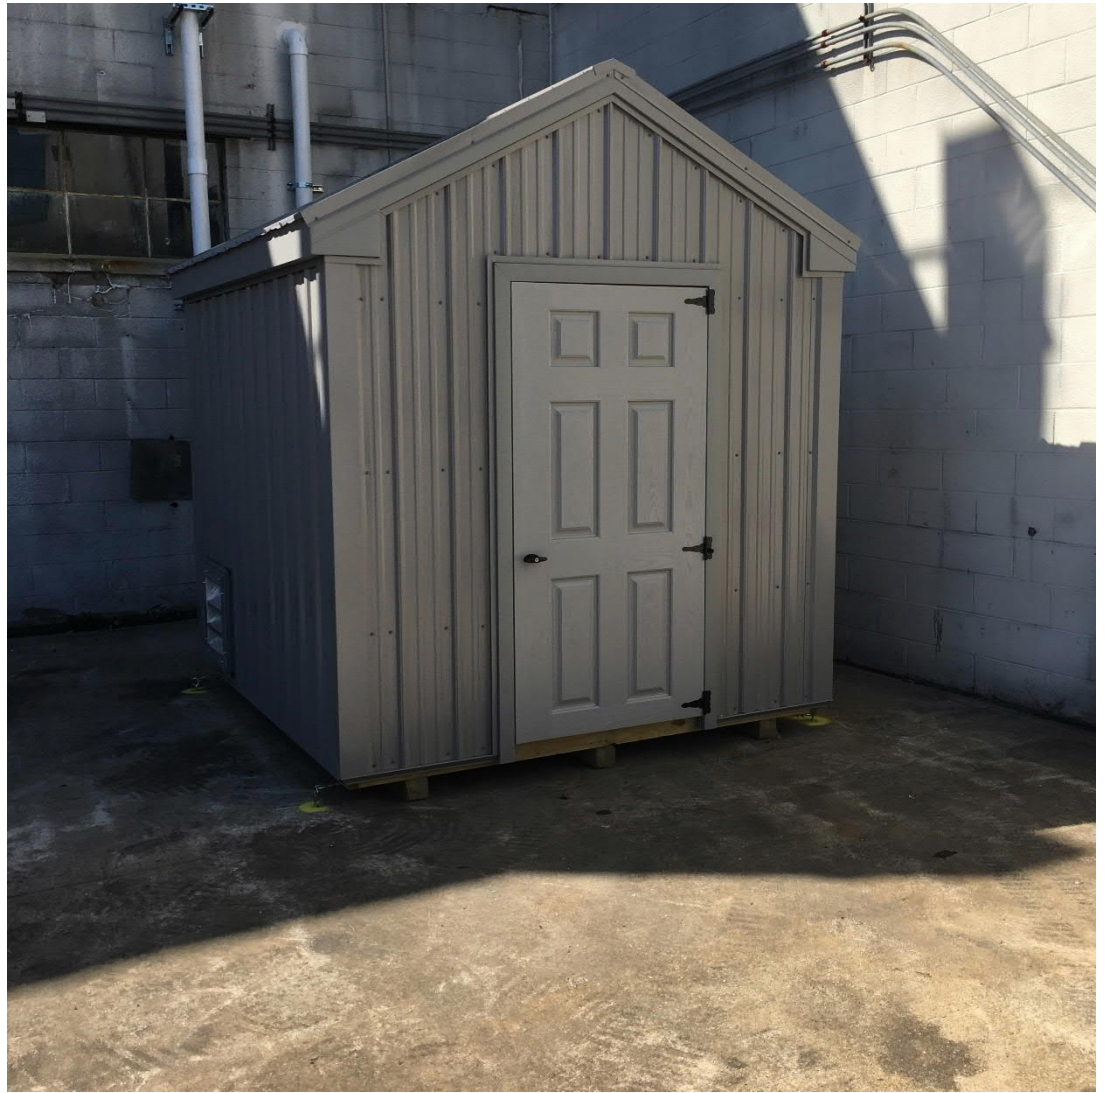
Description:
SSDS equipment shed.

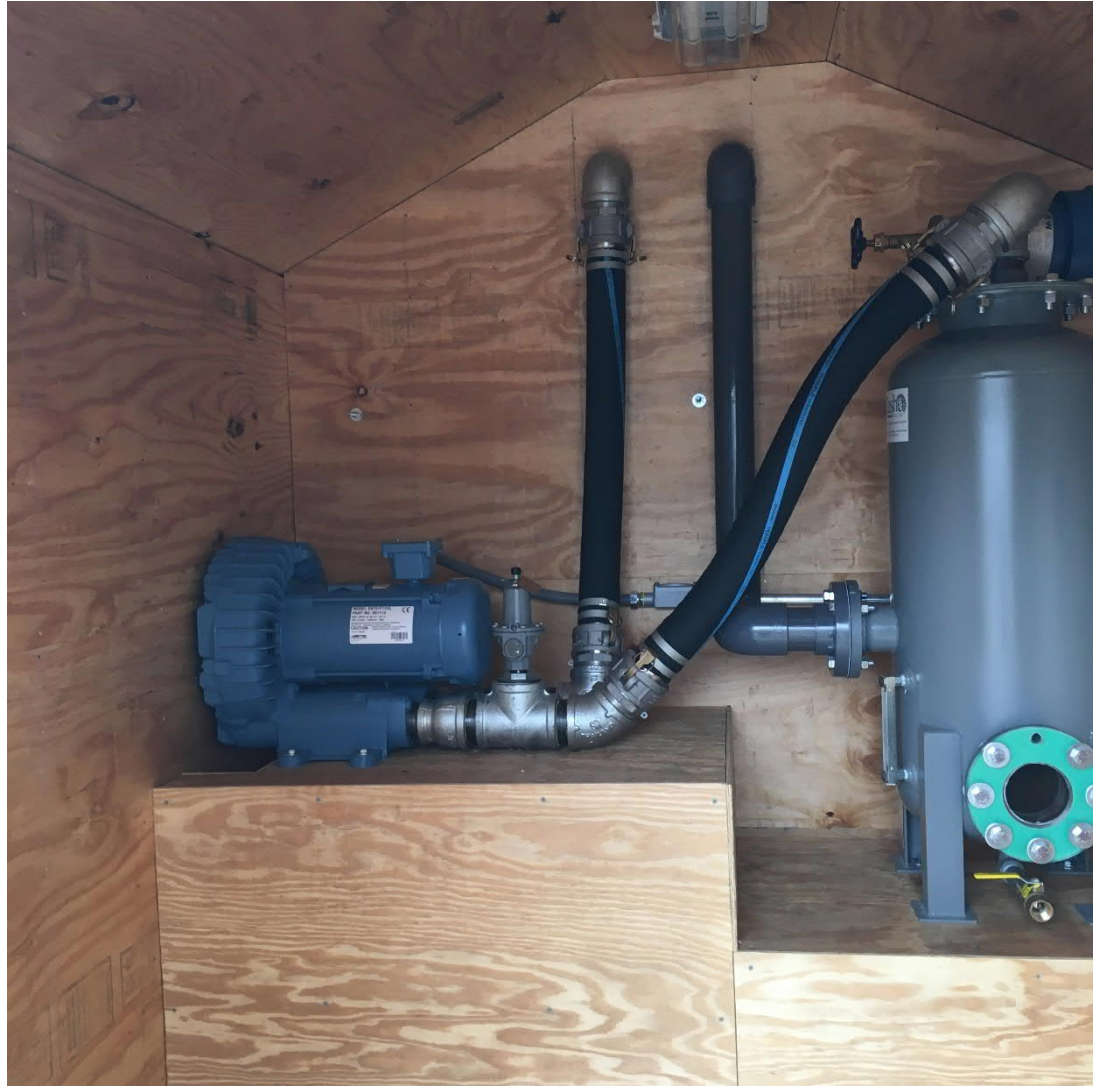
Description:
SSDS blower (left) and
knockout tank inside
equipment shed.

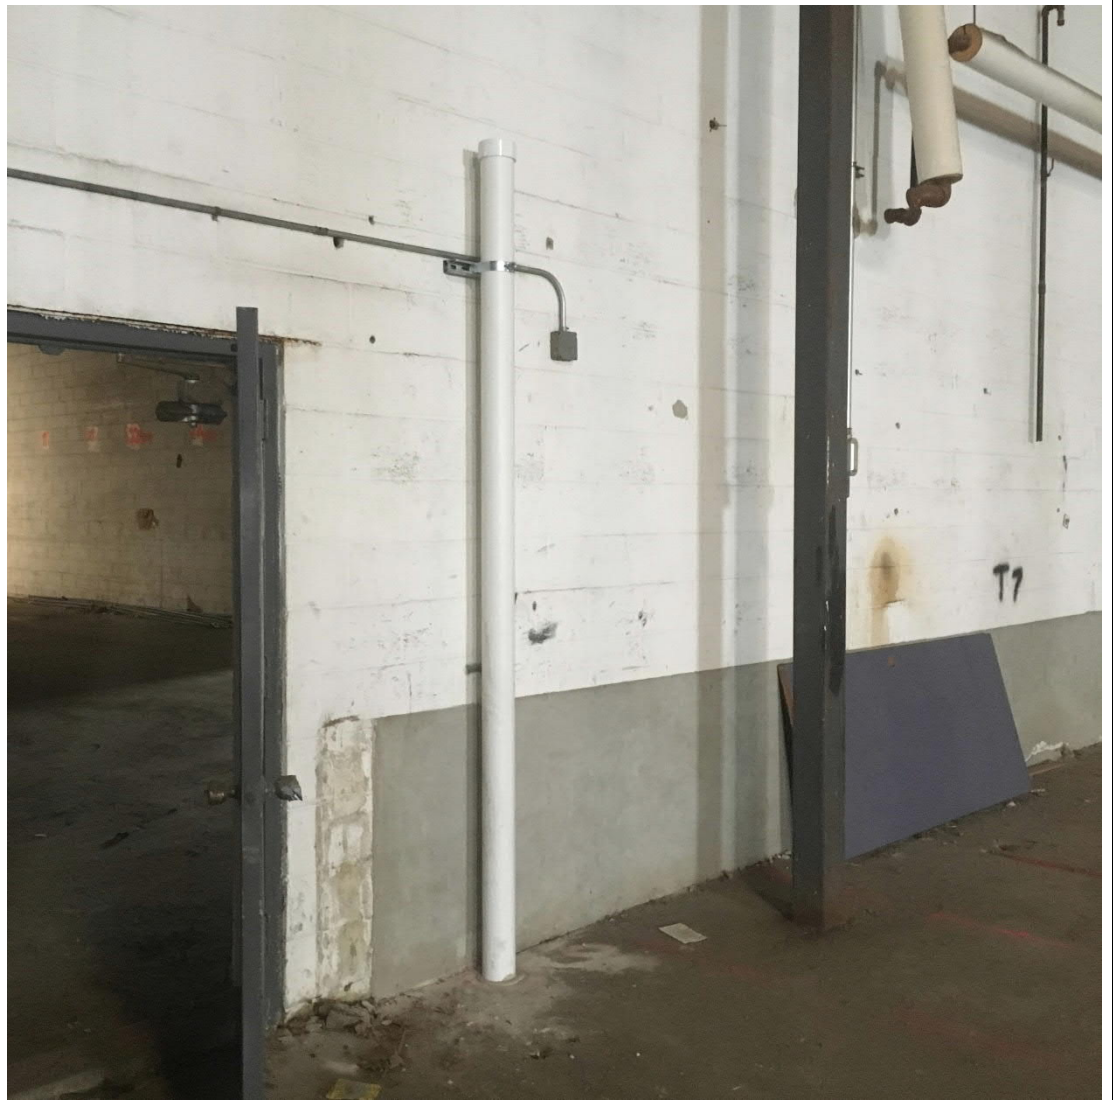
Contingency extraction point EP-10 installed in Room 1.

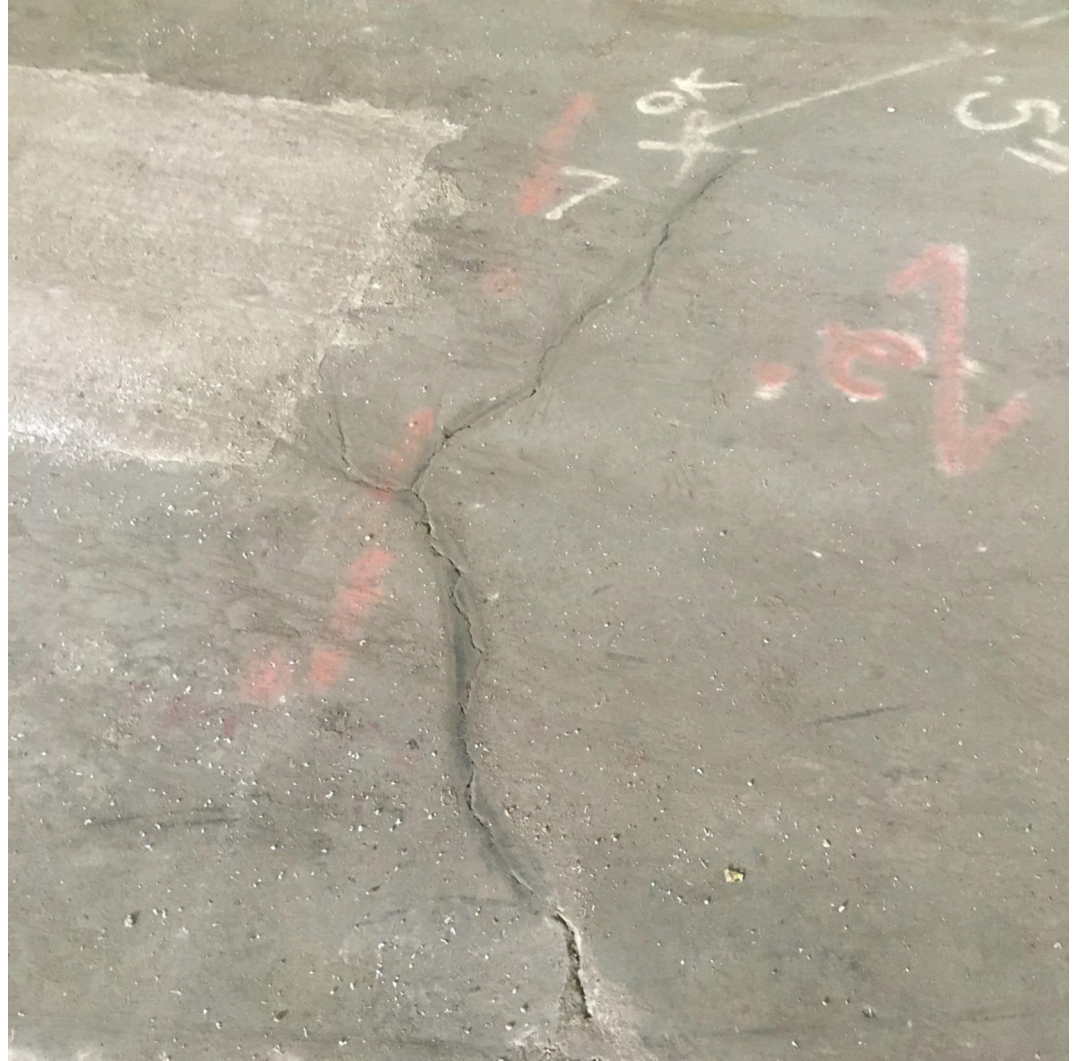
Description:
Crack in Room 2 floor
before sealing.

Rooms 2, 4 and 8 were inspected for the presence of cracks that might allow the intrusion of vapors or decrease system performance. No cracks larger than hairline cracks were observed. All readily accessible cracks were sealed with a non-shrink caulk to eliminate the vapor pathway between the indoor air and sub-slab vapor. The SSDS is connected to a dedicated electrical panel inside the Site building. The electrical circuit used to control the SSDS is labeled as “Sub-Slab Depressurization System”.

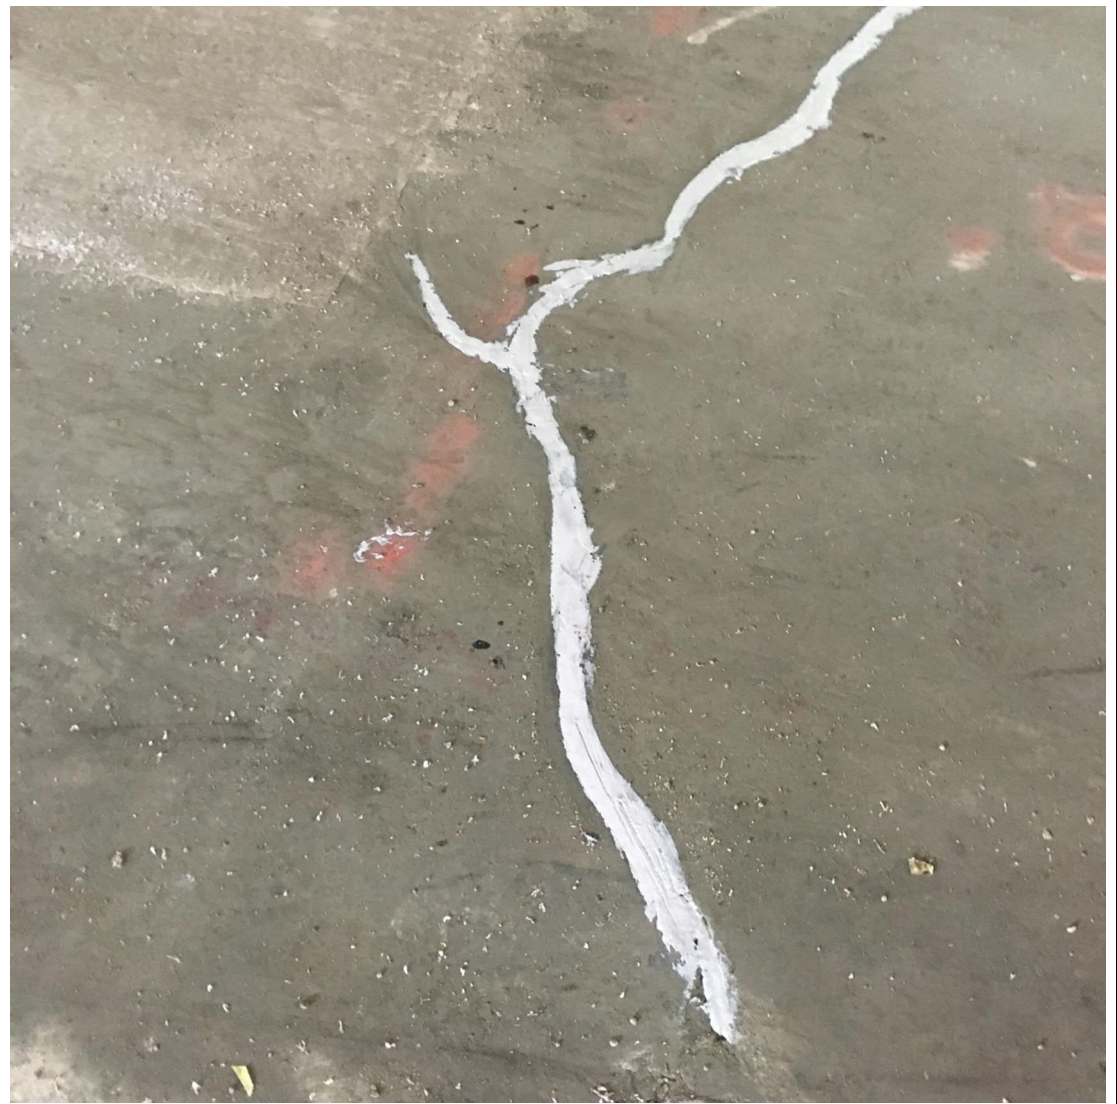
Description:
Crack in Room 2 floor
after sealing.

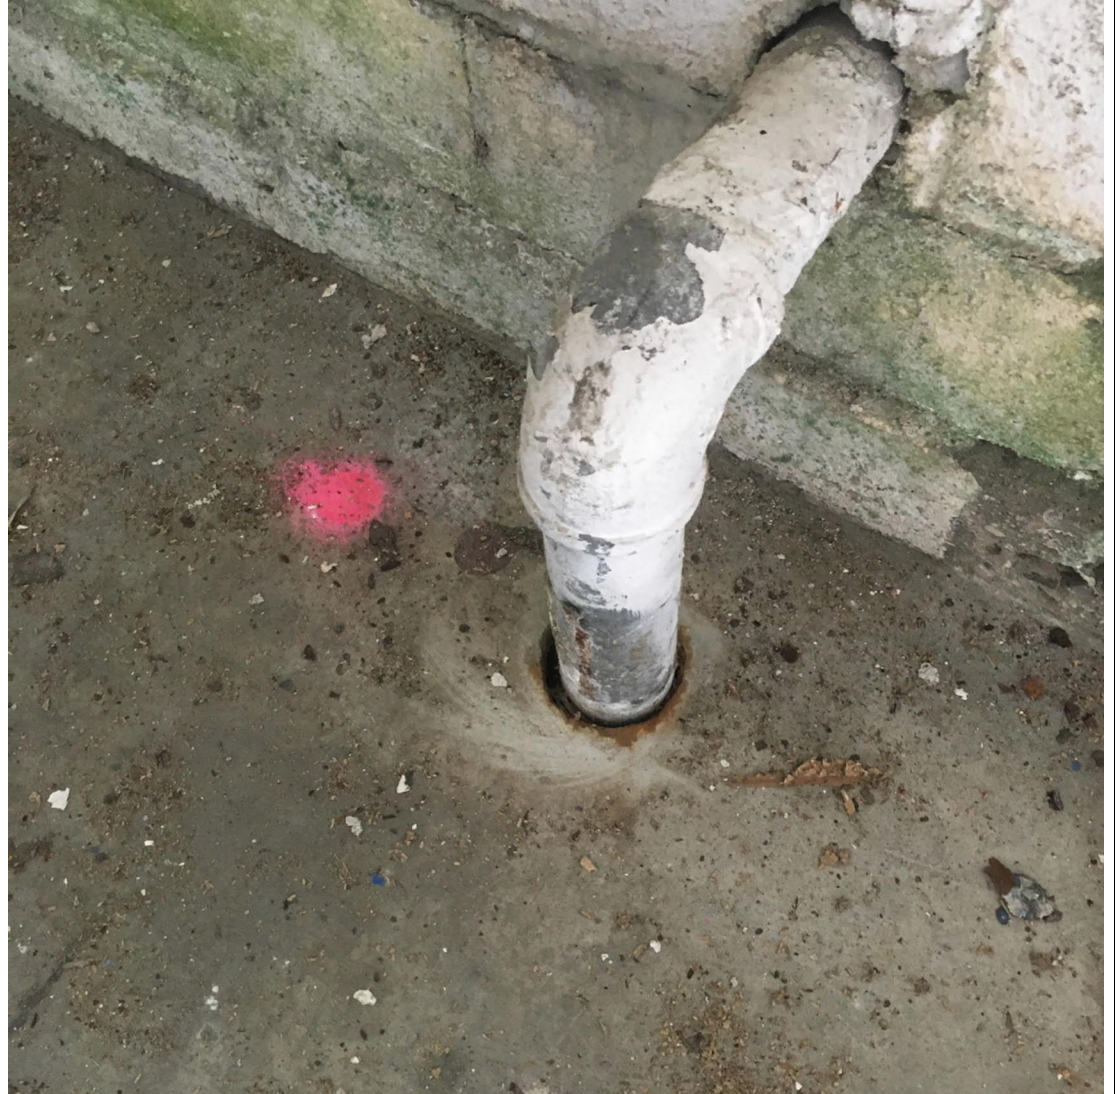
Description:
Vent pipe before
sealing annular space.

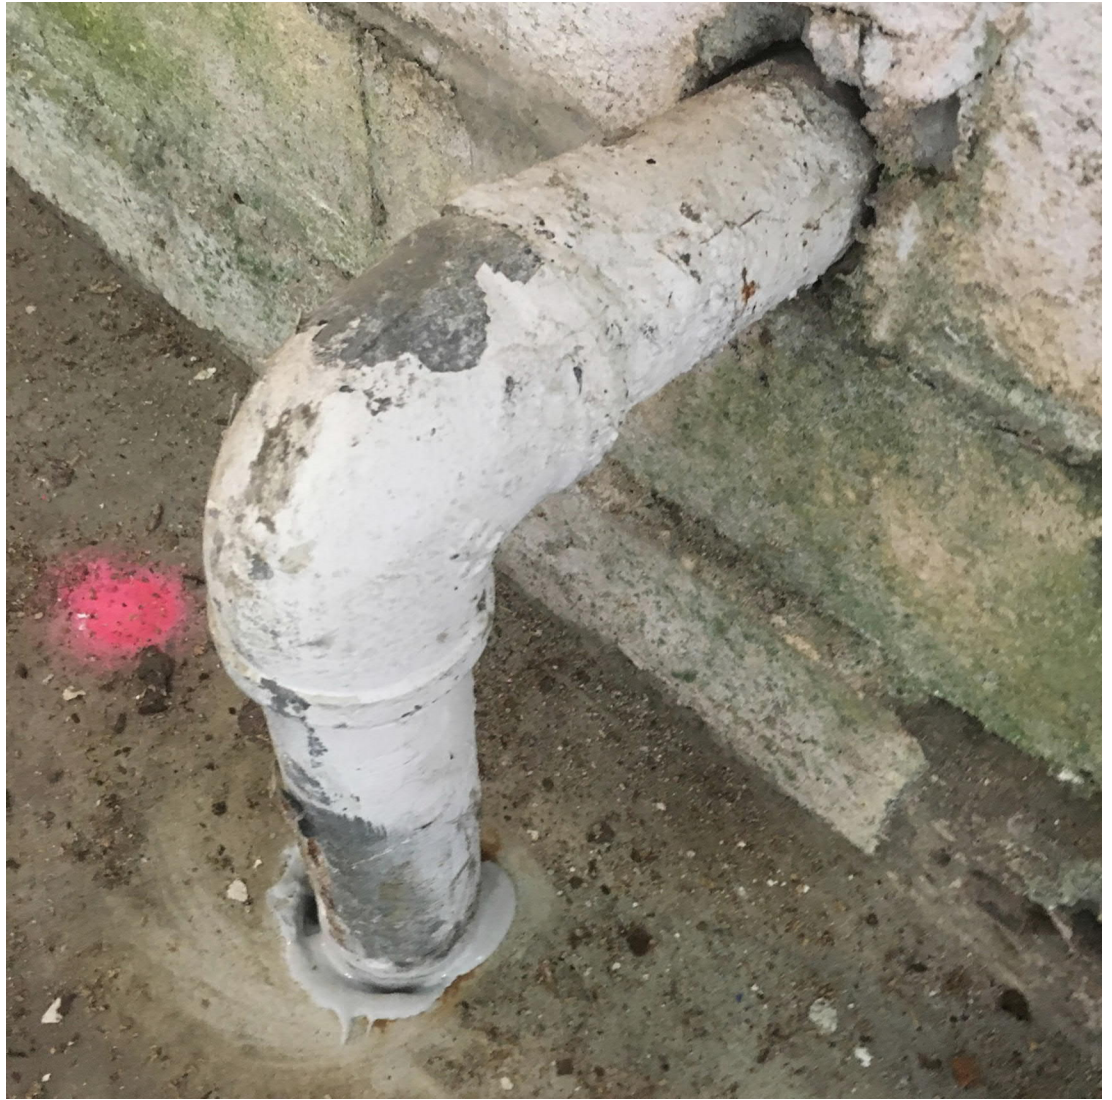
Description:
Vent pipe after sealing
annular space.
