IN-SITU CHEMICAL OXIDATION SUMMARY REPORT - JUNE 2018 THROUGH MARCH 2021

PASS & SEYMOUR SITE
45 SEA CLIFF AVENUE
GLEN COVE, NEW YORK
SITE#: 130053A

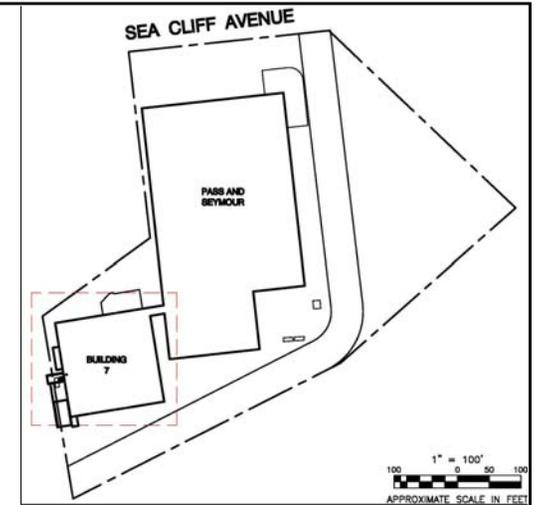
Figure 3: ISCO Pilot Soil Boring Locations

PCE	1,000-10,000 ug/Kg
PCE	10,000-100,000 ug/Kg
PCE	100,000-1,000,000 ug/Kg
PCE	>1,000,000 ug/Kg

ISCO pilot test activities are summarized in the April 26, 2016, *Pilot Test Summary Report & Proposed In-Situ Chemical Oxidation Work Plan*. ISCO pilot test injection point locations, soil boring locations, and posted soil analytical data are included here for reference as Figures 2-4.
