# **Groundwater Monitoring Report (December 2023 Event) Crown Dykman (130054) Glen Cove, New York**

September 2024  
Version: FINAL  
EA Project No. 16025-34-00-CP

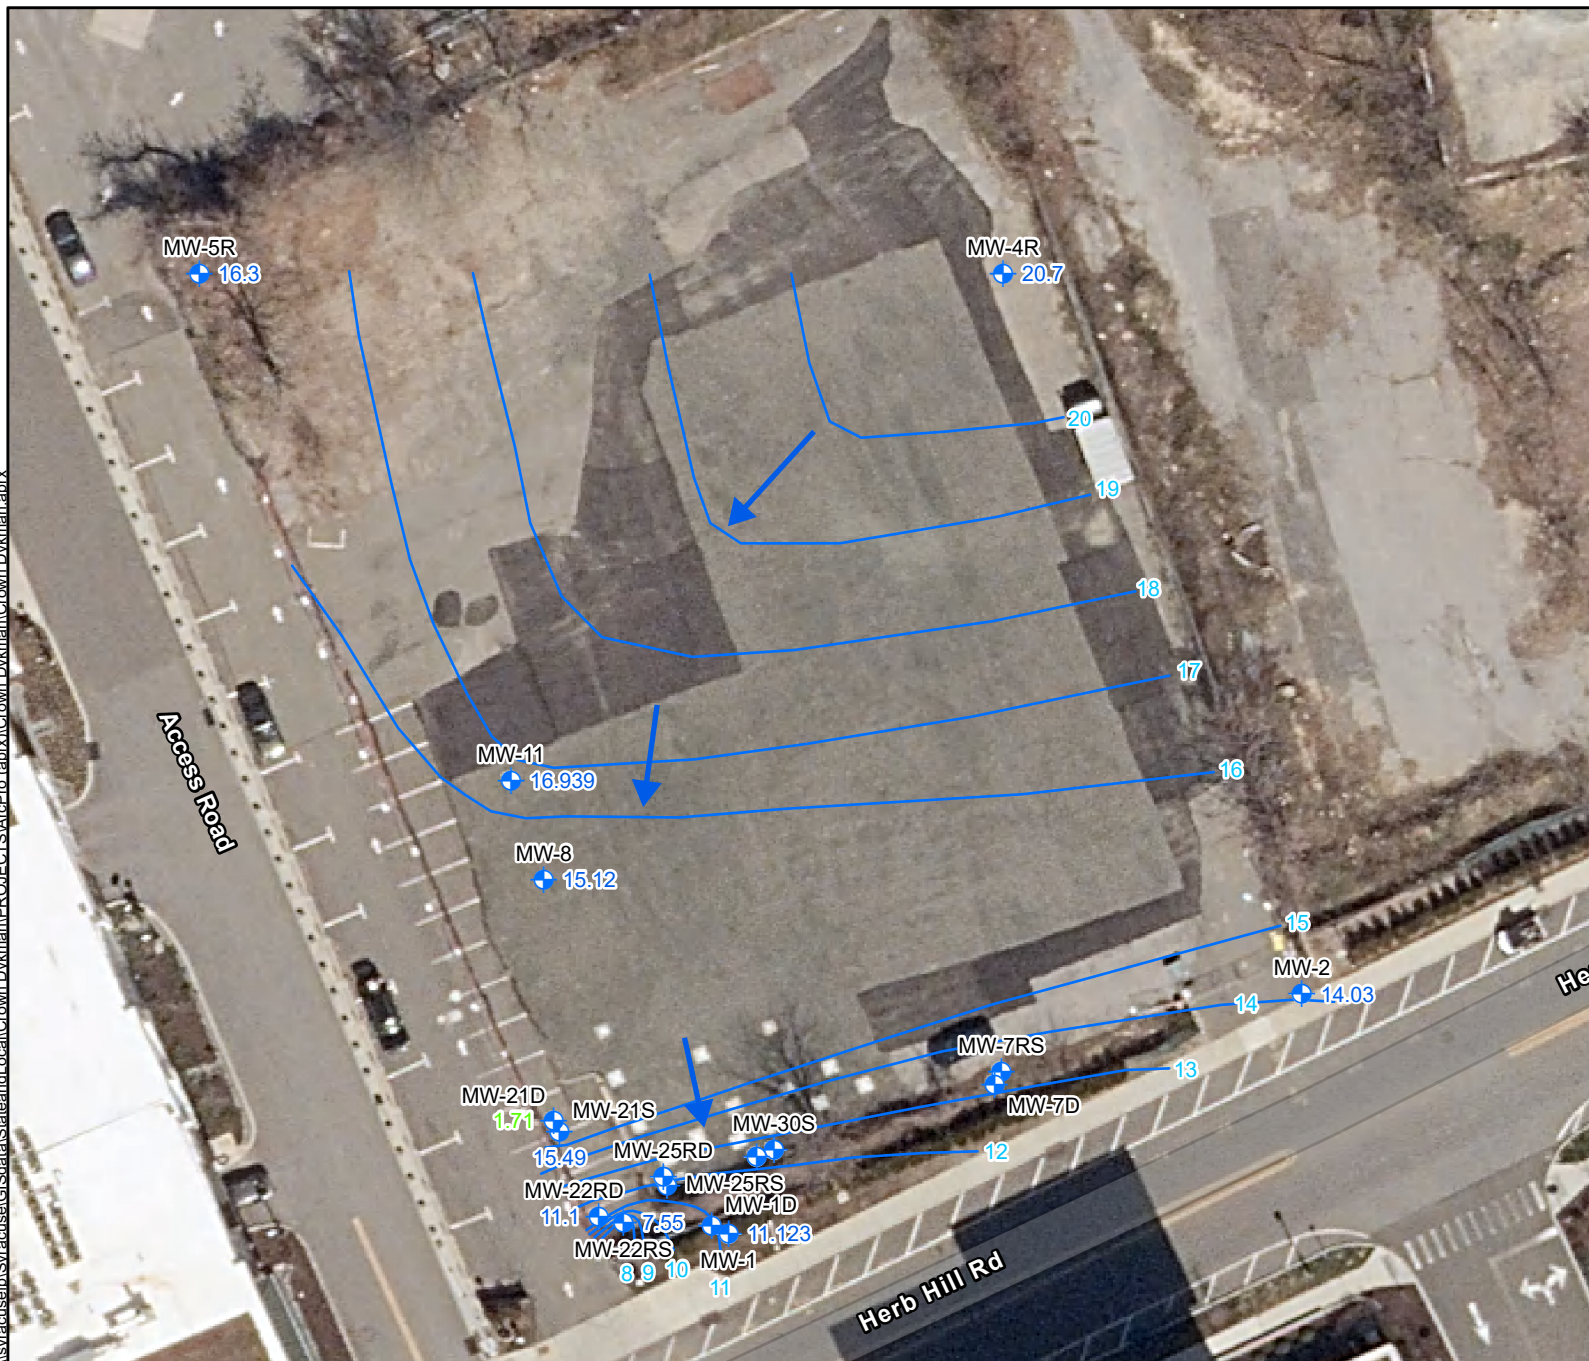
**Figure 3**  
**Groundwater Elevation Contour**  
Crown Dykman (NYSDEC Site 130054)  
66 Herb Hill Rd  
Glen Cove, NY

Note: Groundwater elevation is measured in feet (ft.) above mean sea level (AMSL). Groundwater elevation for MW-21D (noted in green) is omitted as an outlier.

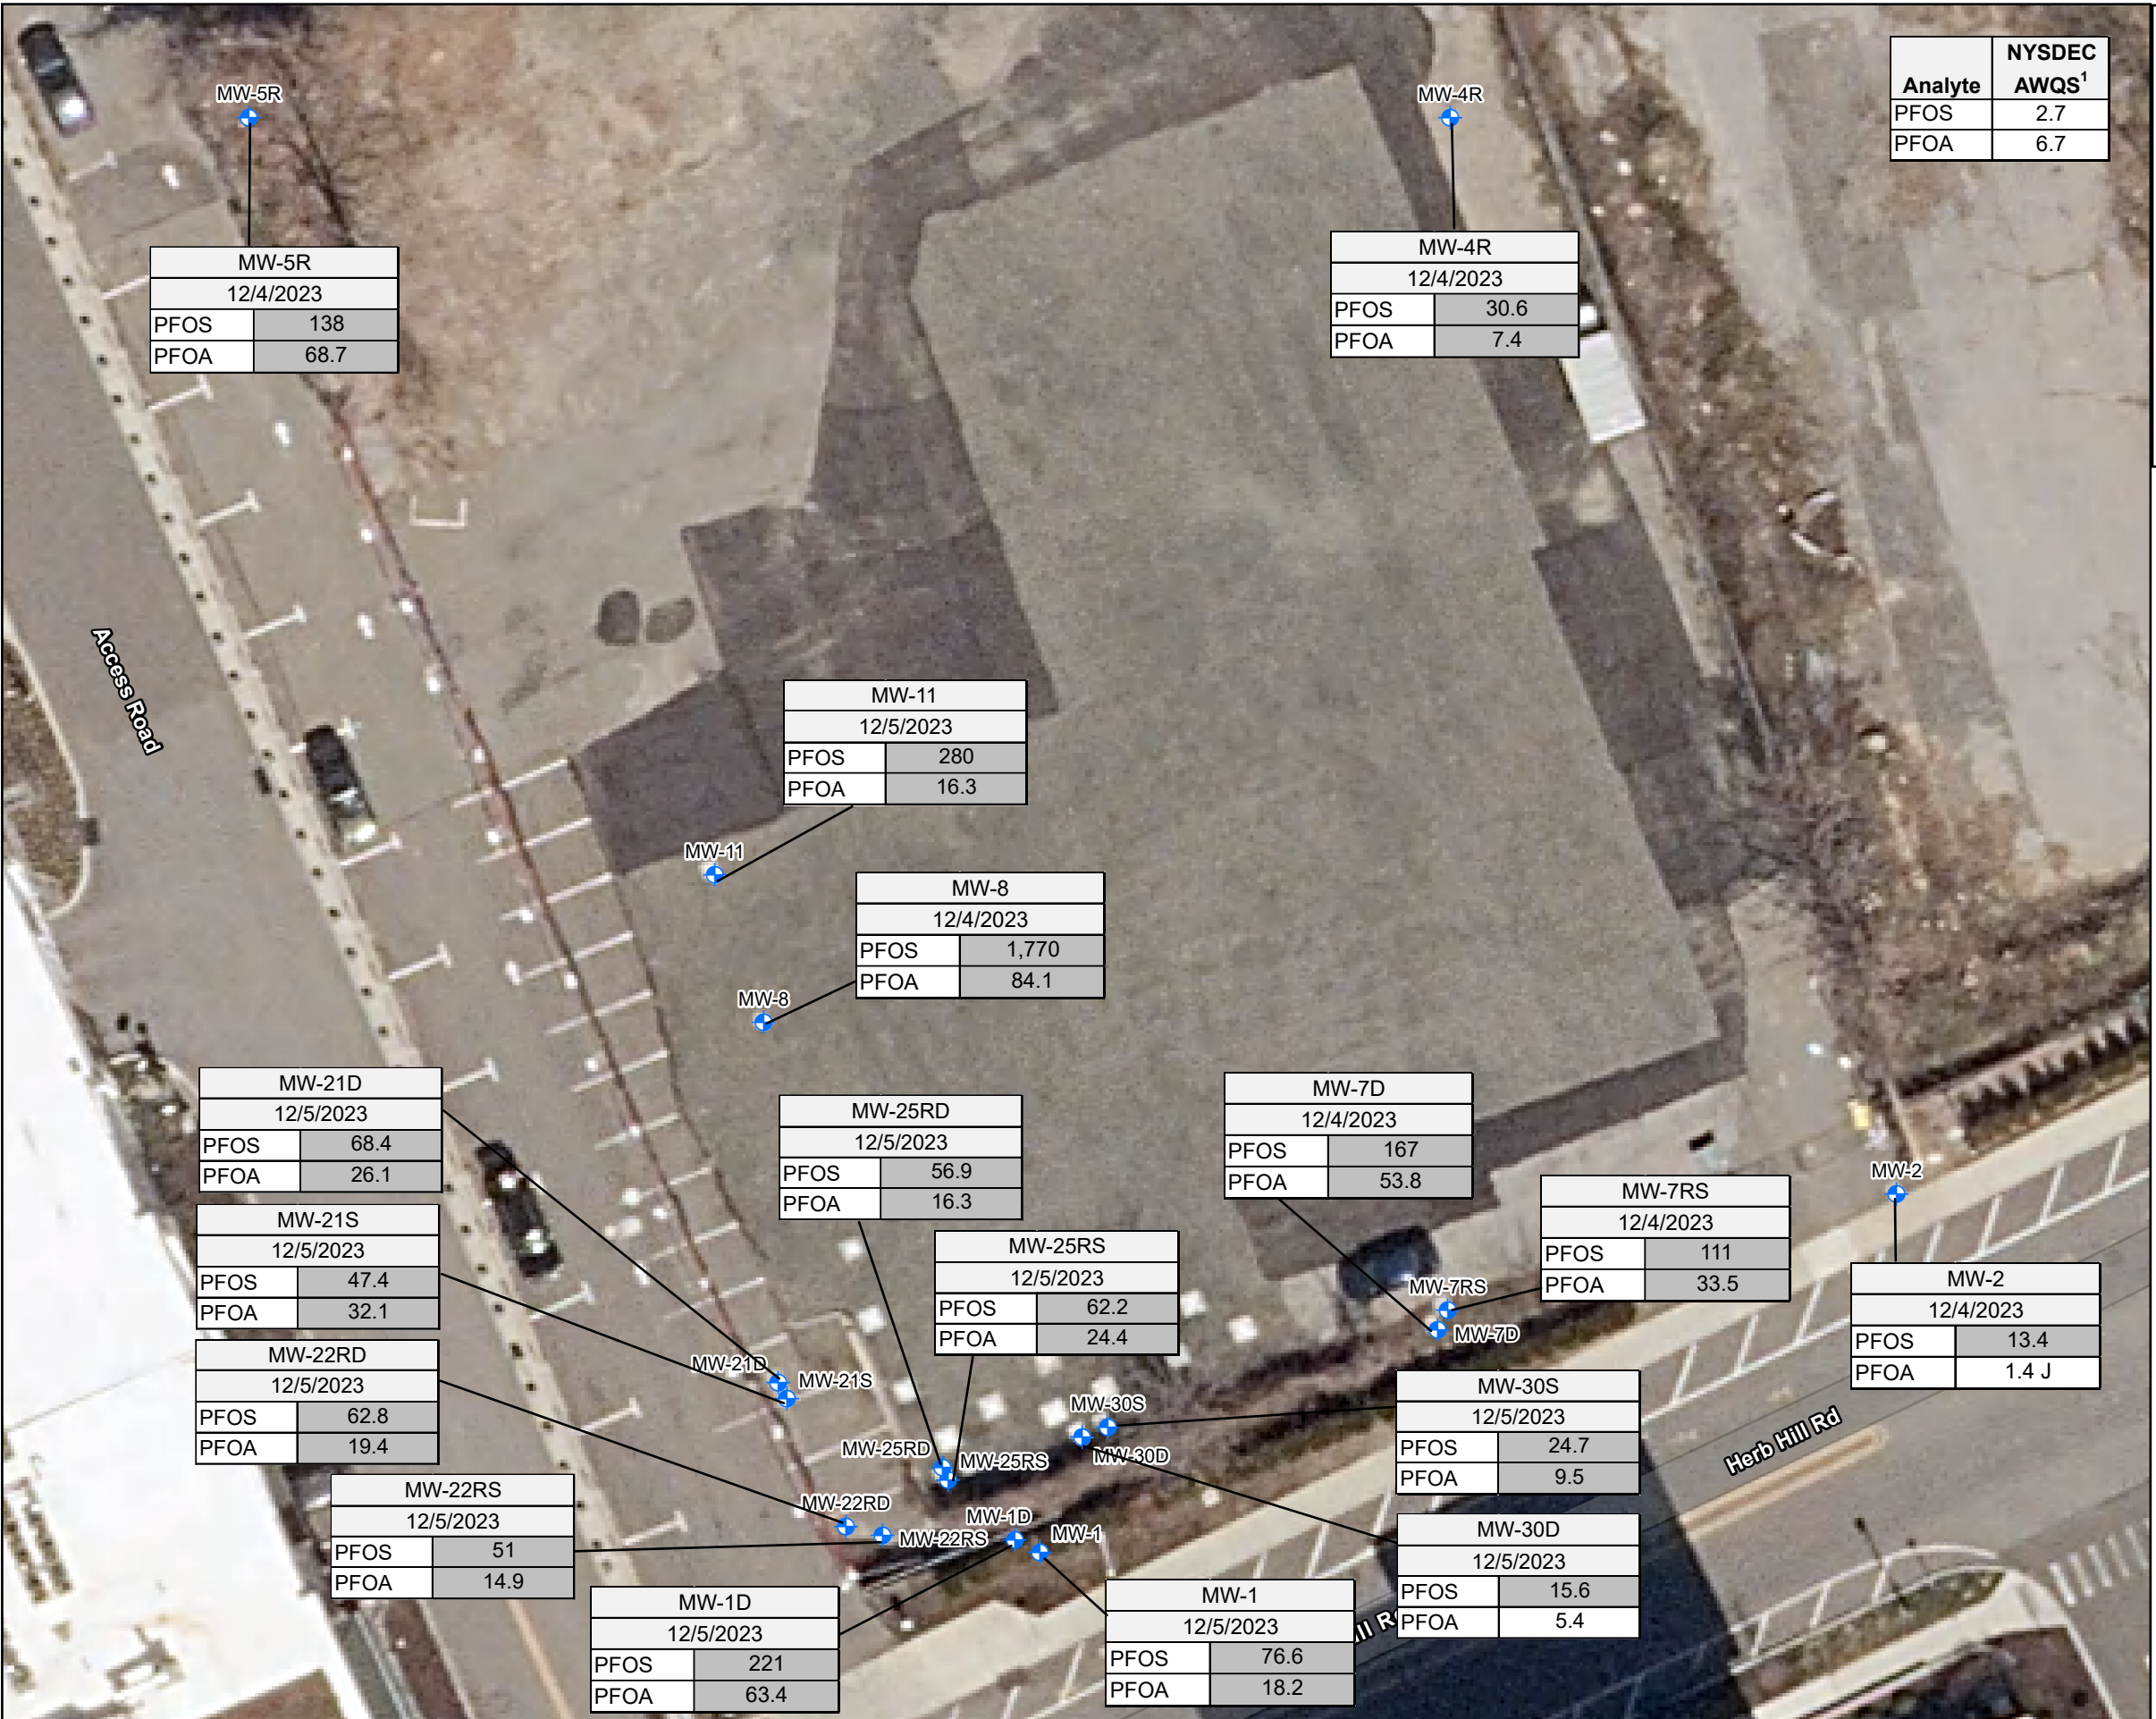
**Figure 5**  
**PFAS Exceedances**  
Crown Dykman (NYSDEC Site 130054)  
66 Herb Hill Rd  
Glen Cove, NY

Twenty PFAS analytes were detected in groundwater samples collected in December 2023. Concentrations reported for detected compounds are summarized in **Table 4**. Perfluorooctanesulfonic acid (PFOS) and perfluorooctanoic acid (PFOA) were detected at concentrations in exceedance of the Class GA AWQS for those compounds (**Figure 5**).

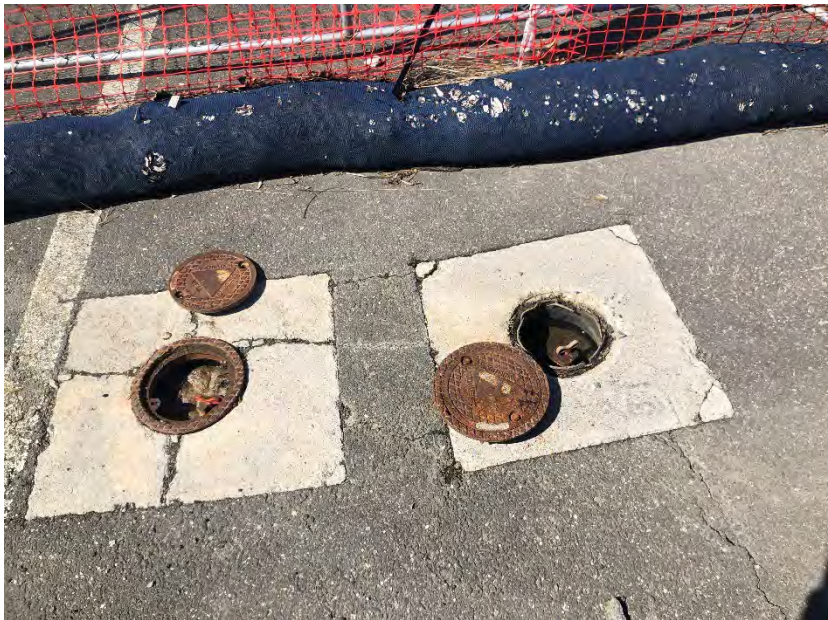
- MW-21S/21D flush mount covers are broken and the well pads needed replacement.
- MW-8 bolt eyelets (small diameter bolts) were stripped and needed to be re-threaded.

- MW-21S/21D filled with water due to broken flush mount covers.
- MW-22RD well casing cracked/broken.
- MW-1DD, MW-23S/23D, and MW-3 could not be located.

| MW-21S (left) and MW-21D (right). Damaged flush mount covers. MW-21D flush mount cover is broken off of the skirt. |

EA will continue quarterly groundwater monitoring at the site, with at a minimum annual inspection of monitoring and injection well conditions. Based on the April and December 2023 site inspections, well repairs are recommended as follows: replacement of select flush mount covers, rethreading of well eyelets, and addition of bolts to secure monitoring wells from runoff. As stated in **Section 2.1**, EA is in the process of procuring a subcontractor to complete well pad replacements.

| Well ID | Well Type | Northing* | Easting* | Ground Surface (ft<br>amsl) | Measure Point (ft<br>amsl) | Rim (ft amsl) | Screen Length (ft) | Well Diamter (in.) | Total Depth (ft bgs) | Screen Interval (ft bgs) | | Screen Interval (ft amsl) | | Condition |
|---|---|---|---|---|---|---|---|---|---|---|---|---|---|---|
| MW-21S | Monitoring | 253447.8705 | 1084075.015 | 16.74 | 16.71 | 16.9 | 10 | 2 | 12.80 | 2.80 | 12.80 | 13.94 | 3.94 | Broken cover, replace well pad |
| MW-21D | Monitoring | 253450.2446 | 1084073.761 | 16.87 | 16.91 | 17.02 | 10 | 2 | 22.60 | 12.60 | 22.60 | 4.27 | -5.73 | Broken cover, replace well pad |

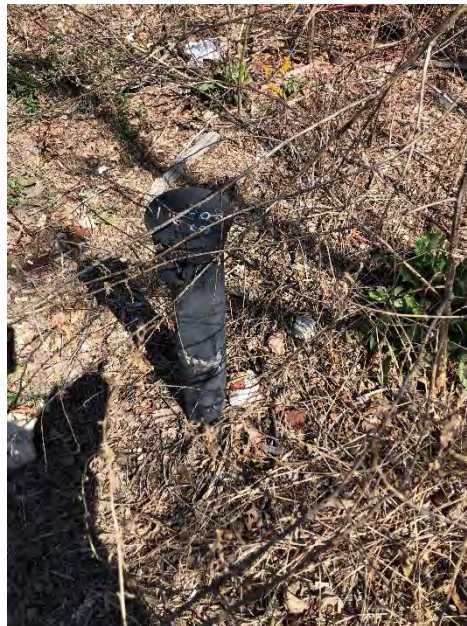
- MW-1/1D/1DD and MW-23S/23D could not be located.
- MW-5R a stickup well was in acceptable condition, but the protective casing appears to have been hit by a car.

MW-5R. Stickup casing in ok condition, collision damage on steel outer casing does not appear to have affected the well.

| Well ID | Well Type | Northing* | Easting* | Ground Surface (ft<br>amsl) | Measure Point (ft<br>amsl) | Rim (ft amsl) | Screen Length (ft) | Well Diamter (in.) | Total Depth (ft bgs) | Screen Interval (ft bgs) | | Screen Interval (ft amsl) | | Condition |
|---|---|---|---|---|---|---|---|---|---|---|---|---|---|---|
| MW-5R | Monitoring | 253624.8 | 1084004.49 | 26.35 | 25.92 | 26.35 | 10 | 2 | 22.15 | 12.15 | 22.15 | 14.20 | 4.20 | Stickup casing is bent, replace well pad |

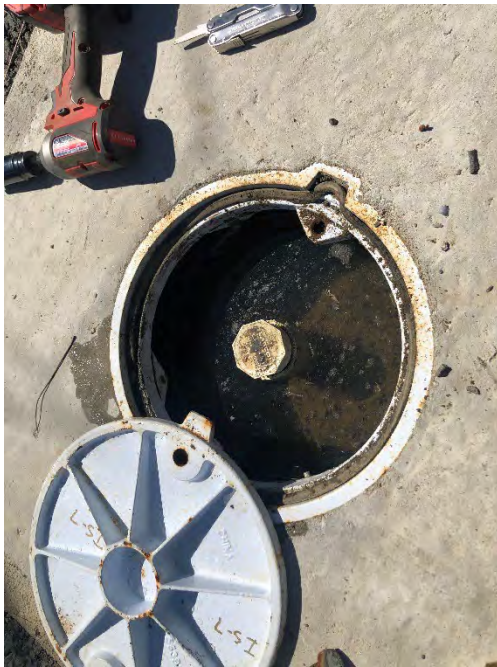
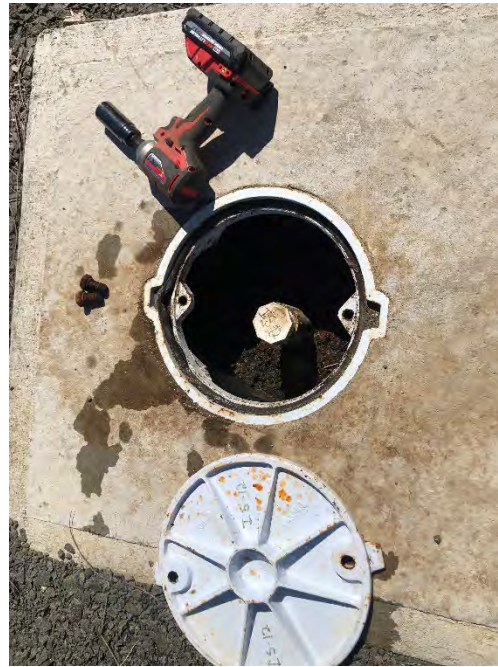
- Injection wells IS-1 through IS-12 and two injection wells labeled “injection gallery” (connected by lateral injection piping) were located on-site and pads were in good condition. IS-7 was flooded when located.

IS-7 (left, flooded) and IS-12 (right)

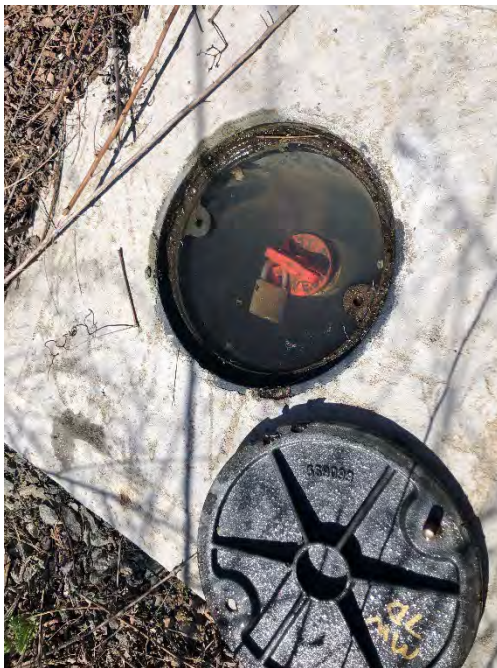
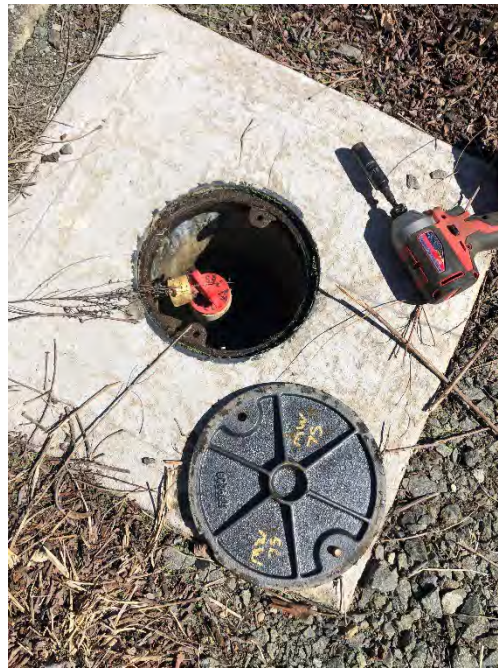
- MW-7D well pad was in good condition, but the annular space was flooded.
- Monitoring wells located within the excavation area appear to have been destroyed and/or abandoned, including MW-25S/D, MW-10S/D, MW-18, MW-20, MW-17R, MW-6R, MW-27, MW-28, MW-13, MW-26, MW-29, MW-16R, MW-19, MW-14R, MW-15R, MW-8, and MW-11<sup>1</sup>.

MW-7D (left, flooded) and MW-7S

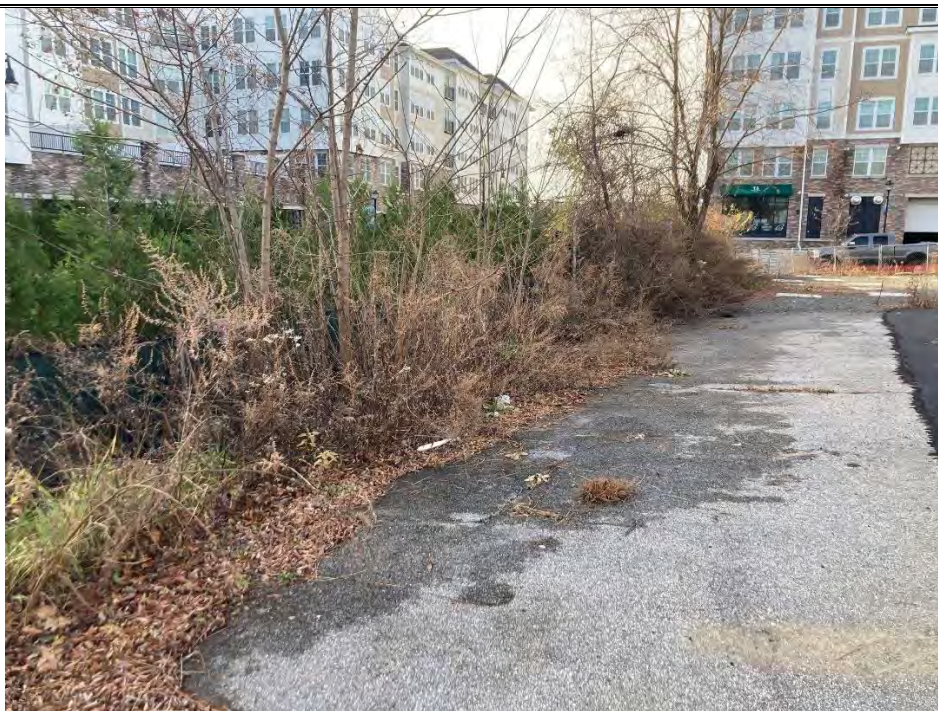
Vegetation along S edge of Site

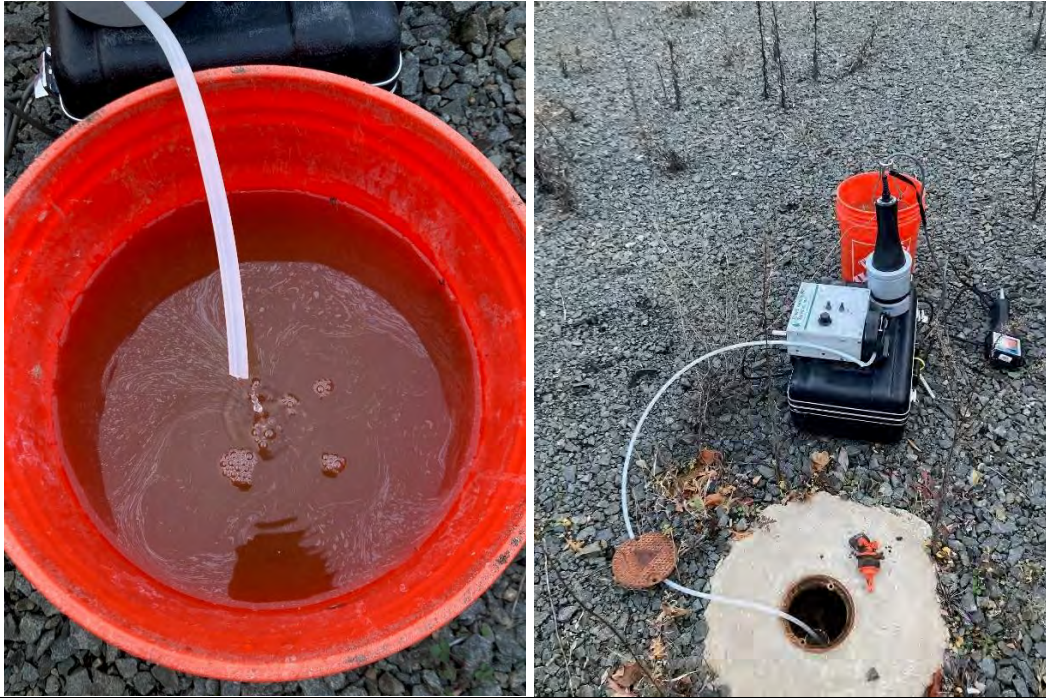
Sheen observed from MW-8 (left), Setup on MW-8

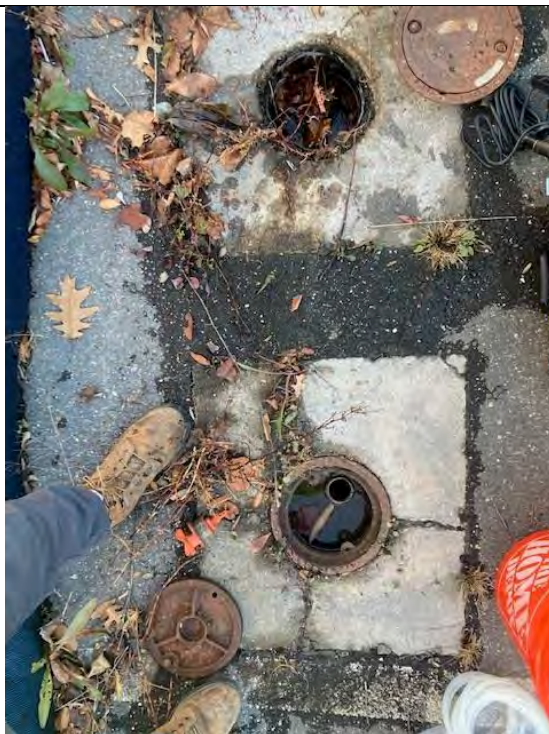
MW-21D and MW-21S

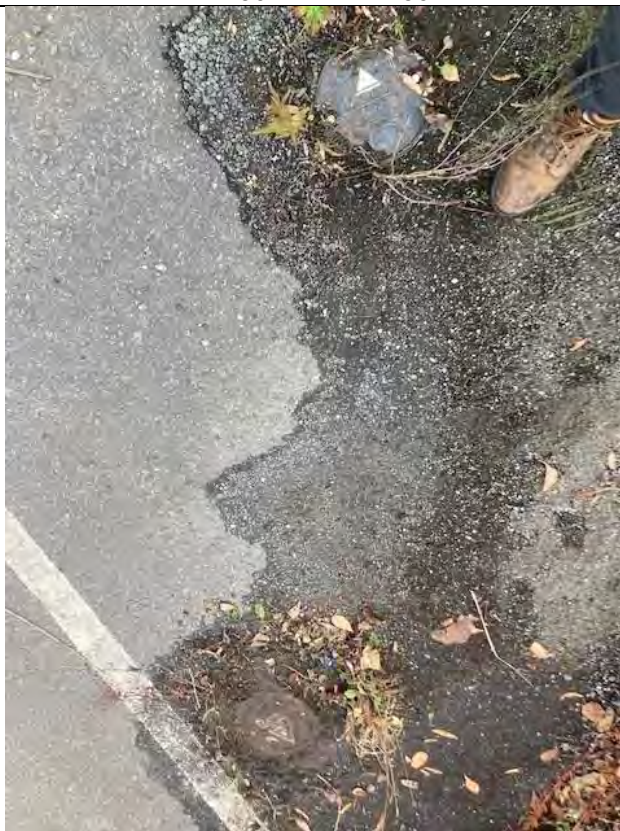
MW-22RS and MW-22RD

| Well ID | Well Type | Northing* | Easting* | Ground Surface (ft<br>amsl) | Measure Point (ft<br>amsl) | Rim (ft amsl) | Screen Length (ft) | Well Diamter (in.) | Total Depth (ft bgs) | Screen Interval (ft bgs) | | Screen Interval (ft amsl) | | Condition |
|---|---|---|---|---|---|---|---|---|---|---|---|---|---|---|
| MW-22RD | Monitoring | 253429.315 | 1084083.595 | 15.27 | 15.02 | NA | 10 | 2 | 29.95 | 19.95 | 29.95 | -4.68 | -14.68 | Casing cracked, replace well pad |
