NASSAU UNIFORM SERVICES

INTERIM REMEDIAL MEASURE CONSTRUCTION COMPLETION REPORT 525 RAY STREET FREEPORT, NEW YORK

SITE NO. 130063
NYSDEC RECORD OF DECISION

MARCH 2011

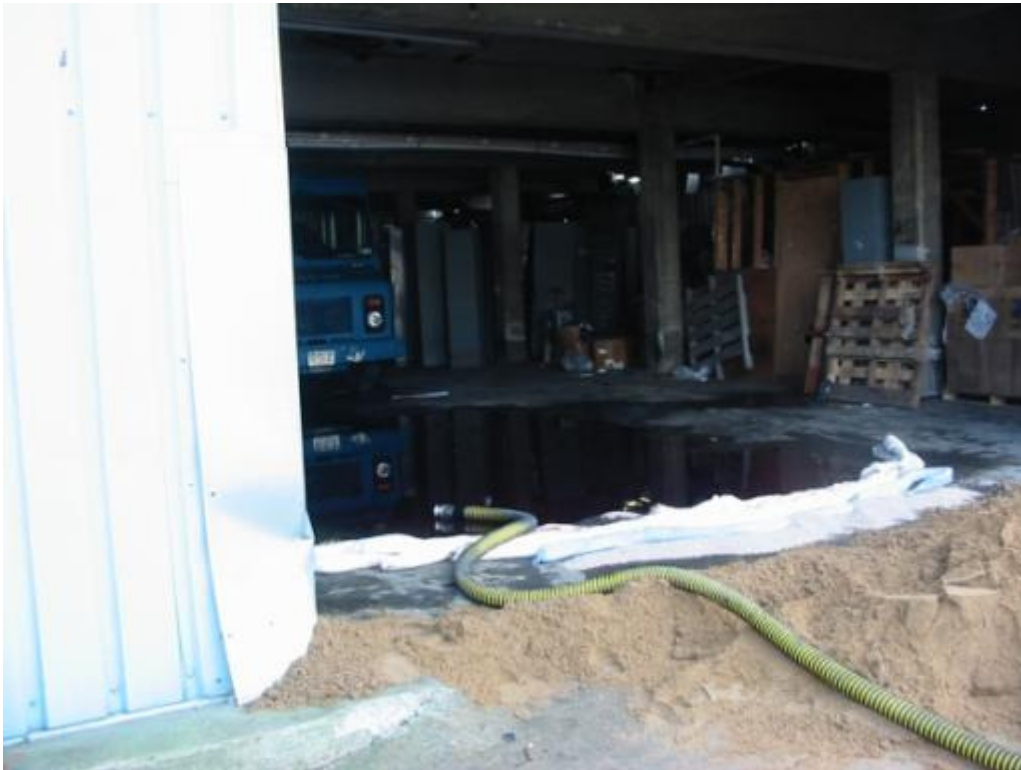
Initial Spill Response (October 2007)

NUS retained a cleanup contractor and fuel oil was removed by vacuum truck and disposed off site in accordance with regulatory requirements. Absorbent materials were placed within the canal and within adjacent sewer-connected manholes to mitigate the release in these areas. The NYSDEC observed all cleanup activities.

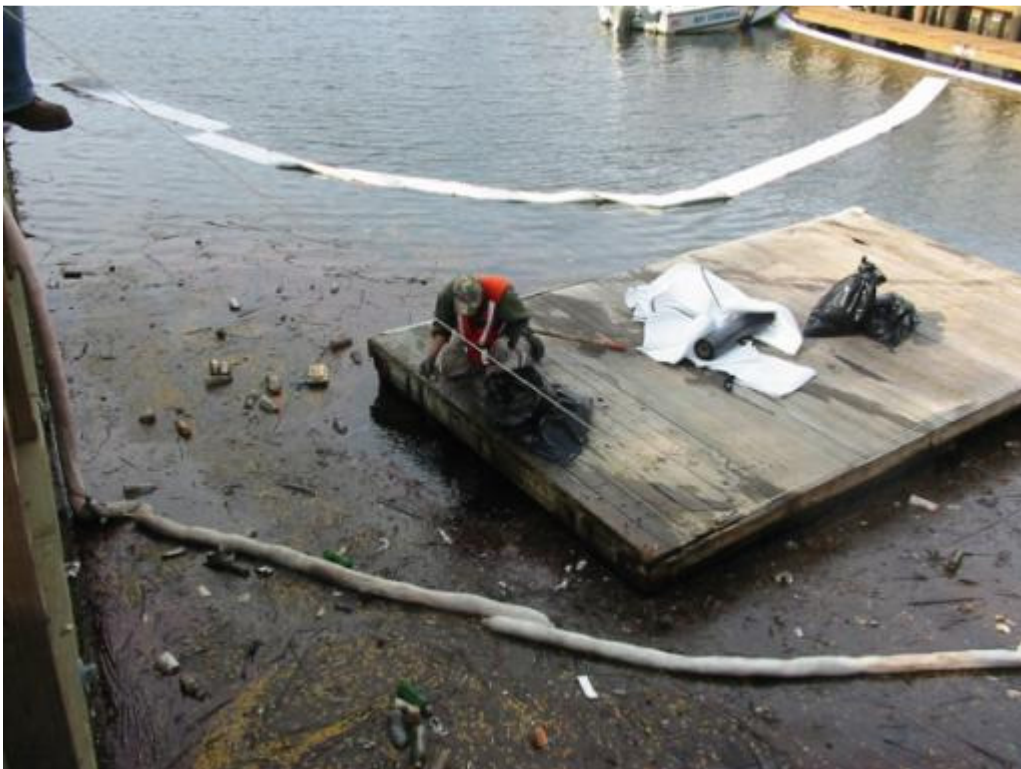
Recovery Effort in the adjacent creek (October 2007)

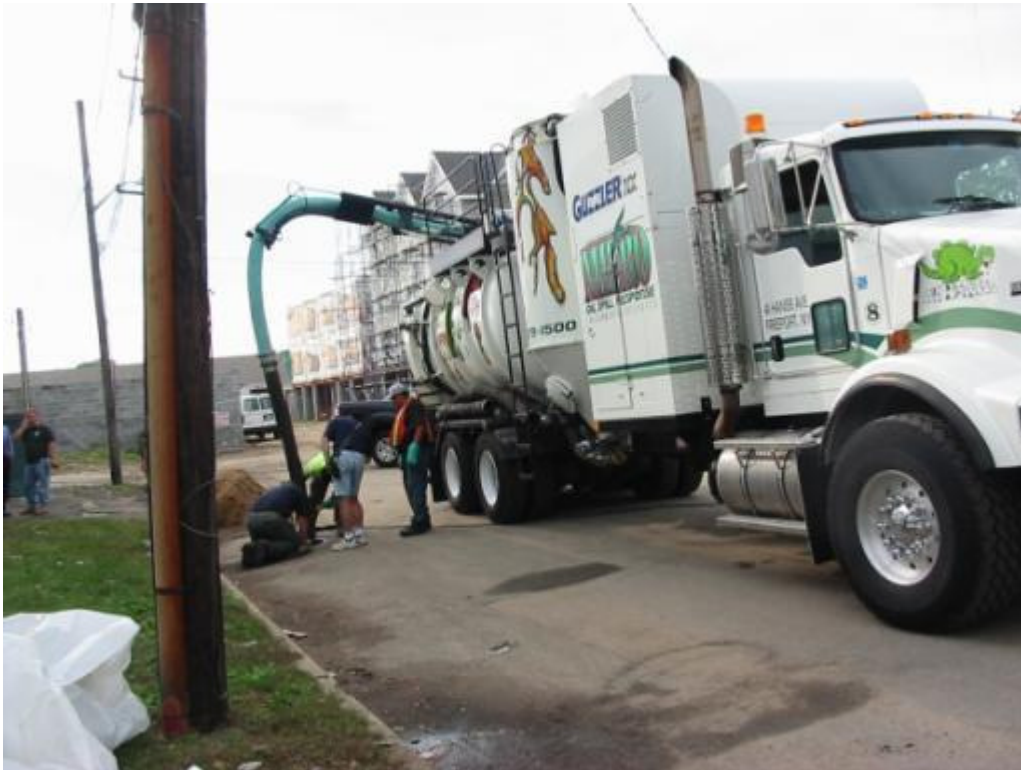
Sediment removal from storm drain on Ray Street (October 2007)

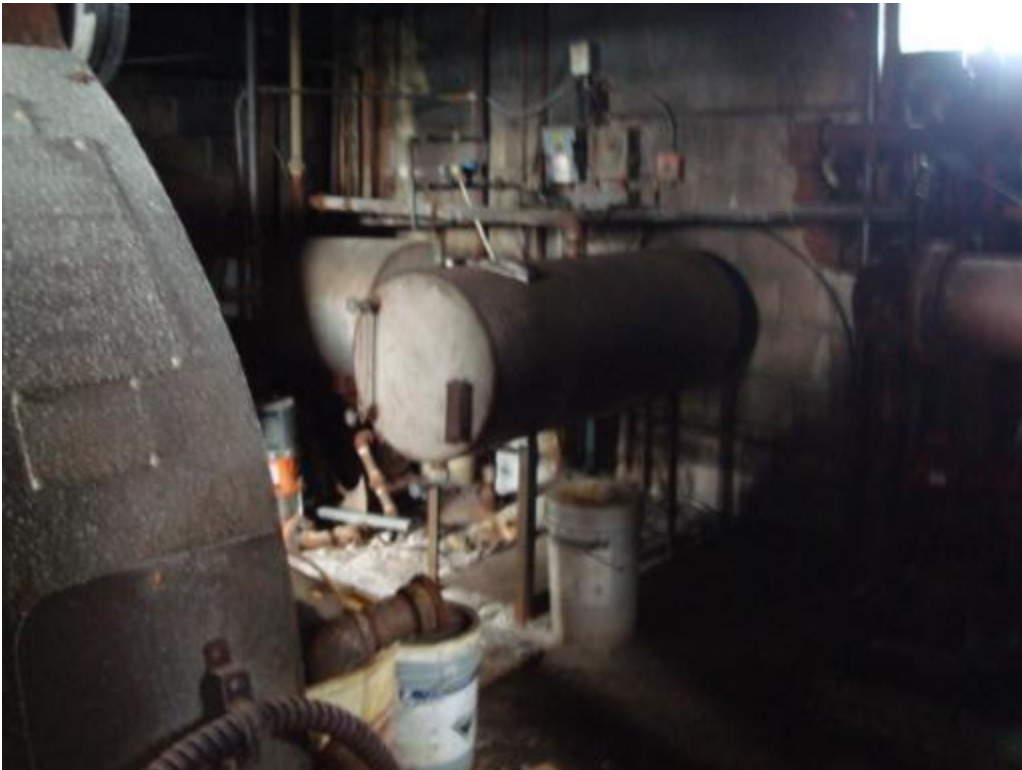
Third Floor Boiler Room and Day Tank Pre-Demolition (June 2009)

On March 22, 2010, GF observed that the 275-gallon day tank in the third floor boiler room had been removed. All piping and associated conduit between the day tank and former oil tank has been removed and the boilers were dismantled. The photolog is presented as Appendix A.

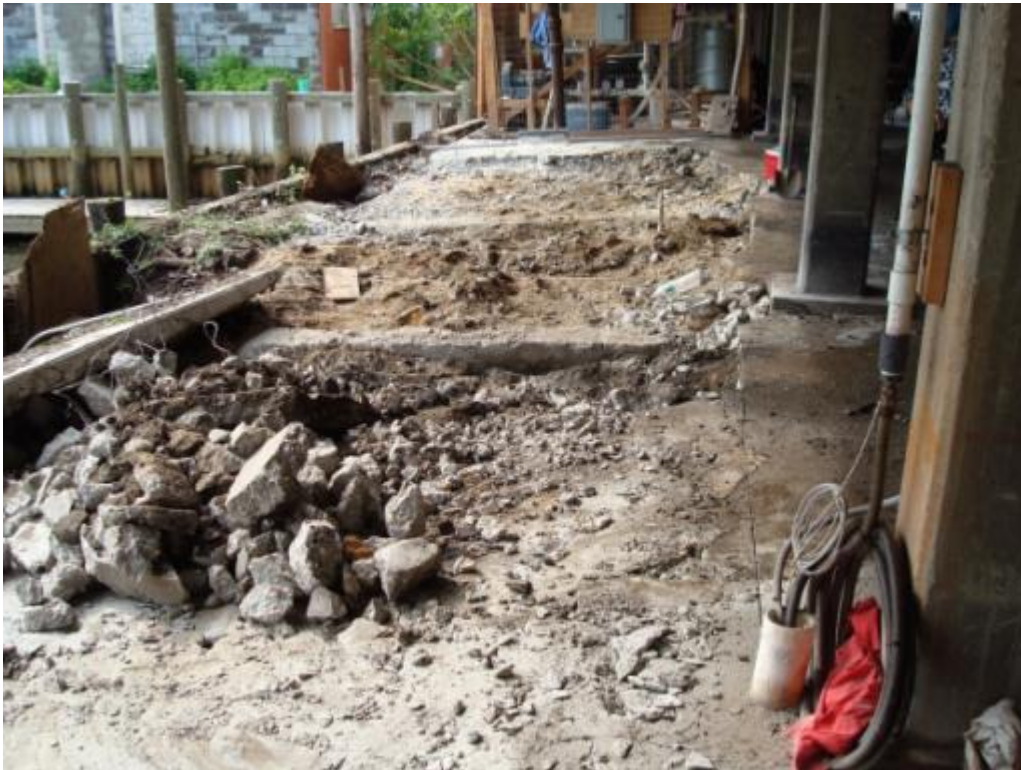
Initial breakup of concrete floor adjacent to old bulkheading (June 2009)

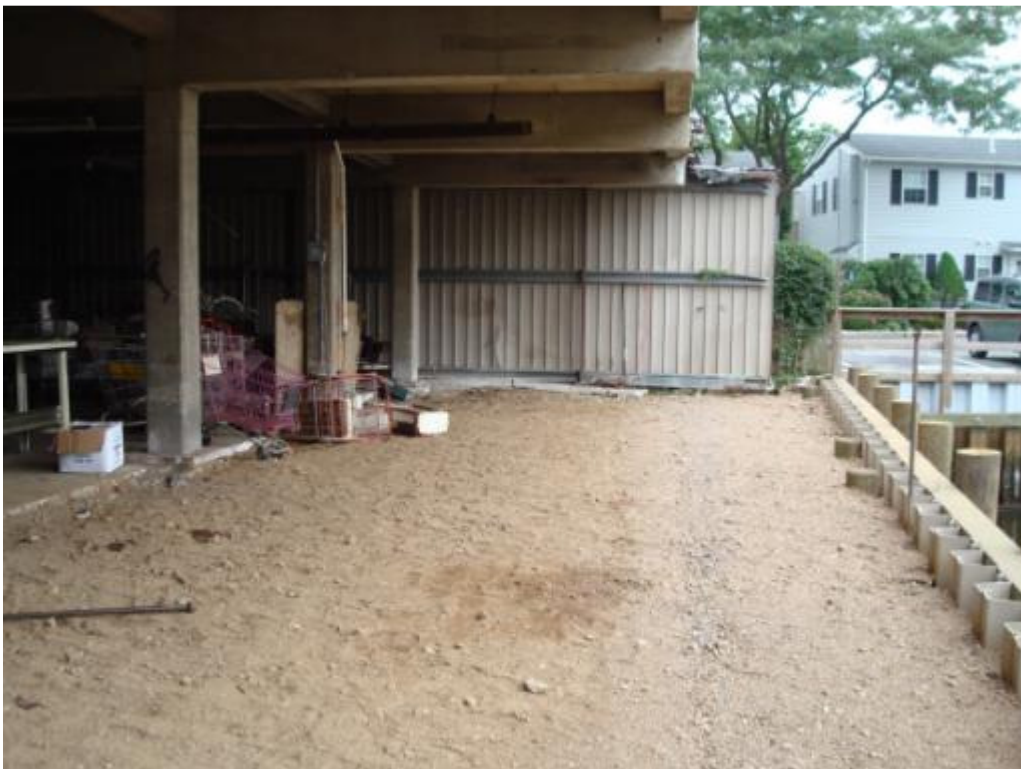
Replaced bulkhead and backfilled ground surface (June 2009)

In June 2009, the bulkhead along Milburn Creek was replaced. In July 2009, excavation of the soil within the machine room and within the room along the creek began. Due to bulkhead

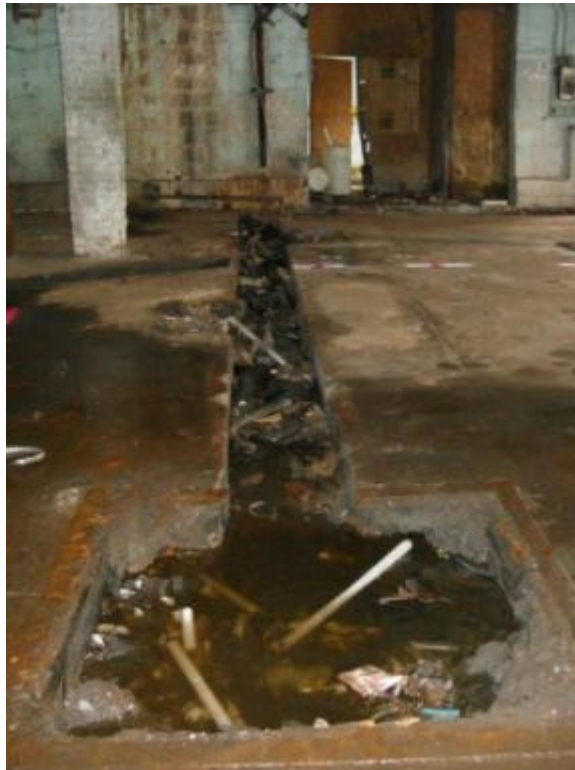
Floor Drain in Machine Room Pre-Demolition (June 2009)

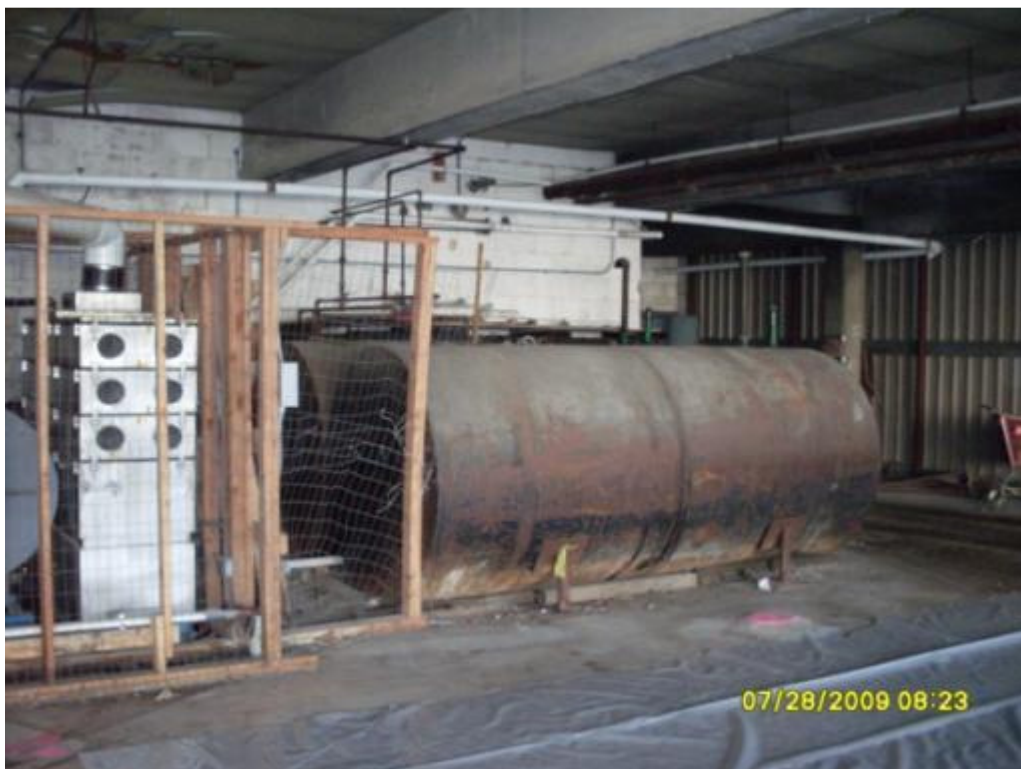
Location of the two former 2,000 gallon petroleum storage tanks (June 2009)

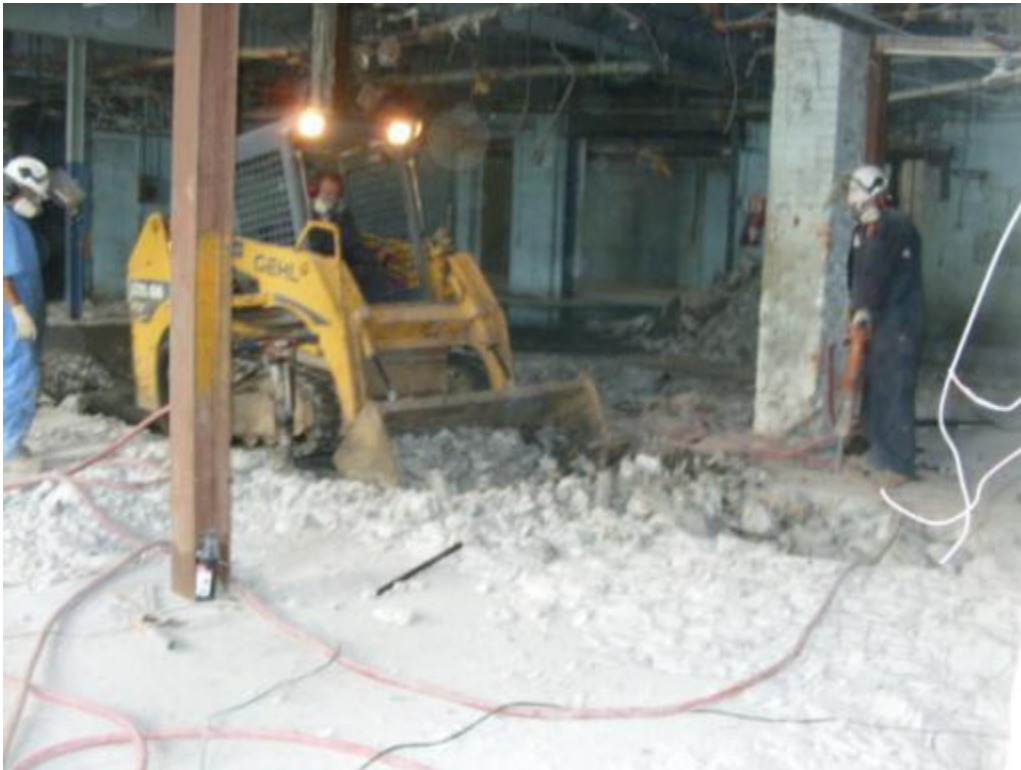
Removing the Top Layer of Concrete in the Machine Room (July 2009)

In late July 2009, NUS began to remove the concrete floor slabs in the machine room in order to begin excavation of soils beneath the slab. NUS removed all piping in the floor and chased all piping in the machine room to observe any signs of contaminated soils around the pipes. Piping removed included piping that connected machines and equipment with the oil/water separator as

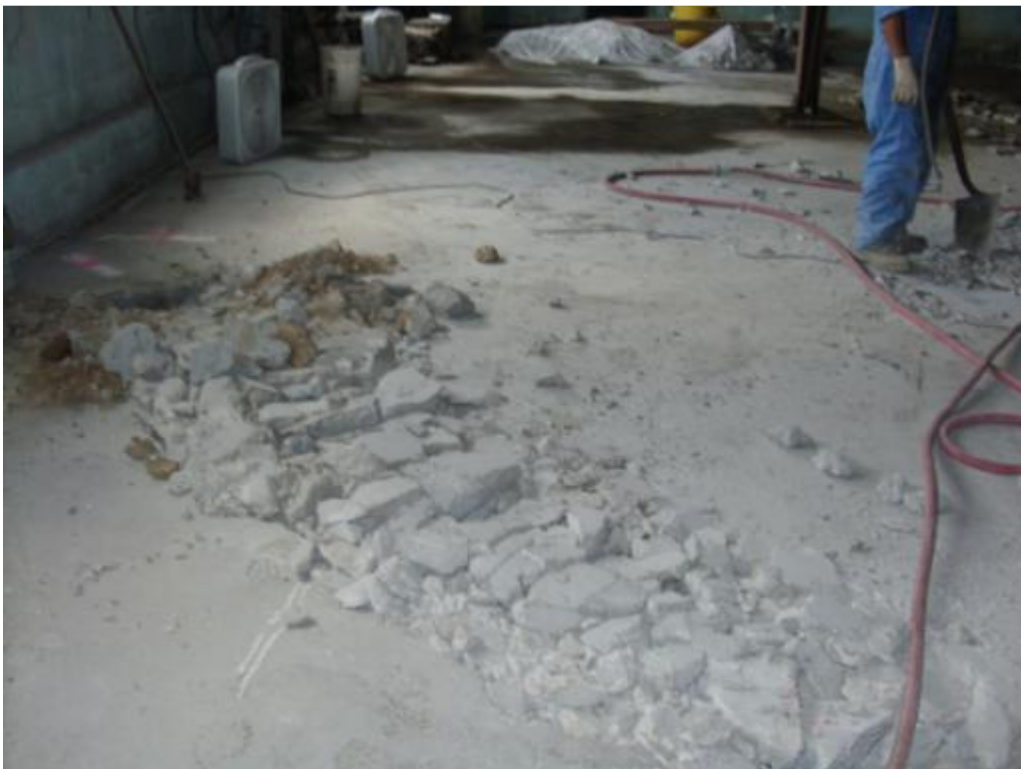
Broken concrete in the machine room to chase pipes connected to oil-water separator (July 2009)

well as concrete conduits that guided wastewater to the oil/water separator. Staining was observed in these conduits and on the surface of the concrete floor, evidence of historic operations within the room.

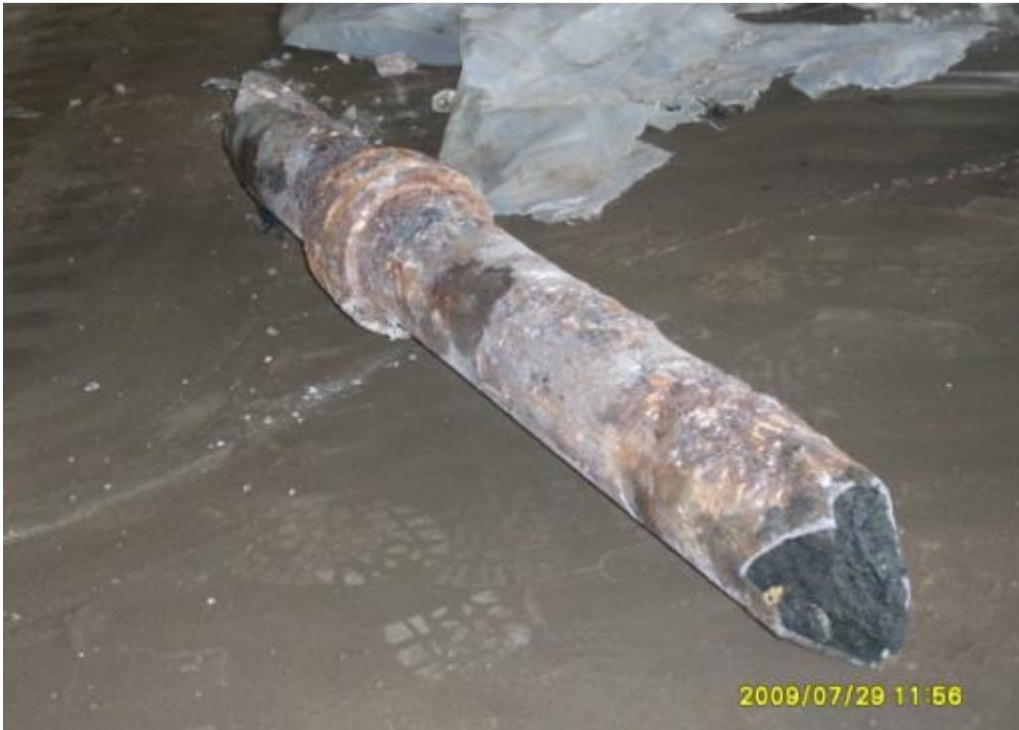
Removal of a former pipe from the machine room floor connected to the oil-water separator (July 2009)

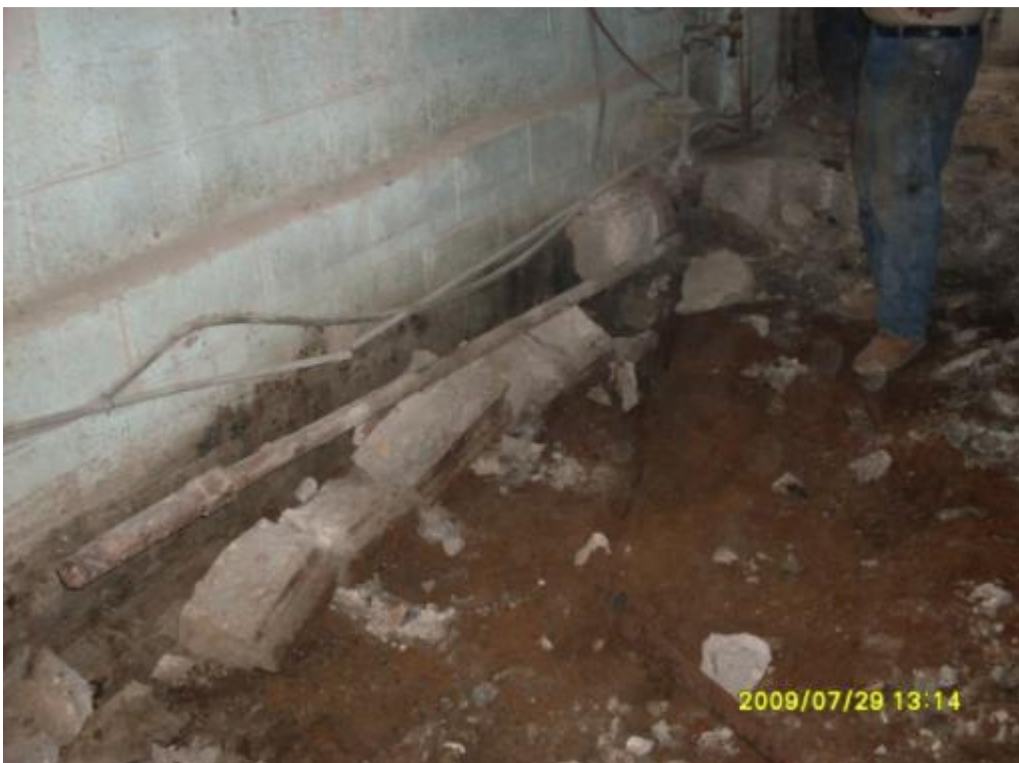
Below Grade Piping Discovered while Demolishing Machine Room floor (July 2009)

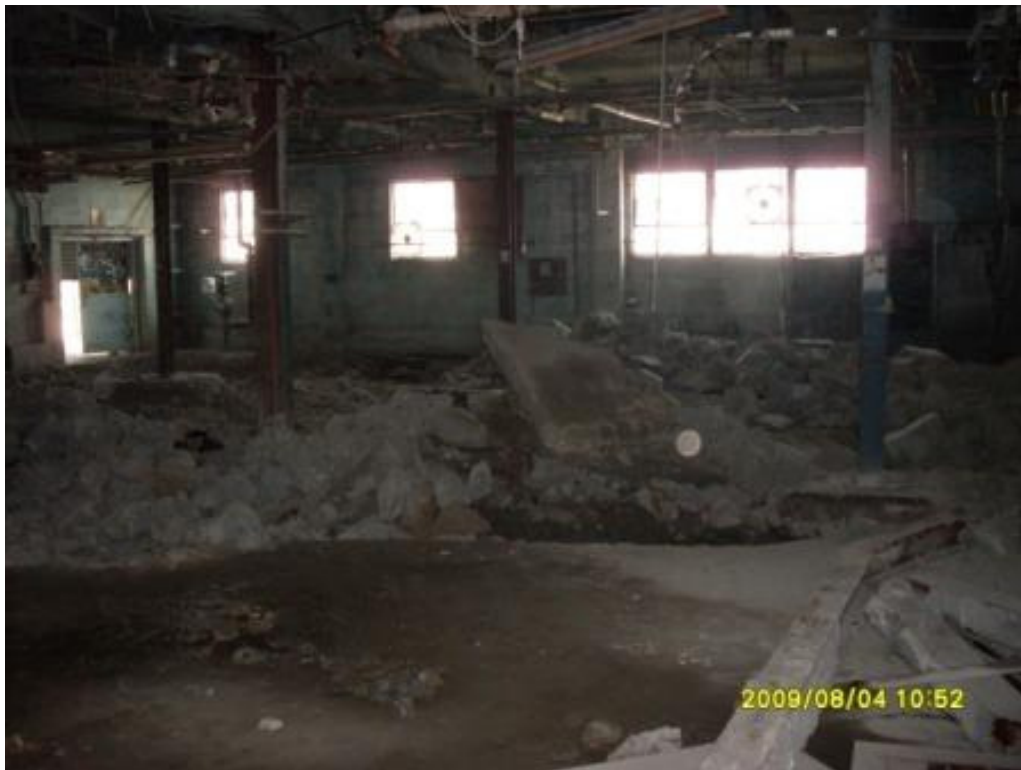
Machine Room during Demolition (August 2009)

In August 2009, NUS finished removing the concrete floor and piping in the machine room and began to remove the concrete slab in the former compressor room and the east end of the creekside bay area room. The concrete was removed by September 2009. In early October 2009, NUS began excavating the areas around the supporting wall between the compressor room and machine room. This excavation was in support of installing shoring to keep the building structurally sound. The walls and supports of the building were completely shored by mid October, at which time the excavation of soils beneath the concrete floors commenced. By January 2010, excavation activities were complete in both rooms. All excavated soil was stockpiled in the northern room of the NUS building. Soil was staged on and covered with plastic sheeting until the soil was transported to an approved facility. Waste disposal manifest are provided in Appendix B.

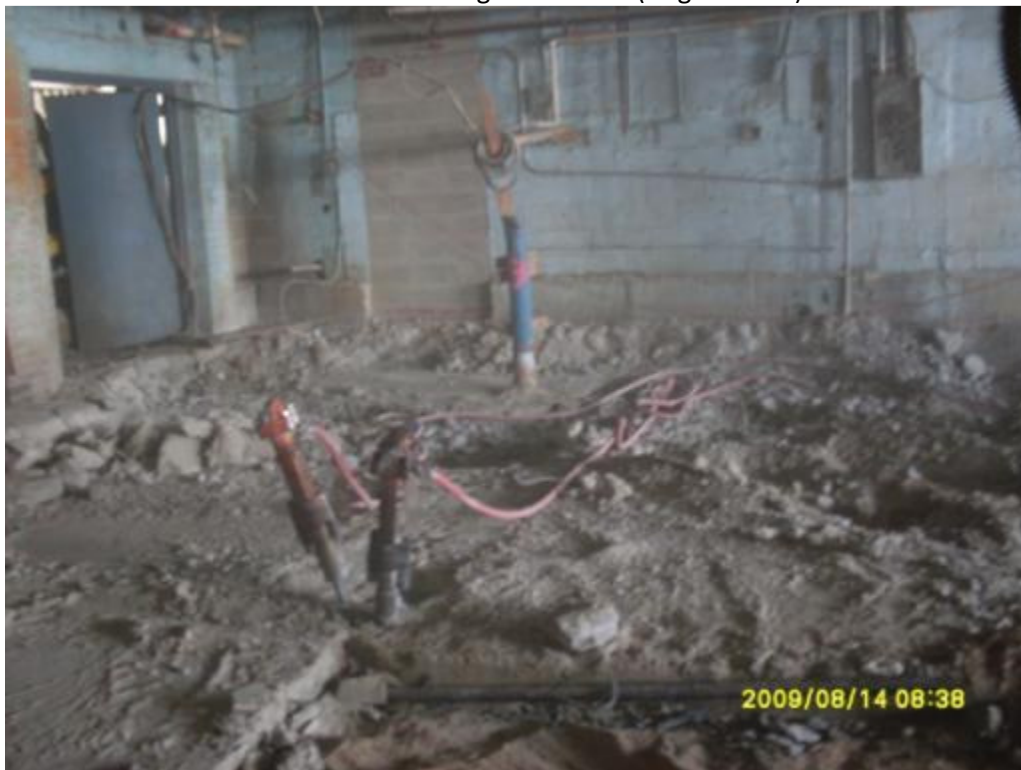
Piping Discovered in Sub-Floor of Machine Room (August 2009)

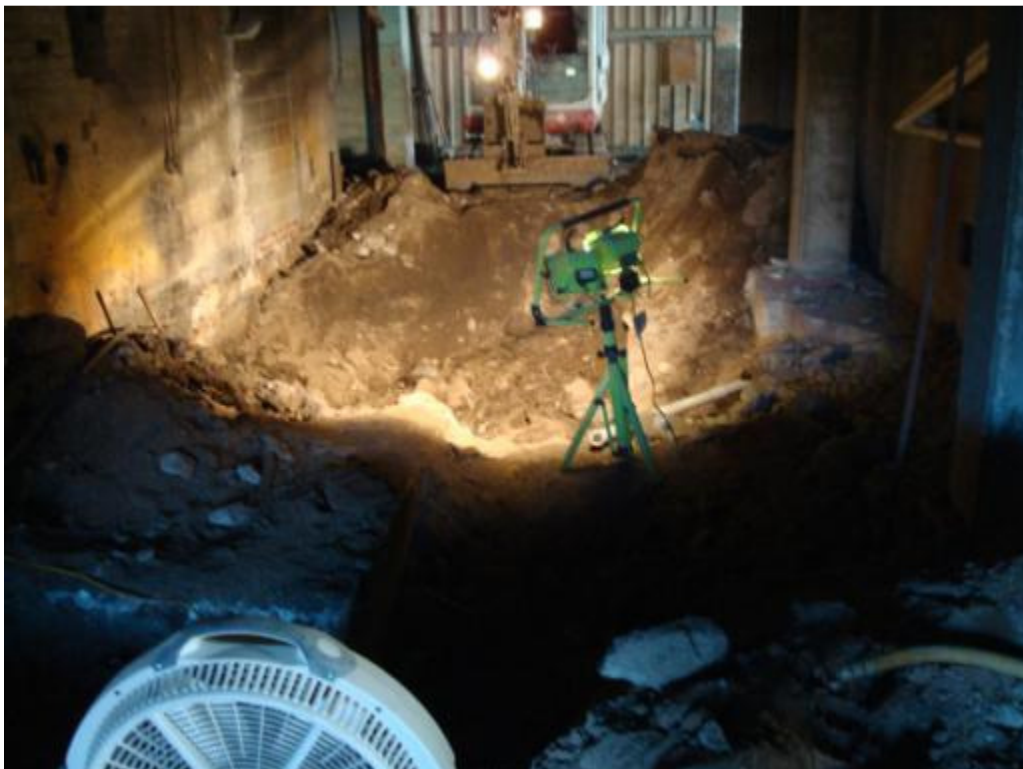
Excavation of Compressor Room Soils (August 2009)

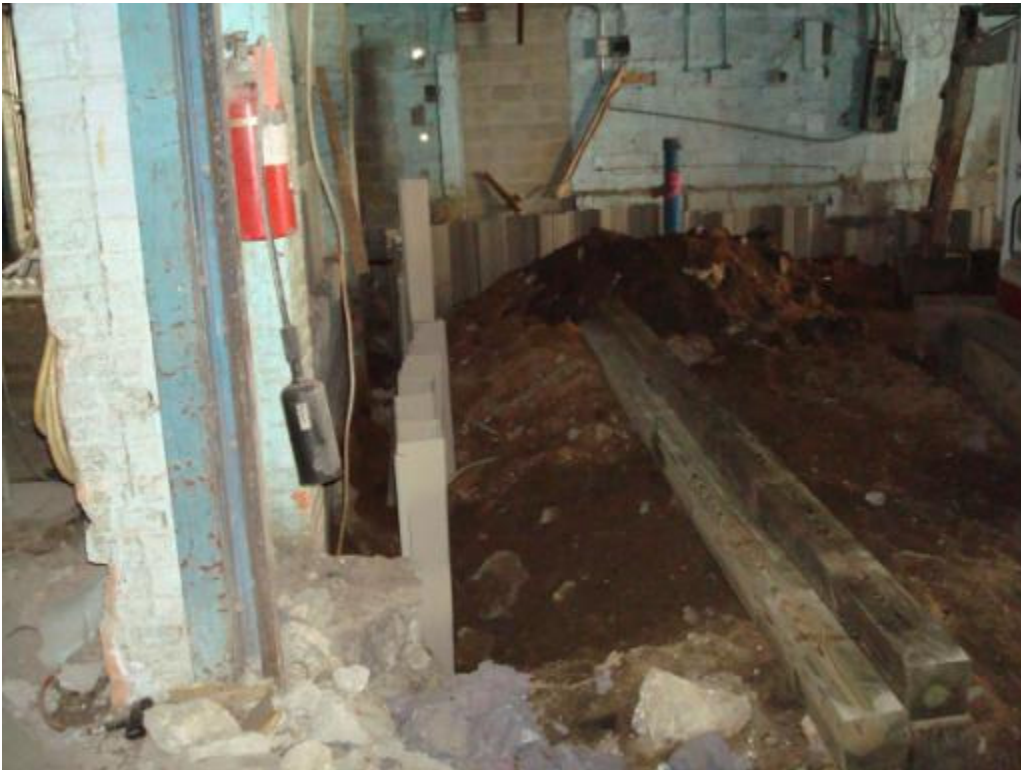
Shoring installed around Load Bearing Walls in Machine Room (September 2009)

Soil samples were not collected along the western, northern, and southern sidewalls of the machine room excavation due to steel, vertical shoring that was installed in order to stabilize the center wall that separates the machine room and bay door area excavations, and stabilize the northern and southern walls of the excavation area.

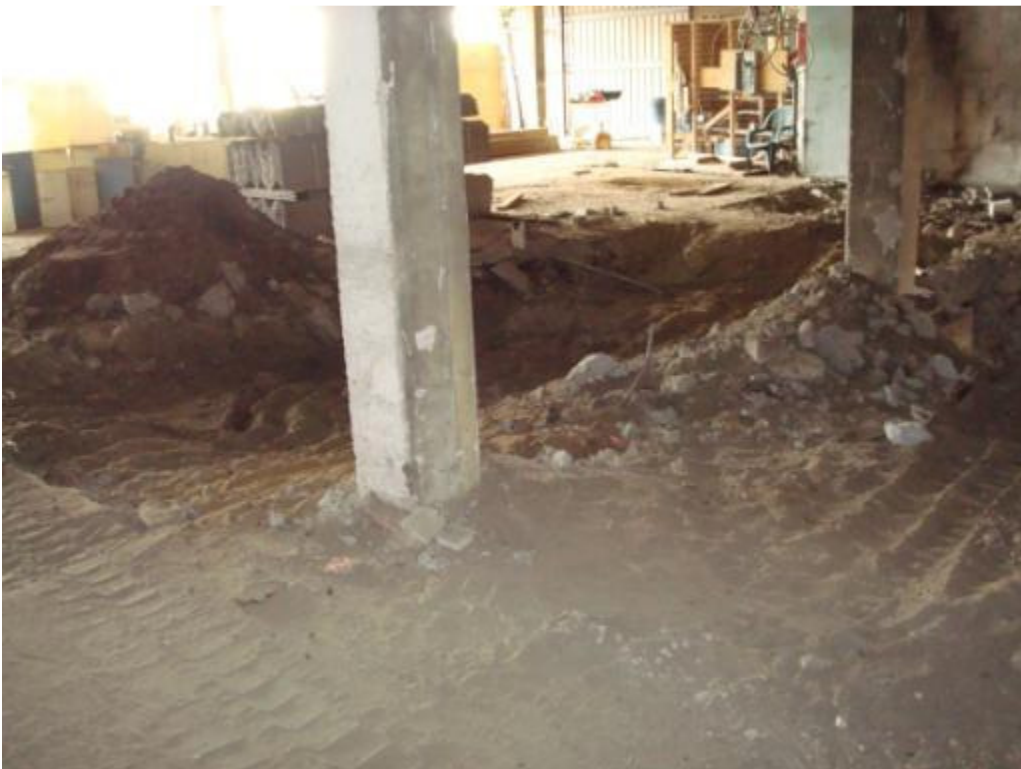
Compressor Room and Canal Room Excavation (September 2009)

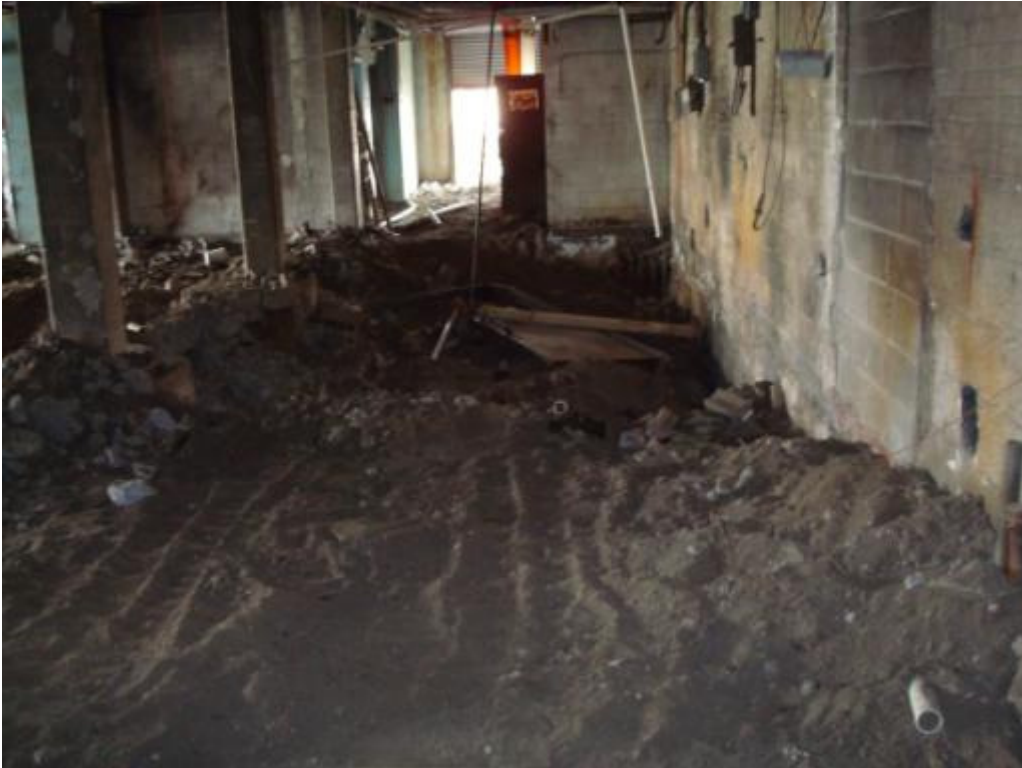
Soils located beneath two the compressor room and boiler room floor (September 2009)

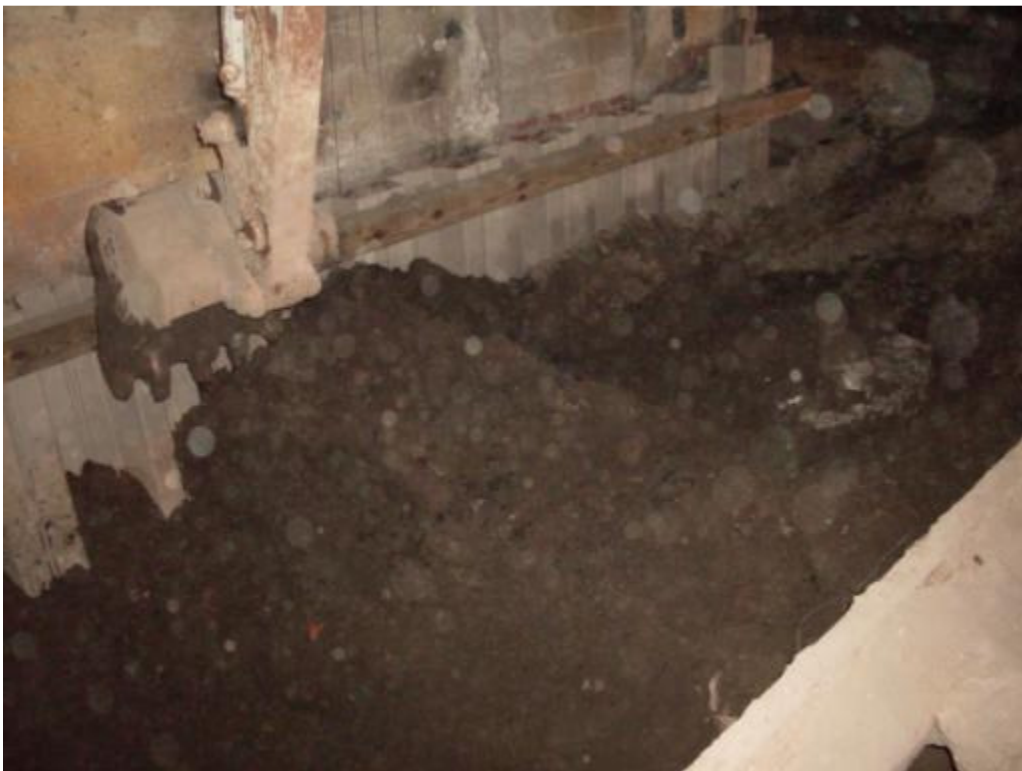
Shoring along the Compressor Room Wall during Excavation (October 2009)

Soil samples were not collected along the eastern wall of the bay door area excavation due to steel, vertical shoring that was installed in order to stabilize the center wall that separates the machine room and bay door area excavations.

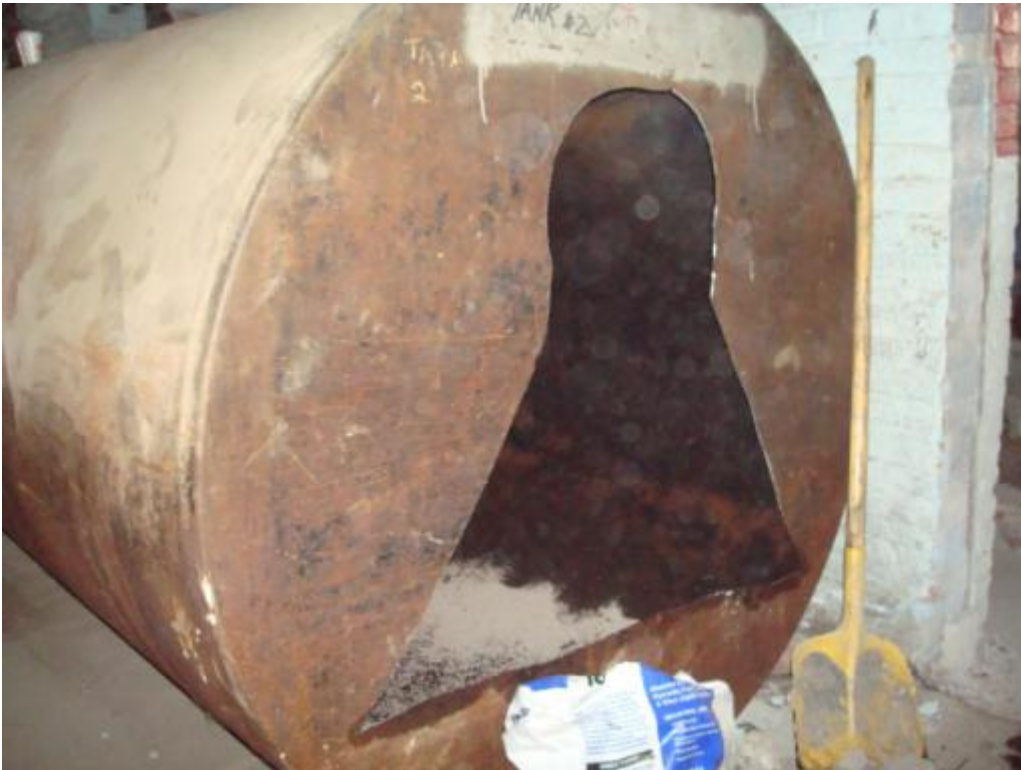
One 2,000 gallon tank following removal and cleanout (October 2009)

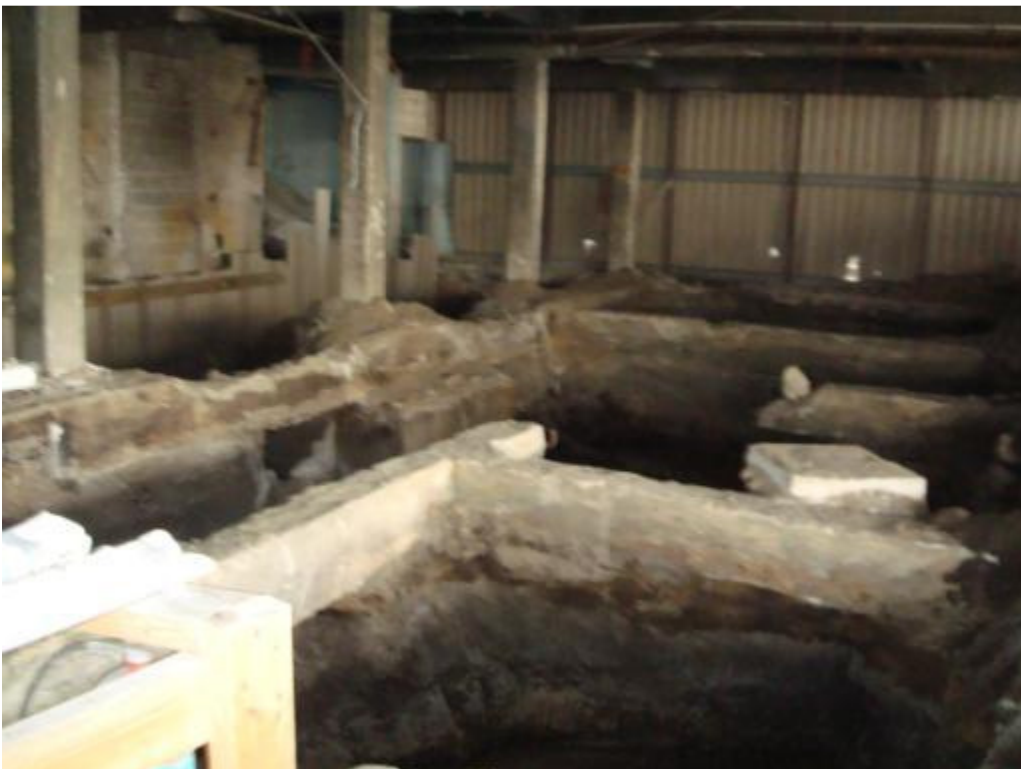
Former Compressor Room and Canal Room Excavation (January 2010)

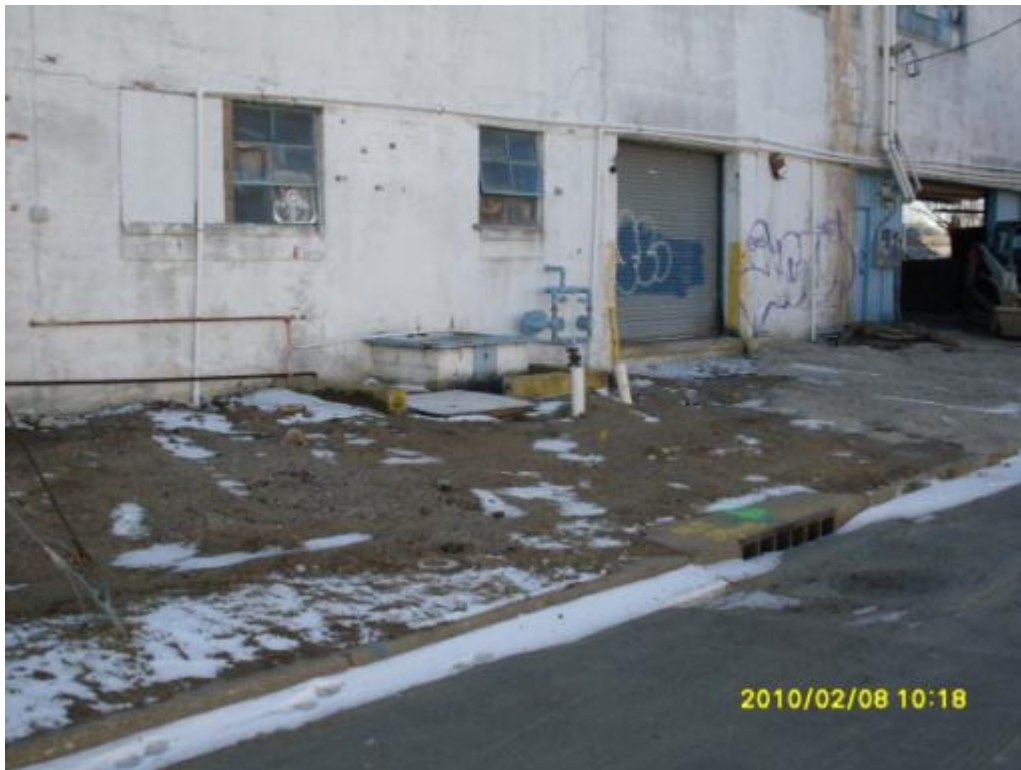
Oil-water separator prior to removal (February 2010)

On February 8, 2010, NUS began to disassemble and remove the oil-water separator located along Ray Street and the north side of the facility. Soils located around and beneath the oil-water separator were inspected for petroleum and VOC impacts and excavated for disposal off-site. All work to remove the oil-water separator and the associated excavation activities were observed by a NYSDEC representative.

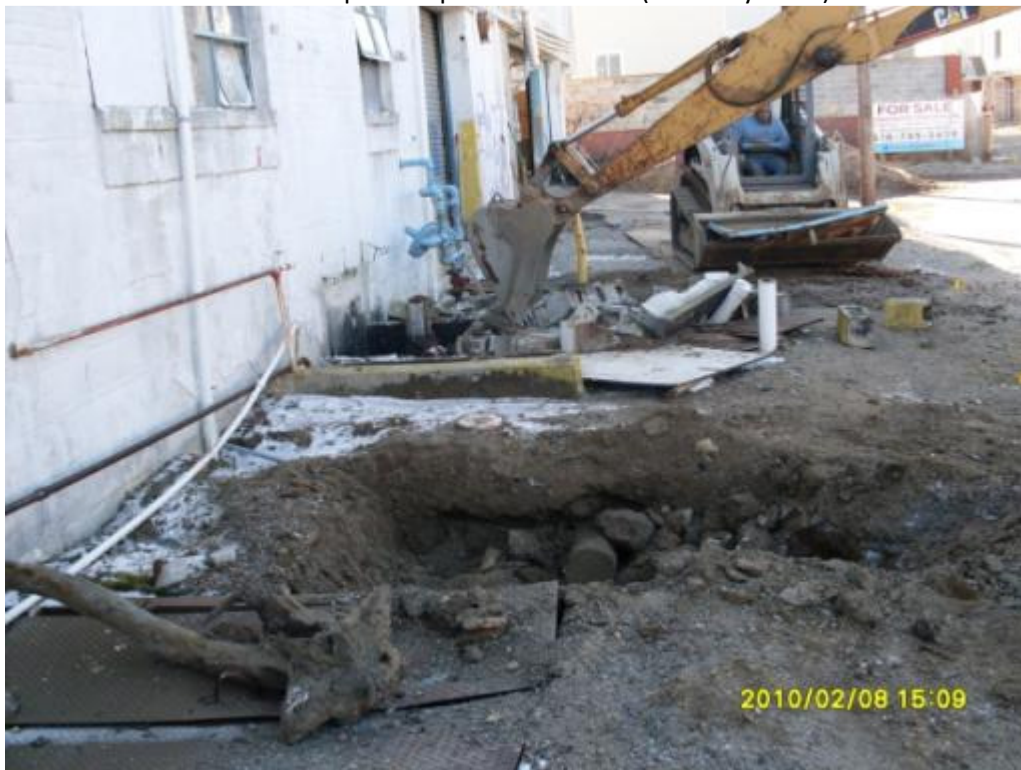
Destruction of the oil-water separator (February 2010)

On February 9, 2010, the excavation work around the former oil-water separator was completed. Waste disposal manifests are provided as Appendix B.

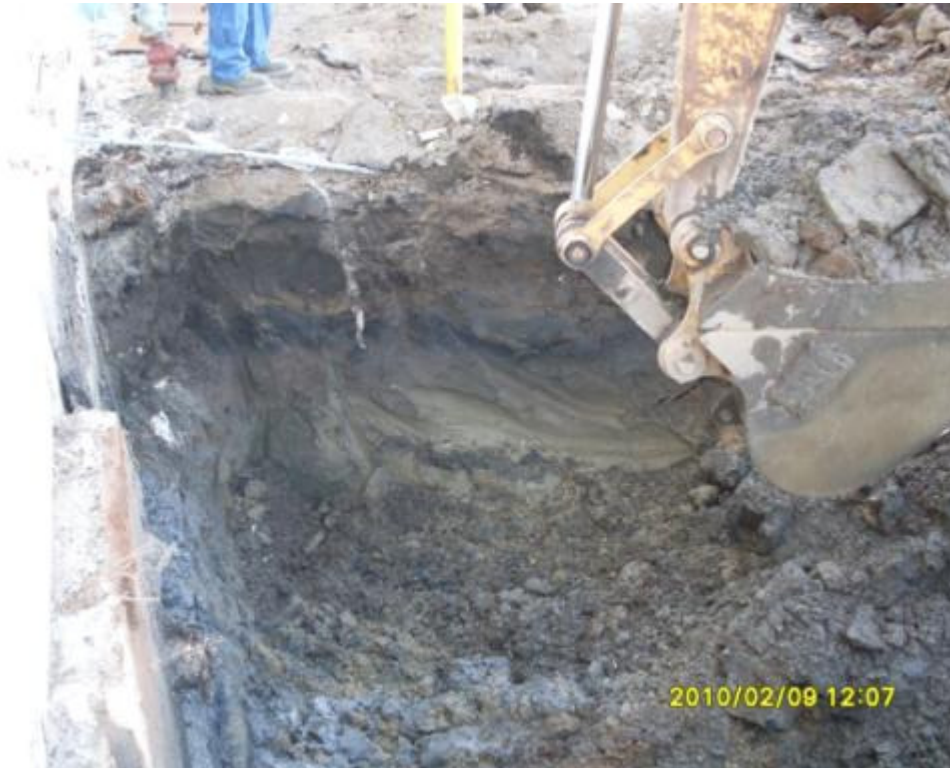
Excavation wall (west side) around the former oil-water separator (February 2010)

GF personnel collected a total of four end-point soil samples (EP-OW-1 through EP-OW-4) from locations approved by the on-site NYSDEC representative, along the perimeter and bottom of the oil-water separator excavation, and submitted the soil samples for laboratory analysis of VOCs, SVOCs, TAL metals, and Mercury. Soil samples were not collected along the southern sidewall of the oil-water separator excavation due to the building wall being located adjacent to this wall.

The OWS endpoint soil samples reported concentrations of VOCs, SVOCs, and metals above standards. Due to the location of the OWS adjacent to the building's structural wall and footing, additional soil removal could not be completed. GF recommends additional delineation of the soil and groundwater impacts surrounding the OWS.

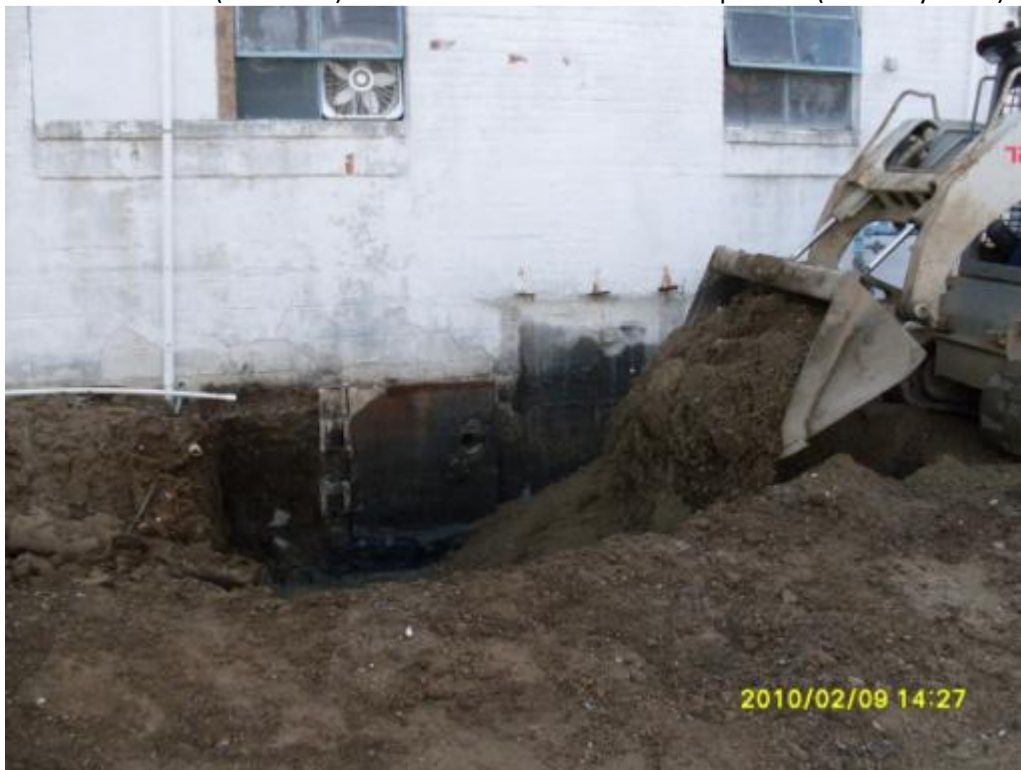
Backfilling oil-water separator excavation (February 2010)

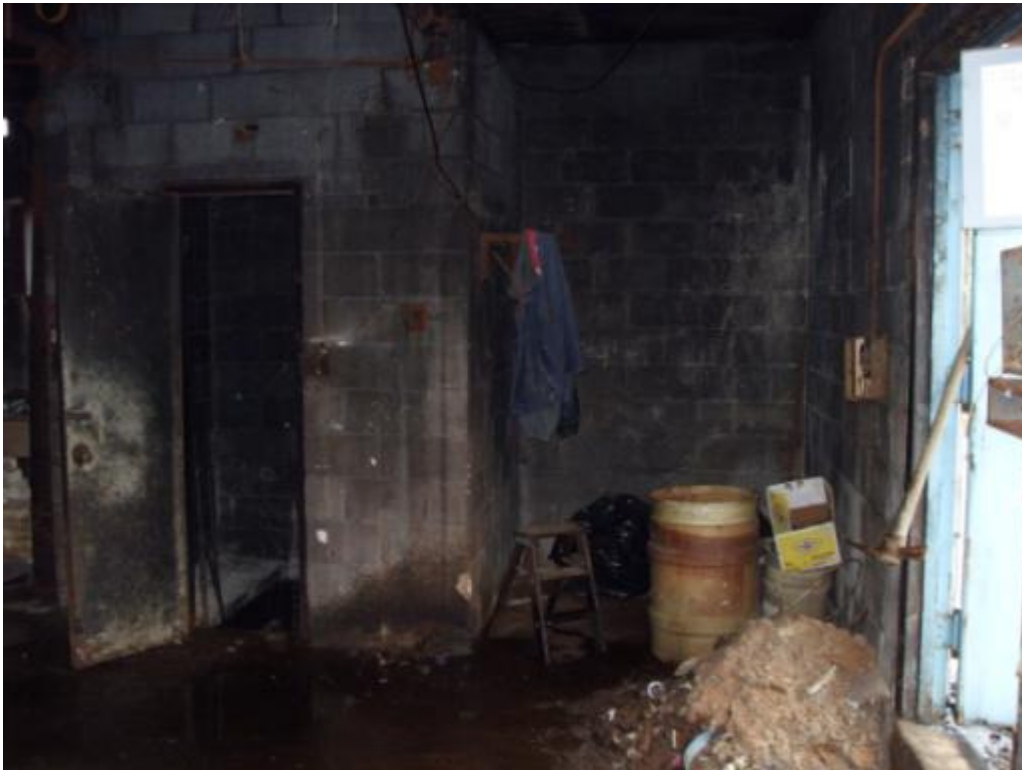
Boiler Room following removal of boilers and day tank (July 2010)
