Quarterly Operation and Maintenance Report – 1Q2019

Stanton Cleaners

NYSDEC Site No: 130072

110 Cuttermill Road, Great Neck, New York

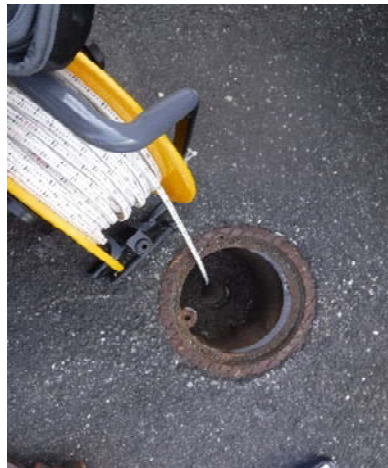
Picture DSCF3462

Routine monitoring well gauging was performed under Task 4.

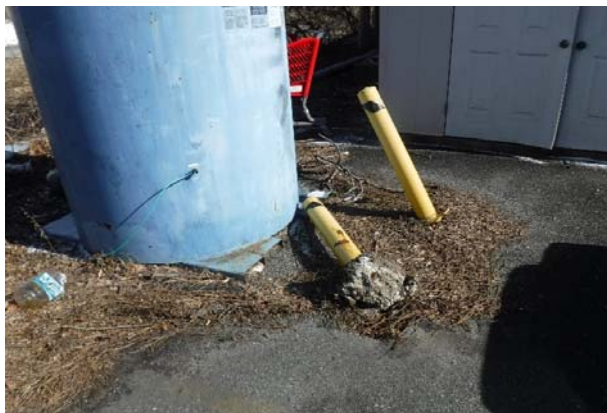
Picture DSCF3759

Initial site inspection noted that the condition of the protective bollards associated with the exterior vapor-phase carbon unit had worsened.

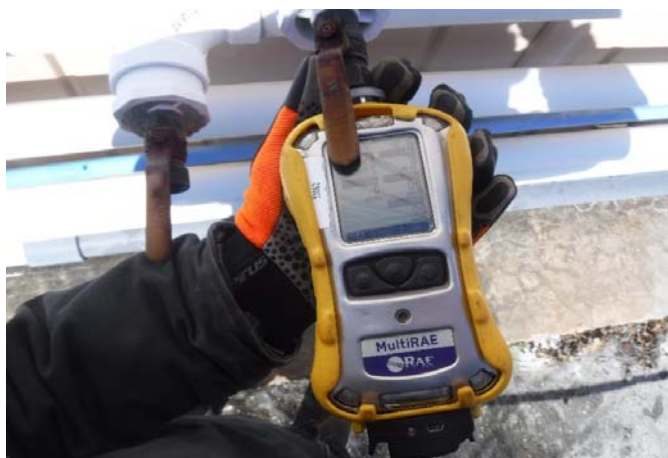
Picture DSCF3756

Due to both the GWTS and SVE System being offline, a limited O&M event was completed. This O&M event included collecting instrument readings of the SVE wells headspace in addition to the SVE sample ports.

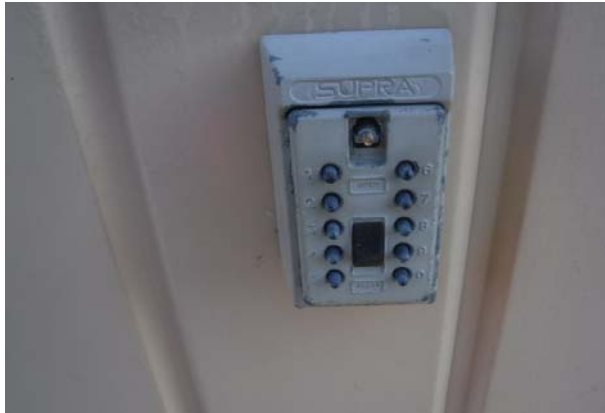
Picture DSCF4088

Upon arrival to the site, it was noted that the lockbox containing the access key had been vandalized and would not open.

13:00 - Performed monitoring well gauging under Task 4.
13:15 - Purchased replacement padlock for shed and lockbox for treatment building, and replacement parts for SVE system repairs.

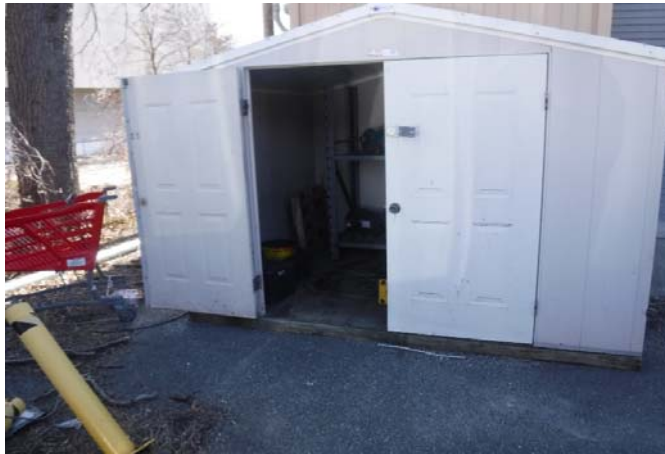
Picture DSCF4078

The shed in front of the treatment building was observed to be open, and the padlock which previously secured it was missing. The non-functioning gas-powered weed trimmer was noted to be missing.

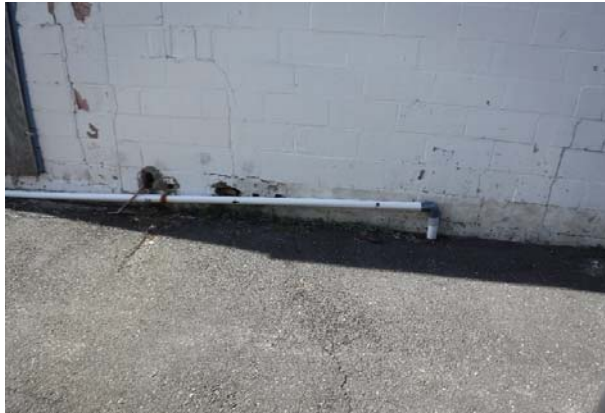
Picture DSCF4089

The SVE SS-A piping was observed to have been vandalized, with a penetration crack along the piping, and the sampling port having been removed.

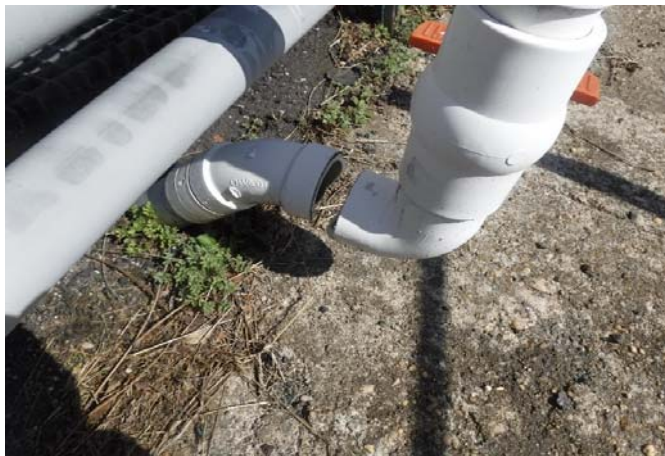
Picture DSCF4094

Additional sections of piping were observed to have been vandalized as well, including a section of piping which has historically been "closed" via the ball valve in the photograph above.
