## Quarterly Operation and Maintenance Report – 2Q2019

Stanton Cleaners

NYSDEC Site No: 130072

*110 Cuttermill Road, Great Neck, New York*

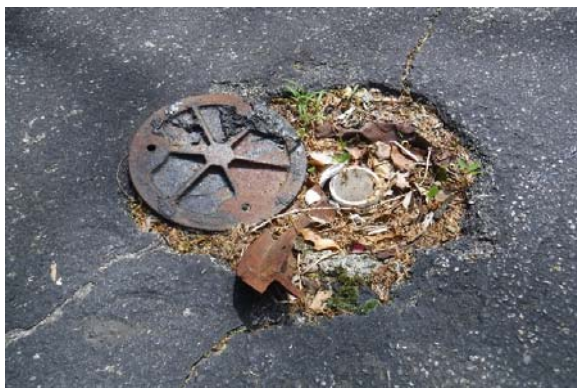
**Picture DSCF2265**

10:20 - 11:20 - DPB and CM performed Task 4 monitoring well gauging activities.
11:10 - Monitoring well MW-9A slip cap observed to have been shattered (possibly due to a car driving over the well).

**View of the completely shattered PVC slip cap for MW-09A (PVC splinters can be seen in the unpaved area surrounding the well).**

- SVE remains offline.
- Delta on-site on 4/26/19 and replaced section of GWTS line/piping. GWTS remained offline until 4/29/19 to allow glue on piping to dry.
- Slip cap for MW-9A was destroyed (likely due to a vehicle driving over it); it was replaced by Preferred Environmental Services on 6/4/19.
- Completed repairs to vandalized sections of SVE piping (4/29/19).

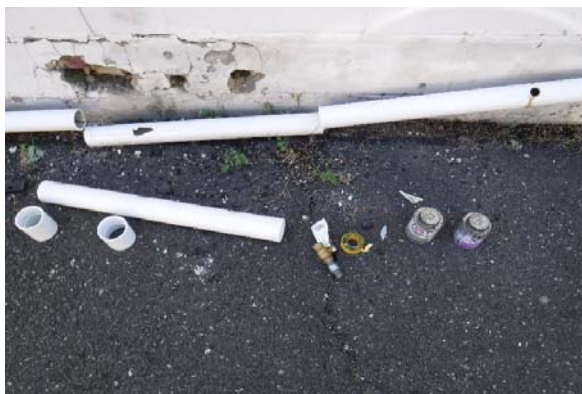
**Picture DSCF2266**

**The vandalized sections of the SVE piping were repaired and/or replaced as necessary.**

12:45 - Collected readings from SVE legs with system offline using 5-gas meter.
13:15 - 14:15 - DPB and CM completed repairs to vandalized sections of SVE piping.

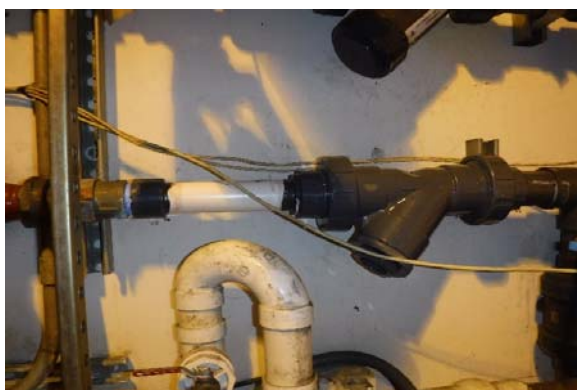
**Picture DSCF2270**

**View of the recently replaced Y-filter and repaired piping for the GWTS. The GWTS was restarted without incident and was running when Preferred secured the treatment system at the end of the day.**

8:15 - Yash Saha (HDR Inc.) on-site to conduct structural engineering inspection.
8:40 - Tom King (Delta Well & Pump) on-site with an assistant.
8:50 - Restarted GWTS. No leaks or other issues noted with piping. Flow rate of 60 GPM observed. Computer readout upstairs incorrectly lists flow as 166 GPM.

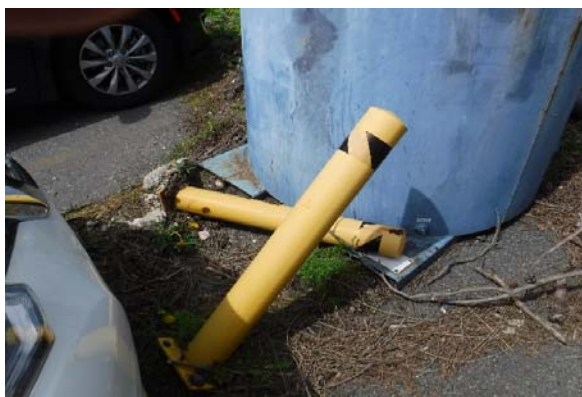
**Picture DSCF2271**

**The bollards protecting the vapor-phase carbon unit have now been completely torn from their anchoring bolts and are in need of replacement and/or reinstallation.**

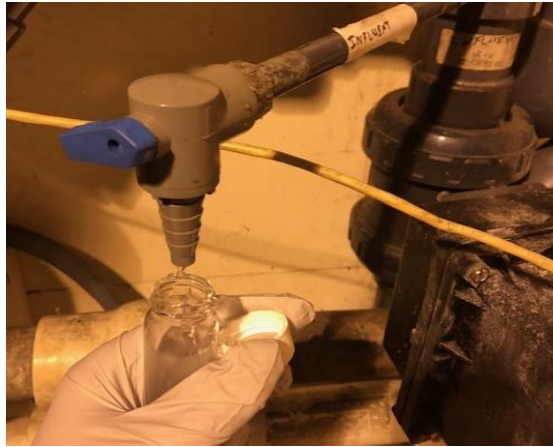
**IMG\_8230**

Samples were collected from the GWTS as part of this O&M event. With the GWTS operating again, Influent and Effluent sample collection will be routine during monthly O&M events.

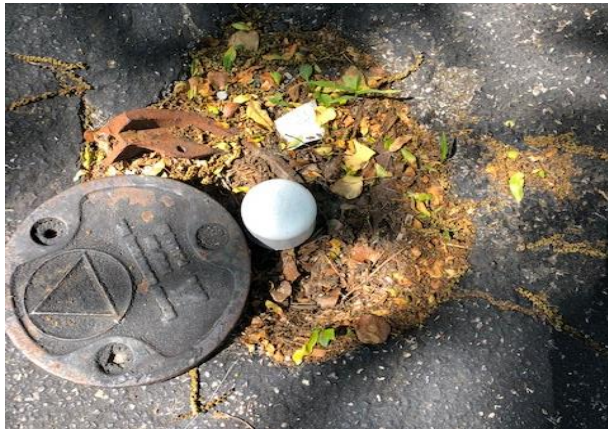
**IMG\_8233**

View of the replaced PVC slip cap for MW-09A

\*Slip cap for MW-9A was replaced.

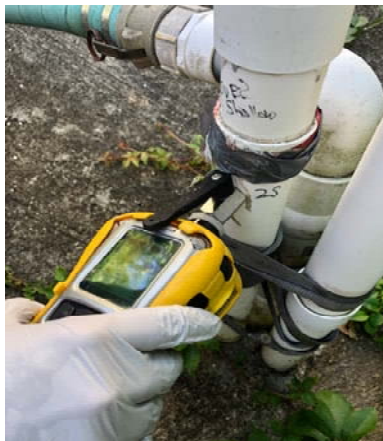
**IMG\_8494**

**SVE sample port readings were collected using a 5-Gas Meter only during this O&M event, due to the system currently being offline.**

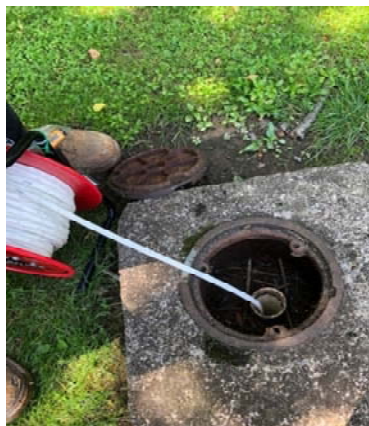
**IMG\_8495**

**View of monitoring well gauging being performed under Task 4.**
