## Quarterly Operation and Maintenance Report – 3Q2019

Stanton Cleaners

NYSDEC Site No: 130072

January 31, 2020

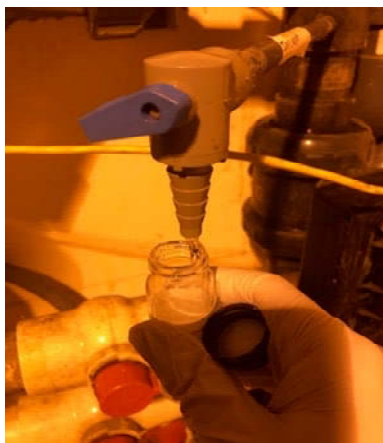
**IMG\_8609**

**GWTS influent and effluent samples were collected during this O&M event.**

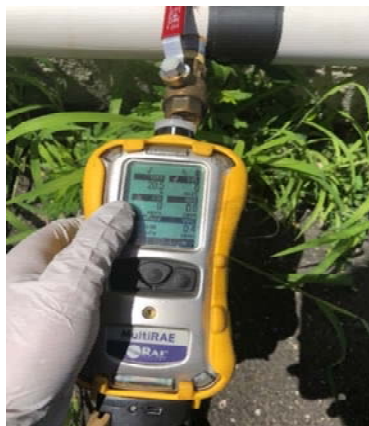
**IMG\_8610**

**SVE sample port readings were collected using a 5-Gas Meter only during this O&M event, due to the system currently being offline.**

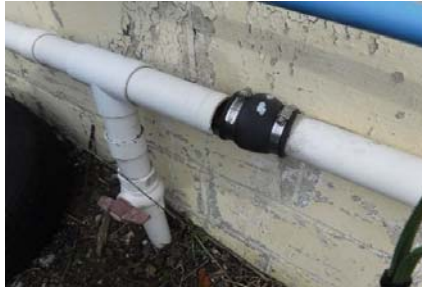
**Picture DSCF3456**

The Fernco connection near the SS-D port was found to be disconnected again. This is likely a result of tree growth along the exterior wall of the building distorting the piping.

\*The Fernco connection of SS-D was found to be disconnected again, likely from the piping being distorted by tree growth along the side of the building. This was reconnected, although this tree will need to be removed to prevent further incidence of the Fernco connection becoming disconnected.

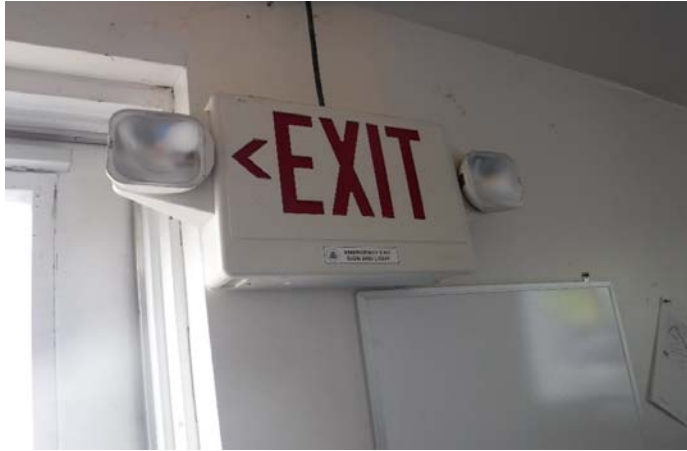
**DSCF1749**

As part of the September 2019 O&M event, punch-list items from the NYSDEC were addressed including looking into replacement parts (batteries, lamps, etc.) for the facility exit lights.

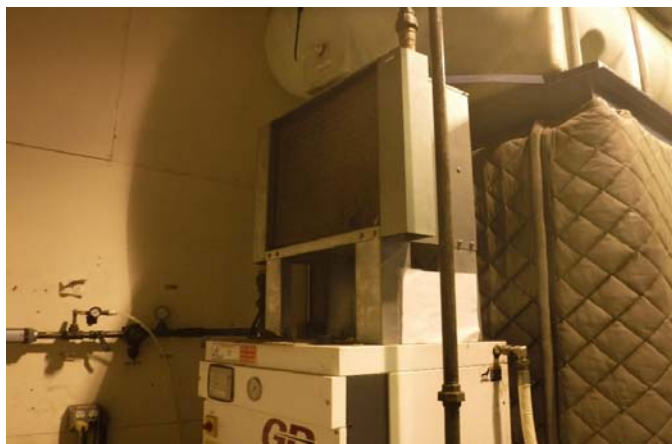
**DSCF1749**

As part of the September 2019 O&M event, the air filter for the Air Sparge System was inspected. The Air Sparge is currently indefinitely offline, but if brought back online, the air filter will need to be replaced.
