Quarterly Operation and Maintenance Report – 4Q2019

Stanton Cleaners

NYSDEC Site No: 130072

January 31, 2020

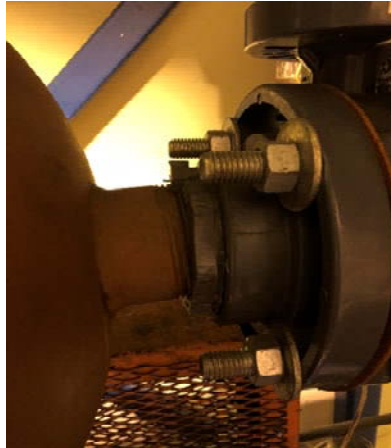
Photo Oct 28, 9:38:02 AM

As part of the October 2019 O&M event, punch-list items from the NYSDEC were addressed including inspection of cross threaded piping of the SVE exhaust.

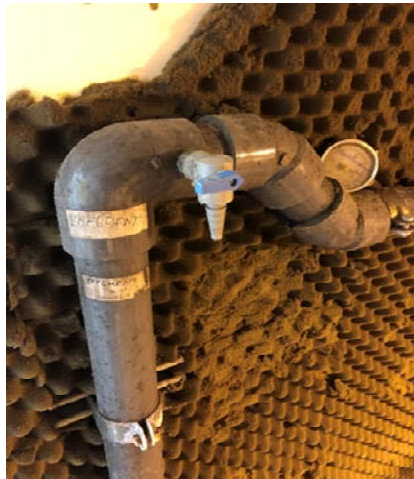
Photo Oct 28, 10:26:17 AM

GWTS Samples were collected from both the Influent and Effluent sample ports during this month's O&M event.

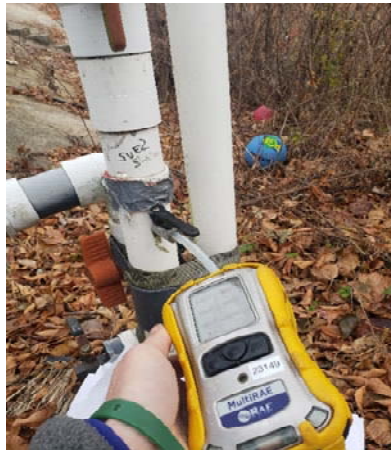
20191127_102518

Readings were taken from SVE sample ports and well headspaces utilizing a MultiRae 5-Gas Meter during this month's O&M event.

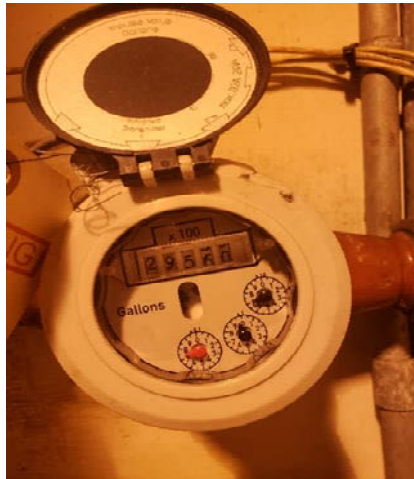
20191127_095819

GWTS readings were taken from the gauges located within the treatment room.

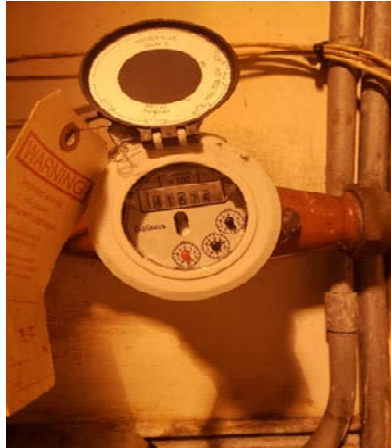
20191211_113227

View of the influent flow meter for the GWTS

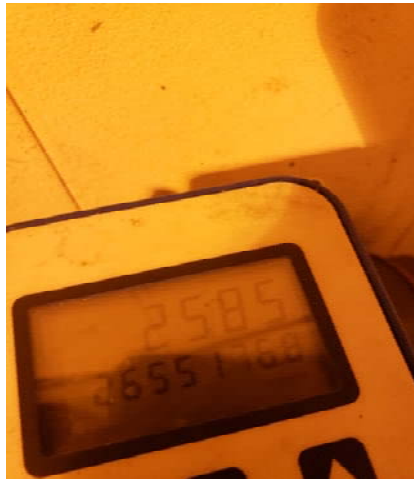
20191211_113233

View of the effluent flow meter for the GWTS.
