# QUARTERLY OPERATION AND MAINTENANCE REPORT – SECOND QUARTER 2023

## **Stanton Cleaners Area Superfund Site**

110 Cutter Mill Road  
Great Neck, New York

NYDEC Site No. 130072

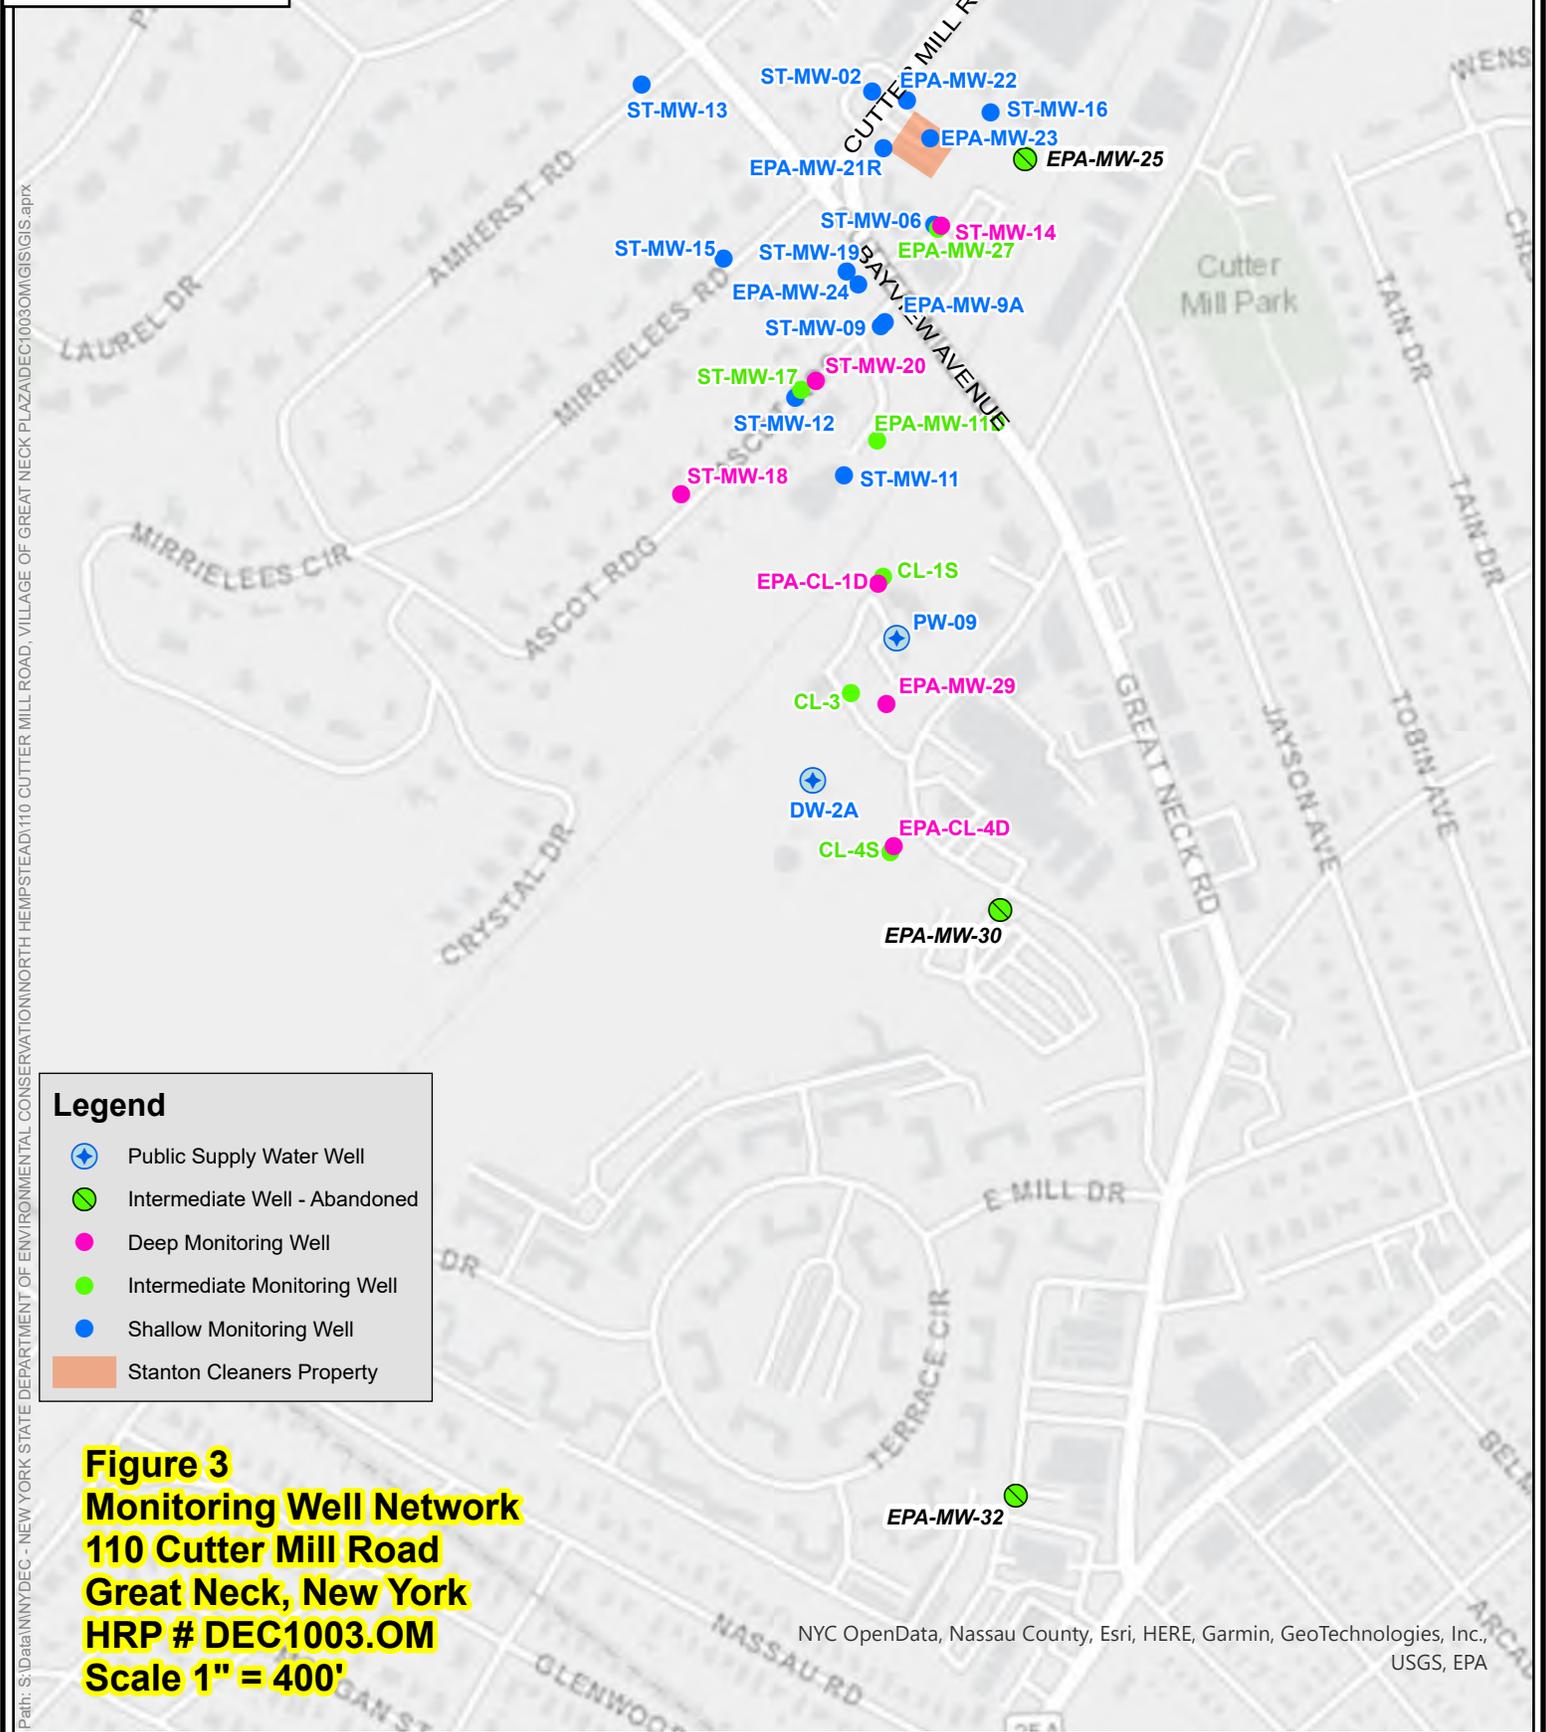
**Figure 3**  
**Monitoring Well Network**  
**110 Cutter Mill Road**  
**Great Neck, New York**  
**HRP # DEC1003.OM**  
**Scale 1" = 400'**

Monitoring wells were gauged for water level during the April 25, 2023 inspection to assess capture zones around the groundwater extraction well EPA-EXT-02. The locations and number of wells monitored were previously determined by the EPA based on the 2014 *Final Capture Zone Analysis Report*. **Appendix C** includes the groundwater level measurements. **Figure 3** depicts the network of monitoring wells. Monthly gauging was discontinued following the April 2023 O&M event since the gauging activities were conducted to monitor the GWE&T system.

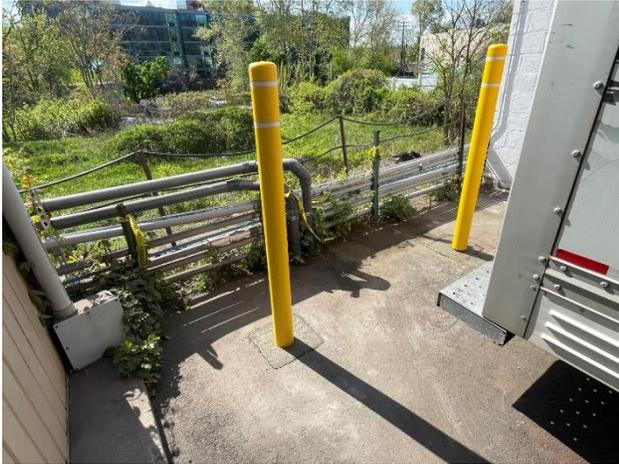
Bollards installed to protect piping

- Based on discussions with NYSDEC and NYSDOH, the GWE&T system was shut down in the first quarter of 2022; therefore, no repairs will be performed to address issues previously identified with the GWE&T system.
- In April 2023, two bollards were installed in the paved area to the southeast of treatment building to protect the exterior treatment system piping. Soil generated from the installation was sampled in preparation for offsite removal and disposal during the May inspection. Soil disposal will be documented in the next quarterly report.
- Fire safety inspections are performed monthly.

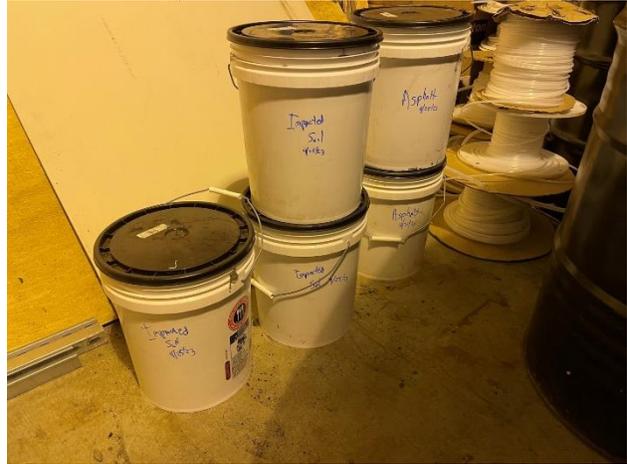
Waste generated during the bollard installation

- Soil disposal from the installation of the bollards will be reported in the Q32023 O&M report.
- Semi-annual groundwater sampling is scheduled to be completed in the third quarter of 2023.
- Annual indoor air sampling at the LIHA is scheduled to be completed in December 2023.

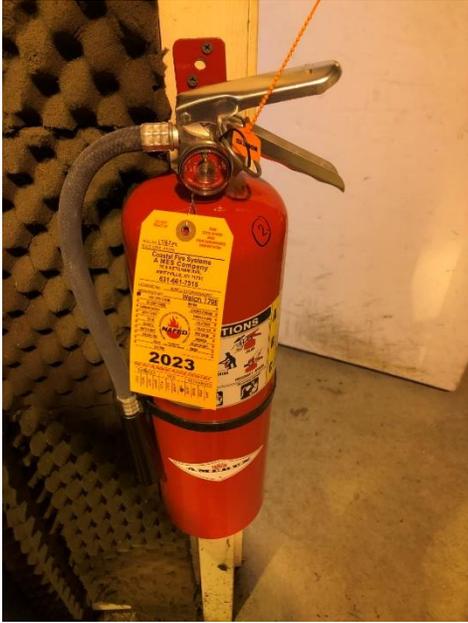
Tag indicates that the fire extinguisher has been serviced in May 2023	
<b>Site Inspector(s):</b> David Adam	<b>Date:</b> 5/25/2023

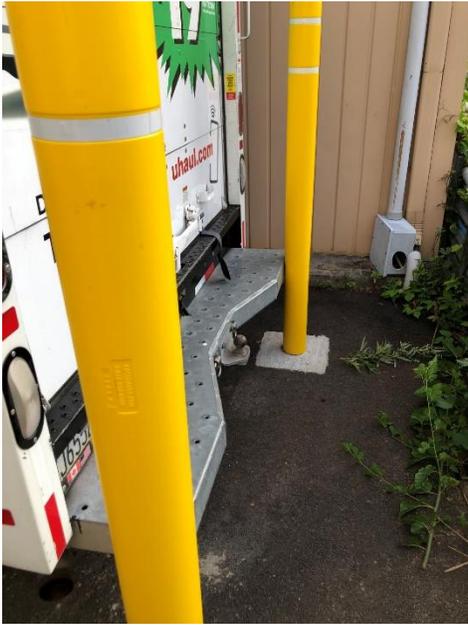
<p>The photograph shows two bright yellow bollards with reflective white bands. They are positioned on a dark asphalt surface next to a white U-Haul truck. The truck has 'U-Haul.com' and a license plate '1022' visible. A concrete base is visible under one of the bollards. The background shows a tan building wall and some green foliage.</p>	
Bollards installed in April 2023	
<b>Site Inspector(s):</b> David Adam	<b>Date:</b> 6/29/2023
