QUARTERLY OPERATION AND MAINTENANCE REPORT – FOURTH QUARTER 2023

STANTON CLEANERS AREA SUPERFUND SITE

110 Cutter Mill Road
Great Neck, New York

Issued On: January 12, 2024

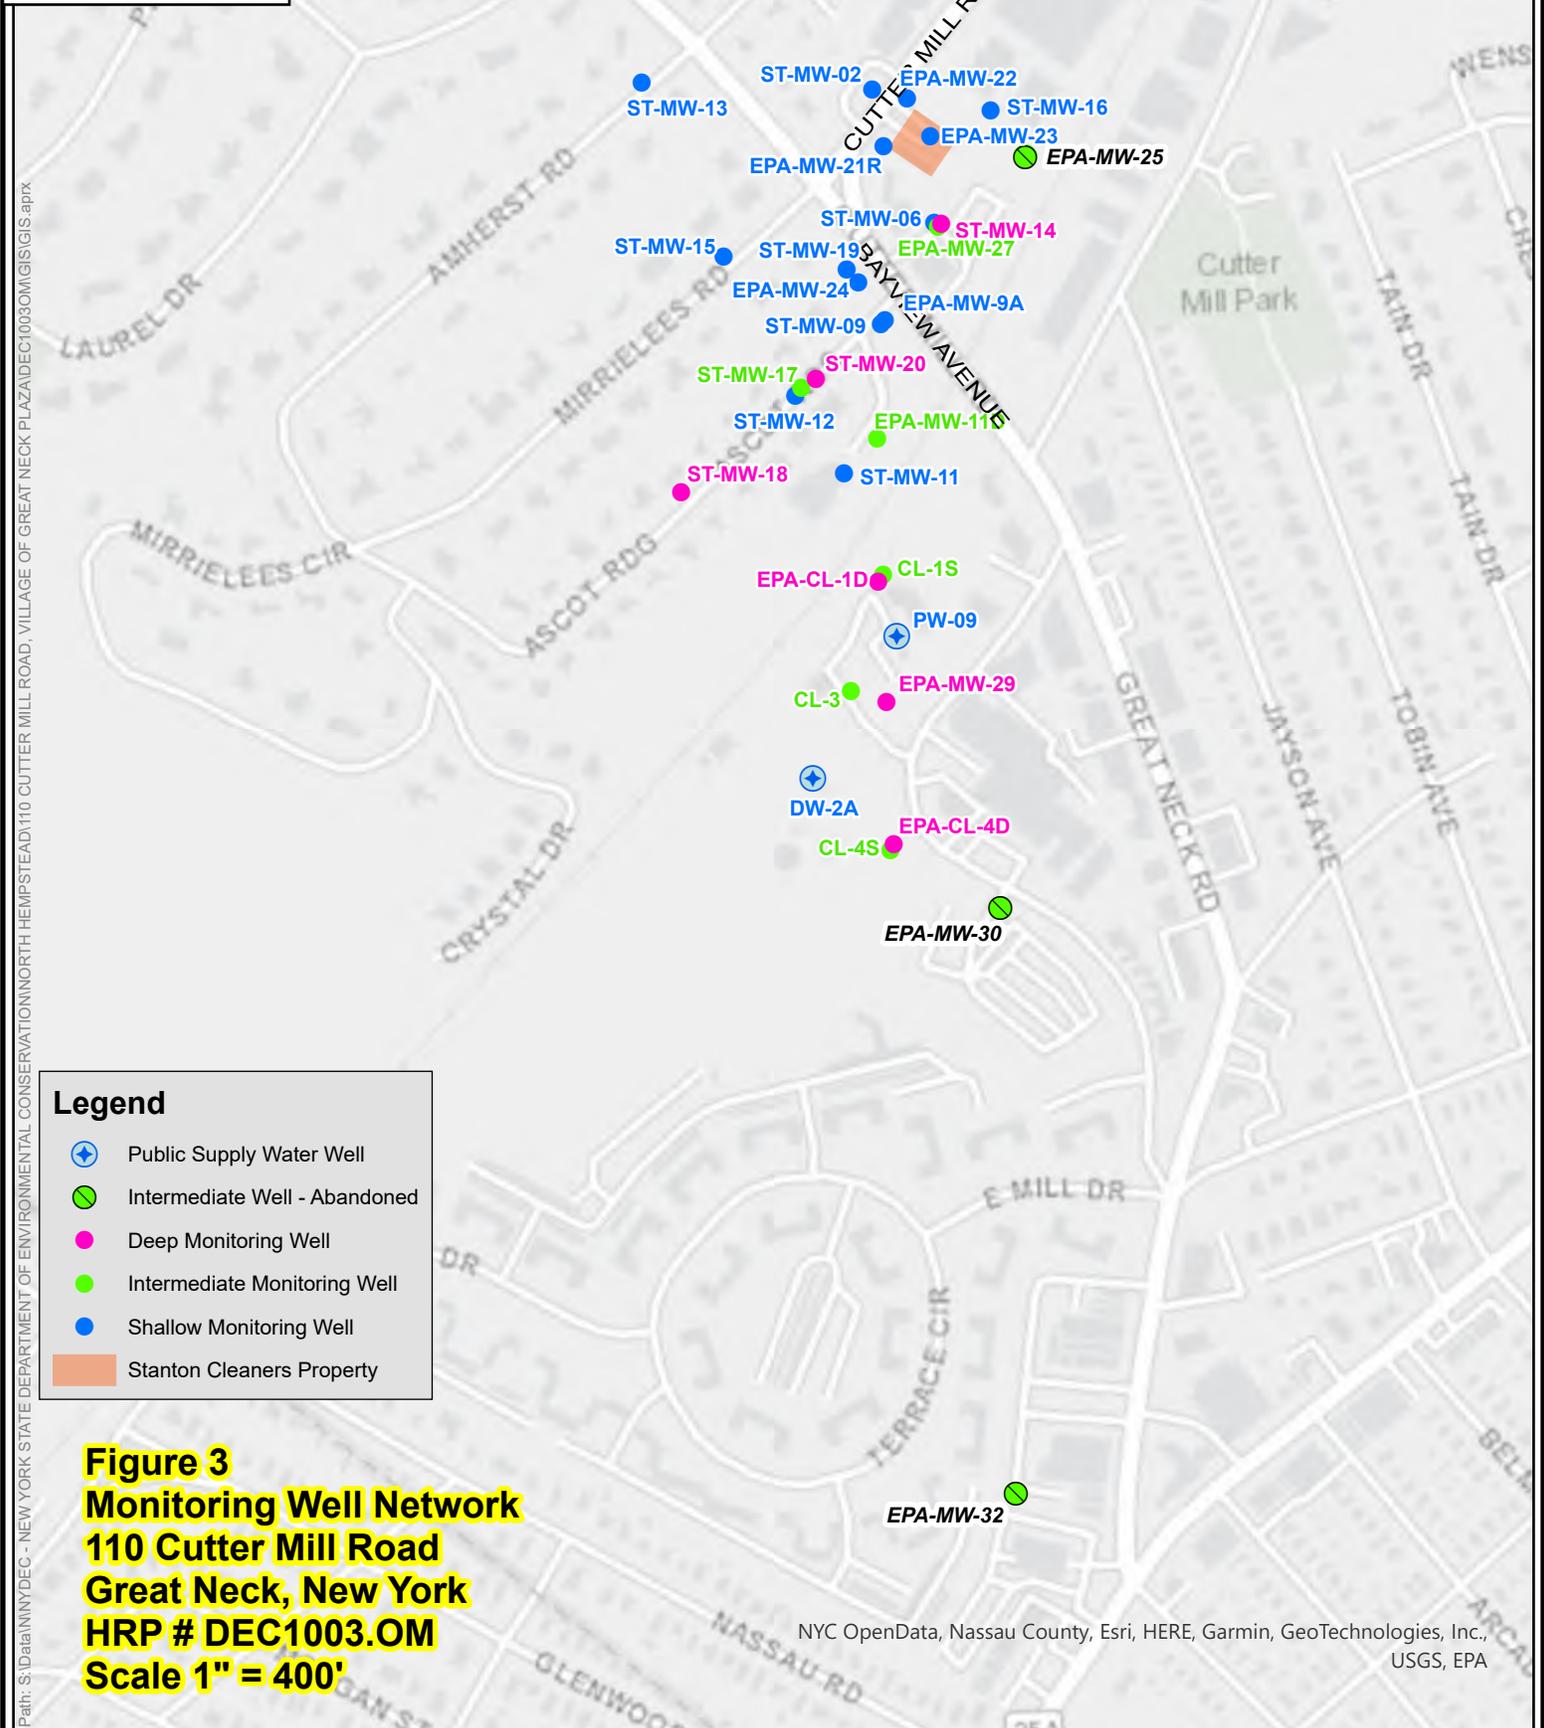
Figure 3
Monitoring Well Network
110 Cutter Mill Road
Great Neck, New York
HRP # DEC1003.OM
Scale 1" = 400'

The locations and number of wells monitored were previously determined by the EPA based on the 2014 *Final Capture Zone Analysis Report*. **Figure 3** depicts the network of monitoring wells.

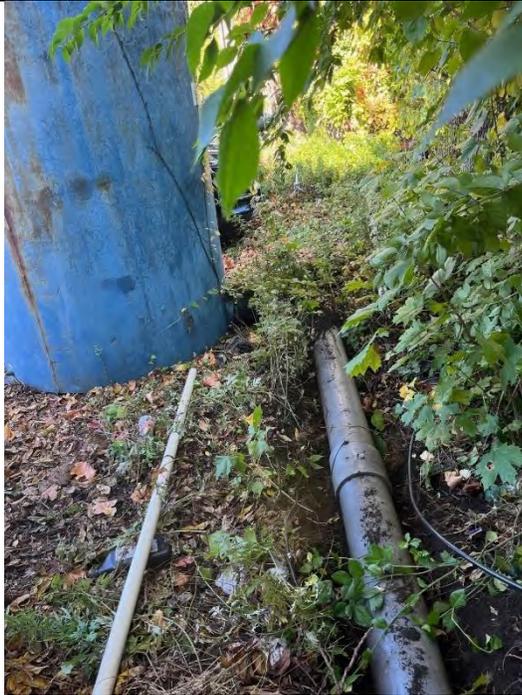
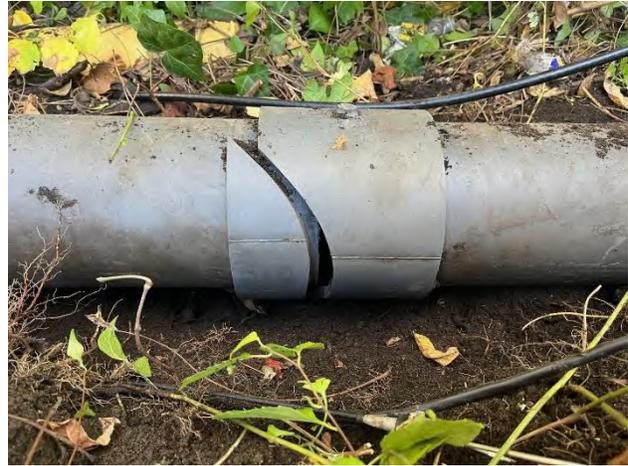
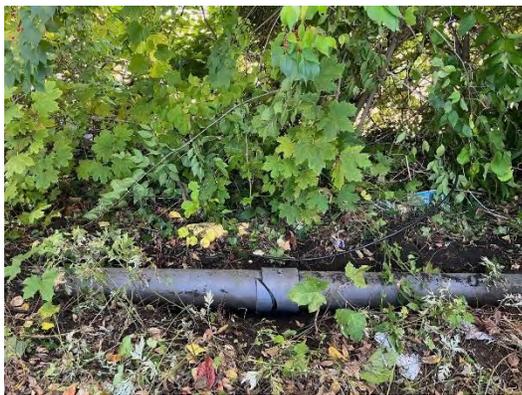
The system was shut down on October 3, 2023, following the discovery of a broken SVE discharge pipe at the exterior carbon vessel. The discharge pipe was repaired on October 26, and the system was restarted, and samples collected.

Broken SVE discharge line at exterior carbon vessel

Repaired SVE discharge line

repaired discharge line pre carbon
restarted system after interior
air sampling completed Stanton bld. @ 2:08pm
sampled effluent 2:15pm influent 2:22pm

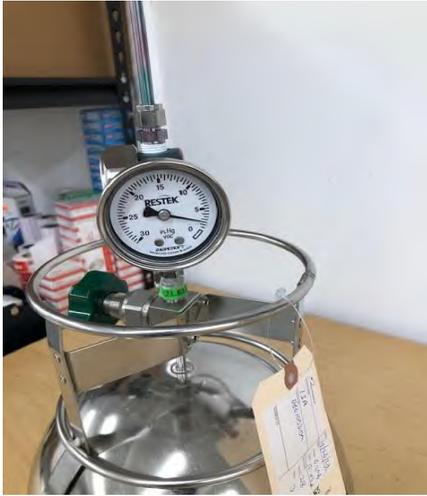
Sample 11A Location

PCE was detected in samples 1IA, 2IA, and 3OA at concentrations (12.0, 3.70, and 5.50 $\mu\text{g}/\text{m}^3$ respectively) below the NYSDOH Air Guidance Value of 30 $\mu\text{g}/\text{m}^3$. TCE was detected in sample 1IA at a concentration (0.390 $\mu\text{g}/\text{m}^3$) below the NYSDOH Air Guidance Value of 2 $\mu\text{g}/\text{m}^3$.
