Re: Fourth Quarter 2019 Progress Report
150 Fulton Avenue NPL Site - Operable Unit I
USEPA Consent Judgment No. CV-09-3917
DOJ Ref. No. 90-11-2-09329
Garden City Park Industrial Site NYSDEC#130073

On behalf of Genesco Inc. (Settling Defendant), this letter transmits the Fourth Quarter 2019 (October – December) Progress Report for the Fulton Avenue Superfund Site (Site).

GROUNDWATER MONITORING WELL REPAIR PHOTO LOG

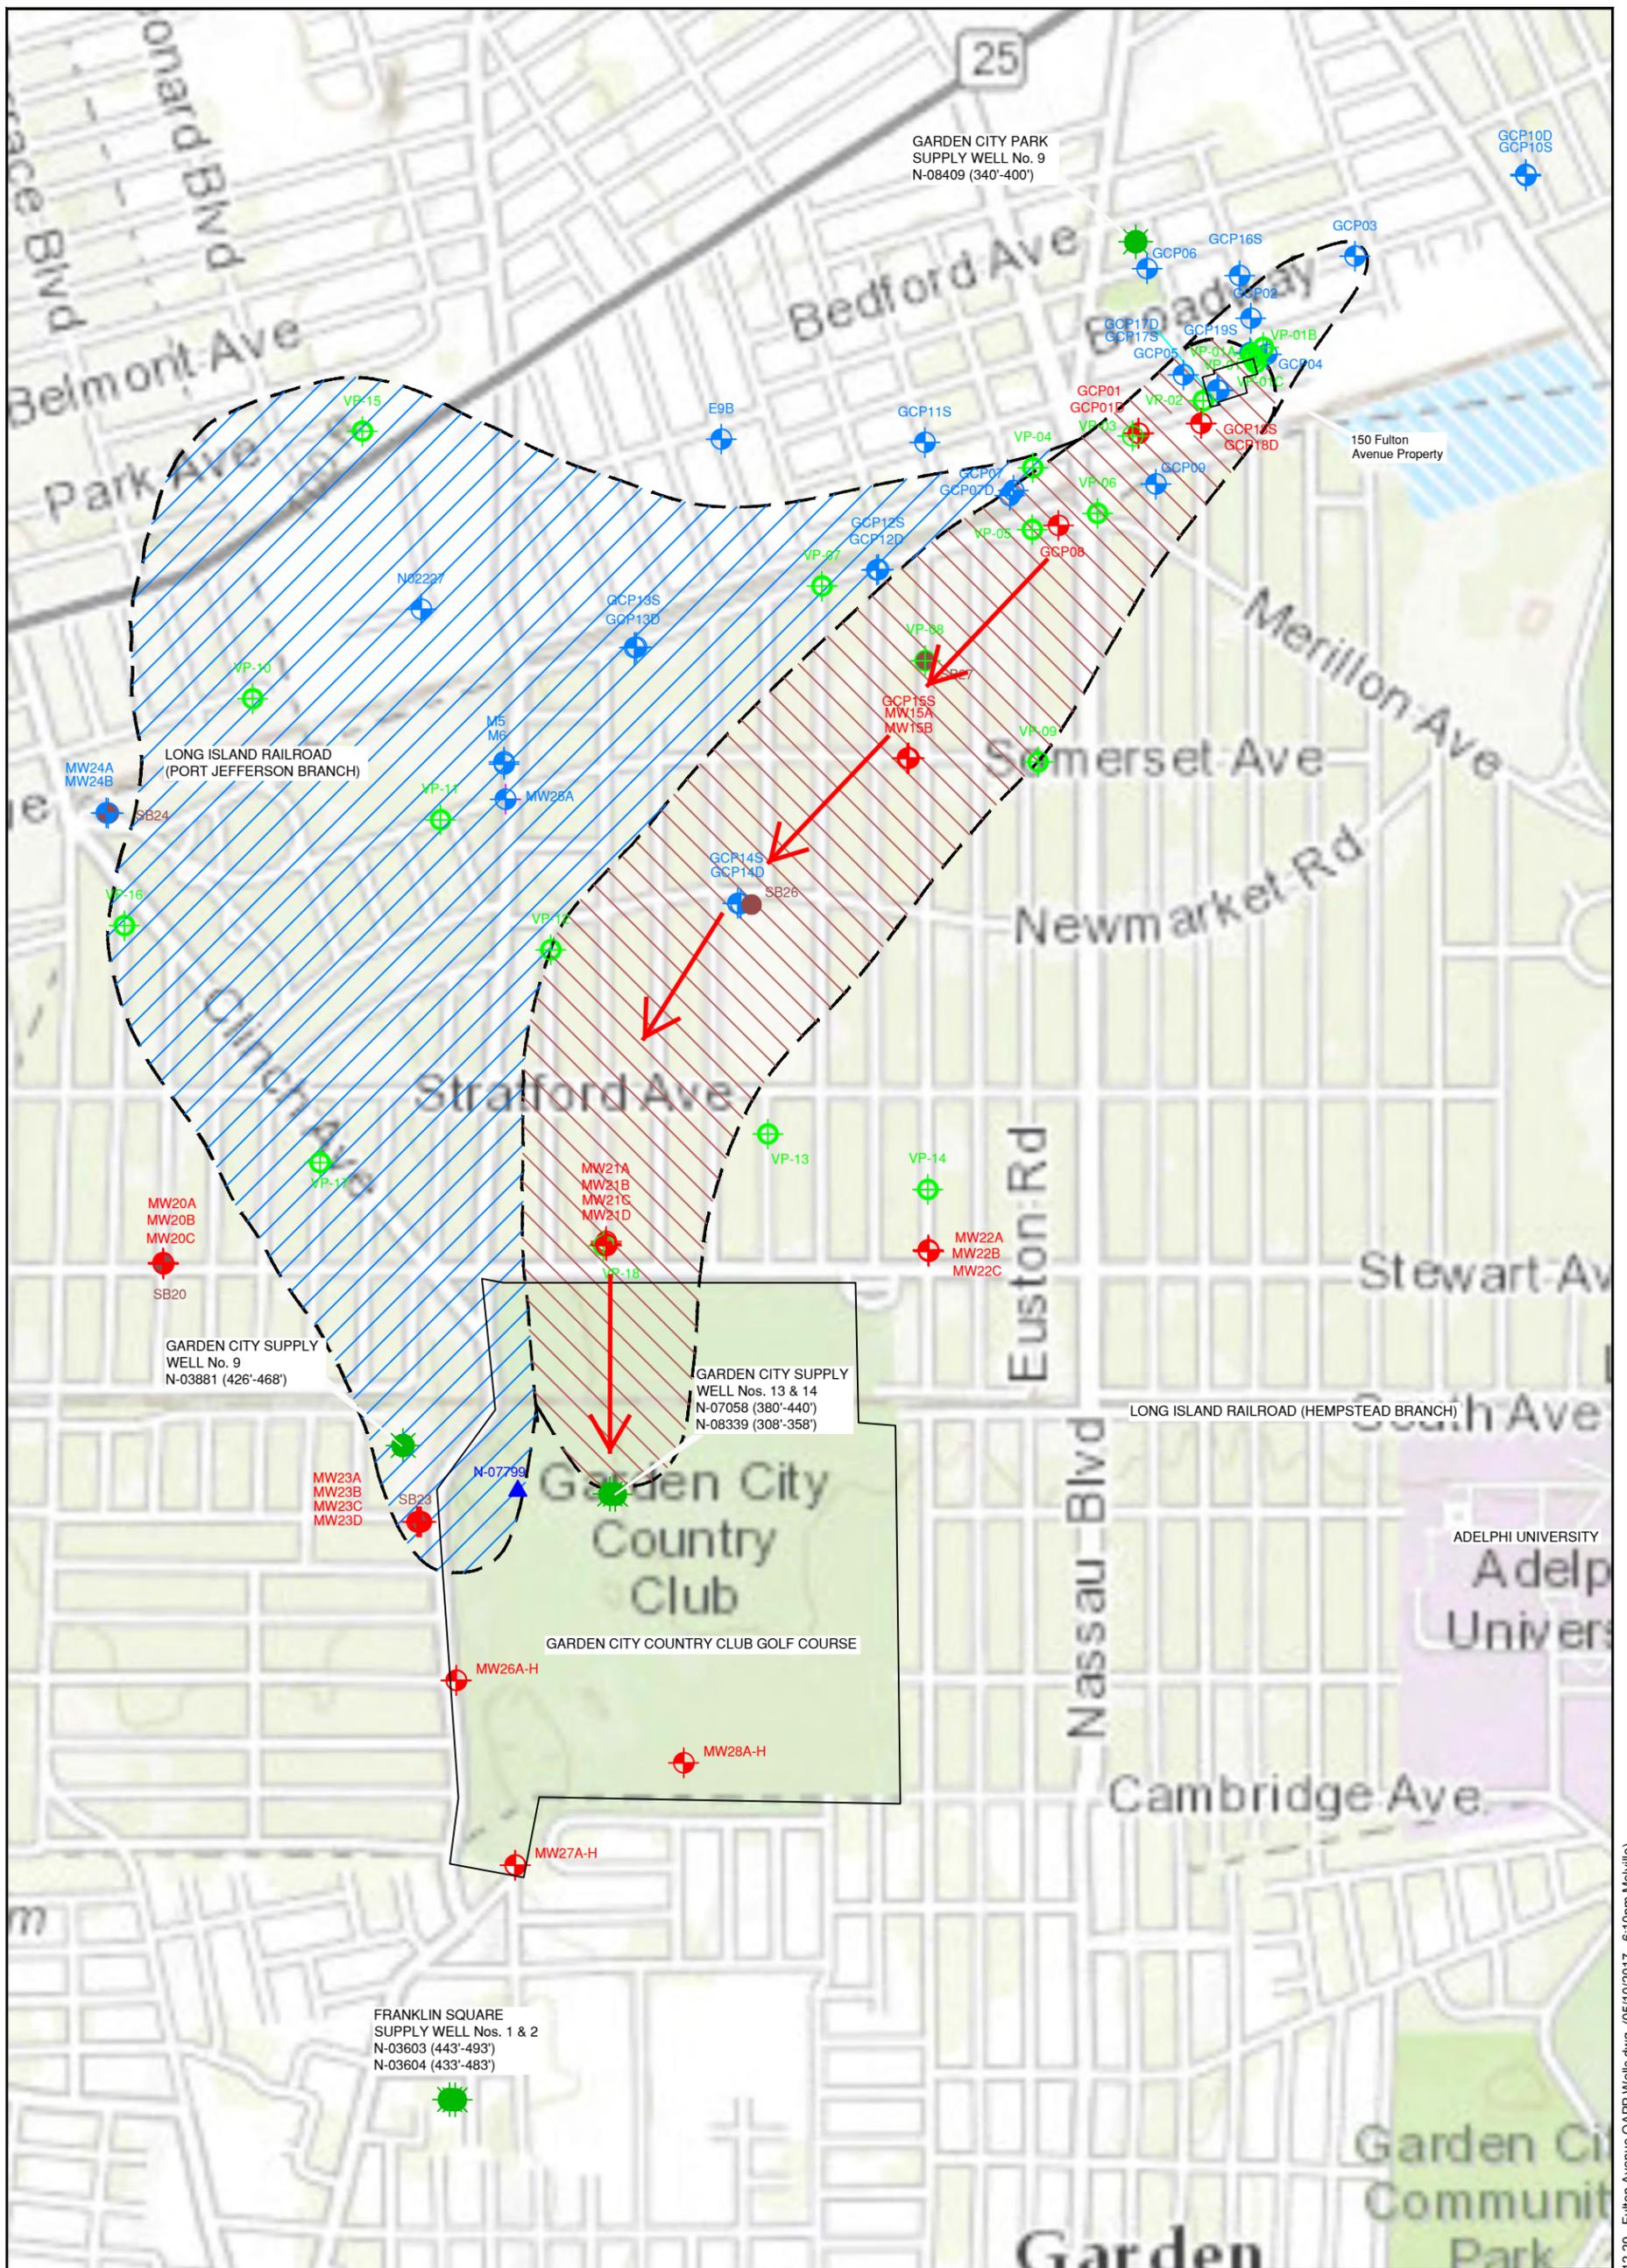
TITLE Long-Term Groundwater Monitoring Well Network Well Locations Fulton Avenue Superfund Site Garden City/Garden City Park, NY			
PREPARED FOR Genesco Inc.			
Environmental Resources Management <small>ERM</small>			FIGURE 1
DRAWN BY EMF	SCALE AS SHOWN	DATE 10/04/16	JOB NO. 0097881

Long-term groundwater monitoring well network locations are shown on the map presented as Figure 1.

SB27 SOIL BORING LOCATION
 No. 9/N-03881 SUPPLY WELL
 (426'-468')=SCREEN INTERVAL
 N-07799 IRRIGATION WELL

[Blue Hatched] HISTORICAL EXTENT OF OU1 PLUME (TETRACHLOROETHENE {PCE}-DOMINANT PLUME) WHERE THE TOTAL VOLATILE ORGANIC CONCENTRATION WAS >100 UG/L*

[Red Hatched] HISTORICAL EXTENT OF OU2 PLUME (TRICHLOROETHENE {TCE}-DOMINANT PLUME) WHERE THE TOTAL VOLATILE ORGANIC CONCENTRATION WAS >100 UG/L*

* NOTE:
 THE AREAL EXTENT OF CHLORINATED VOLATILE ORGANIC COMPOUNDS DEPICTED IN THIS FIGURE IS BASED ON THE MAXIMUM CONCENTRATIONS DETECTED IN GROUNDWATER SAMPLES OBTAINED FROM VERTICAL PROFILE TEMPORARY WELLS INSTALLED DURING 1999 - 2000, AND PERMANENT WELLS DURING SEPTEMBER 2001 - MAY 2005.

→ GENERALIZED GROUNDWATER FLOW PATH

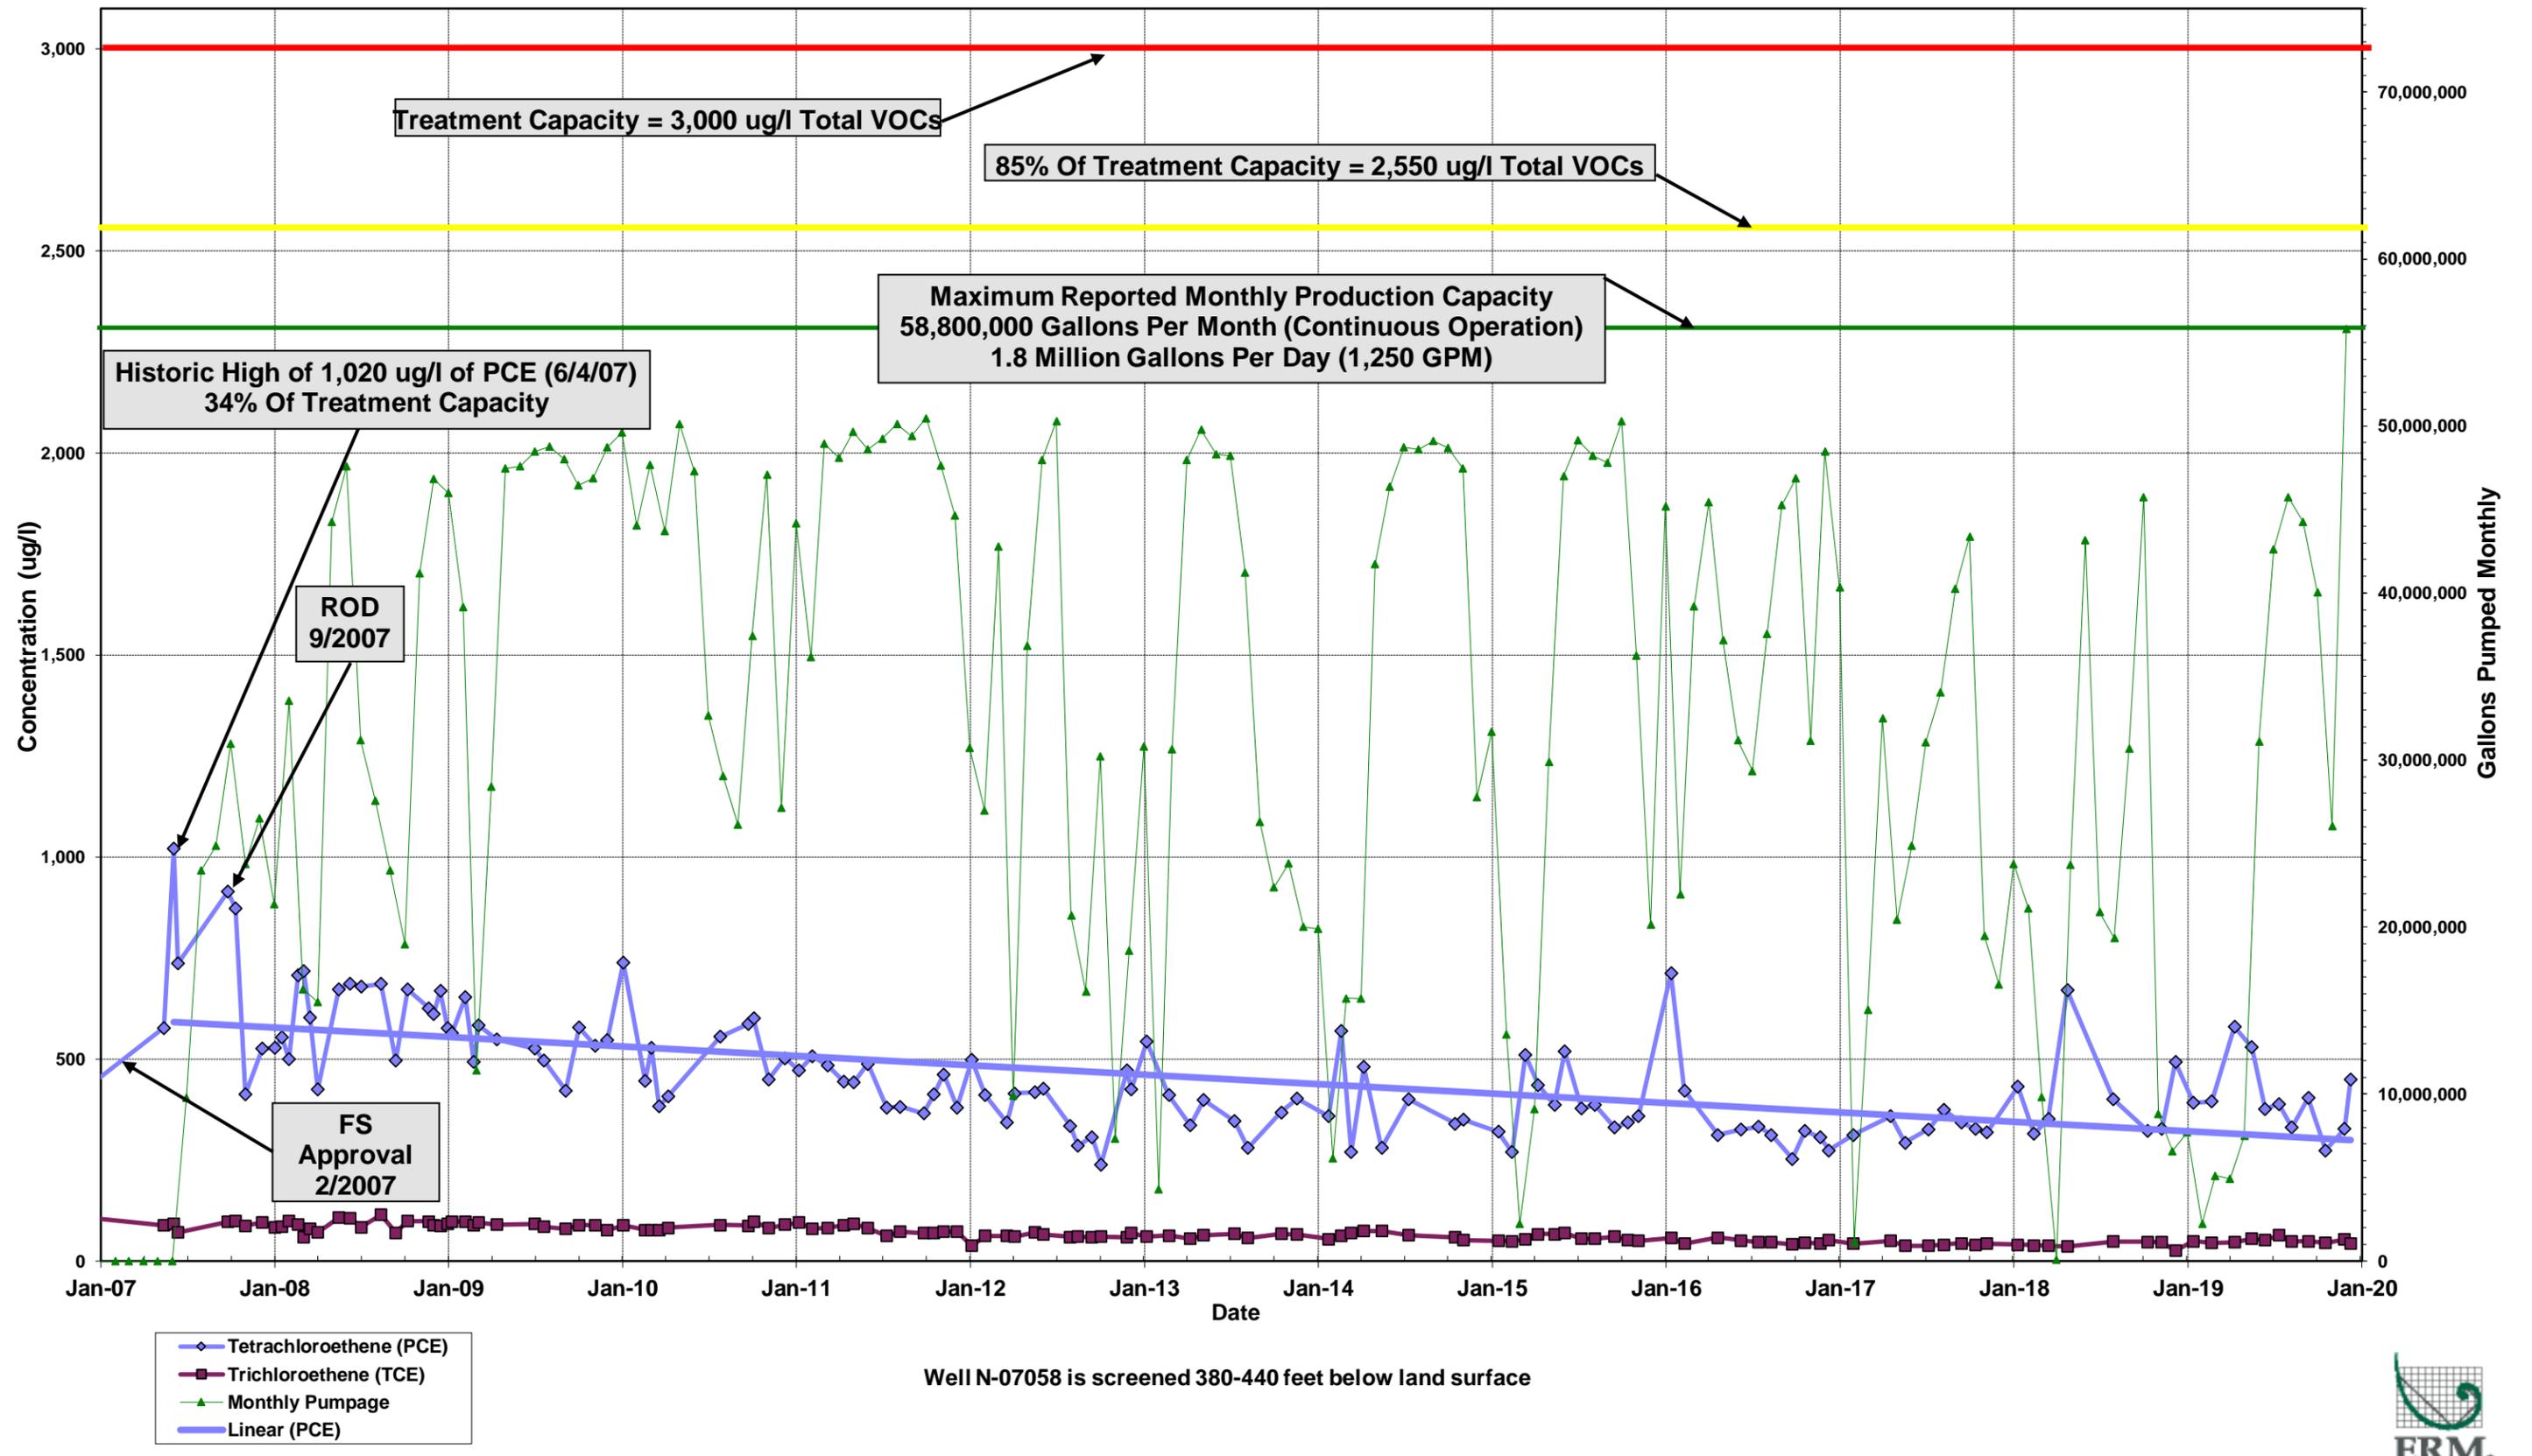
FIGURE 2
HISTORICAL TETRACHLOROETHENE & TRICHLOROETHENE CONCENTRATIONS AND MONTHLY WELL PUMPAGE: JANUARY 2007 - DECEMBER 2019
PUBLIC WATER SUPPLY WELL # N-07058 (GARDEN CITY WELL NO. 13), GARDEN CITY, NEW YORK

The new data were incorporated into the existing database set, and used to update corresponding charts for the Well Nos. 13 & 14 showing PCE and TCE concentrations versus time, and historic monthly pumpage versus time to evaluate recent contaminant concentration trends depicted in the same. The updated charts for Well Nos. 13 & 14 are presented as Figures 2 & 3, respectively.

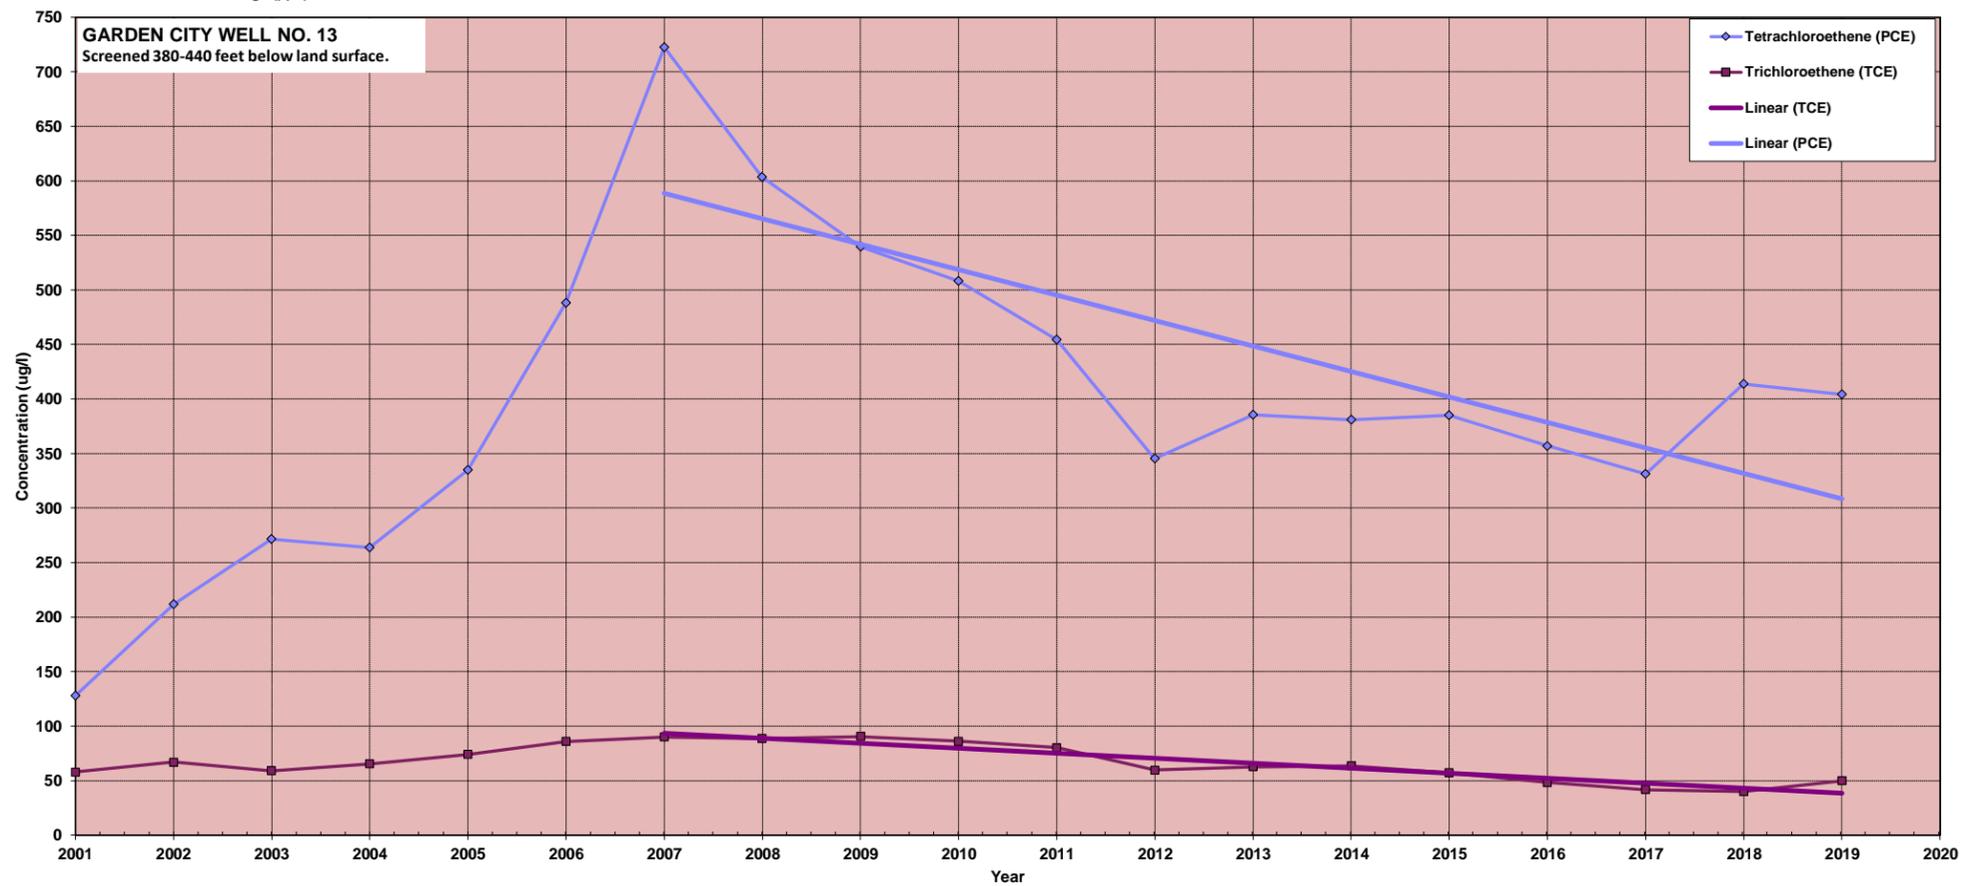
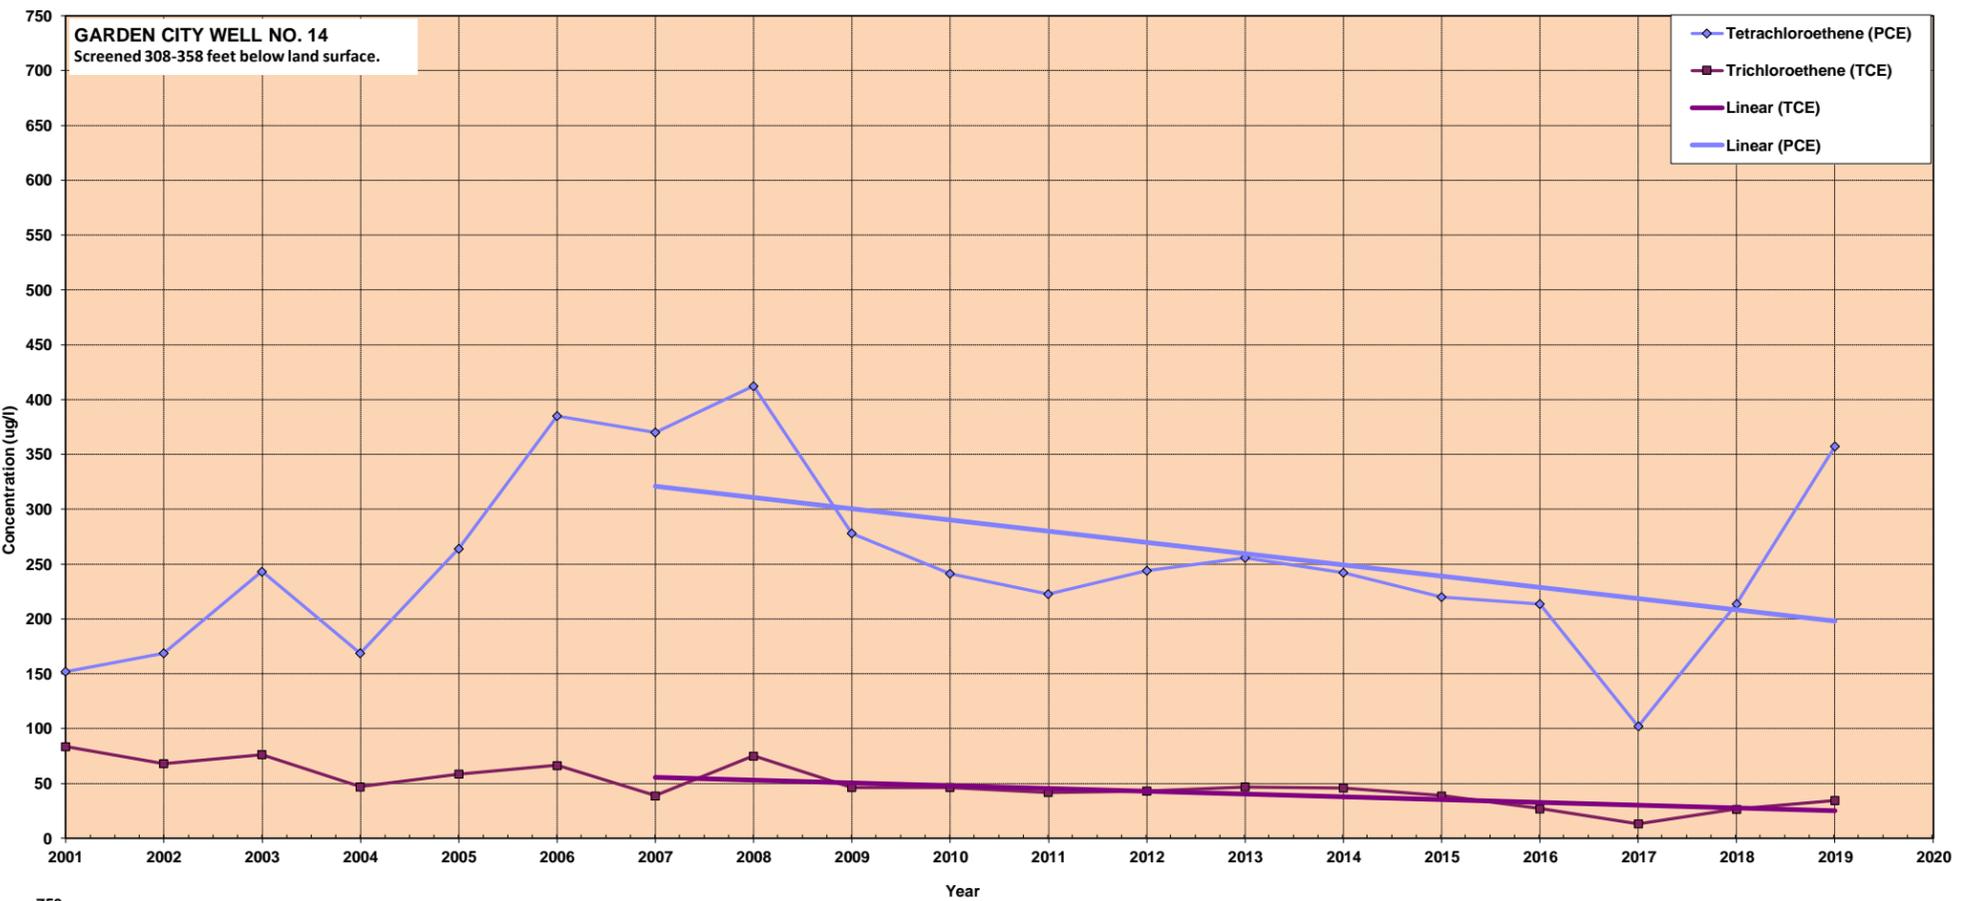
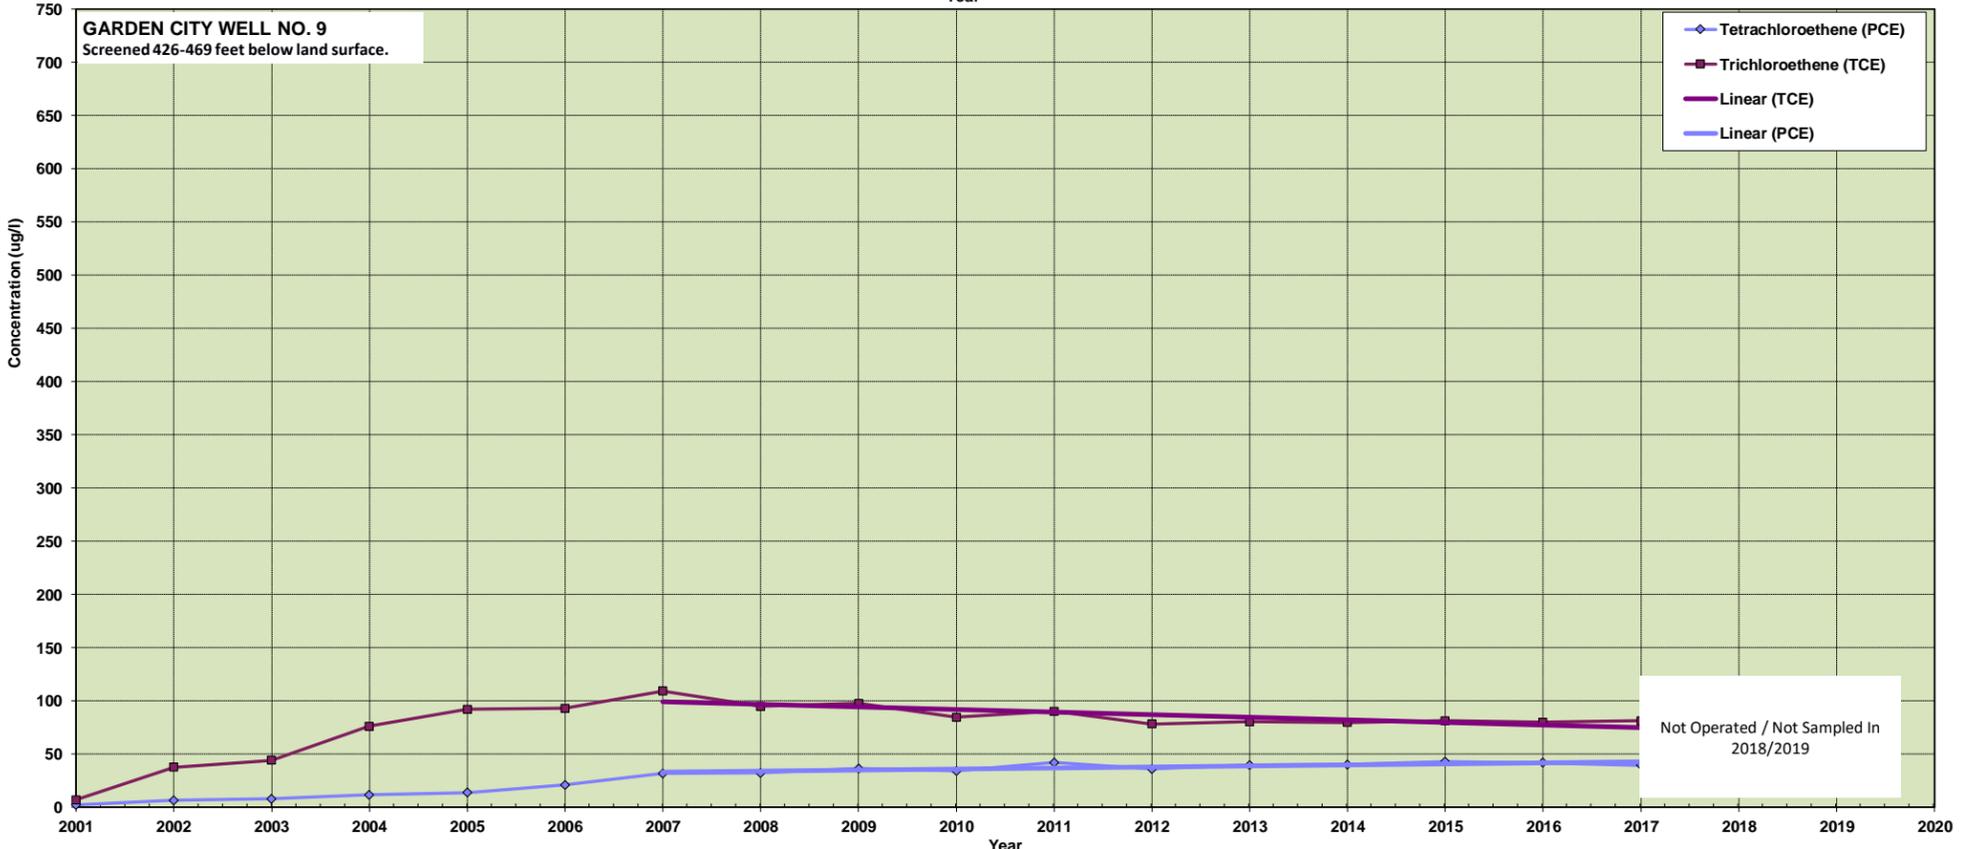
FIGURE 4
HISTORIC AVERAGE TETRACHLOROETHENE AND TRICHLOROETHENE CONCENTRATIONS BY YEAR 2001 - 2019
GARDEN CITY PUBLIC WATER SUPPLY WELL NOS. 9, 13 14, GARDEN CITY, NEW YORK

Figure 4 presents average concentrations of PCE and TCE (and the corresponding PCE/TCE ratio) for each of the three wells by year (2001 – 2019), and plots of average annual PCE and TCE concentrations versus time for each of the three wells for comparative viewing. The data and resultant plots indicate that since 2007, concentrations of PCE have fluctuated over time since 2007, but both maximum observed and annual average concentrations of PCE have been declining in Well Nos. 13 & 14. Concentrations of TCE have been declining in Well No. 13, and are beginning to decline in Well No. 14. A brief summary that puts the relative concentrations in perspective is presented in the table below.

Year	2001		2002		2003		2004		2005		2006		2007		2008		2009		2010		2011		2012		2013		2014		2015		2016		2017		2018		2019	
		Compound	PCE	TCE	PCE	TCE	PCE	TCE	PCE	TCE	PCE	TCE	PCE	TCE	PCE	TCE	PCE	TCE	PCE	TCE	PCE	TCE	PCE	TCE	PCE	TCE													
Well No. 13 (N-07058)	Average Concentration	128.0	57.8	211.8	67.0	271.7	59.0	263.6	65.3	335.0	73.9	488.3	85.8	722.6	90.0	603.4	88.5	539.5	90.3	508.3	86.1	454.3	80.2	345.4	59.7	385.5	62.5	381.1	63.4	385.1	57.1	357.0	48.3	331.3	41.6	413.6	40.0	404.1	49.9
	Ratio PCE/TCE	2.2		3.2		4.6		4.0		4.5		5.7		8.0		6.8		6.0		5.9		5.7		5.8		6.2		6.0		6.7		7.4		8.0		10.3		8.1	
Well No. 14 (N-08339)	Average Concentration	152.0	83.6	168.7	68.2	243.3	76.2	168.6	46.9	264.2	58.6	385.0	66.5	370.1	38.9	412.4	75.0	278.1	46.3	241.2	46.2	222.8	41.7	244.1	43.1	255.8	46.6	242.1	45.9	219.9	38.8	213.6	27.1	102.0	13.1	213.6	26.5	357.5	34.5
	Ratio PCE/TCE	1.8		2.5		3.2		3.6		4.5		5.8		9.5		5.5		6.0		5.2		5.3		5.7		5.5		5.3		5.7		7.9		7.8		8.1		10.4

Well No. 9 (N-03881)	Average Concentration	2.1	7.0	6.6	37.5	7.9	44.0	11.6	76.0	13.7	92.0	21.0	93.0	31.6	109.0	32.0	94.8	36.4	97.5	33.9	84.6	42.0	90.0	35.7	78.1	39.5	80.2	40.1	79.6	42.8	81.2	41.8	79.8	39.4	81.2	Not Operated / Not Sampled			
	Ratio PCE/TCE	0.3		0.2		0.2		0.2		0.1		0.3		0.3		0.3		0.4		0.4		0.5		0.5		0.5		0.5		0.5		0.5		0.5		Not Operated / Not Sampled

Concentrations are in ug/l (ppb).
