**REMEDIAL INVESTIGATION REPORT
FORMER JIMMY'S DRY CLEANER
61 NASSAU ROAD, ROOSEVELT, NEW YORK
NYS DEC SITE NO. D003666-32.0**

Revision 1 – August 26, 2003

Remedial Investigation Report

NYSDEC Site No. D003666-32.0

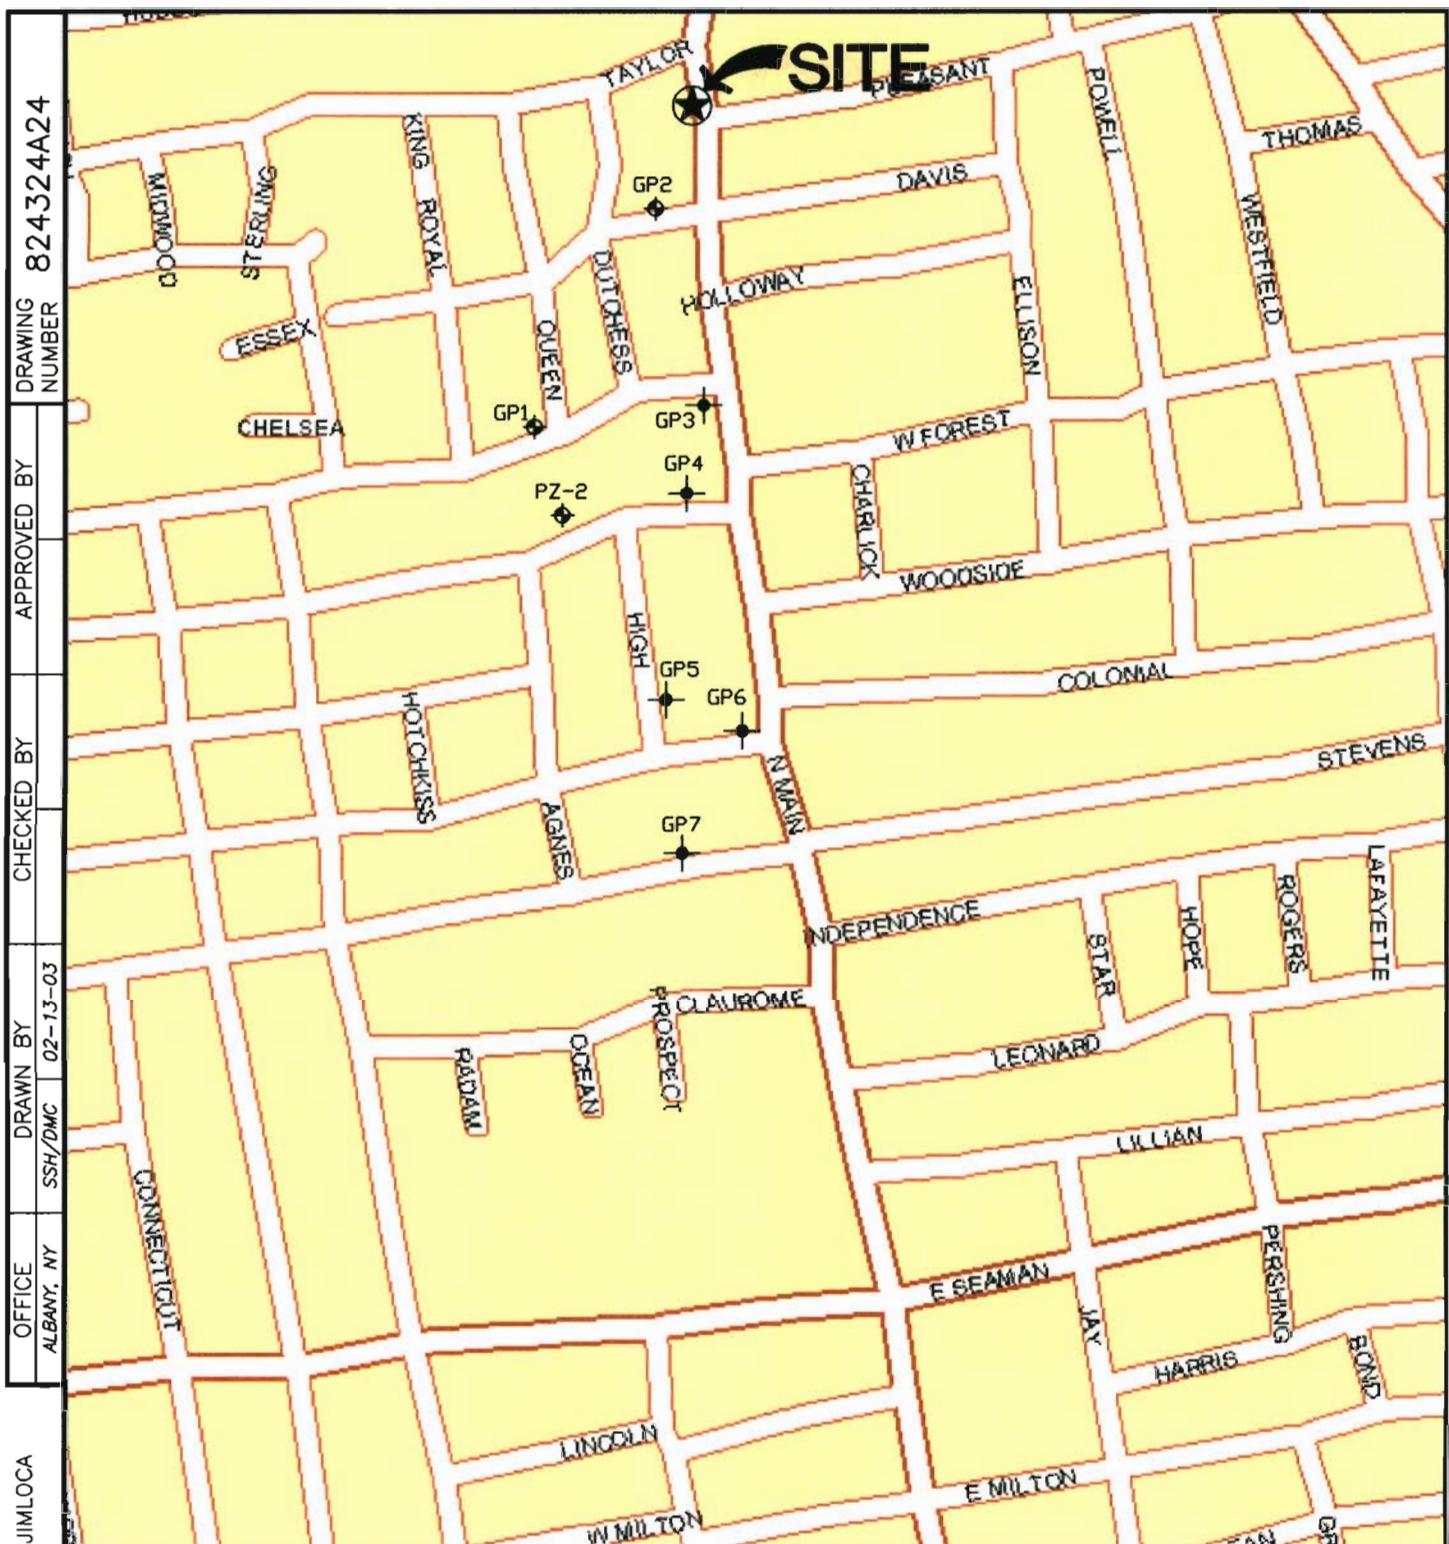
FIGURE 5
HISTORIC DOWN-GRADIENT SAMPLE LOCATION MAP

- ◆ HISTORICAL(1999) MONITORING WELL LOCATION
- ◆ HISTORICAL(1999) DIRECT PUSH DRILLING GROUNDWATER SAMPLING LOCATION
