Re: Site Assessment & Remediation Report
Gem Cleaners
84 N. Village Ave.
Rockville Centre, NY

**SITE ASSESSMENT & REMEDIATION REPORT
FOR THE PROPERTY LOCATED AT
84 NORTH VILLAGE AVENUE
ROCKVILLE CENTRE, NEW YORK**

Prepared by: P.W. Grosser Consulting Engineer & Hydrogeologist, P.C.

AUGUST 1997

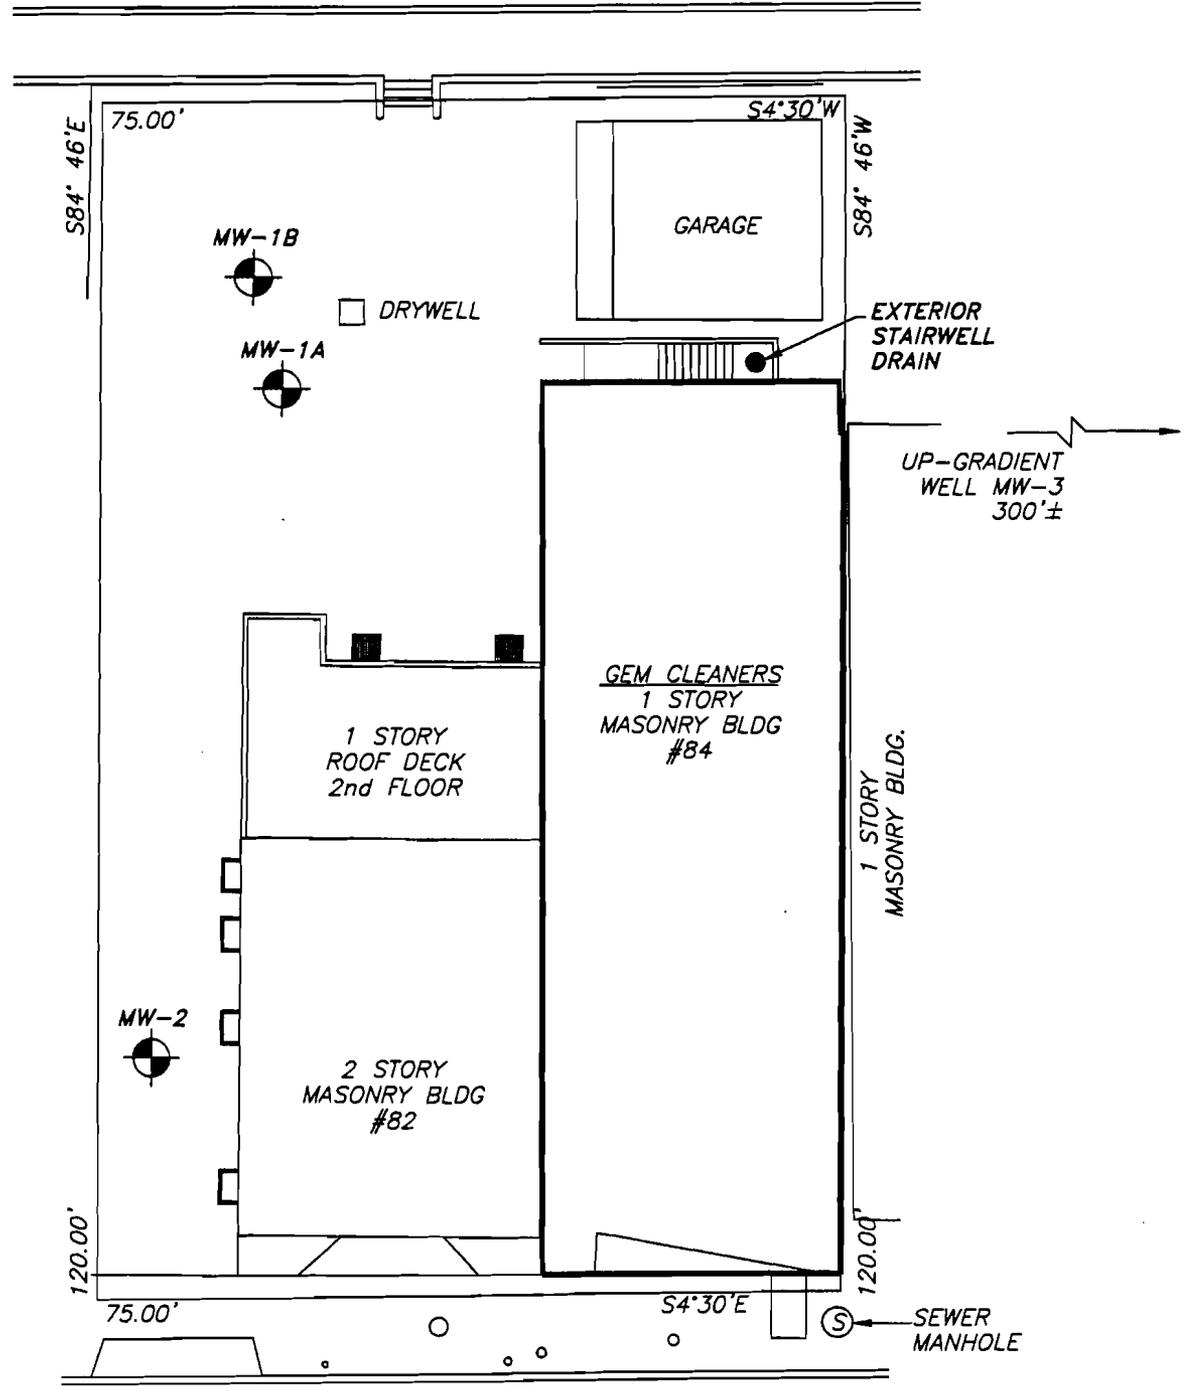
Figure No:
1

Based on the information obtained during the Phase I, EEA performed a Phase II Environmental Subsurface Investigation. Phase II work was completed in May, 1995. The scope of work for the Phase II included a soil boring conducted through the exterior drainage structure. Multiple soil samples were collected from within the structure and analyzed from various depths (2-4', 8-10', 13-15', and 18-20') to provide a vertical profile of soil quality. Depth to water beneath the site is approximately 18 feet below grade. In addition, a total of four groundwater monitoring wells (three water table and one deep) were installed and sampled. One well was located approximately 300 feet north (up-gradient) of the site, two wells (one water table and one deep) were installed directly down-gradient from the exterior drainage structure, and one well was located down-gradient of the sump pit located in the basement of the subject building. Since no water table elevation contours are presented in EEA's report, it is assumed EEA used regional groundwater flow patterns to determine up-gradient and down-gradient positions relative to the site (see Figure 1).

The results of the Phase II investigation indicated that PCE was detected at 7 ug/kg, well below the NYSDEC TAGM soil cleanup objective, in the 0-2' foot soil sample collected within the exterior drainage structure. PCE was below detectable levels in subsequent soil samples collected within the structure. The results of the groundwater samples collected from the monitoring wells indicated relatively low concentrations of PCE in the groundwater beneath the property, in addition to well MW-3 installed up-gradient of the site. The highest concentrations of PCE were detected in water table monitoring well MW-1A (26 ug/l -56 ug/l), which is located adjacent to the exterior drainage structure (see Figure 1).

**SITE PLAN
GEM CLEANERS**

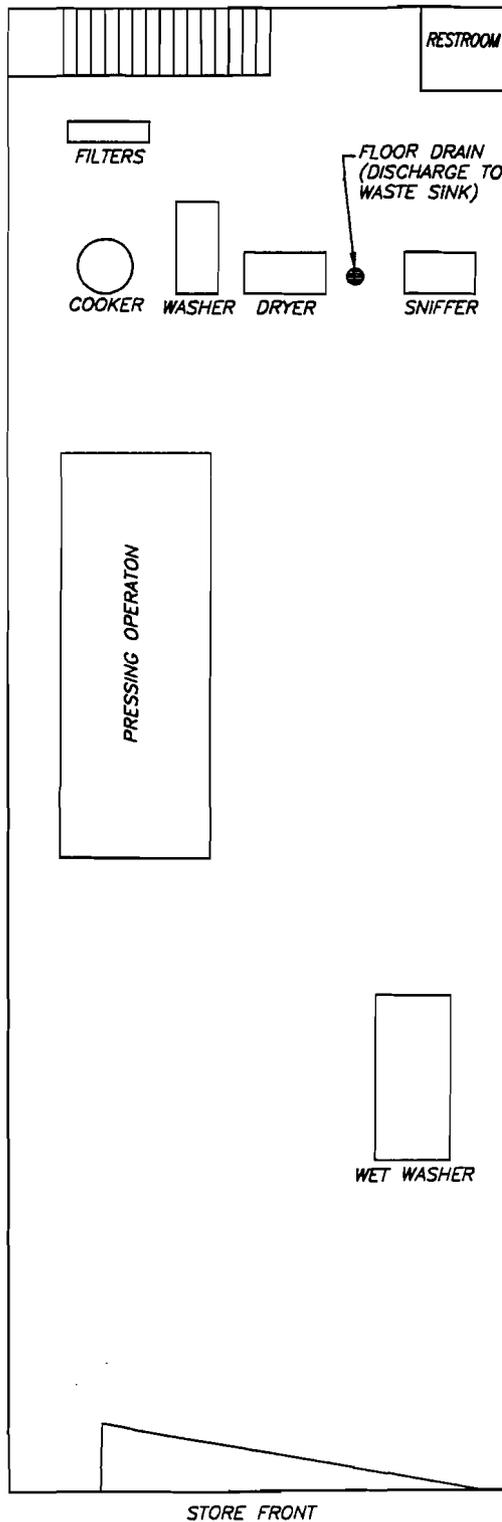
FIRST FLOOR PLAN GEM CLEANERS 84 N. Village Ave. Rockville Centre, N.Y.	Figure No: 2
--	----------------------------

The initial site inspection was conducted on January 22, 1997 and focused on the current operations of the facility and the generation of liquid waste. During the site inspection, it was noted that early generation (transfer machine) equipment is still being utilized and the facility consumes approximately 200 gallons of PCE per year. Early generation machines do not employ many of the waste reduction and recovery technologies that are inherent in the later generation equipment, such as refrigerator condensers. Therefore, these operations tend to use more PCE throughout the year and generate greater volumes of liquid waste. Equipment used during the process includes the following; a Washex washing machine, Solve Miser dryer, Sniff-O-Miser sniffer, Filter King filters, Per Corporation cooker, and Remi-Dri vacuum system. With the exception of the vacuum system, the dry cleaning equipment is utilized on the first floor of the subject building. Figure 2 shows a general layout of the first floor.

FIRST FLOOR PLAN
N.T.S.

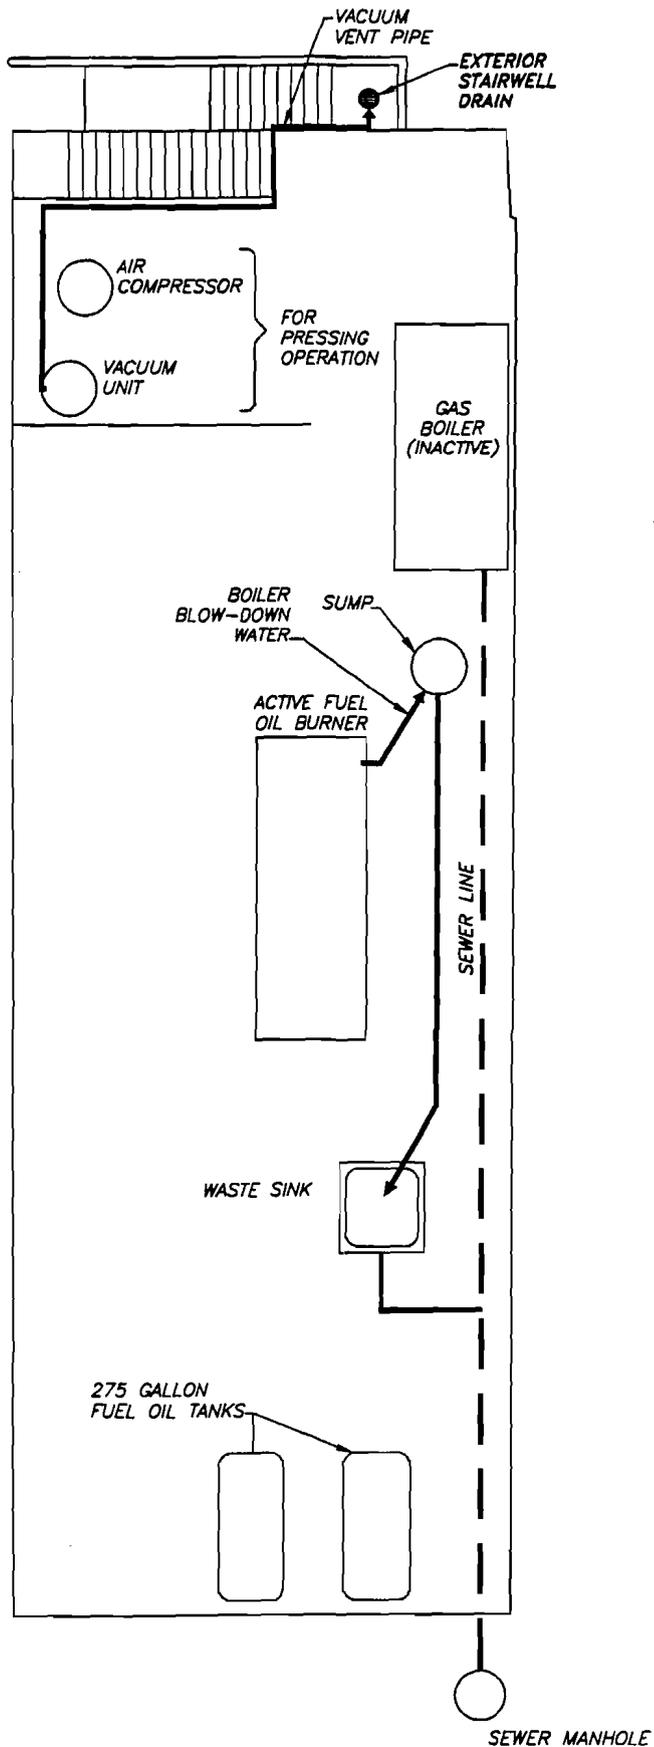
Figure No:

Figure 3 shows the general layout of the basement. As described in EEA's Phase I report, a sump pit is located off the northwest corner of the active fuel oil fired boiler. The sump pit consists of a pre-fabricated metal receptacle fitted into the basement floor which is currently receiving boiler condensate. No piping was noted in the sump pit and probing with a steel bar revealed it contained a solid bottom. The sump did contain a float activated sump pump, which turns on the pump when liquids reach a designated level. The sump pump discharged, via flex hose, to the waste sink also located in the basement. Numerous other pipes were also routed to the waste sink. One appeared to be from the floor drain located on the first floor, while another appeared to be an abandoned washing machine used for typical wet cleaning also located on the first floor.

The vacuum unit and associated equipment are located in the southwest corner of the basement. The system is designed to pull vapor and residual water from the press and spotting board operations located on the first floor. This vapor and water contains PCE released from the clothes. Water collected during the process is drained through the bottom of the unit when the system is shut down, while the vapor is typically released through a vent routed to the outside of the building. The vacuum vent at Gem Cleaners, constructed of PVC, was routed along the basement's west wall and horizontally out through a hole cut in the wooden basement door. Since the vent pipe was not routed vertically up, small quantities of water drawn into the system are released. The majority of liquid appeared to drain on the inside of the basement door, where a six inch concrete curb exists preventing water from entering or leaving the basement. Some liquid did appear to drain on the outside of the

BASEMENT FLOOR PLAN
N.T.S.

door to the exterior stairwell, where a small diameter drain (approximately 6 inches) is located. This stairwell drain is located directly up-gradient (north) of monitoring well MW-1A. Additional liquid generated by the vacuum system is drained at the base of the unit and contained in a small pail. The employee at the facility indicated that this liquid was also disposed of in the building's toilet. The operator was made aware of the condition of the vacuum system vent and has since extended it vertically up to the roof and capped it with a "T", thereby, eliminating the discharge.

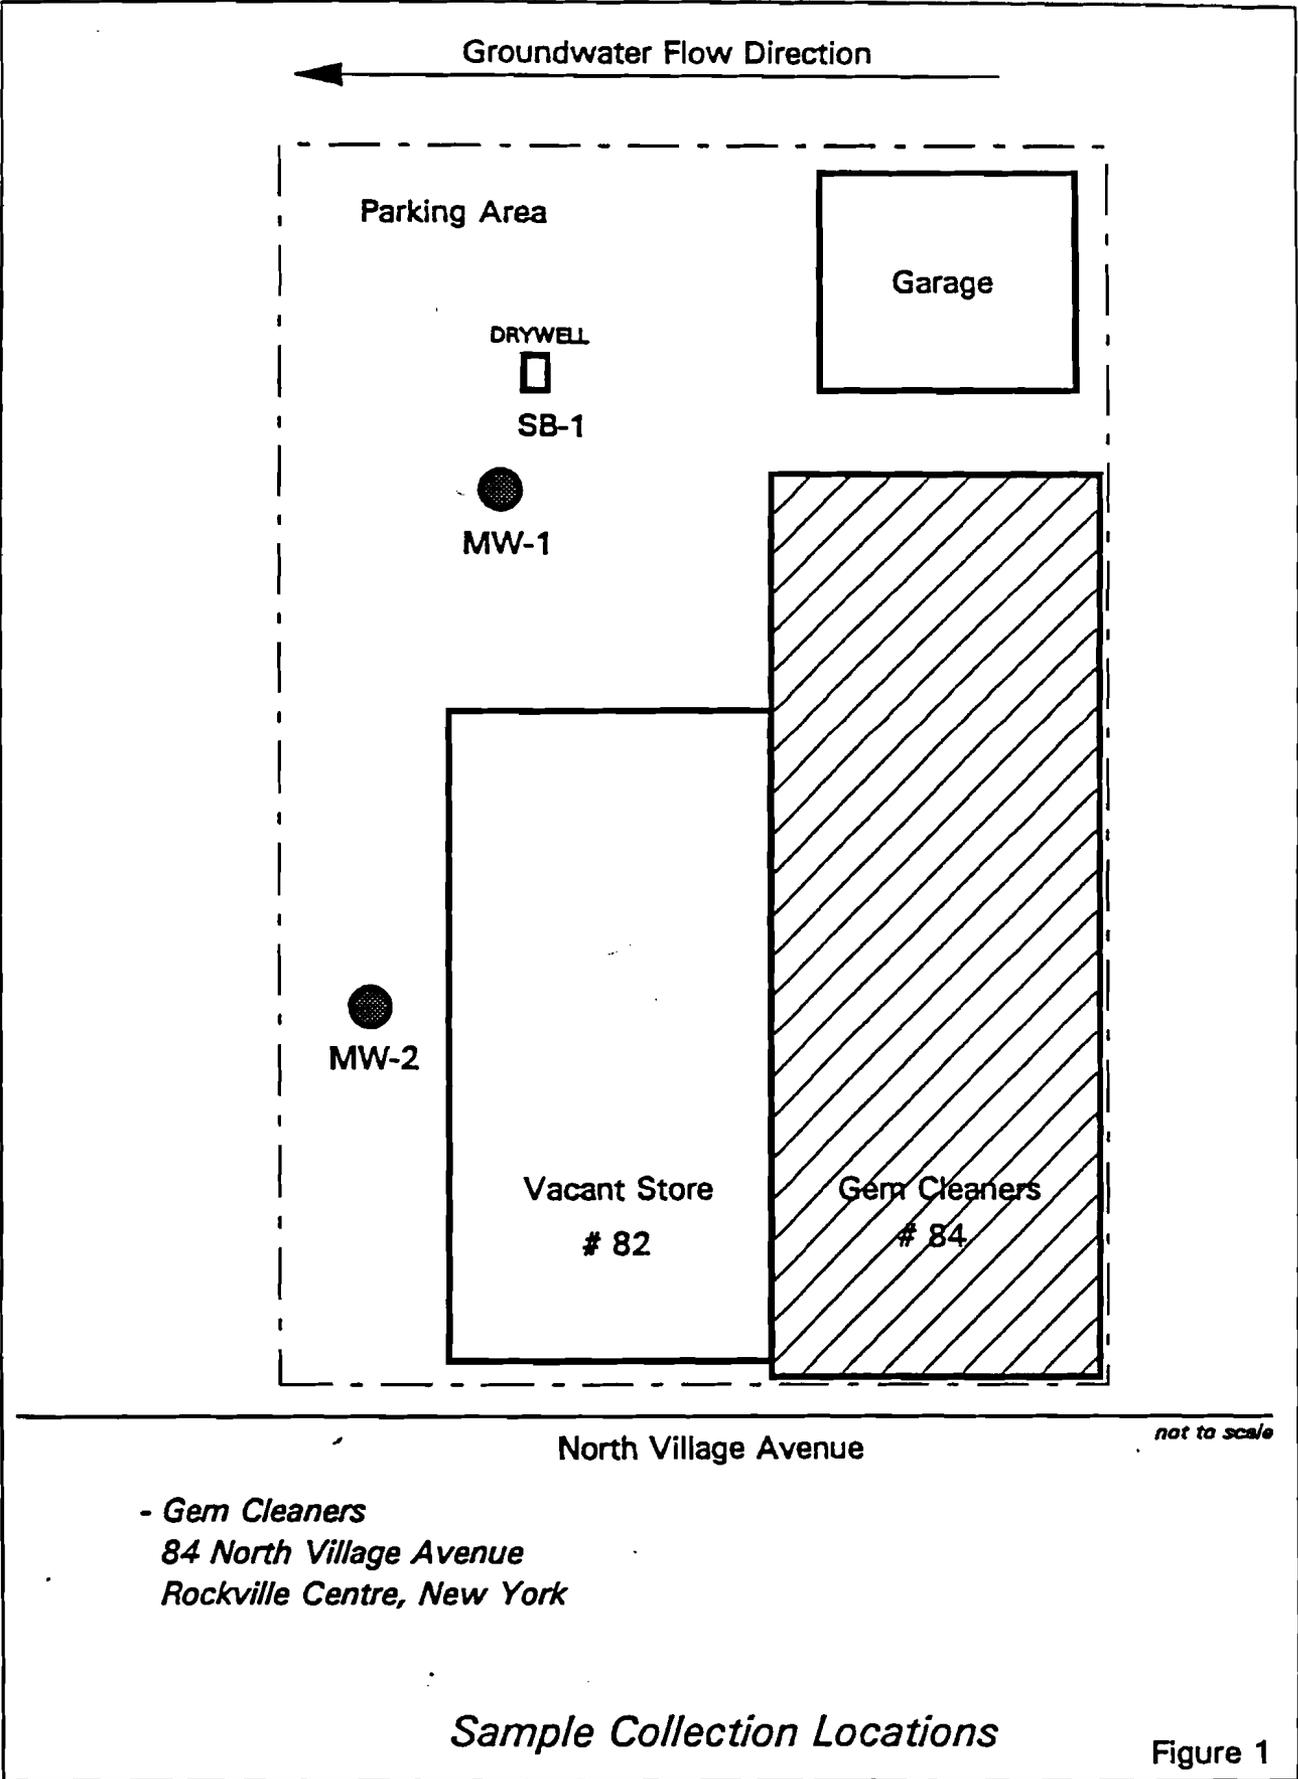
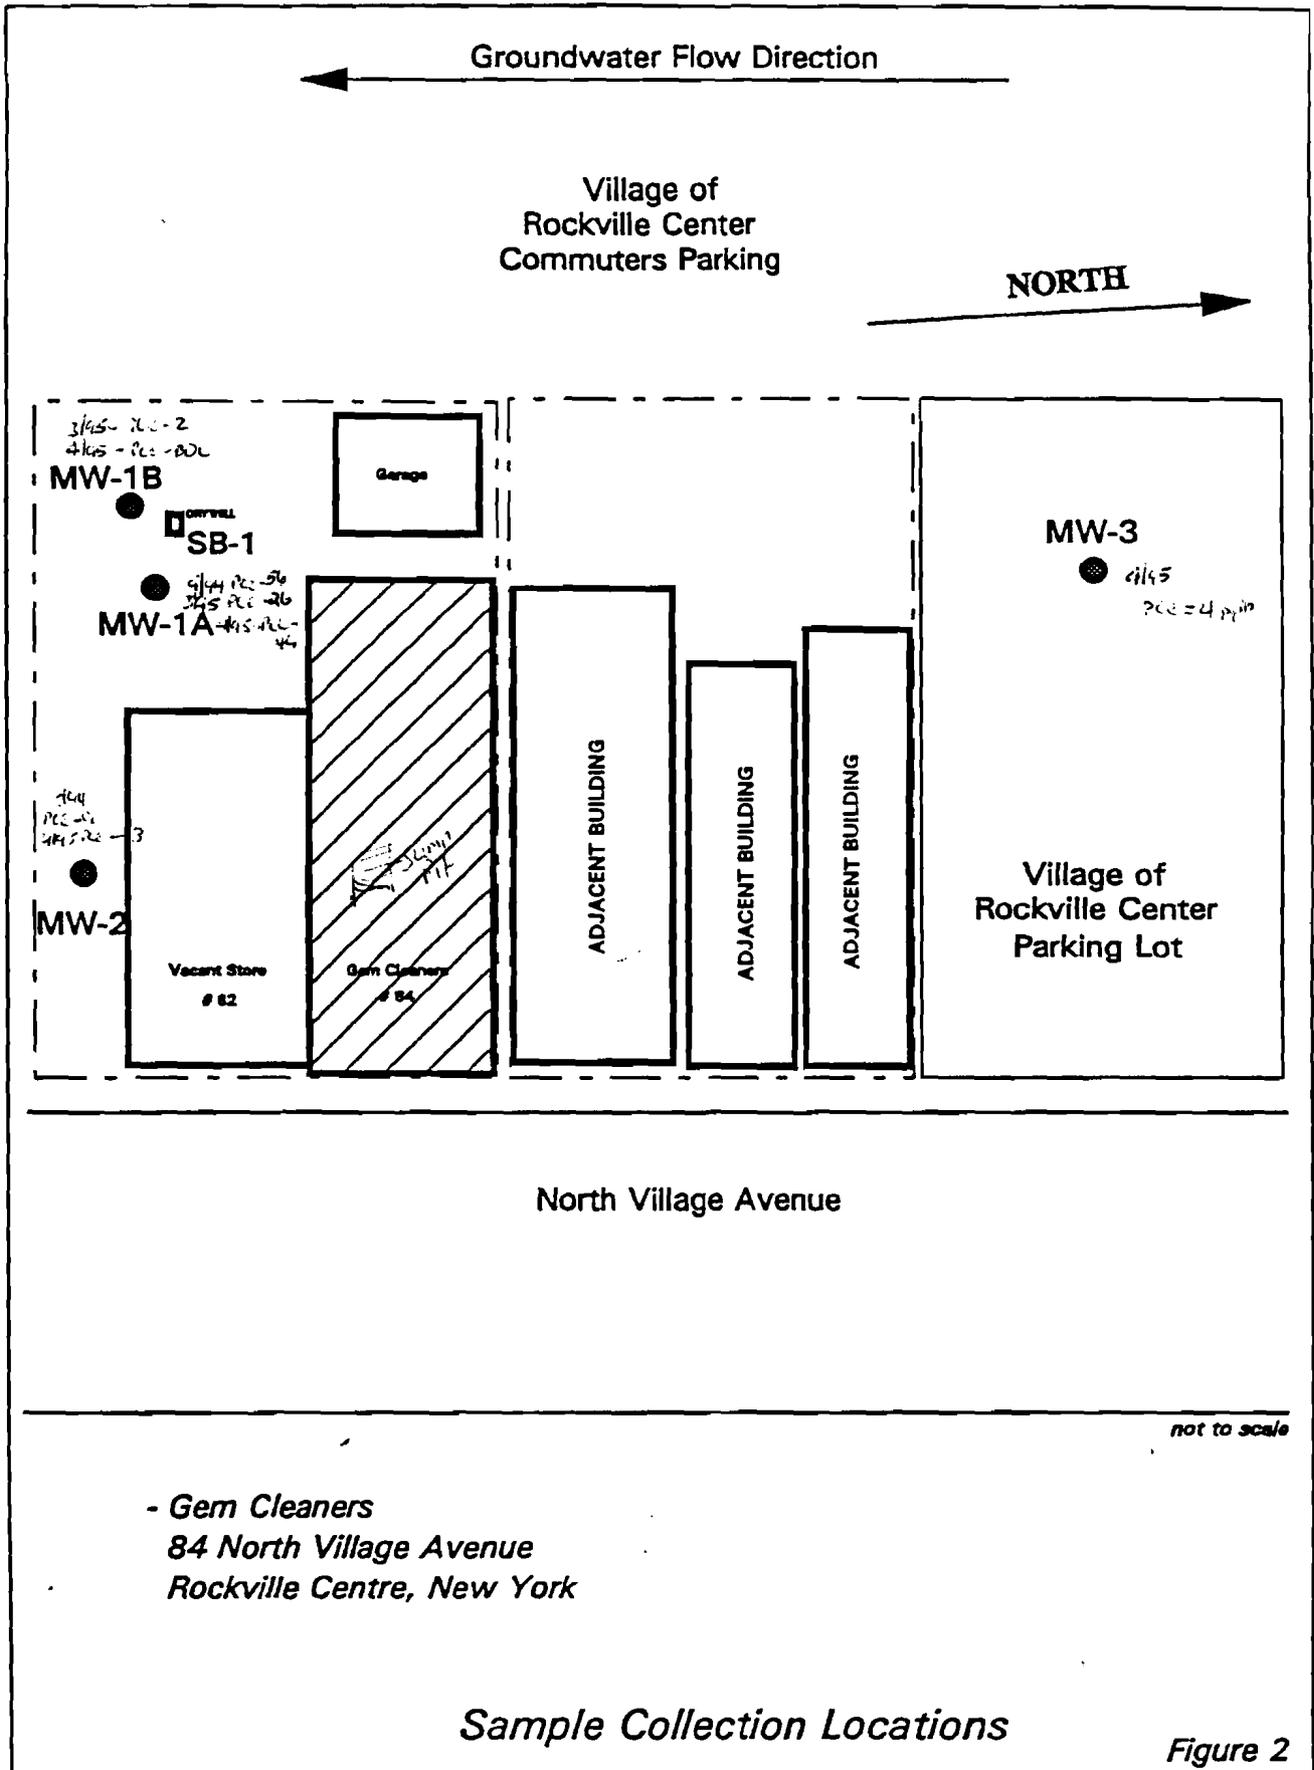
Figure 2

The results of soil and groundwater samples were prepared by EcoTest Laboratories, Inc. (New York State certified laboratory). The tables below present a summary of the results. The chain-of-custody records, as well as the analytical laboratory data sheets, are presented in the Appendix to this report. The sample collection locations are shown on Figures 1 and 2.
