Prepared for:
Superfund Standby Program
NYSDEC
Albany, NY

Prepared by:
AECOM
Chestnut Ridge, NY
60250556
May 2013

2013 Periodic Review Report
Farmingdale Plaza Cleaners Site,
Site #1-30-107
Work Assignment No. D007626-14

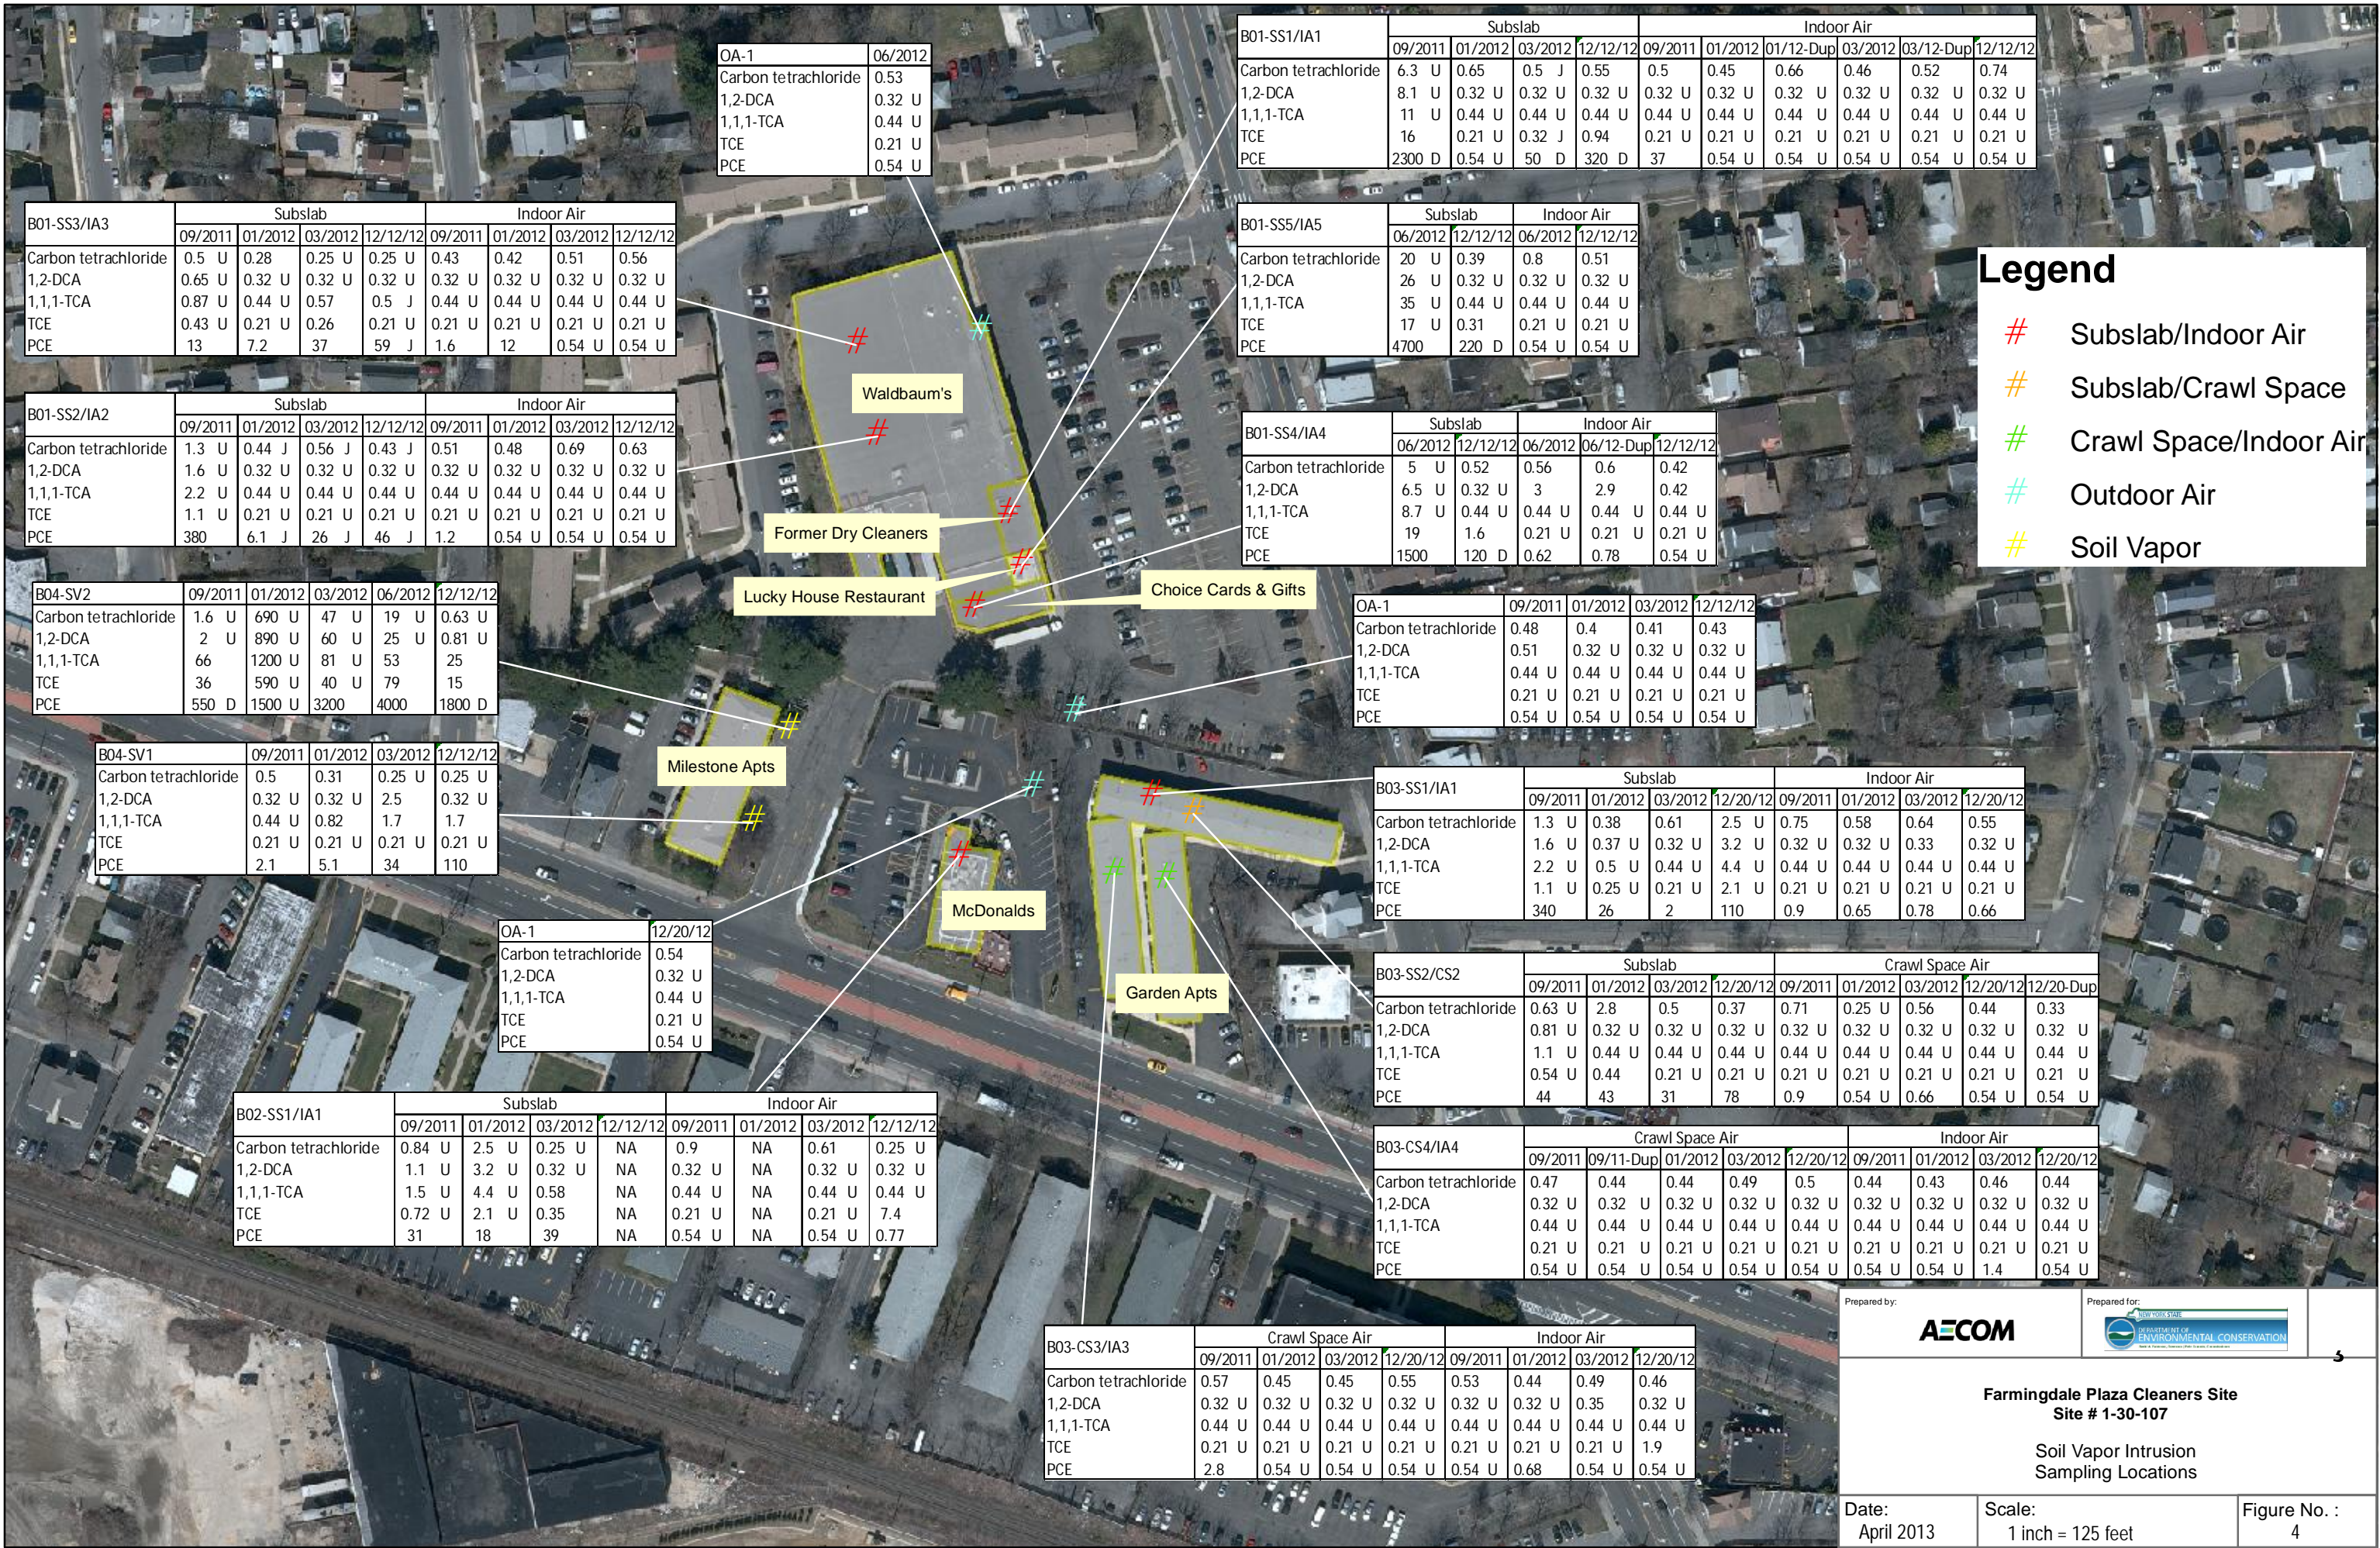
Date: April 2013 Scale: 1 inch = 125 feet Figure No.: 4

PCE soil vapor concentrations continue to exceed the NYSDOH criterion at several locations, the highest of which are the soil vapor points near the Milestone Apartments (1,800 µg/m³ at B04-SV2). Rebound was noted in the PCE concentrations during the December 2012 sampling event compared to the March 2012 results for several locations including the former Waldbaum's samples, the former dry cleaners and the Garden Apartments. Some areas may require additional assessment of soil vapor concentrations.
