MEMORANDUM

SUBJECT: VOC Groundwater Sampling April 2023

Site Name: Farmingdale Plaza Cleaners **Site Code:** 130107

DATE: September 12, 2023

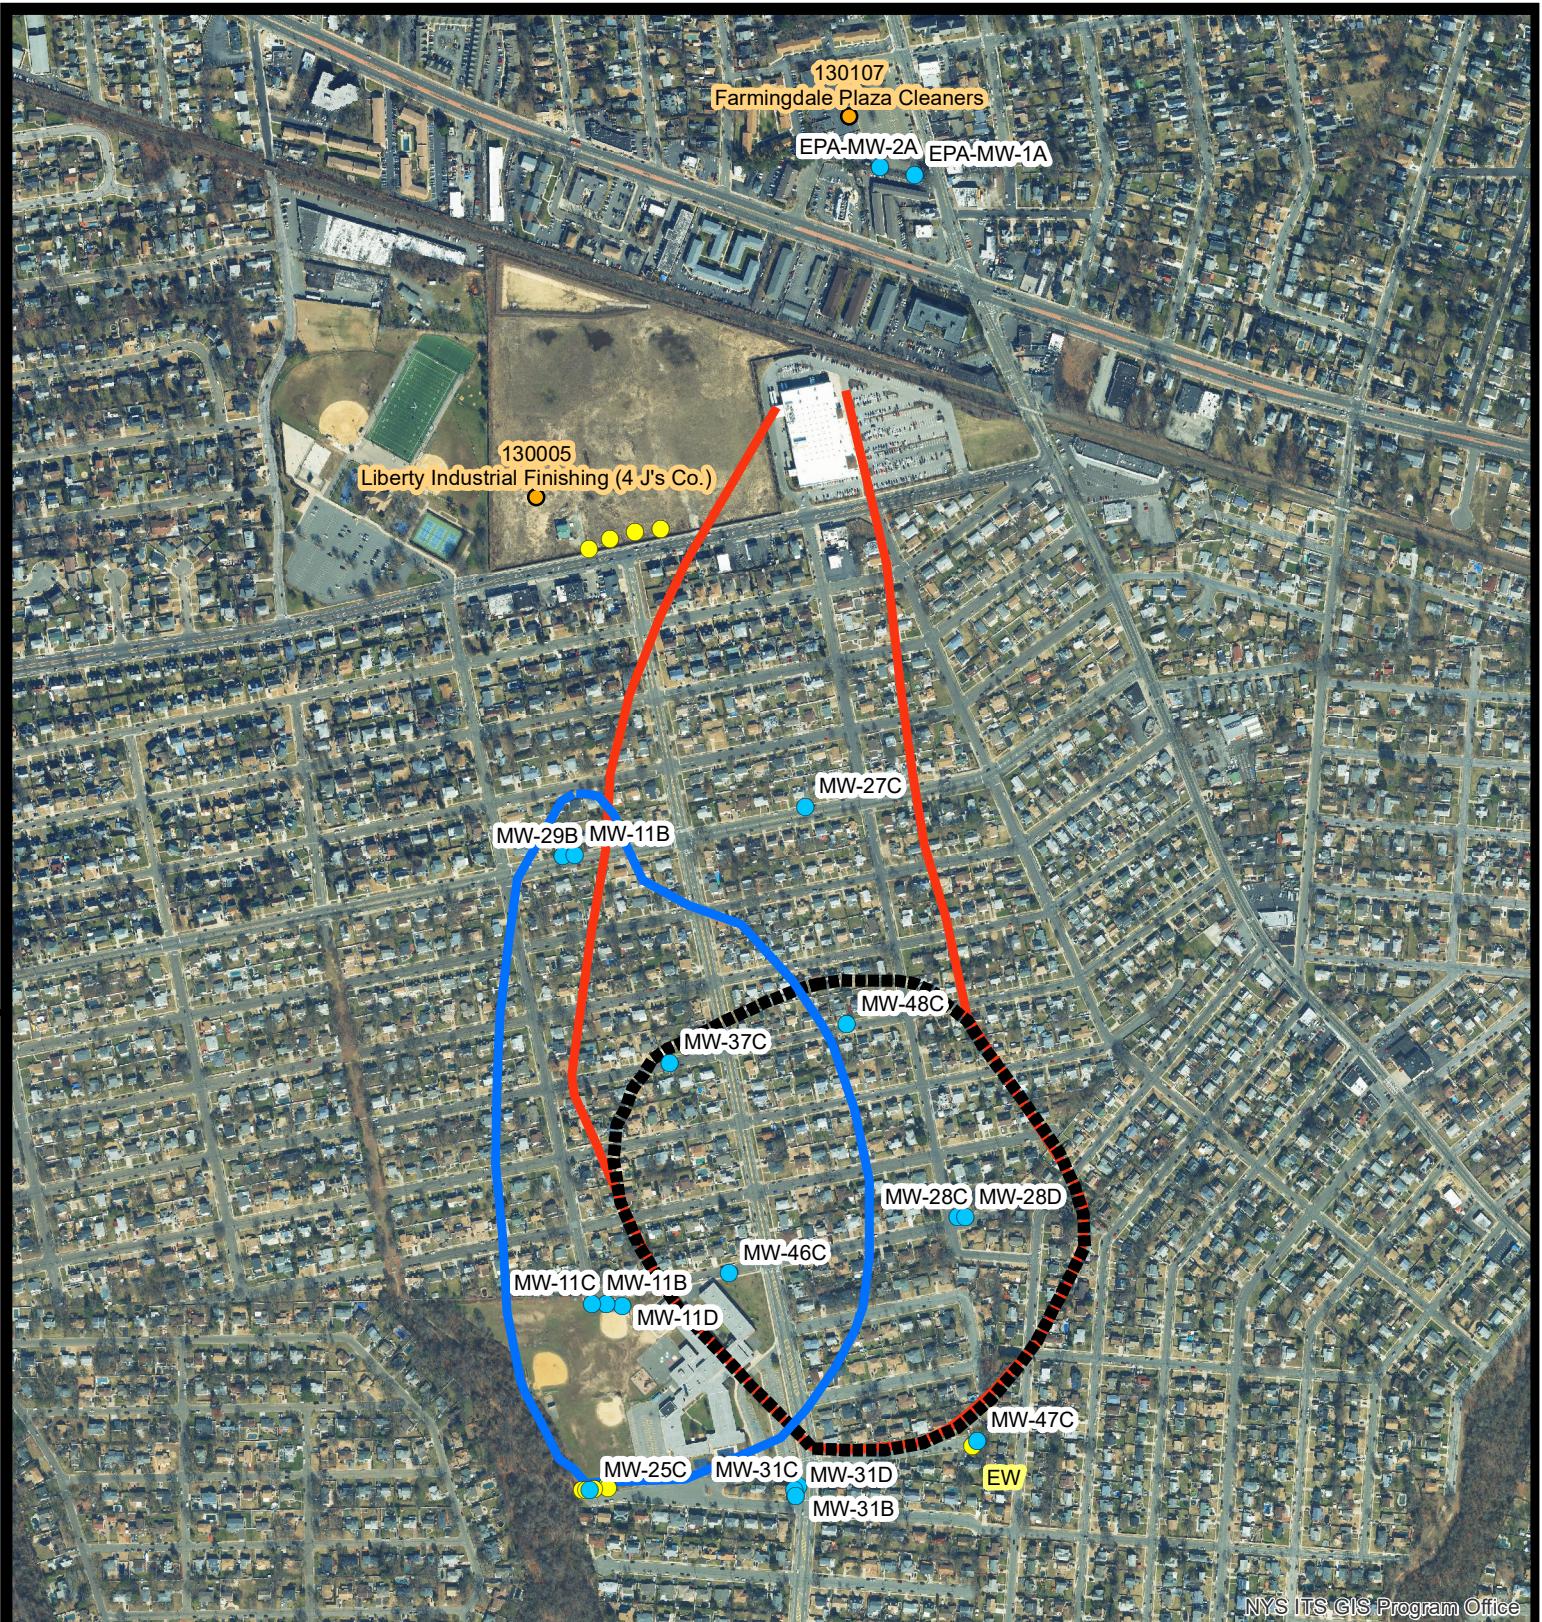
Figure 1: Plume Map
Farmingdale Plaza Cleaners - Farmingdale, NY
Site Number 130107

Figure 1 shows both sites, plumes A and B, extraction wells, and some of the monitoring wells. Figure 1 Plume A 2012 reflects TCE extents presented in the 2013 Remedial Investigation Report based on 2012 data. Figure 1 also presents two years of Plume B data that represent data from 2012 and 2017. Plume B 2012 reflects PCE extents presented in the 2013 Remedial Investigation Report. Plume B 2017 incorporates PCE data from 2012 and 2017 to provide an updated representation of groundwater conditions. The modification to Plume B extents was based on 2017 groundwater concentrations from MW-48C, which were slightly above groundwater criteria and permitted the northern extents of PCE contamination to be adjusted south.

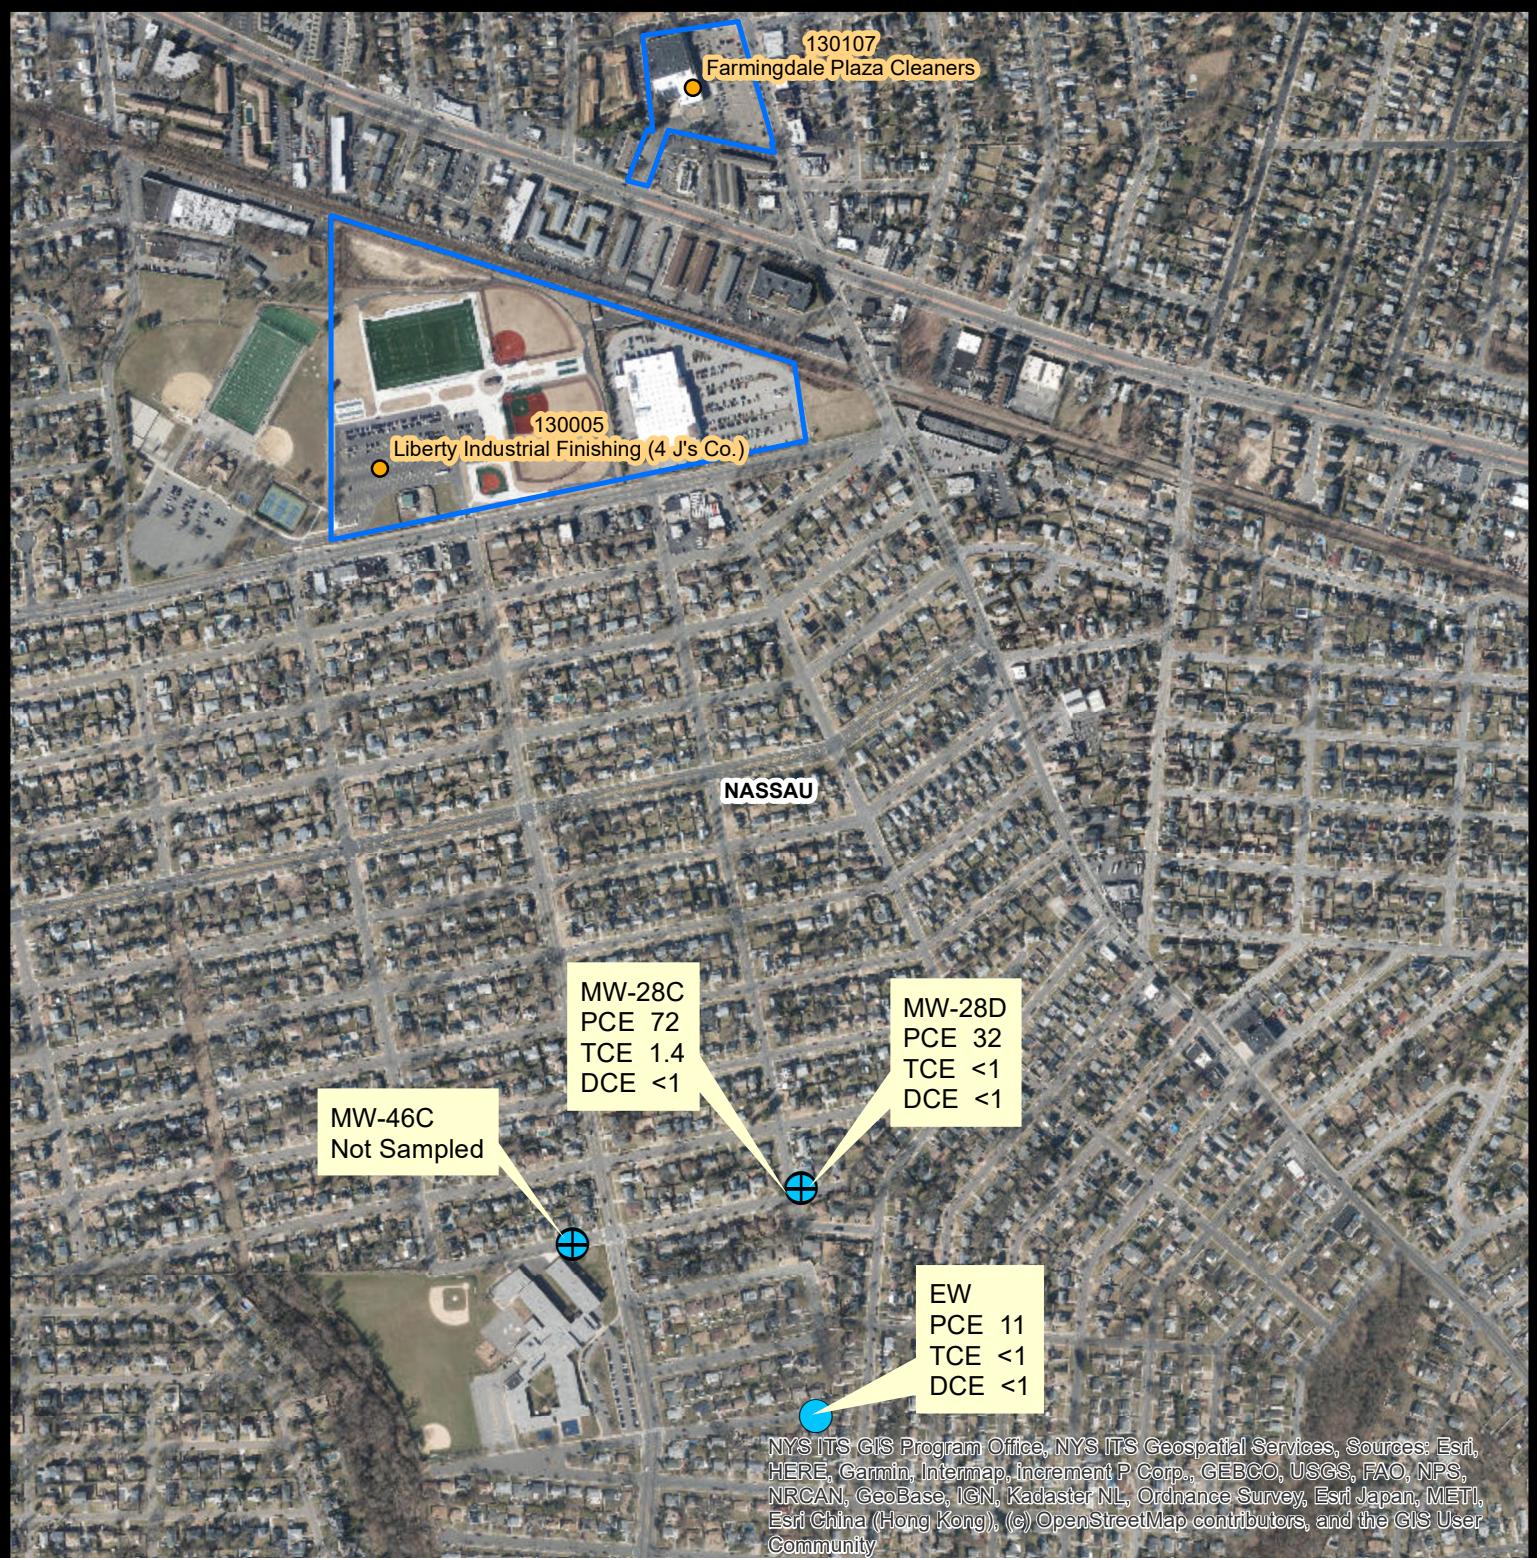
Figure 2: Groundwater Results - April 2023
Farmingdale Plaza Cleaners - Farmingdale, NY
Site Number 130107

A groundwater sampling event was performed to assess site contaminants from select wells, identified as MW-28C, MW-28D, and EW, see Figure 2 for locations. On March 23, 2023, passive

The April 2023 groundwater analytical results are presented in Table 1. The highest PCE concentration was 72 micrograms per liter ($\mu\text{g/l}$) at MW-28C, which is above the groundwater standard of 5 $\mu\text{g/l}$. MW-28D contained PCE at 32 $\mu\text{g/l}$. The concentration of PCE at the extraction well location was 11 $\mu\text{g/l}$, which is slightly above the groundwater standard. Minor detections of PCE breakdown products were detected within Plume B. Figure 2 shows site contamination detected.

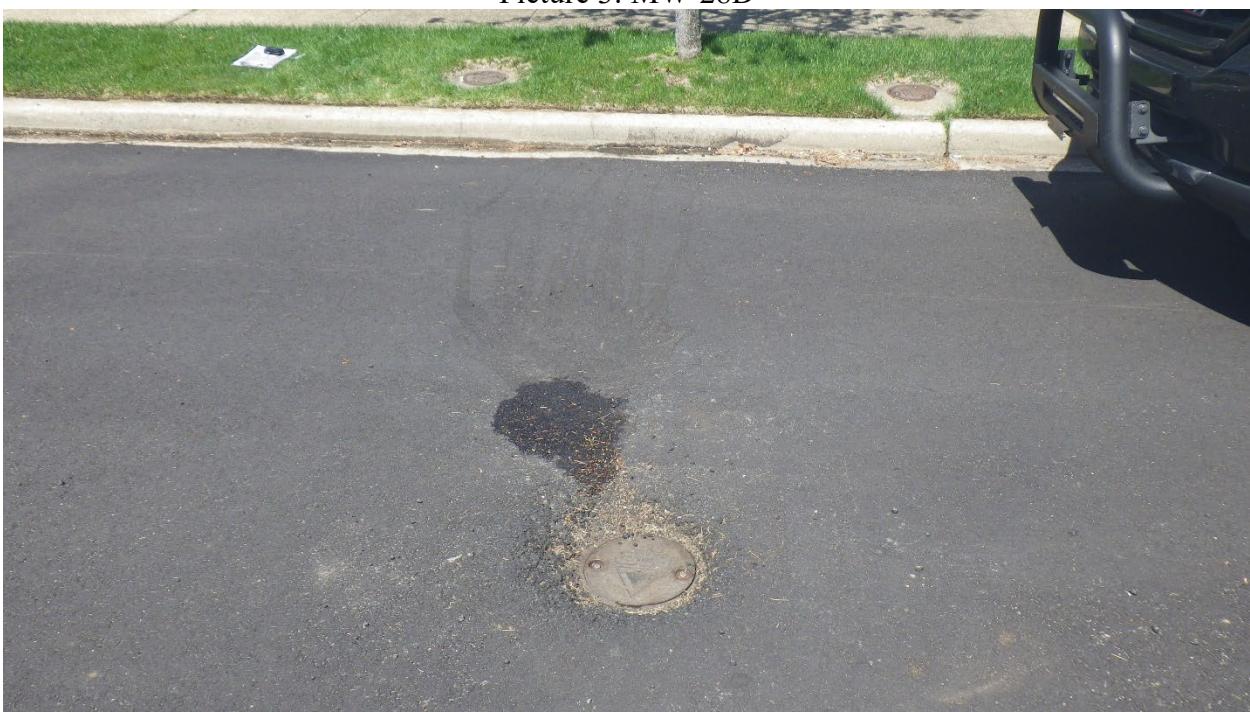
Picture 3: MW-28D

The eastern end of Spielman Avenue, which includes MW-28D, was paved. The monitoring well was still accessible but the flushmount must be reset so it is flush with the pavement. An assessment of the monitoring well network was performed to determine if any additional flushmount repairs were warranted. Flushmounts at twelve locations off-site and five locations on-site required further repairs to secure the flushmount cover. Groundwater & Environmental Services, Inc. (GES) was tasked with evaluating the flushmounts and performing the necessary repairs to secure the cover. In August 2023, GES mobilized and completed basic repairs (e.g., replaced bolts) at DEC-MW-3, EPA-MW-1A, EPA-MW-8A, MW-22A/B, MW-27C, MW-28 B/C, MW-29C/D, MW-31 B/C/D, MW-37C/D, MW-46C/D, MW-47C, MW-48C, WMW-1, two unknown wells. An additional mobilization will be performed to reset flushmounts that have broken bolt ears (EPA-0S-3A and EPA-MW-8A), broken concrete pad (EPA MW 1B), recessed (MW-28D and MW-37C), raised (MW-37D), have the wrong lid (EPA-MW-4A), or is missing a lid and filled in with soil/debris (unknown well). Some of these repairs will occur at locations where initial repairs were performed to secure the cover. GES field notes are included in Appendix C.

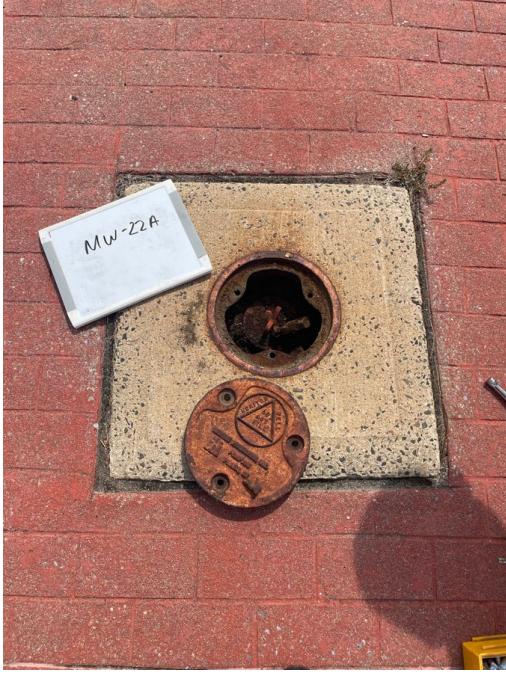
Client: New York State DEC		Project: 1102851/08/207
Site Name: NYSDEC Farmingdale Plaza Cleaners		Site Location: 450 Main Street, Farmingdale, NY
Photo #:	1	
Date:	08/21/2023	
Direction:	NA	
Comments: MW-22A in median. 3 bolts missing. Vault and lid in good condition. Concrete pad in good condition. **Bolts need to replaced with 1/2"**

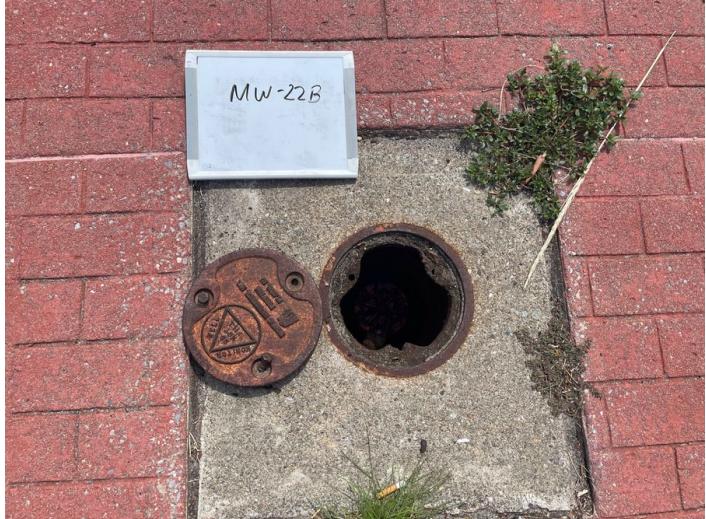
Client: New York State DEC		Project: 1102851/08/207
Site Name: NYSDEC Farmingdale Plaza Cleaners		Site Location: 450 Main Street, Farmingdale
Photo #:	2	
Date:	08/21/2023	
Direction:	NA	
Comments: MW-22B in median. 3 bolts missing. Vault and lid in good condition. Concrete pad in good condition. **Bolts need to replaced with 1/2"**

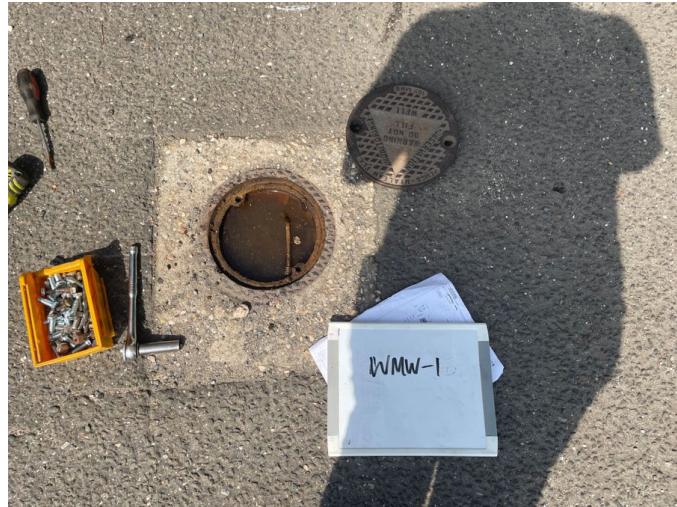
Client: New York State DEC Site Name: NYSDEC Farmingdale Plaza Cleaners	Project: 1102851/08/207 Site Location: 450 Main Street, Farmingdale
Photo #: 3 Date: 08/21/2023 Direction: NA Comments: <p>WMW-1 in parking lot. 2 bolts missing. Vault filled with water, some tubing in vault. lid in good condition. Concrete pad in ok condition.</p>

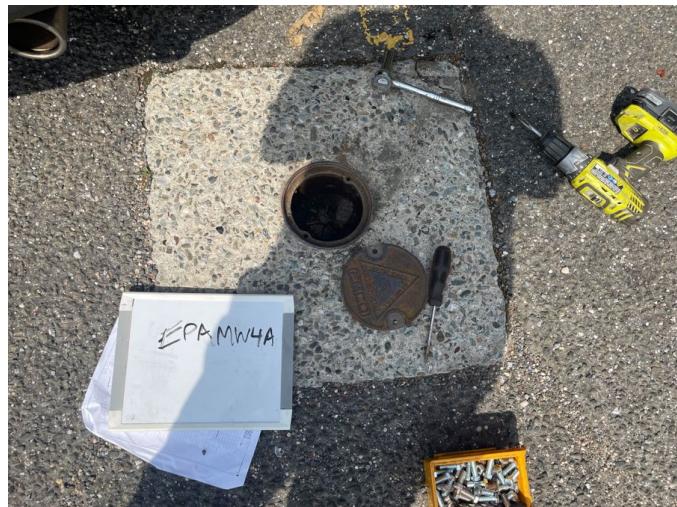
Client: New York State DEC Site Name: NYSDEC Farmingdale Plaza Cleaners	Project: 1102851/08/207 Site Location: 450 Main Street, Farmingdale
Photo #: 4 Date: 08/21/2023 Direction: NA Comments: <p>EPA-MW-4A in parking lot. Small diameter well missing bolts of unknown size. Current lid does not line up with bolt ears in vault. Concrete pad in good condition.</p>

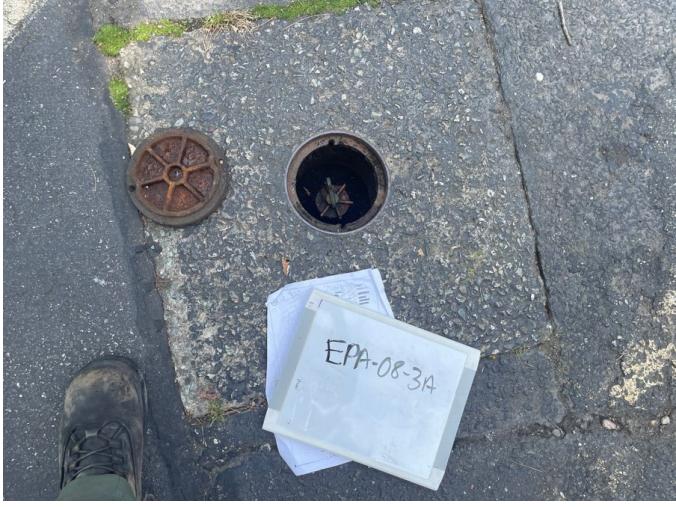
Client: New York State DEC Site Name: NYSDEC Farmingdale Plaza Cleaners	Project: 1102851/08/207 Site Location: 450 Main Street, Farmingdale
Photo #: 9 Date: 08/21/2023 Direction: NA Comments: EPA-0S-3A in parking lot. Small diameter well missing bolts of unknown size. Lid and vault have broken bolt ears. Concrete pad in good condition.

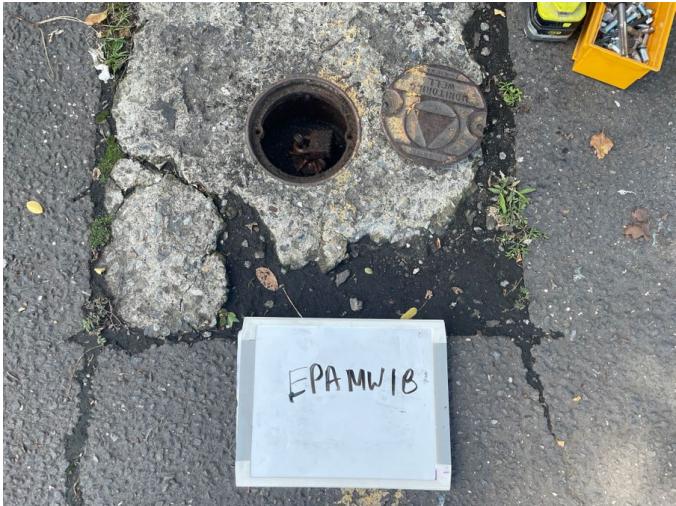
Client: New York State DEC Site Name: NYSDEC Farmingdale Plaza Cleaners	Project: 1102851/08/207 Site Location: 450 Main Street, Farmingdale
Photo #: 10 Date: 08/21/2023 Direction: NA Comments: EPA-MW-1B in parking lot. Small diameter well missing bolts of unknown size. Lid and vault have broken bolt ears. Concrete pad is broken and cracked.

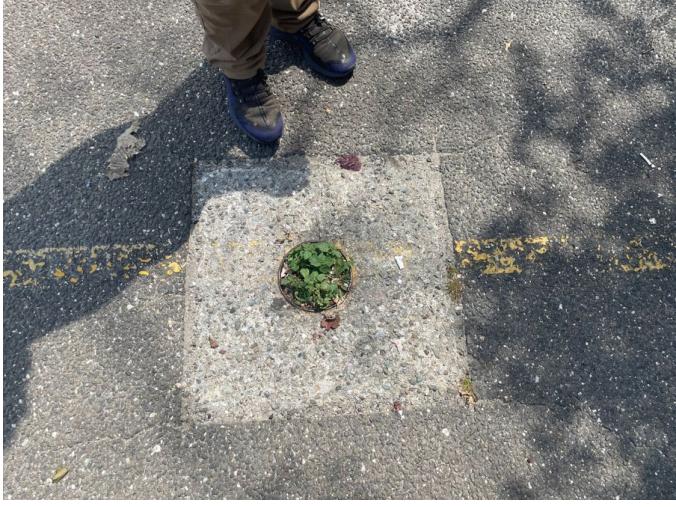
Client: New York State DEC Site Name: NYSDEC Farmingdale Plaza Cleaners	Project: 1102851/08/207 Site Location: 450 Main Street, Farmingdale
Photo #: 11 Date: 08/21/2023 Direction: NA Comments: Well of unknown ID in parking lot. No lid, vault grown over.

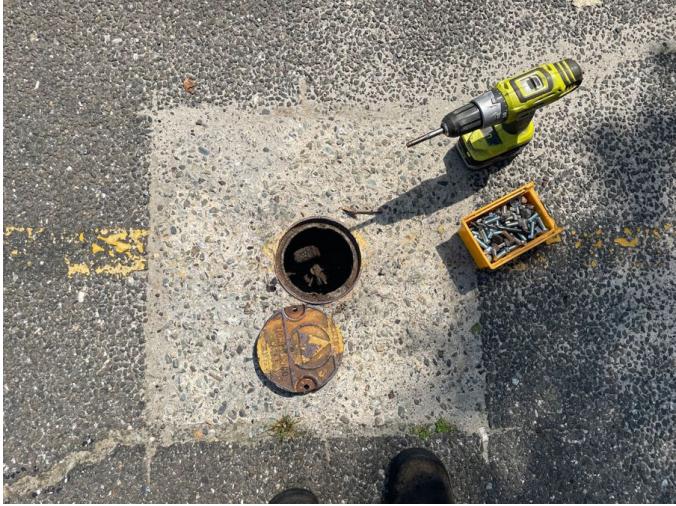
Client: New York State DEC Site Name: NYSDEC Farmingdale Plaza Cleaners	Project: 1102851/08/207 Site Location: 450 Main Street, Farmingdale
Photo #: 12 Date: 08/21/2023 Direction: NA Comments: Well of unknown ID in parking lot. Needs bolts for smaller diameter vault.

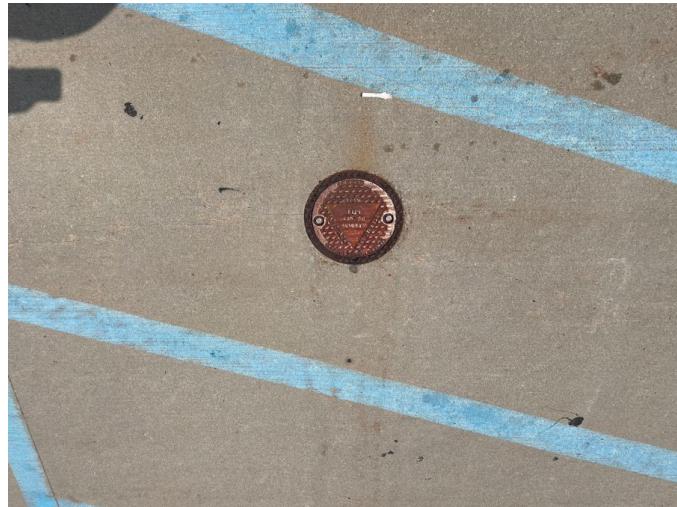
Client: New York State DEC Site Name: NYSDEC Farmingdale Plaza Cleaners	Project: 1102851/08/207 Site Location: 450 Main Street, Farmingdale
Photo #: 13 Date: 08/21/2023 Direction: NA Comments: Well of unknown ID in CVS parking lot in good condition.

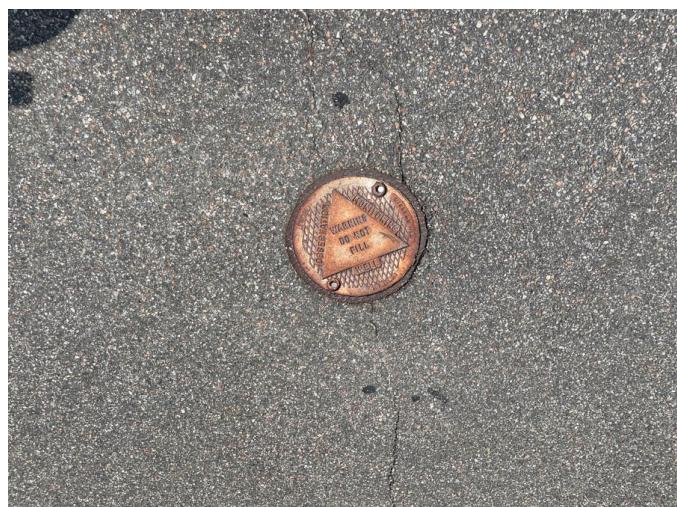
Client: New York State DEC Site Name: NYSDEC Farmingdale Plaza Cleaners	Project: 1102851/08/207 Site Location: 450 Main Street, Farmingdale
Photo #: 14 Date: 08/21/2023 Direction: NA Comments: Well of unknown ID in CVS parking lot in good condition.

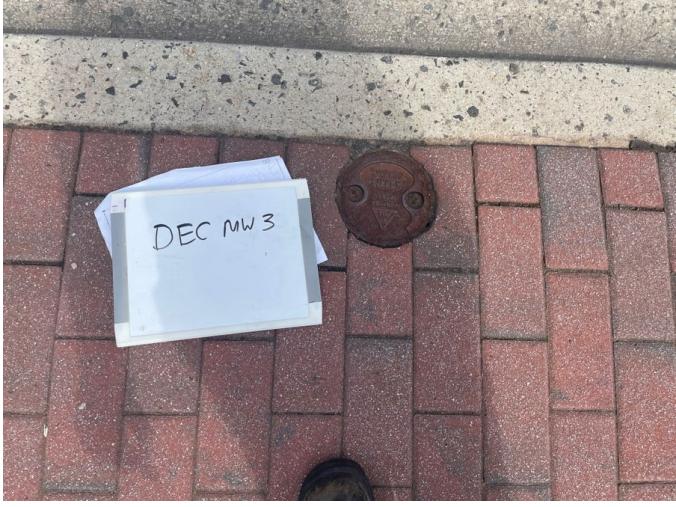
Client: New York State DEC Site Name: NYSDEC Farmingdale Plaza Cleaners	Project: 1102851/08/207 Site Location: 450 Main Street, Farmingdale
Photo #: 15 Date: 08/21/2023 Direction: NA Comments: DEC-MW-3 in sidewalk. Missing 2 bolts. Vault filled in with soil and has no bolt ears. Well has PVC cap not plug. No concrete pad (in brick sidewalk).

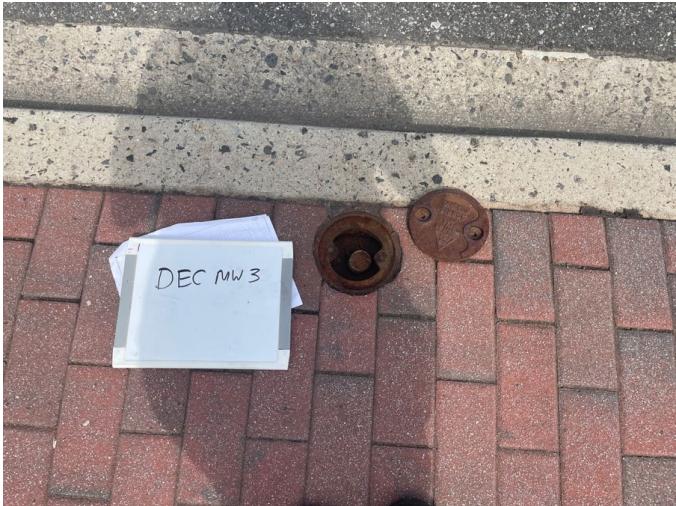
Client: New York State DEC Site Name: NYSDEC Farmingdale Plaza Cleaners	Project: 1102851/08/207 Site Location: 450 Main Street, Farmingdale
Photo #: 16 Date: 08/21/2023 Direction: NA Comments: DEC-MW-3 in sidewalk. Missing 2 bolts. Vault filled in with soil and has no bolt ears. Well has PVC cap not plug. No concrete pad (in brick sidewalk).

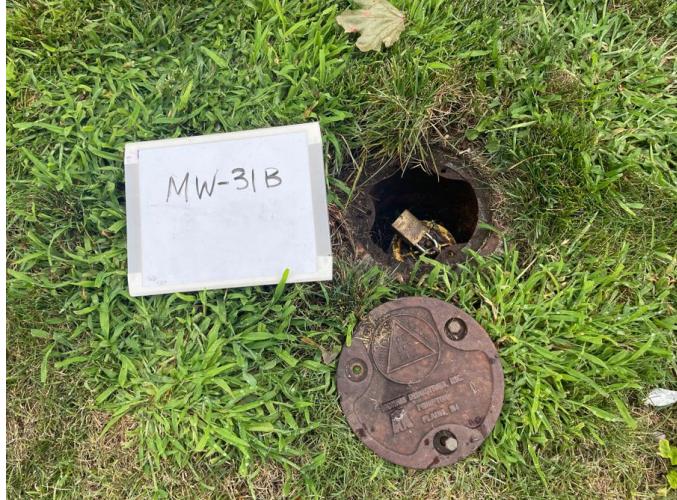
Client: New York State DEC Site Name: NYSDEC Farmingdale Plaza Cleaners	Project: 1102851/08/207 Site Location: 450 Main Street, Farmingdale, NY
Photo #: 1 Date: 08/21/2023 Direction: NA Comments: MW-31B in grass. Missing 2 bolts. Vault and lid in good condition. Concrete pad covered by grass.

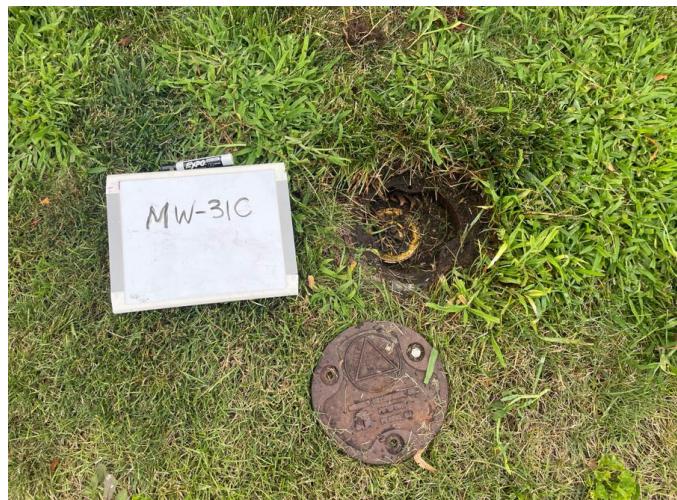
Client: New York State DEC Site Name: NYSDEC Farmingdale Plaza Cleaners	Project: 1102851/08/207 Site Location: 550 Main Street, Farmingdale, NY
Photo #: 2 Date: 08/21/2023 Direction: NA Comments: MW-31C in grass. Missing 2 bolts. Vault filled with soil but not covering top of casing. Lid in good condition. Concrete pad covered by grass.

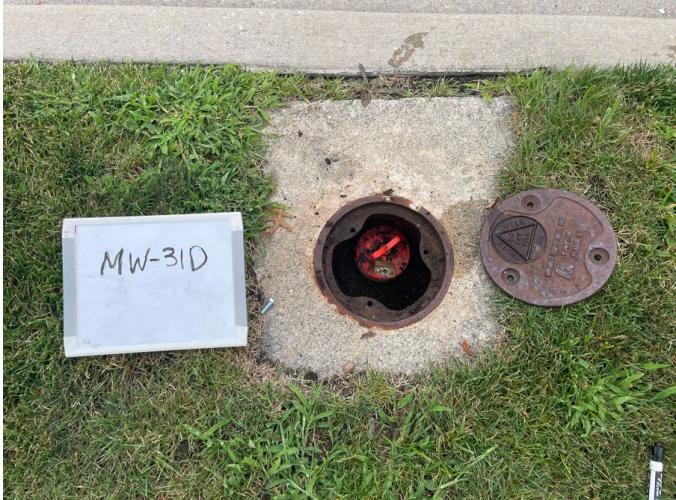
Client: New York State DEC		Project: 1102851/08/207
Site Name: NYSDEC Farmingdale Plaza Cleaners		Site Location: 550 Main Street, Farmingdale, NY
Photo #:	3	
Date:	08/21/2023	
Direction:	NA	
Comments:		
MW-31D in grass. Missing 3 bolts. Vault and Lid in good condition. Concrete pad in good condition.

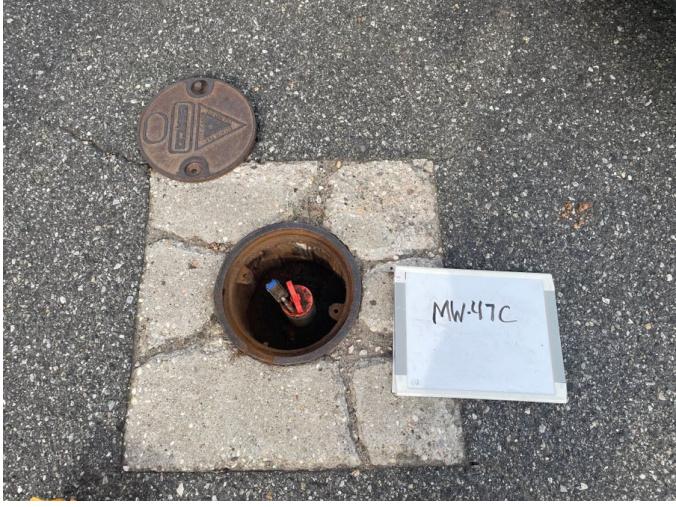
Client: New York State DEC Site Name: NYSDEC Farmingdale Plaza Cleaners		Project: 1102851/08/207 Site Location: 550 Main Street, Farmingdale, NY
Photo #:	7	
Date:	08/21/2023	
Direction:	NA	
Comments: MW-47C in street. Missing 1 bolt and other bolt stripped. Vault and Lid in good condition. Concrete pad cracked. PW-20 is well adjacent to it and concrete pad is in similar condition.

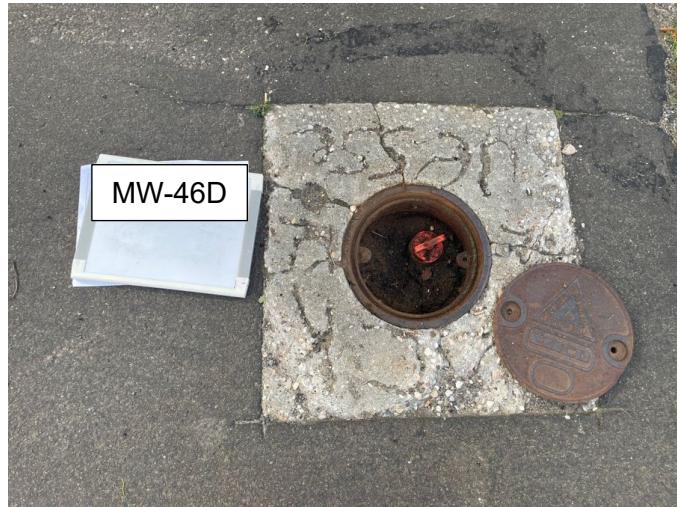
Client: New York State DEC		Project: 1102851/08/207
Site Name: NYSDEC Farmingdale Plaza Cleaners		Site Location: 550 Main Street, Farmingdale, NY
Photo #:	9	
Date:	08/21/2023	
Direction:	NA	
Comments:		
MW-46D in street. 2 bolts missing. Vault and lid in good condition. Concrete pad cracked and crumbling.

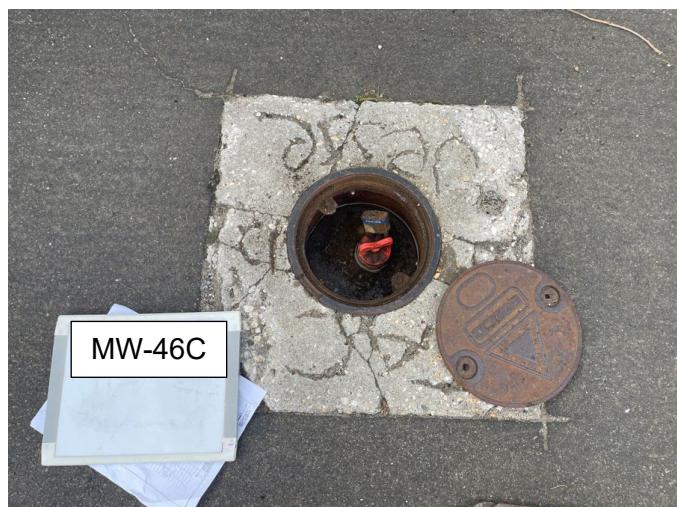
Client: New York State DEC		Project: 1102851/08/207
Site Name: NYSDEC Farmingdale Plaza Cleaners		Site Location: 550 Main Street, Farmingdale, NY
Photo #:	10	
Date:	08/21/2023	
Direction:	NA	
Comments:		
MW-46C in street. 2 bolts missing. Vault filled with water. Lid in good condition. Concrete pad cracked and crumbling.

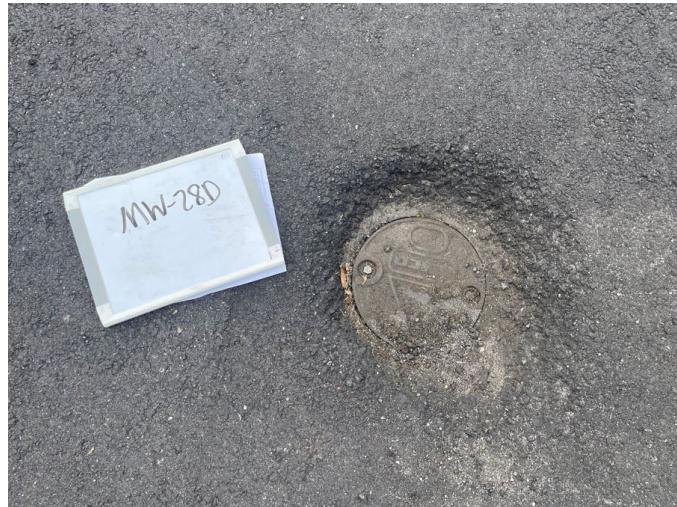
Client: New York State DEC		Project: 1102851/08/207
Site Name: NYSDEC Farmingdale Plaza Cleaners		Site Location: 550 Main Street, Farmingdale, NY
Photo #:	13	
Date:	08/21/2023	
Direction:	NA	
Comments: MW-28D in road. No concrete pad, well is approximately 2" depressed.

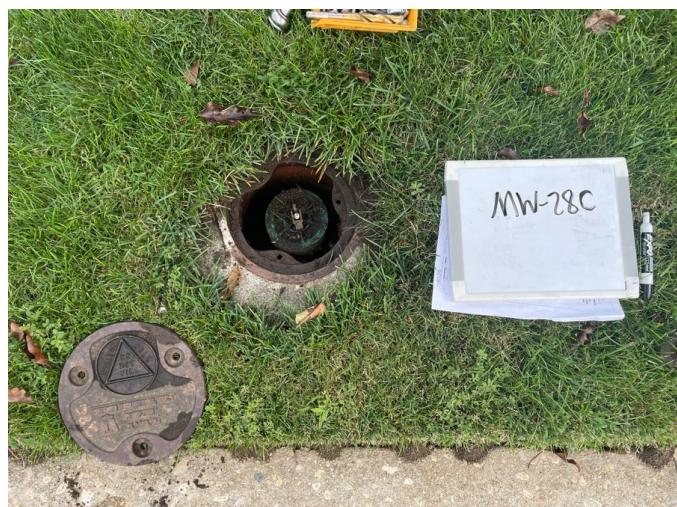
Client: New York State DEC		Project: 1102851/08/207
Site Name: NYSDEC Farmingdale Plaza Cleaners		Site Location: 550 Main Street, Farmingdale, NY
Photo #:	14	
Date:	08/21/2023	
Direction:	NA	
Comments: MW-28C in grass. 3 bolts missing. Well plug broken/missing lock. Vault and lid in good condition. Concrete pad in good condition under grass.

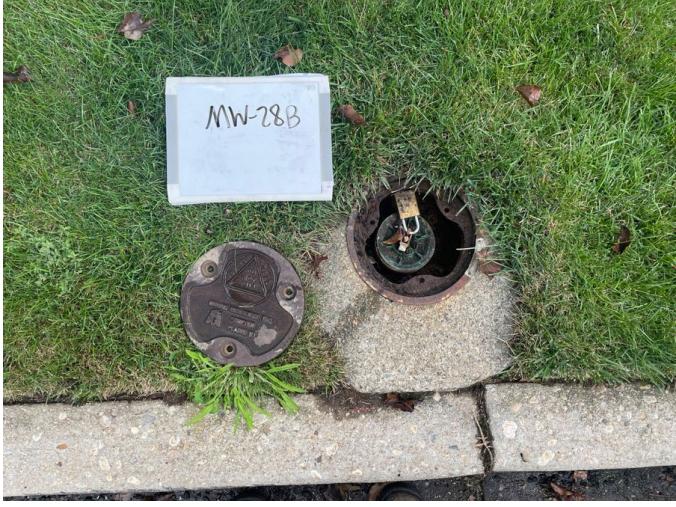
Client: New York State DEC Site Name: NYSDEC Farmingdale Plaza Cleaners	Project: 1102851/08/207 Site Location: 550 Main Street, Farmingdale, NY
Photo #: 15 Date: 08/21/2023 Direction: NA Comments: MW-28B in grass. 3 bolts missing. Vault and lid in good condition. Concrete pad in good condition under grass.

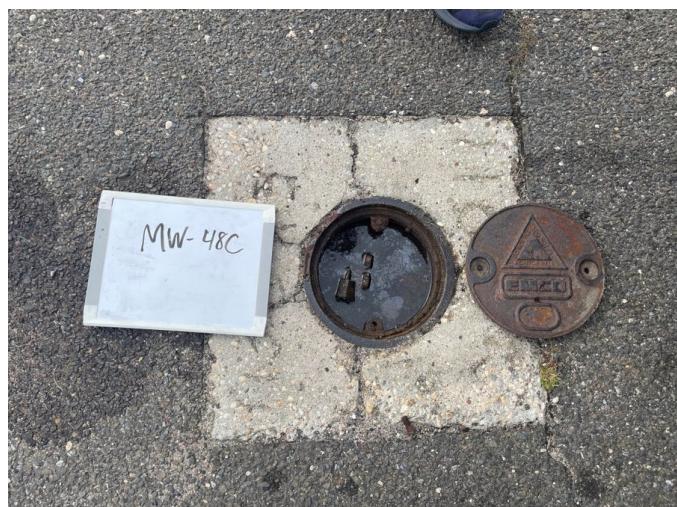
Client: New York State DEC Site Name: NYSDEC Farmingdale Plaza Cleaners		Project: 1102851/08/207 Site Location: 550 Main Street, Farmingdale, NY
Photo #:	18	
Date:	08/21/2023	
Direction:	NA	
Comments: MW-48C in street. 1 bolt missing 1 bolt broken. Vault filled with water. lid in good condition. Concrete pad cracked.

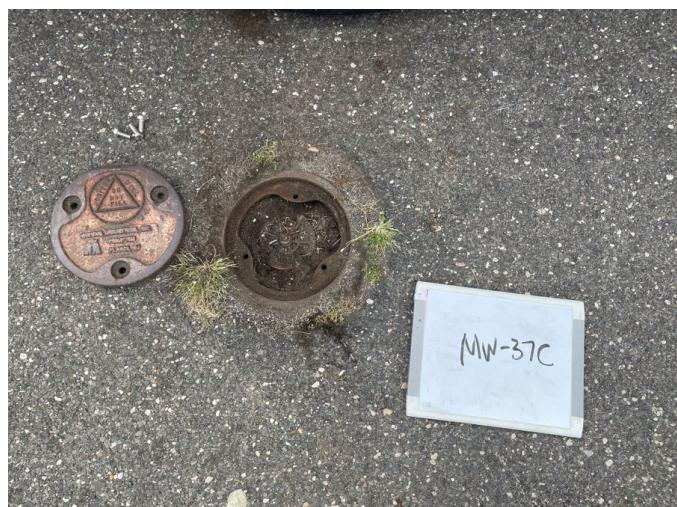
Client: New York State DEC Site Name: NYSDEC Farmingdale Plaza Cleaners	Project: 1102851/08/207 Site Location: 550 Main Street, Farmingdale, NY
Photo #:	20
Date:	08/21/2023
Direction:	NA
Comments: MW-37C in street. 3 bolts missing. Vault full of soil covering well plug and also vault is not set securely in asphalt (moving). Lid in good condition. No Concrete pad and well is sunken in 1".

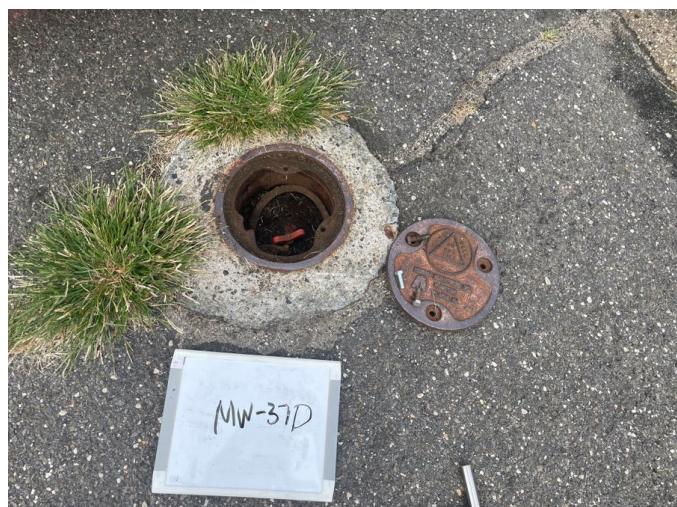
Client: New York State DEC		Project: 1102851/08/207
Site Name: NYSDEC Farmingdale Plaza Cleaners		Site Location: 550 Main Street, Farmingdale, NY
Photo #:	22	
Date:	08/21/2023	
Direction:	NA	
Comments:		
MW-37D in street. 3 bolts missing. Vault loose (moving) and one bolt ear is broken. Lid in good condition. Concrete pad raised above asphalt and in bad condition.

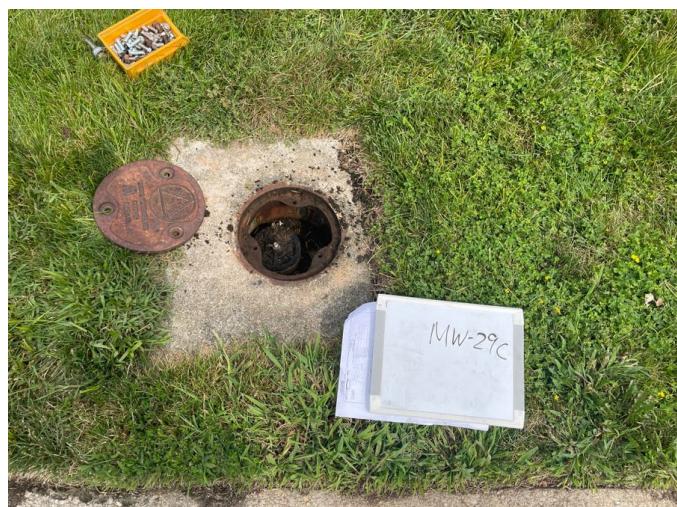
Client: New York State DEC Site Name: NYSDEC Farmingdale Plaza Cleaners	Project: 1102851/08/207 Site Location: 550 Main Street, Farmingdale, NY
Photo #:	24
Date:	08/21/2023
Direction:	NA
Comments: MW-29C in grass. 3 bolts missing. Well plug broken/missing lock. Vault and lid in good condition. Concrete pad in good condition.

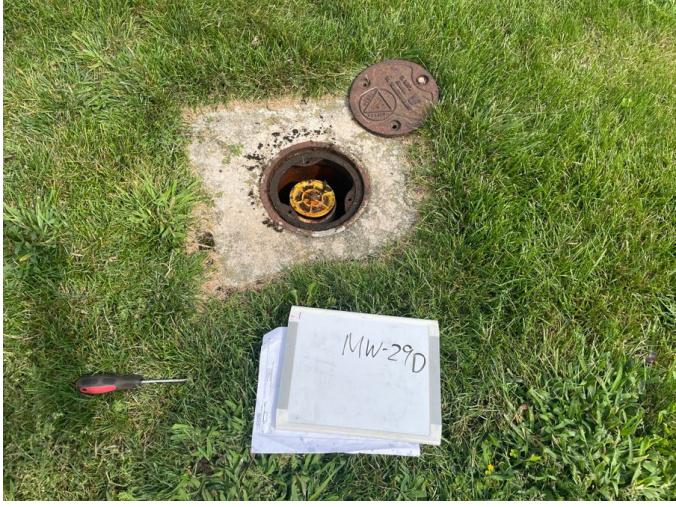
Client: New York State DEC		Project: 1102851/08/207
Site Name: NYSDEC Farmingdale Plaza Cleaners		Site Location: 550 Main Street, Farmingdale, NY
Photo #:	25	
Date:	08/21/2023	
Direction:	NA	
Comments:		
MW-29D in grass. 3 bolts missing. Well plug broken/missing lock and doesn't fit casing. Vault and lid in good condition. Concrete pad in good condition.

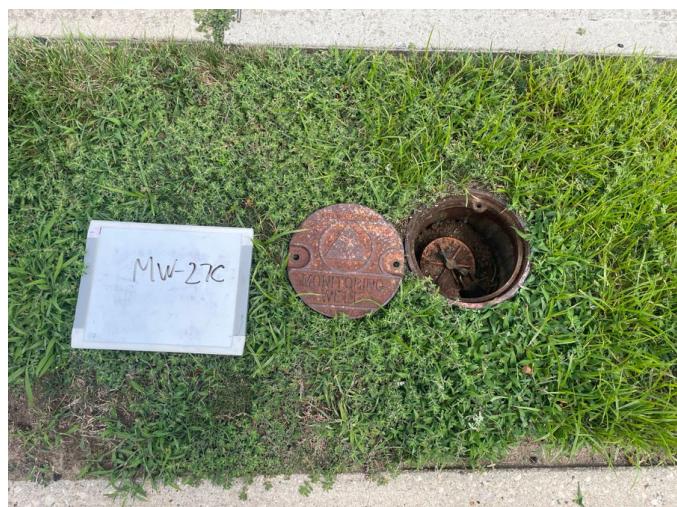
Client: New York State DEC Site Name: NYSDEC Farmingdale Plaza Cleaners		Project: 1102851/08/207 Site Location: 550 Main Street, Farmingdale, NY
Photo #:	28	
Date:	08/21/2023	
Direction:	NA	
Comments: MW-27C in grass. 2 bolts missing. Vault and lid in good condition. No Concrete pad.

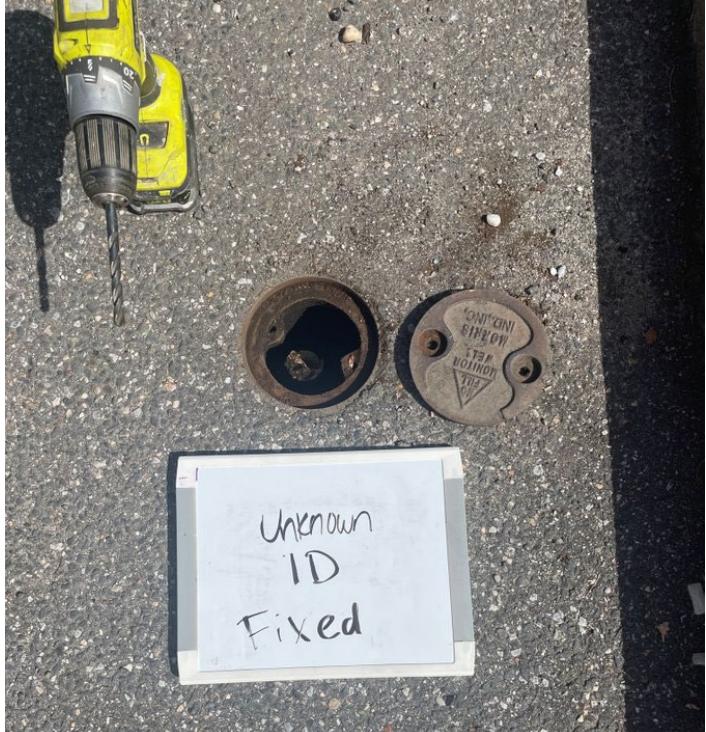
Client: New York State DEC Site Name: NYSDEC/FarmingdaleNYMainSt450		Project: 1102851/08/207 Site Location: 450 Main Street
Photo #: 4	Date: 08/31/2023

<p>Unknown well ID located adjacent to McDonalds parking lot. Missing 2 bolts.</p>
Comments: Unknown well ID located adjacent to McDonalds parking lot. Missing 2 bolts.

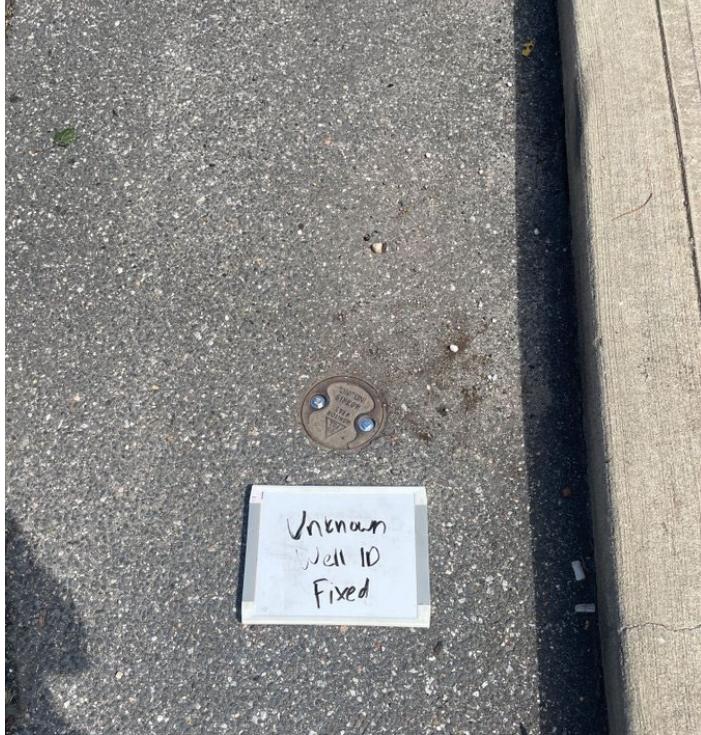
Client: New York State DEC Site Name: NYSDEC/FarmingdaleNYMainSt450		Project: 1102851/08/207 Site Location: 450 Main Street
Photo #: 5 Date: 08/31/2023 Direction: NA Comments: Unknown well ID with two (2) 3/8" bolts
