Former Fresh and Clean Laundry Site Remedial Investigation Report Site No. 130111

REMEDIAL INVESTIGATION REPORT

**FORMER FRESH & CLEAN LAUNDRY
GLEN HEAD, NEW YORK**

**D&B ENGINEERS AND ARCHITECTS
WOODBURY, NEW YORK**

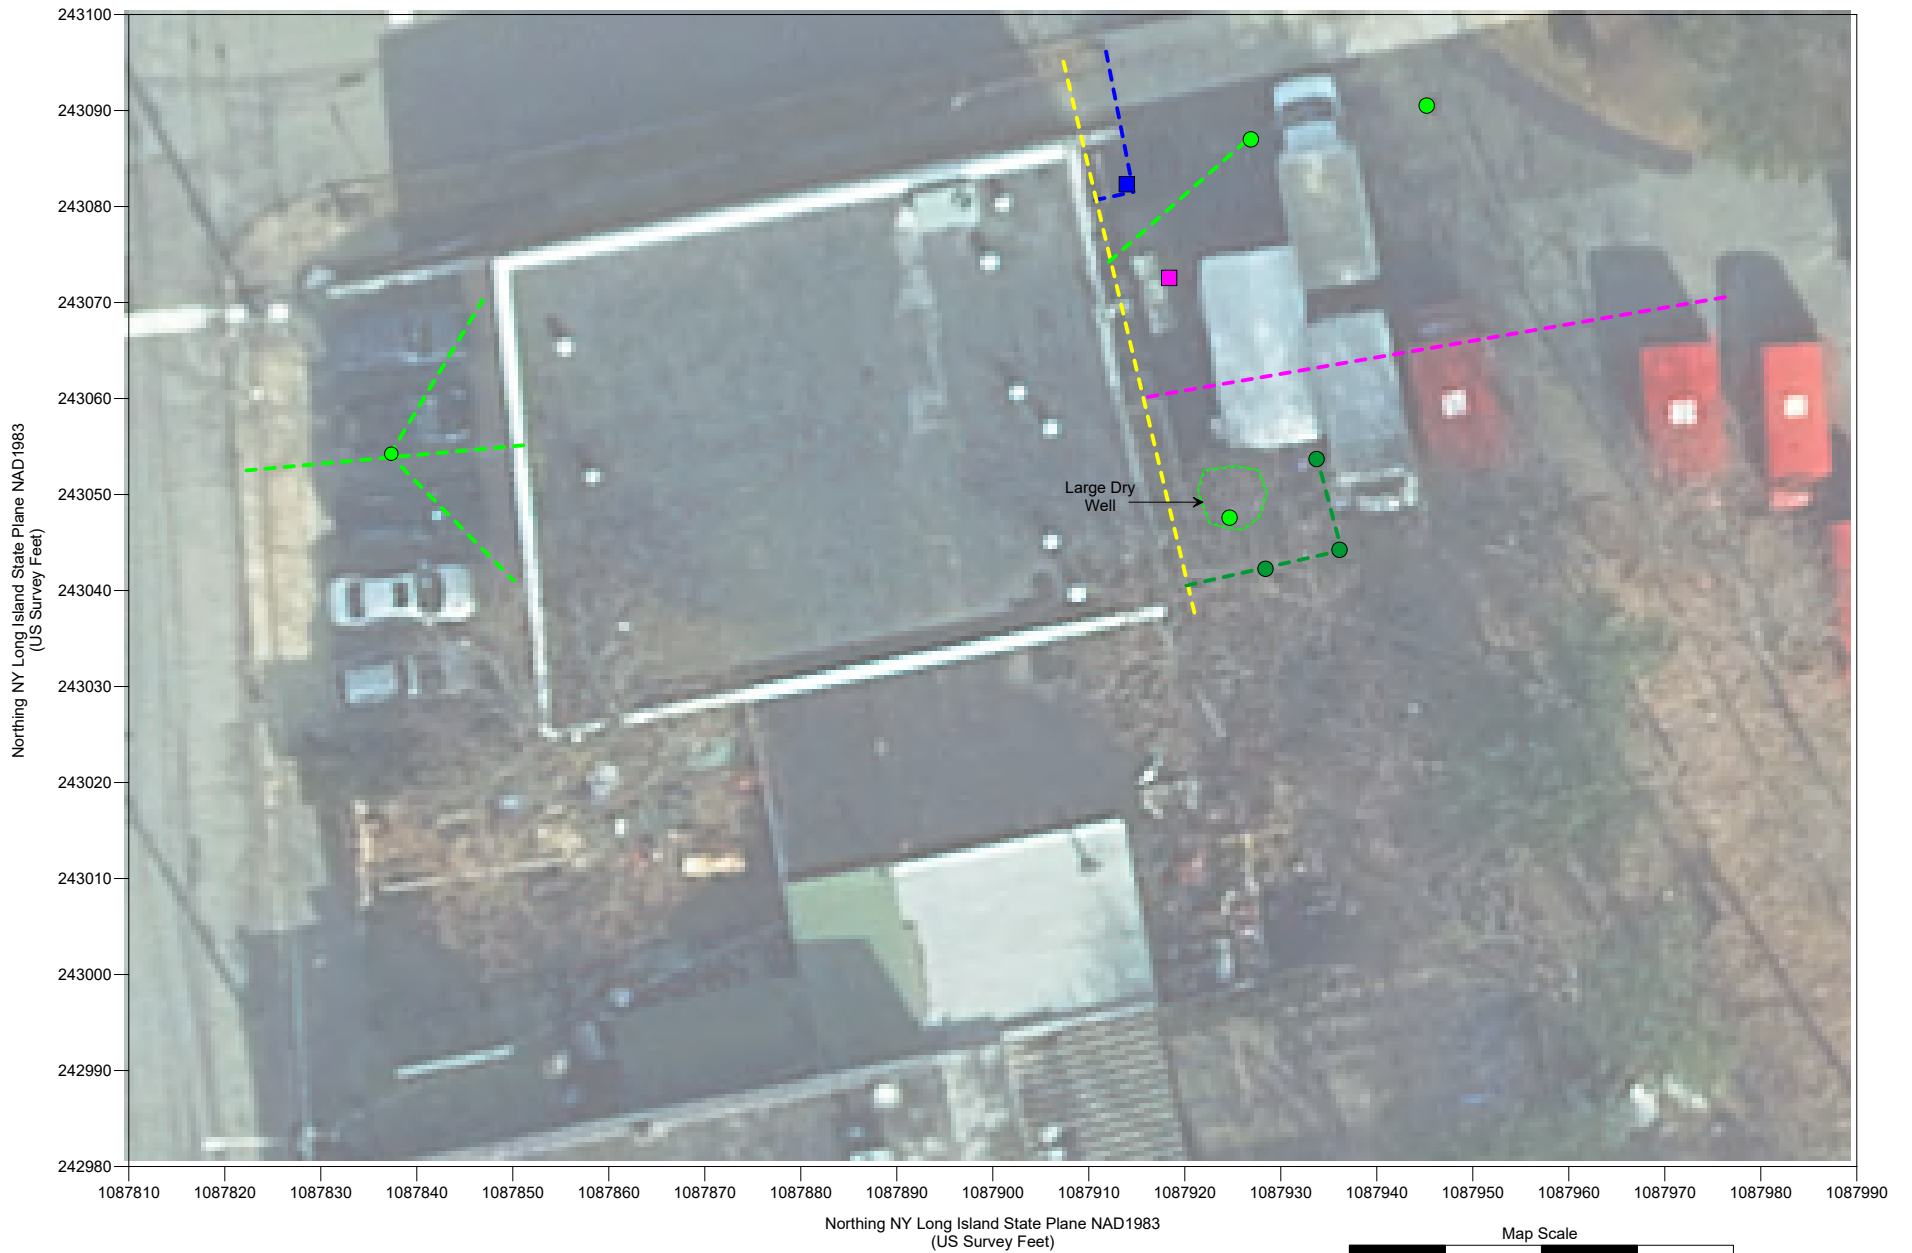
Enclosed: Figure 1

The geophysical investigation objectives were achieved utilizing the GPR and RF methods, as well as direct observation of certain features. AGS identified several storm drain lines, a water utility, a natural gas utilities, unknown utilities, and a sanitary drain/septic tank system. A large dry well was observed through it's manhole, and the approximate limits were identified using the GPR methods. A probable paved over manhole was identified with the GPR method and its true nature could not be determined during the geophysical investigation. Features identified during the geophysical investigation are represented on Figure 1.

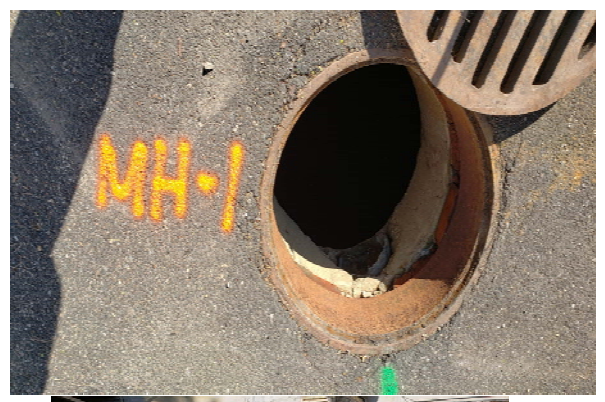
STRUCTURE SKETCH

(in feet)	Invert	NAVD88 Elev	Type
Rim		149.99	
Pipe 1	2.90	147.09	8" Dia. DIP
Pipe 2			
Pipe 3			
Pipe 4			
Pipe 5			
Pipe 6			
Structure	18.4	131.59	CONC.
Ceiling

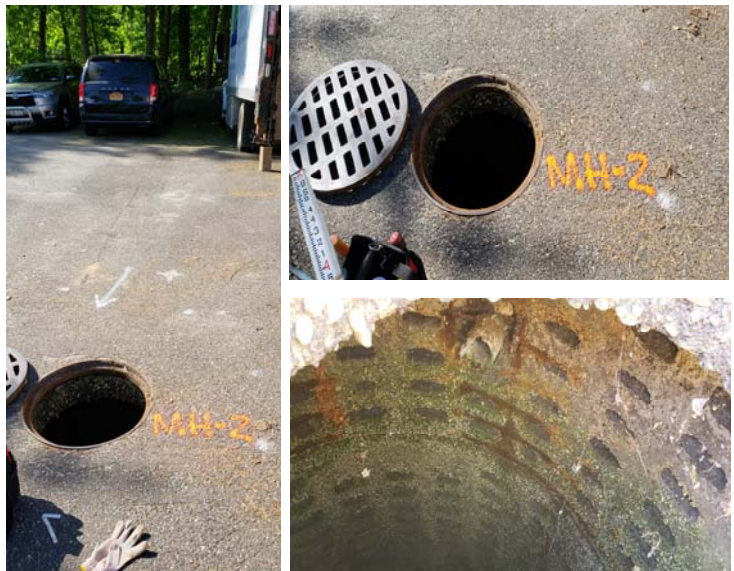
STRUCTURE SKETCH

(in feet)	Invert	NAVD88 Elev	Type
Rim		114.39	
Pipe 1	3.12	111.27	6" Dia. DIP
Pipe 2			
Pipe 3			
Pipe 4			
Pipe 5			
Pipe 6			
Structure	21.25	93.14	CONC.
Ceiling

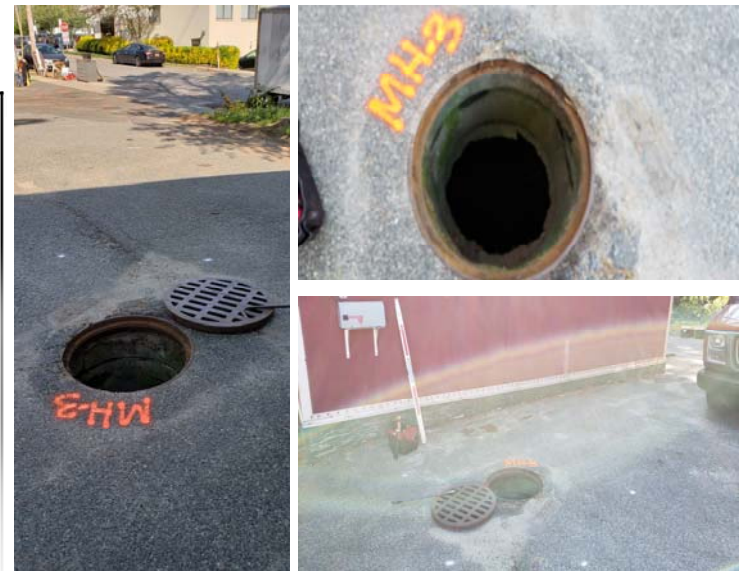
STRUCTURE SKETCH

(in feet)	Invert	NAVD88 Elev	Type
Rim		149.51	
Pipe 1			
Pipe 2			
Pipe 3			
Pipe 4			
Pipe 5			
Pipe 6			
Structure	16.47	133.04	CONC.
Ceiling

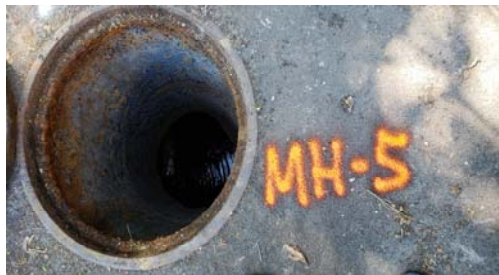
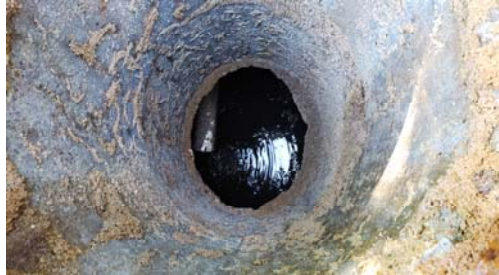
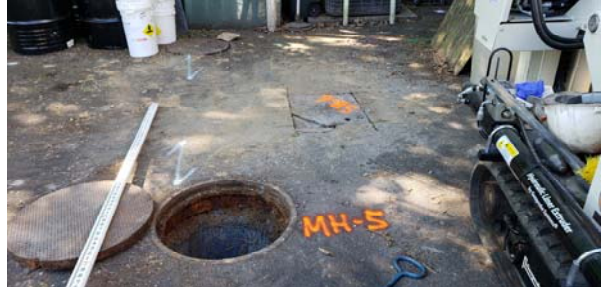
STRUCTURE SKETCH

(in feet)	Invert	NAVD88 Elev	Type
Rim		150.69	
Pipe 1	6.70	143.99	4" Dia. PVC
Pipe 2			
Pipe 3			
Pipe 4			
Pipe 5			
Pipe 6			
Structure			
Ceiling

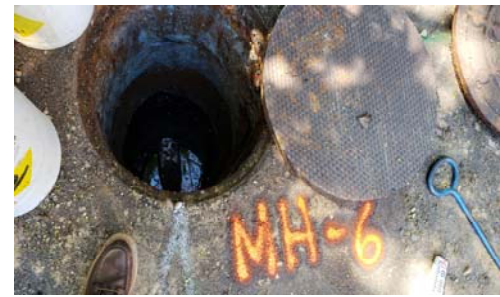
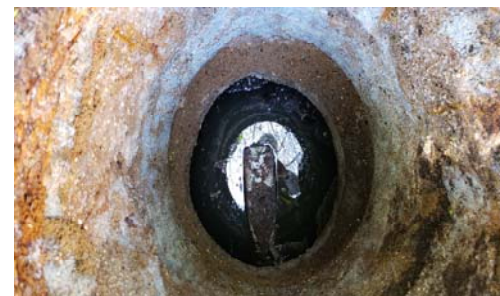
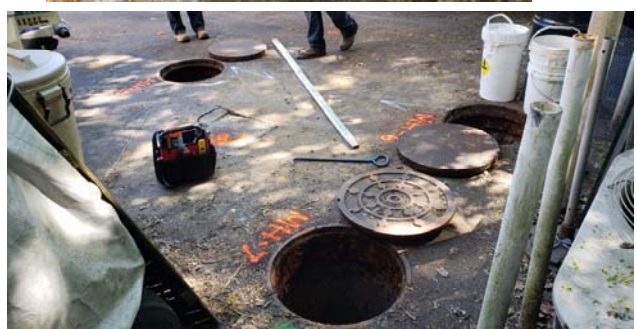
STRUCTURE SKETCH

(in feet)	Invert	NAVD88 Elev	Type
Rim		150.88	
Pipe 1	4.00	146.88	4" Dia. PVC
Pipe 2			
Pipe 3			
Pipe 4			
Pipe 5			
Pipe 6			
Structure			
Ceiling

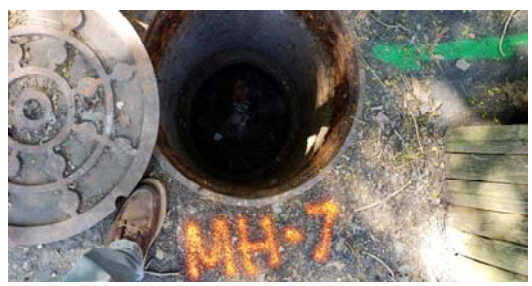
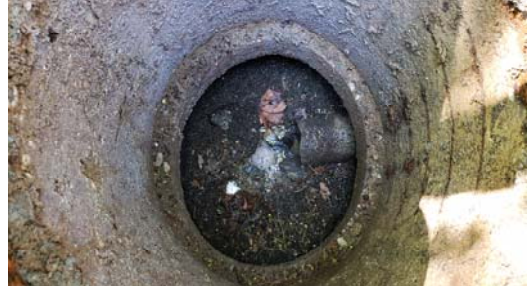
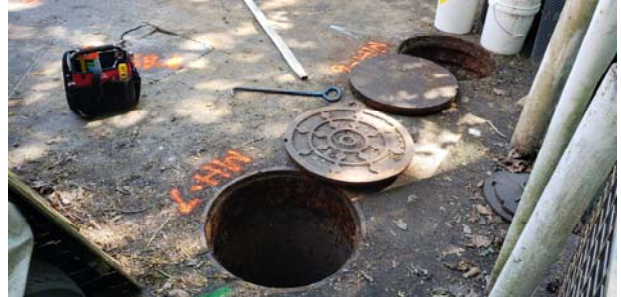
STRUCTURE SKETCH

(in feet)	Invert	NAVD88 Elev	Type
Rim		150.85	
Pipe 1	4.25	146.60	6" Dia. PVC
Pipe 2			
Pipe 3			
Pipe 4			
Pipe 5			
Pipe 6			
Structure			
Ceiling

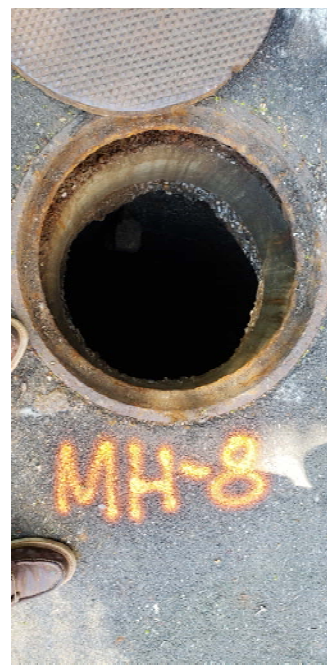
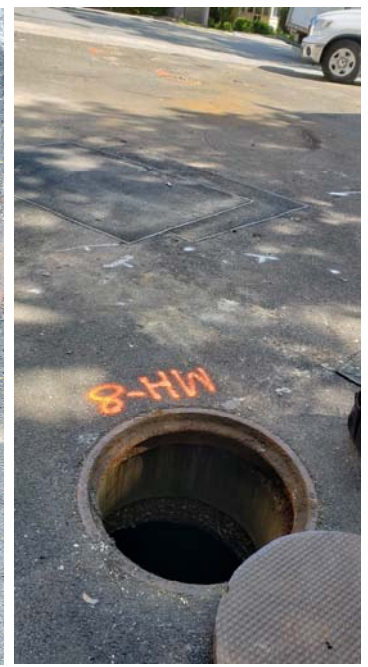
STRUCTURE SKETCH

(in feet)	Invert	NAVD88 Elev	Type
Rim		150.73	
Pipe 1			
Pipe 2			
Pipe 3			
Pipe 4			
Pipe 5			
Pipe 6			
Structure	21.3	129.43	CONC.
Ceiling

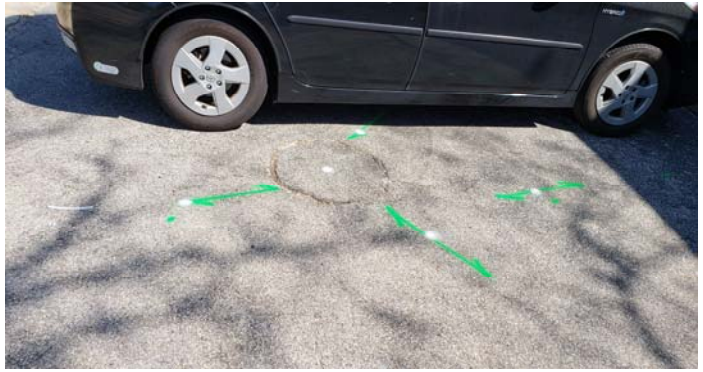
STRUCTURE SKETCH

(in feet)	Invert	NAVD88 Elev	Type
Rim		161.30	
Pipe 1			
Pipe 2			
Pipe 3			
Pipe 4			
Pipe 5			
Pipe 6			
Structure			
Ceiling

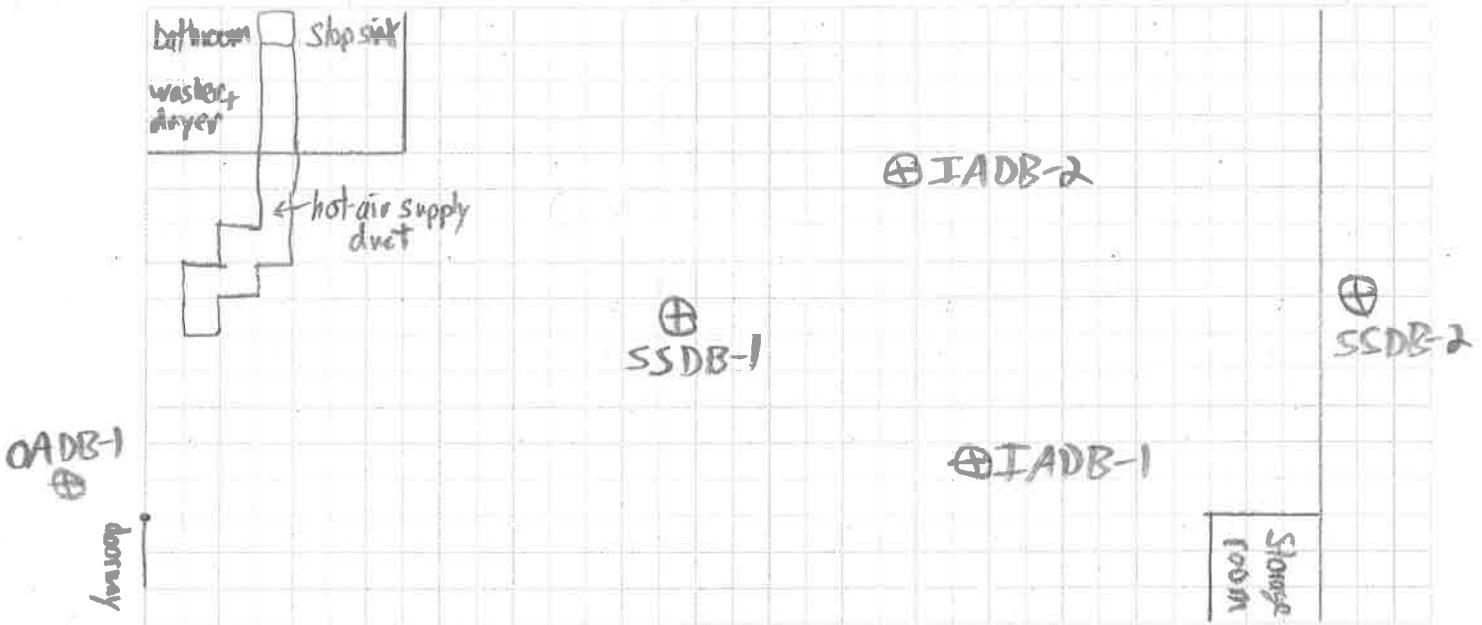
Basement:

Draw a plan view sketch of the basement and first floor of the building. Indicate air sampling locations, possible indoor air pollution sources and PID meter readings. If the building does not have a basement, please note.
