**VOLUNTARY INVESTIGATION  
& INTERIM REMEDIAL MEASURE  
WORK PLAN**

**FORMER FRESH & CLEAN LAUNDRY**

**22-26 RAILROAD AVENUE  
GLEN HEAD, NEW YORK 11545**

**ENVIRONMENTAL SERVICES INC.**

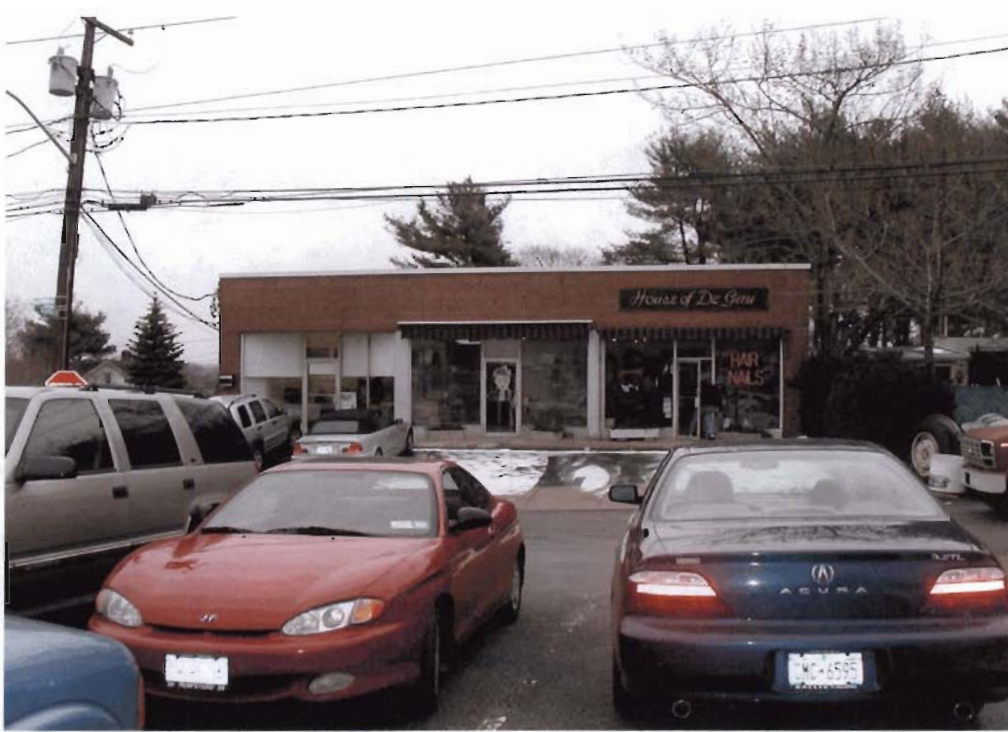
**Photograph No. 1 – Front of 22-26 Railroad Avenue (Former Fresh & Clean Laundry). Note current commercial uses and municipal parking.**

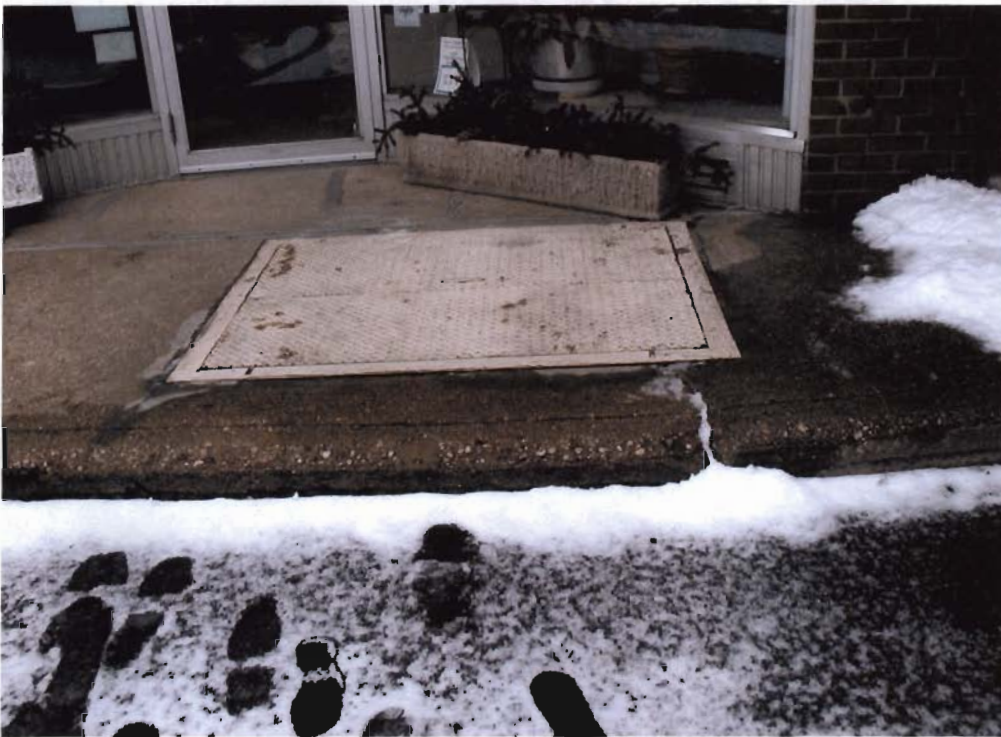
**Photograph No. 2 – Access to partial basement at 26 Railroad Avenue (House DeGau).**

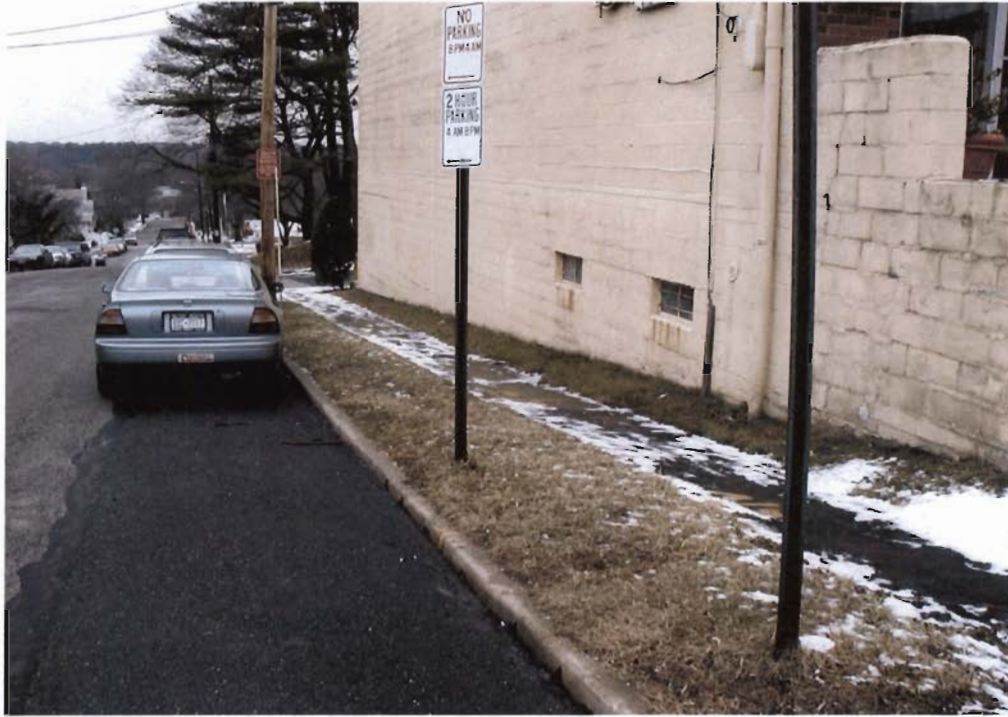
**Photograph No. 3 – Side (north) of 22-26 Railroad Avenue; note slope of street towards rear of the property.**

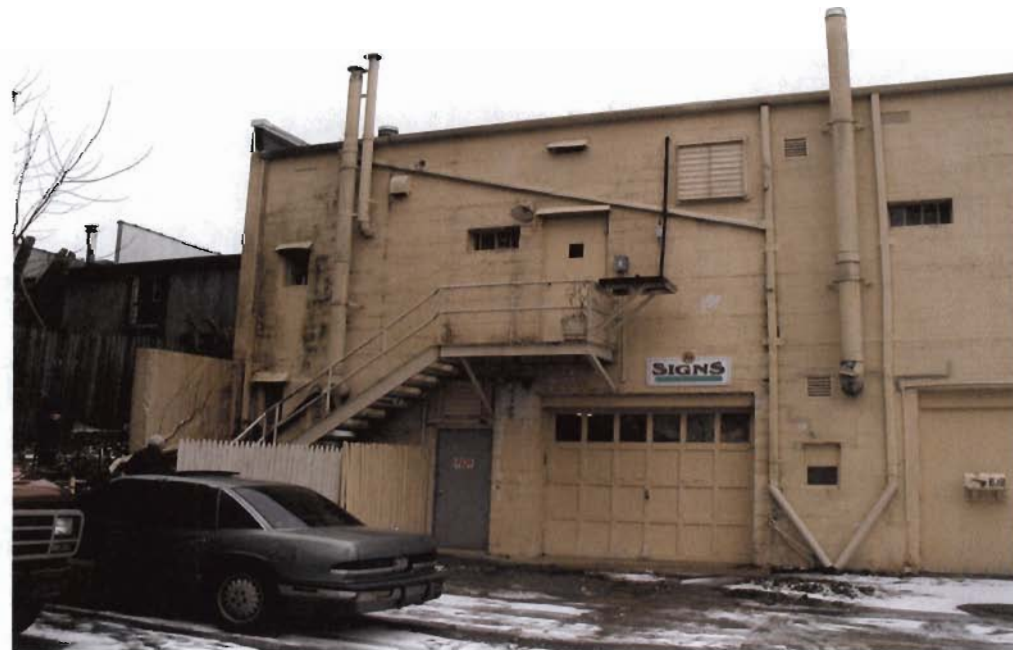
**Figure 4 – Rear of 22-26 Railroad Avenue, location of A+ Graphics and Signs. Two (one former and one active) garage doors and paved parking area.**

It should be noted that the January 2004 NCDH site inspection revealed that the A+Graphics & Signs use tetrachloroethylene in their etching operations.

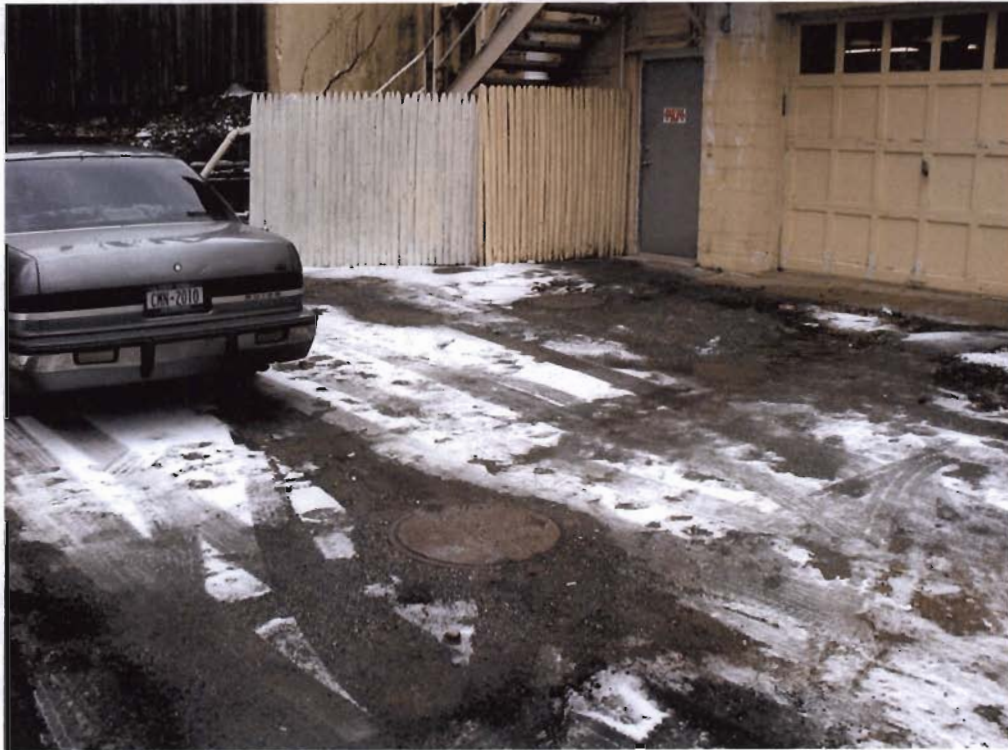
**Figure 5 – Rear of 22-26 Railroad Avenue, location of septic system distribution box, septic tanks and cesspools, within paved parking area.**

Laundry processes and directed the discharge to three at grade cesspools and possibly to an additional below grade overflow pool. Three cast iron pipes were observed exiting the distribution box in directions which apparently generally corresponded with locations of cesspools designated CP- 1, C P-2 and CP-3, with all three pools having manhole covers at grade. Of note, the Grosser report indicated that all of the cast iron pipes observed at the distribution box were filled with concrete. The sanitary system is currently served by one active cesspool, CP-4. Two additional manhole covers were observed southeast of the building; same were determined in the Phase II to reportedly be a septic tank. There was an additional manhole identified, the sanitary cesspool (CP-4) serving the septic tank. The Grosser report indicated that visual confirmation of connection pipes entering the cesspool could not be accomplished due to standing liquid in the structure with an obstruction of view. CP-4 was sampled due to the possibility of interconnection with the other cesspools at the site.

Bottom sediments from the four cesspools were sampled and submitted for laboratory analysis for VOCs by EPA Method 8260. The testing data indicated that primarily three cesspools (CP-1, CP-2, & CP-3) had received discharges of common industrial solvents and cleaners. Cesspool CP-2 reported the highest VOC contamination with a concentration of PCE of 1,500,000 part per billion (ppb). The main VOC constituents reported above NYSDEC recommended soil cleanup objectives (RSCOs) in the cesspools were PCE and 1,2-dichloroethene and trichloroethylene (breakdown products of PCE). In addition, low levels of petroleum products were reported above allowable limits, specifically xylenes and 1,2-dichlorobenzene. Several VOCs were reported above their respective RSCOs at CP-4; however, these VOCs were present at substantially lower concentrations than the other cesspools. Each of the bottom sediments samples were collected at the base of each structure, approximately 20-22 feet below grade surface (bgs).

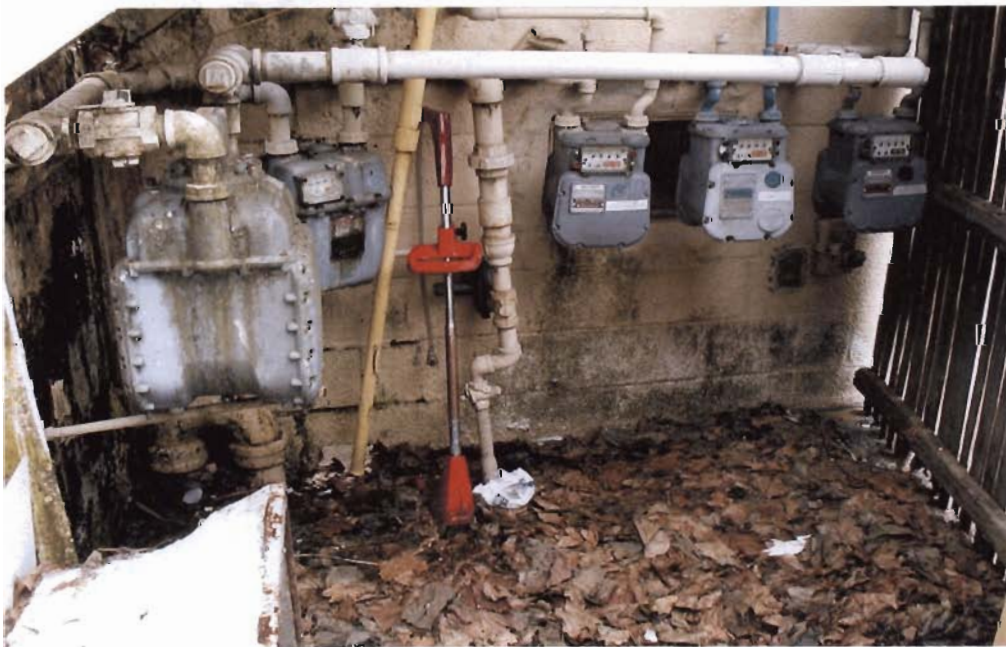
**Figure 6 – Rear of 22-26 Railroad Avenue, location of natural gas lines and service meters.**

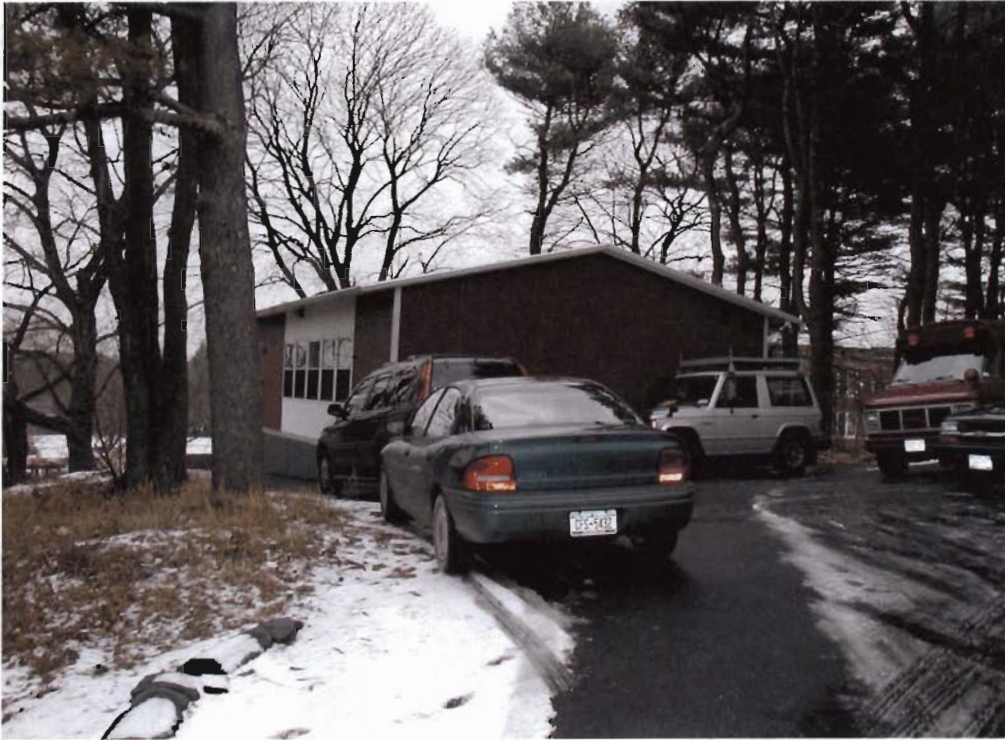
**Figure 7 – Rear paved parking area with four storm water dry wells. Area formerly wooded undeveloped land. Abuts location of school maintenance building.**

Stormwater drainage at the front of the property appears to flow via overland transport on asphalt pavement onto Railroad Avenue and to perimeter areas of the subject property. A round indentation was noted in the asphalt-paved parking area serving the storefronts, along Railroad Avenue. No information regarding building or site infrastructure was available

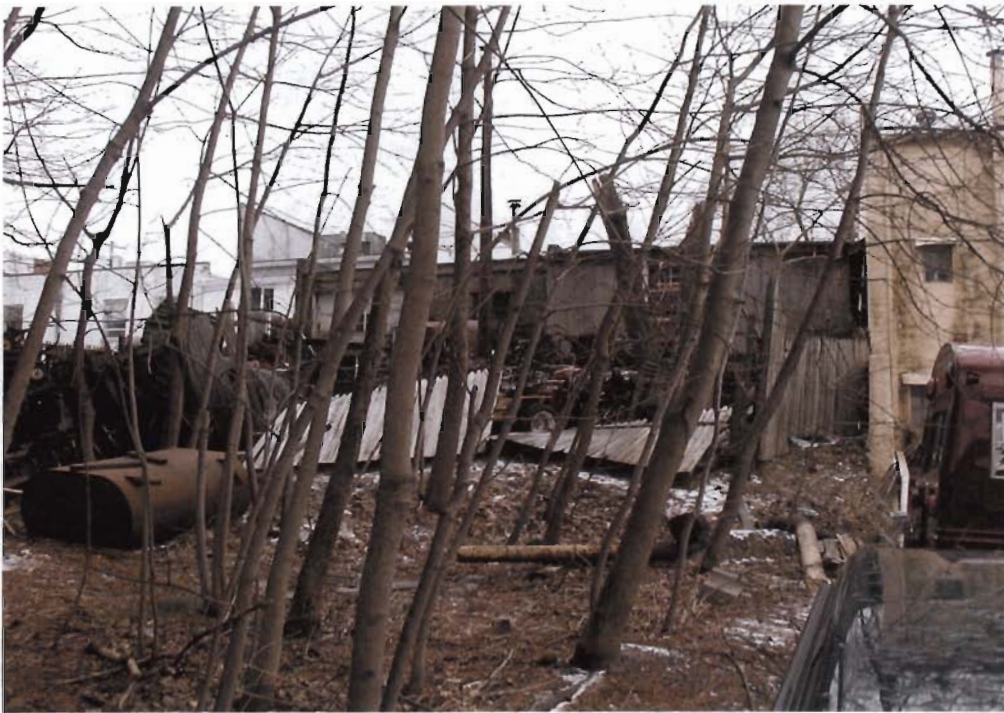
**Figure 8 – Adjoining (rear) neighbor to the south of 22-26 Railroad Avenue, location of Tom's Lawnmower and Welding Service. Note drums, abandoned tanks, etc.**
