**Phase-II
Environmental Investigation**

**Former Thypin Steel Corp.
Manorhaven, New York**

April 12, 1999

**C.A. Rich Consultants, Inc.
404 Glen Cove Avenue
Sea Cliff, New York 11579**

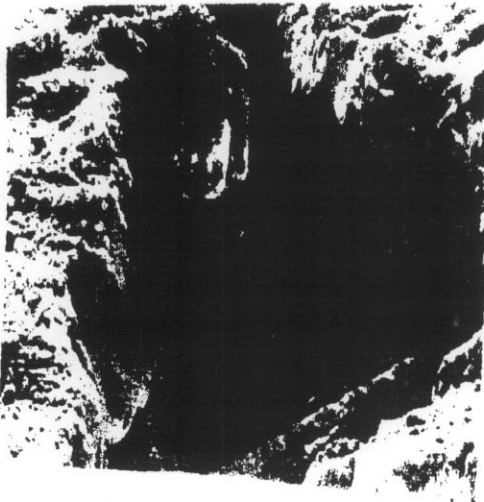
PHOTO 3

Test pit TP-6D after the removal of former drain.

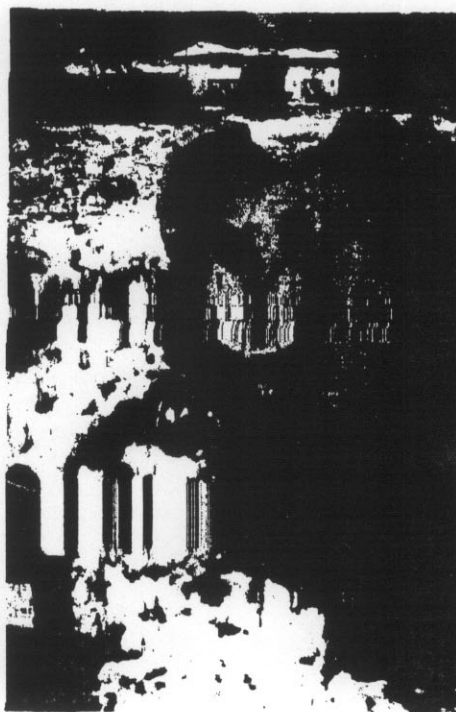
PHOTO 8

Test pit TP-11 was excavated at a manhole located on the western portion of the property. The backhoe removed the cement collar of the structure and unearthed the soil until the water table was reached. The excavation of this area did not reveal any visible signs of contamination or any detections with field instrumentation.

Dome of manhole removed during the excavation of test pit TP-11.
