Re: Test Pit Investigation for Unknown Structures
National Grid Inwood Former Holder Site
Intersection of Nassau Avenue and Sheridan Blvd
Inwood, Nassau County, New York
Site No. 1-30-121, Order on Consent Index # A2-0552-0606

The purpose of this letter report is to document the findings of the unknown structures investigation undertaken by National Grid Site Investigation and Remediation (SIR) on June 9 and 10, 2020 at the Inwood Former Holder Site (the Site) located in Inwood, Nassau County, New York.

GEOPHYSICAL INVESTIGATION REPORT

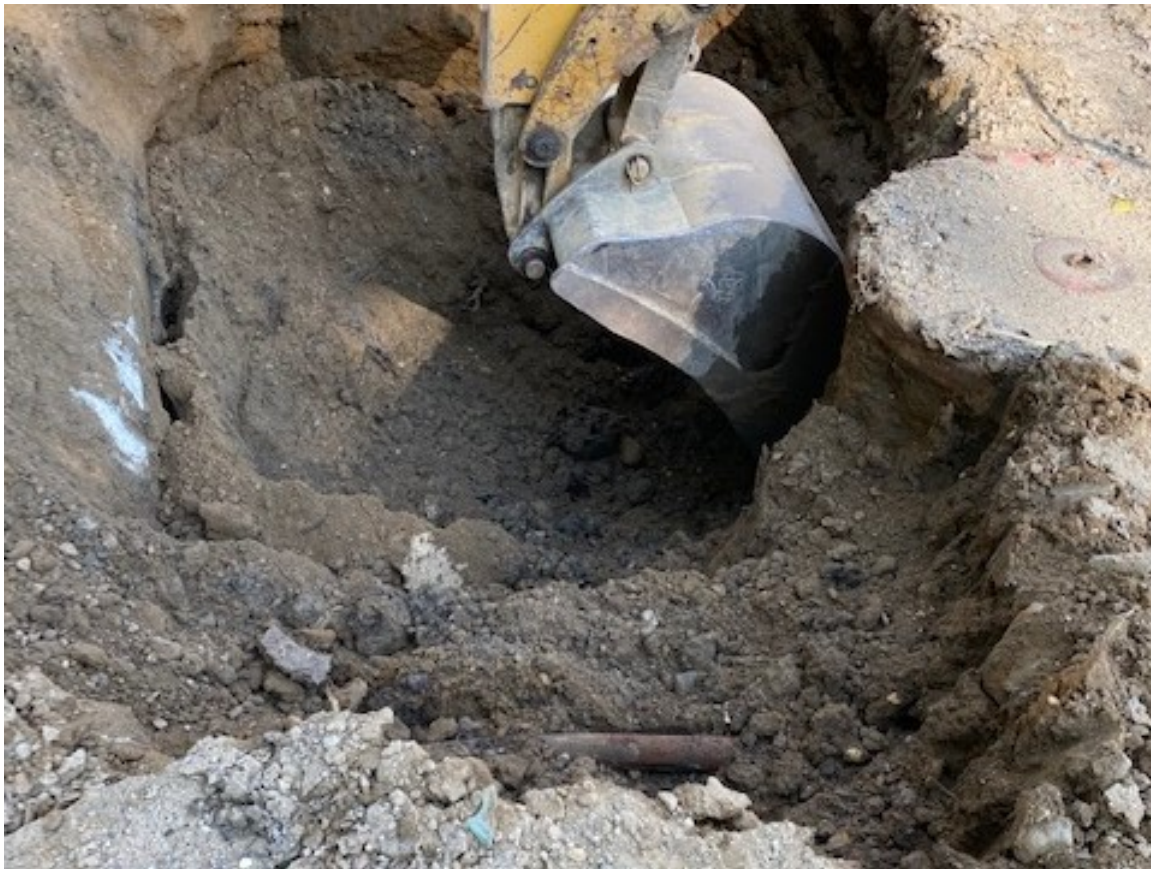
Figure 1: 36" diameter pipe at approximately 3' and a 2" diameter steel pipe at 1ft.

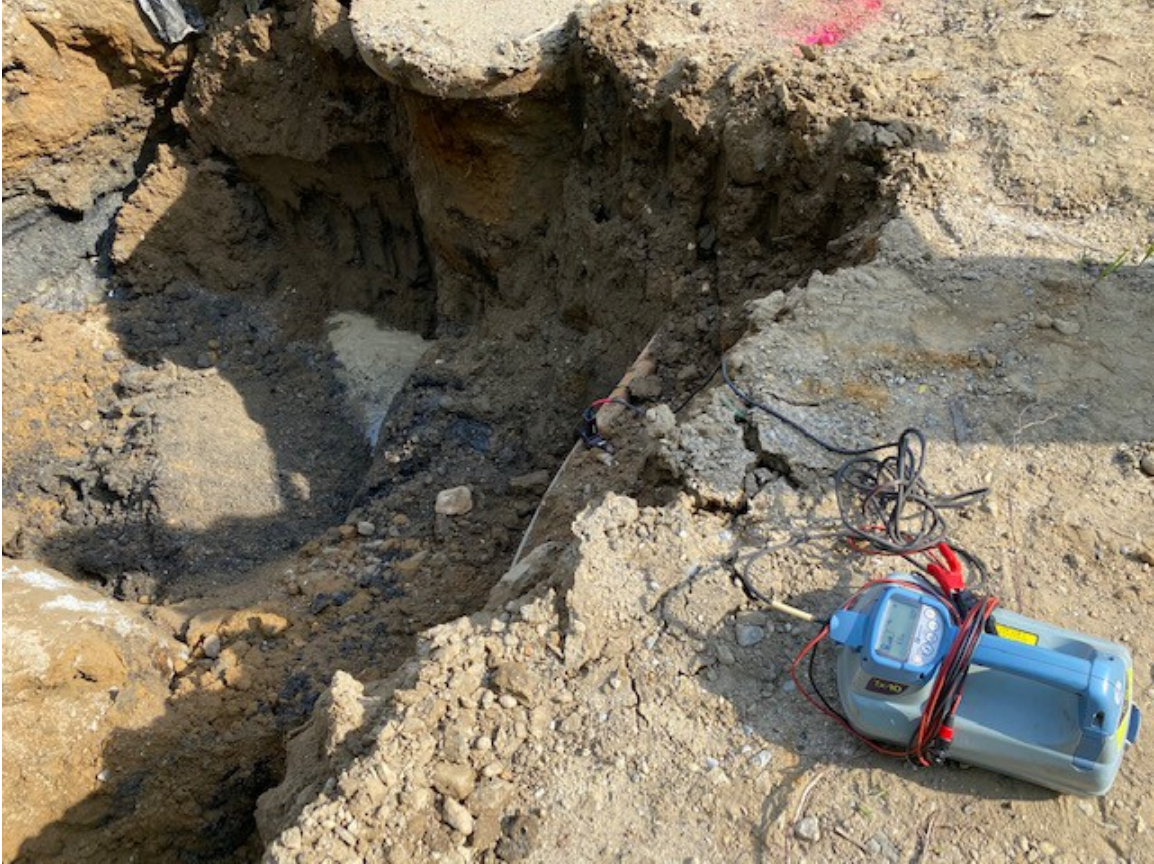
Figure 2: 36" diameter pipe at approximately 3' and a 2" diameter steel pipe at 1ft.

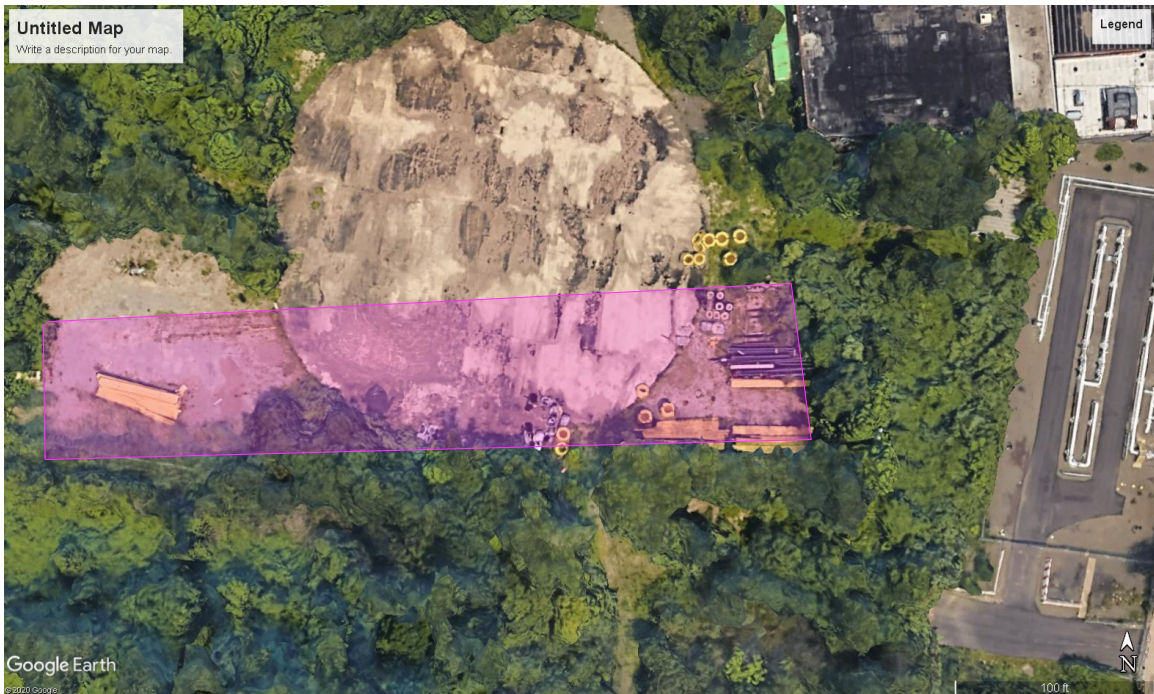
Figure 3: Area of investigation highlighted in pink. *(Not to scale)

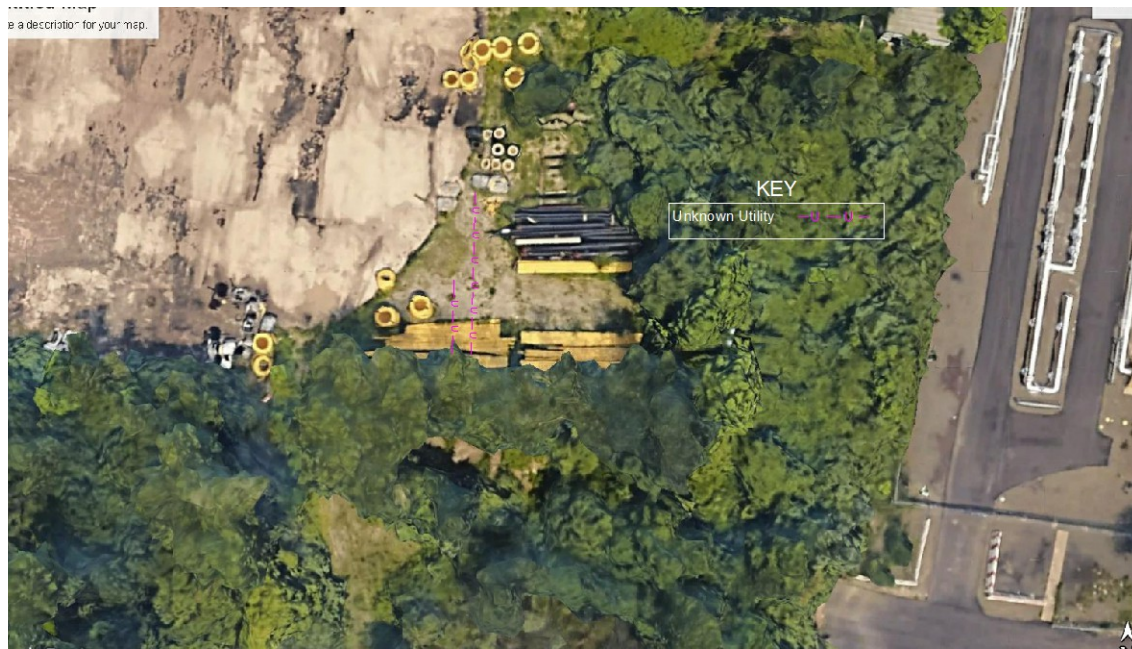
The previously identified 36" diameter pipeline was exposed at TP19B and noted to be at approximately 3 ft bgs, and the 2" diameter pipe was identified at 1 ft bgs. These pipelines were traced, and Figure 4 of the Enviroprobe Report shows the approximate alignment of these identified pipelines running north to south with the 36" pipeline on the left (west) and 2" pipeline on the right (east).

Figure 4: Confirmed utilities. Running from south to north the larger diameter pipe is located on the left side while the smaller pipe at approximately 1ft is located on the right. *(Not to scale)

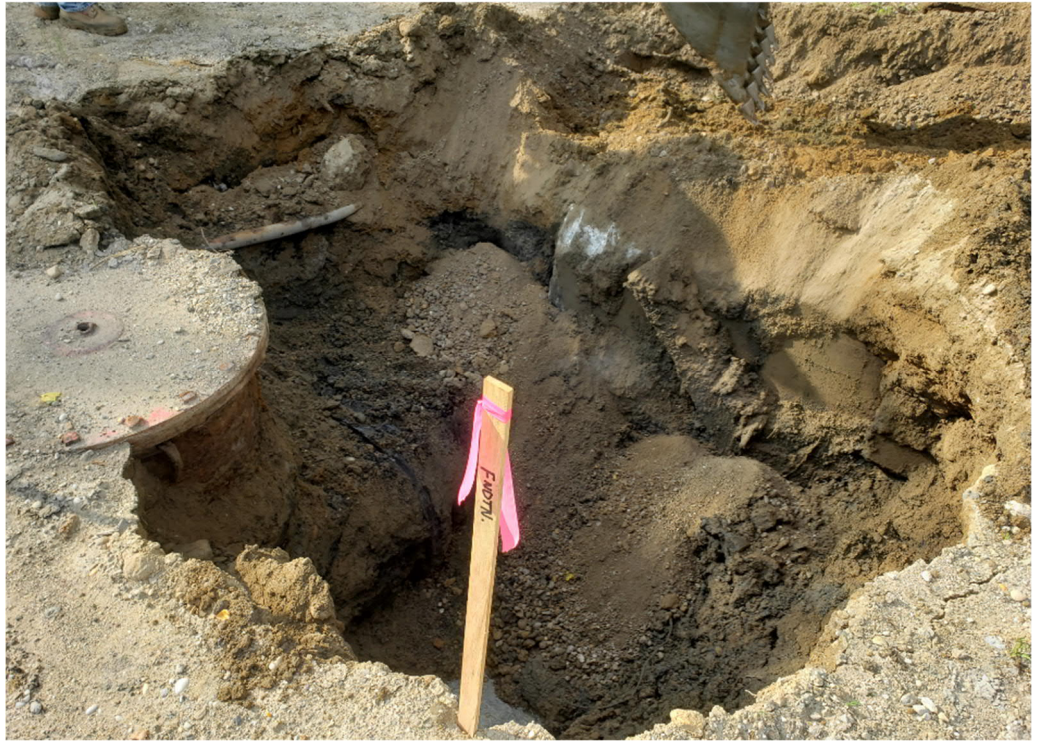
Photo No.
1

The previously identified 36” steel pipeline was confirmed to be present at 3 ft bgs, and the 2” steel pipeline confirmed at 1ft bgs. Tracing of the 36” diameter steel pipeline did not identify the pipeline to the north of TP19B.

Exposure of 36" diameter pipe and 2" diameter pipe at TP19.

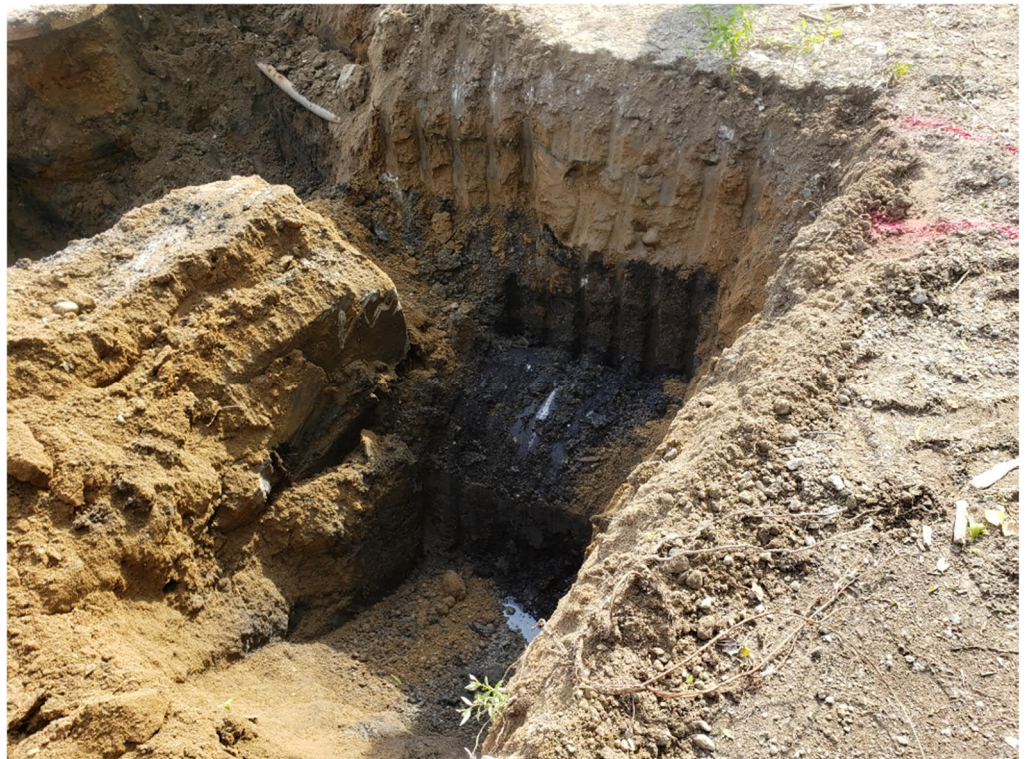
Photo No.
2

36" diameter pipe and 2" diameter pipe running north to south at TP19. Minor groundwater seepage observed. The top of pipe can be seen in the top left corner of photo.

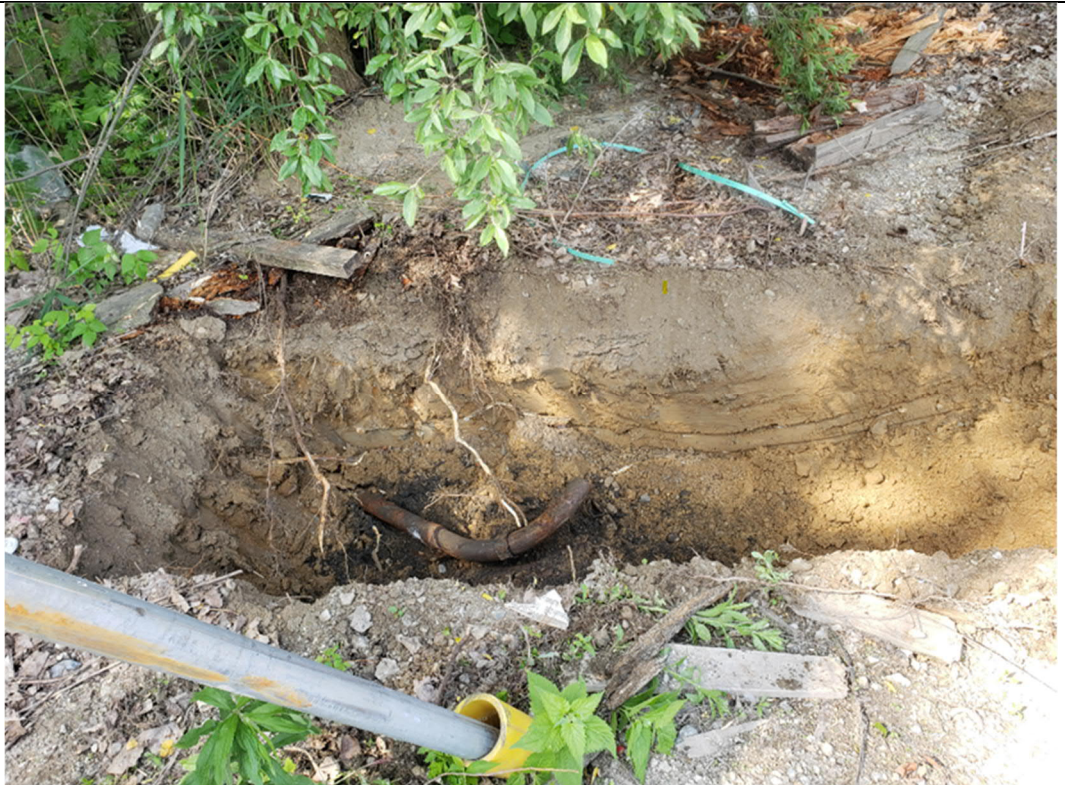
Photo No.
3

- A cut 2” diameter steel pipe at approximately 1 ft bgs.
- Two 1” diameter steel pipes at approximately 3 ft bgs running east to west. One of these pipes appeared to be a conduit.

2" diameter cut pipe at TP20.

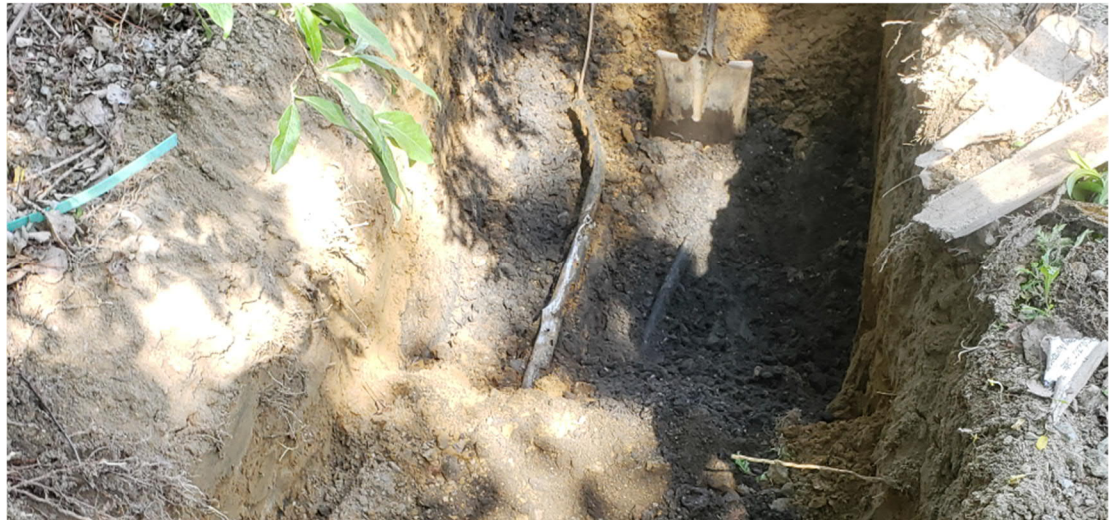
Photo No.
4

Three additional pipes were identified in TP20 including a cut 2” diameter steel pipe at approximately 1 ft bgs, and two 1” diameter steel pipes at approximately 3 ft bgs running east to west. This pipework is likely associated with the former Engine Room located in proximity to TP20.

Two 1" diameter pipes at TP20.

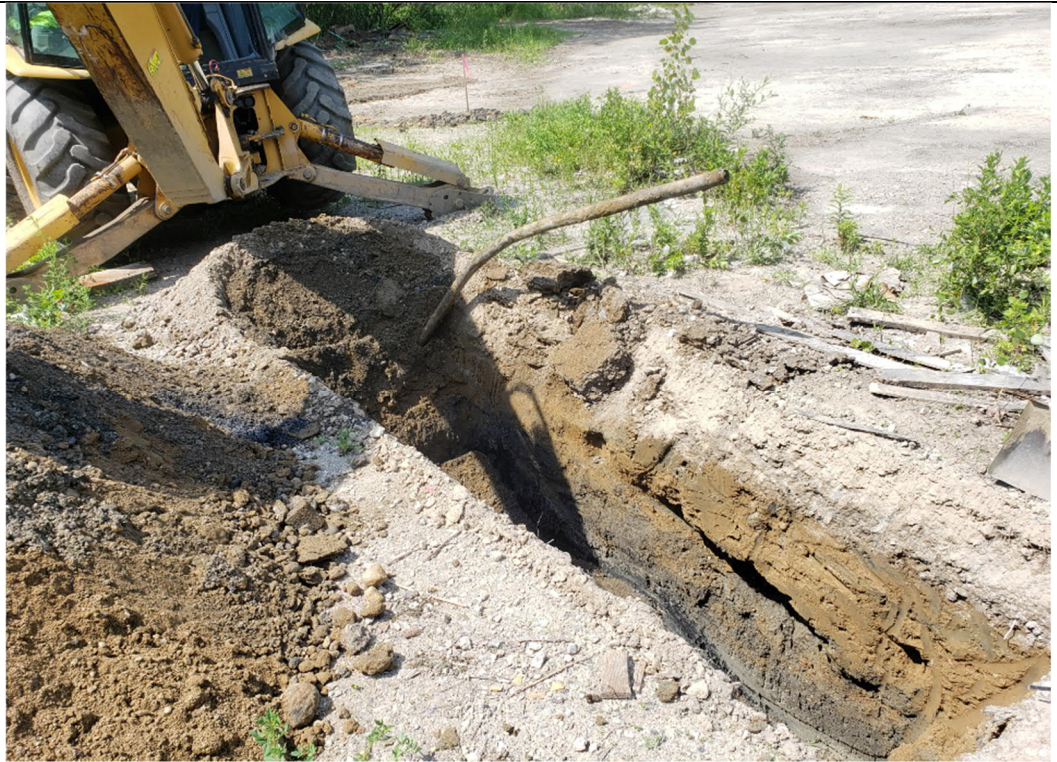
Photo No.
5

TP21: Soils to 2 ft bgs were comprised of brown sandy fill material with gravel. Underlying soils to 5 ft bgs included black silty clays. No evidence of visual or olfactory impacts were noted, and no elevated PID readings were recorded. The northern extent of the previously identified 2” diameter steel pipe was confirmed in this test pit, and the pipe is inferred to end at TP21.

End of 2" diameter pipe at TP21.

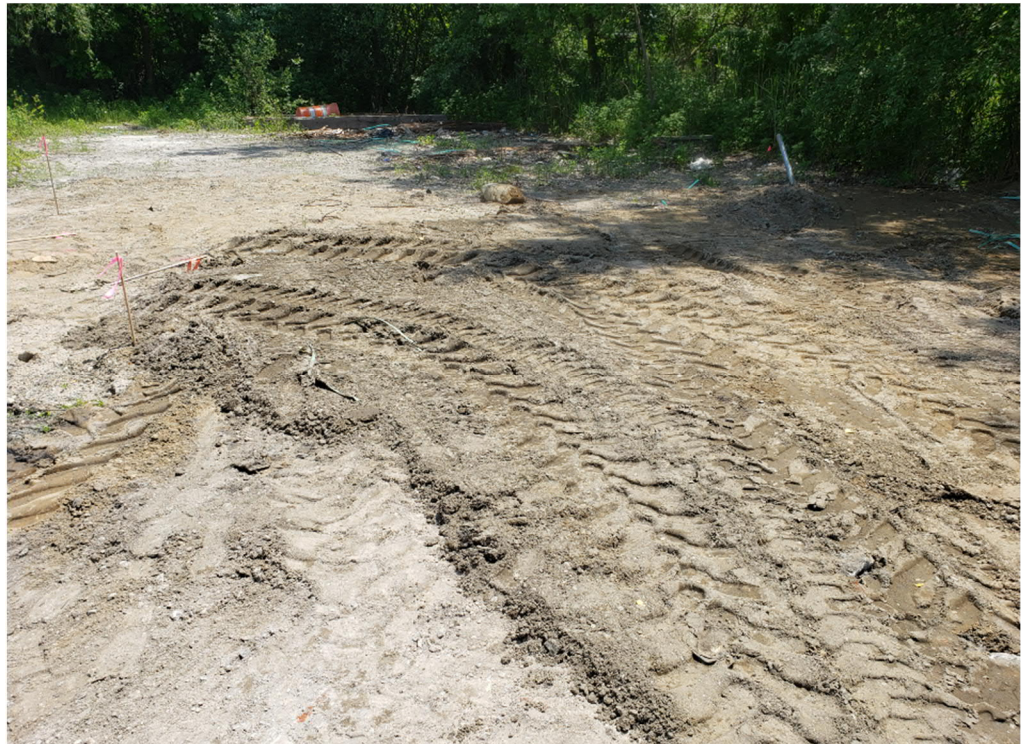
Photo No.
6

Backfill at TP19.
