**Town of Oyster Bay
Mill Neck Marina
Environmental Investigation Report**

**Town of Oyster Bay
Department of Public Works
Syosset, New York**

**Cashin Associates, P.C.
1200 Veterans Memorial Highway
Hauppauge, New York**

August 5, 2004

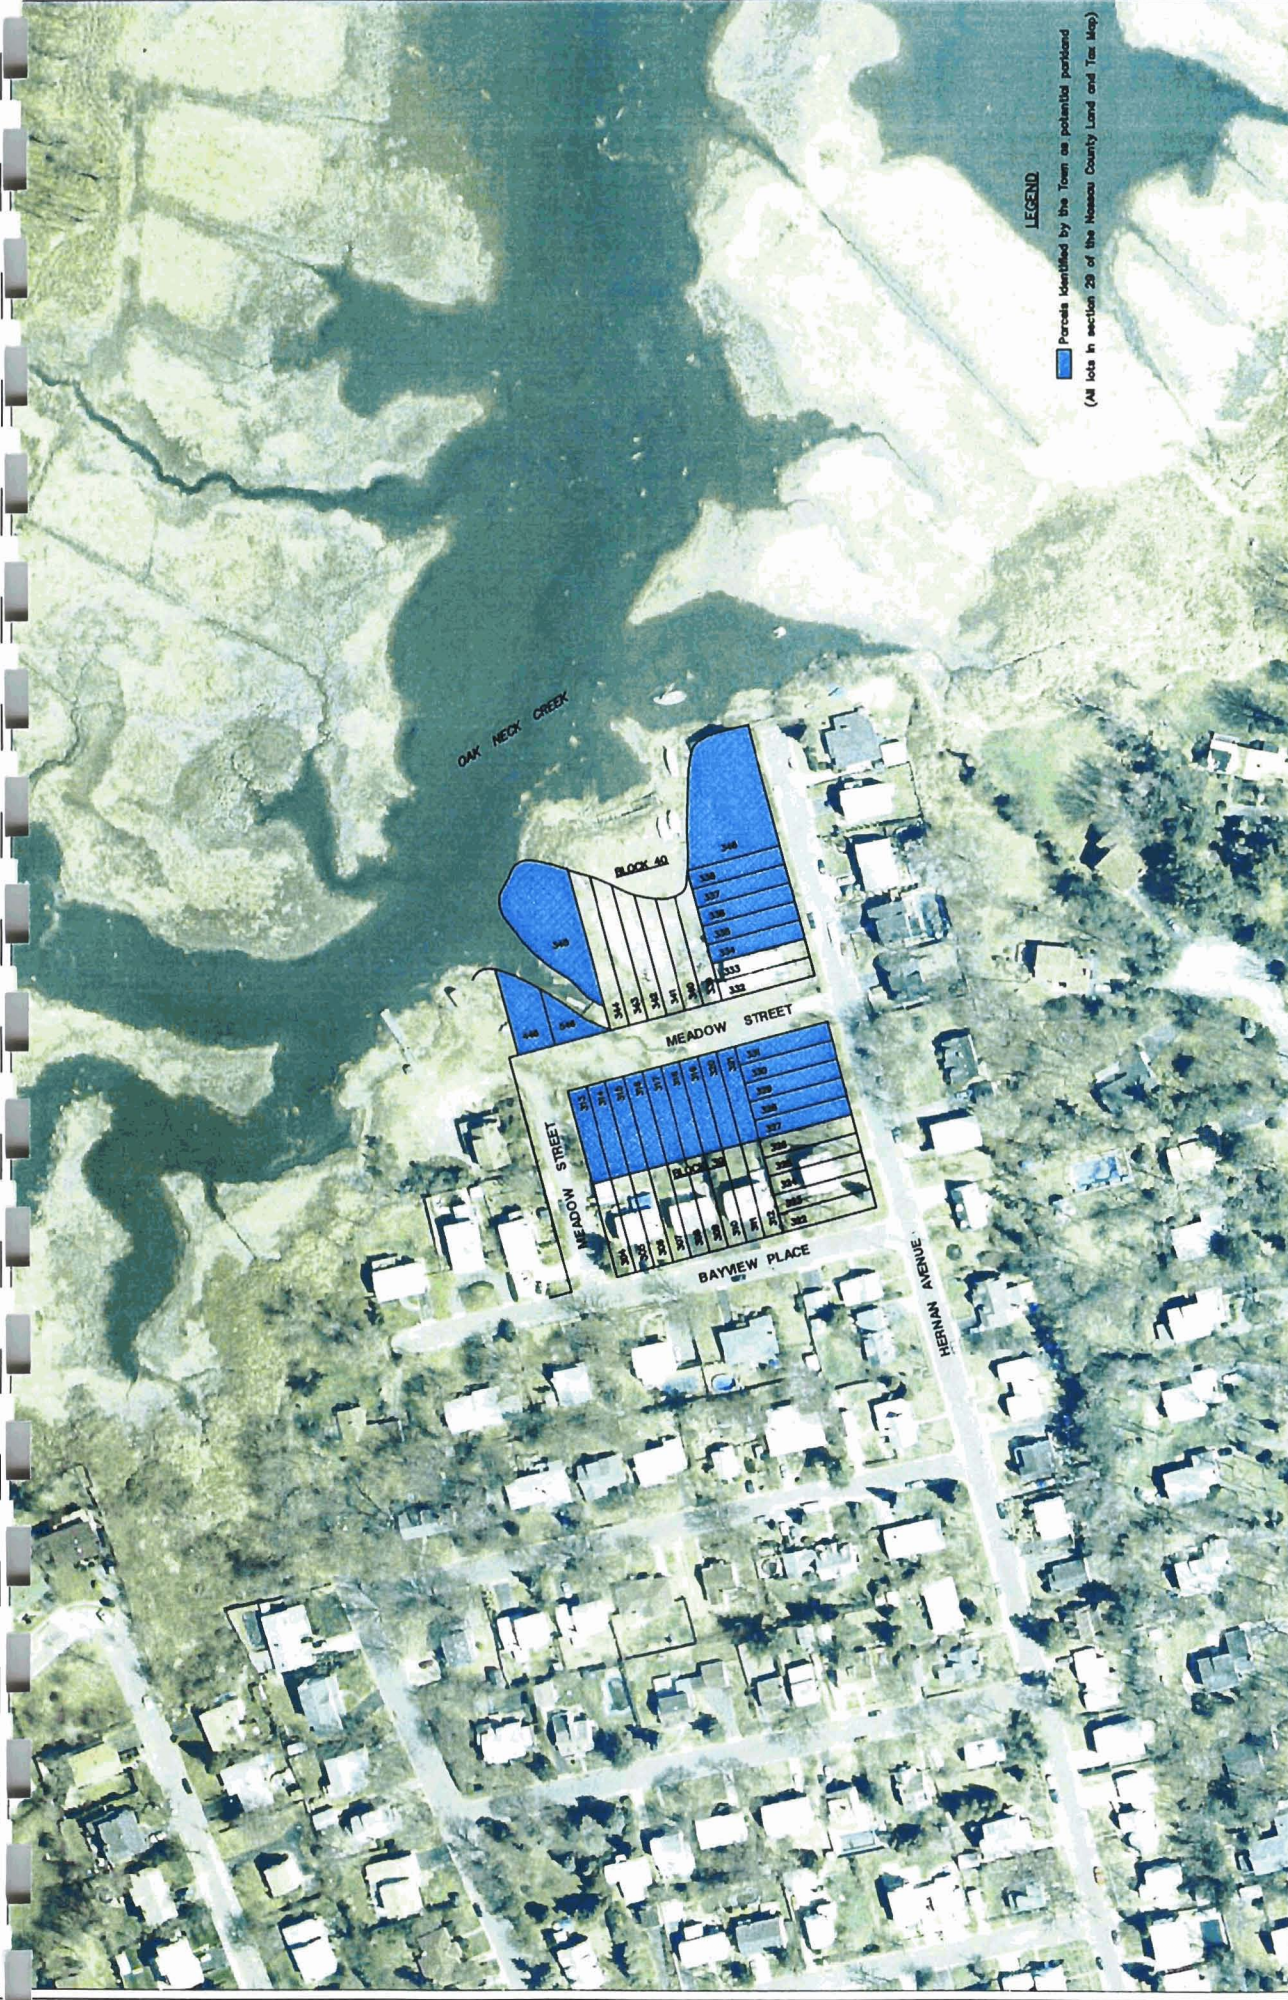
FIGURE 2
TOWN OF OYSTER BAY
MILL NECK MARINA
LOT MAP
 SCALE: 1" = 200'±

The former Mill Neck Marina property is located on the north side of Hernan Avenue, at its easterly terminus at Oak Neck Creek (a tributary of Mill Neck Creek), in the Locust Valley community in the Town of Oyster Bay (see Figure 1). The subject property covers a total of approximately 1.4 acres of land, which is presently vacant, and comprises a total of 23 individual tax lots (Figure 2) on the Nassau County Land and Tax Map. The attached aerial photograph and lot map indicate the area of interest for this investigation.

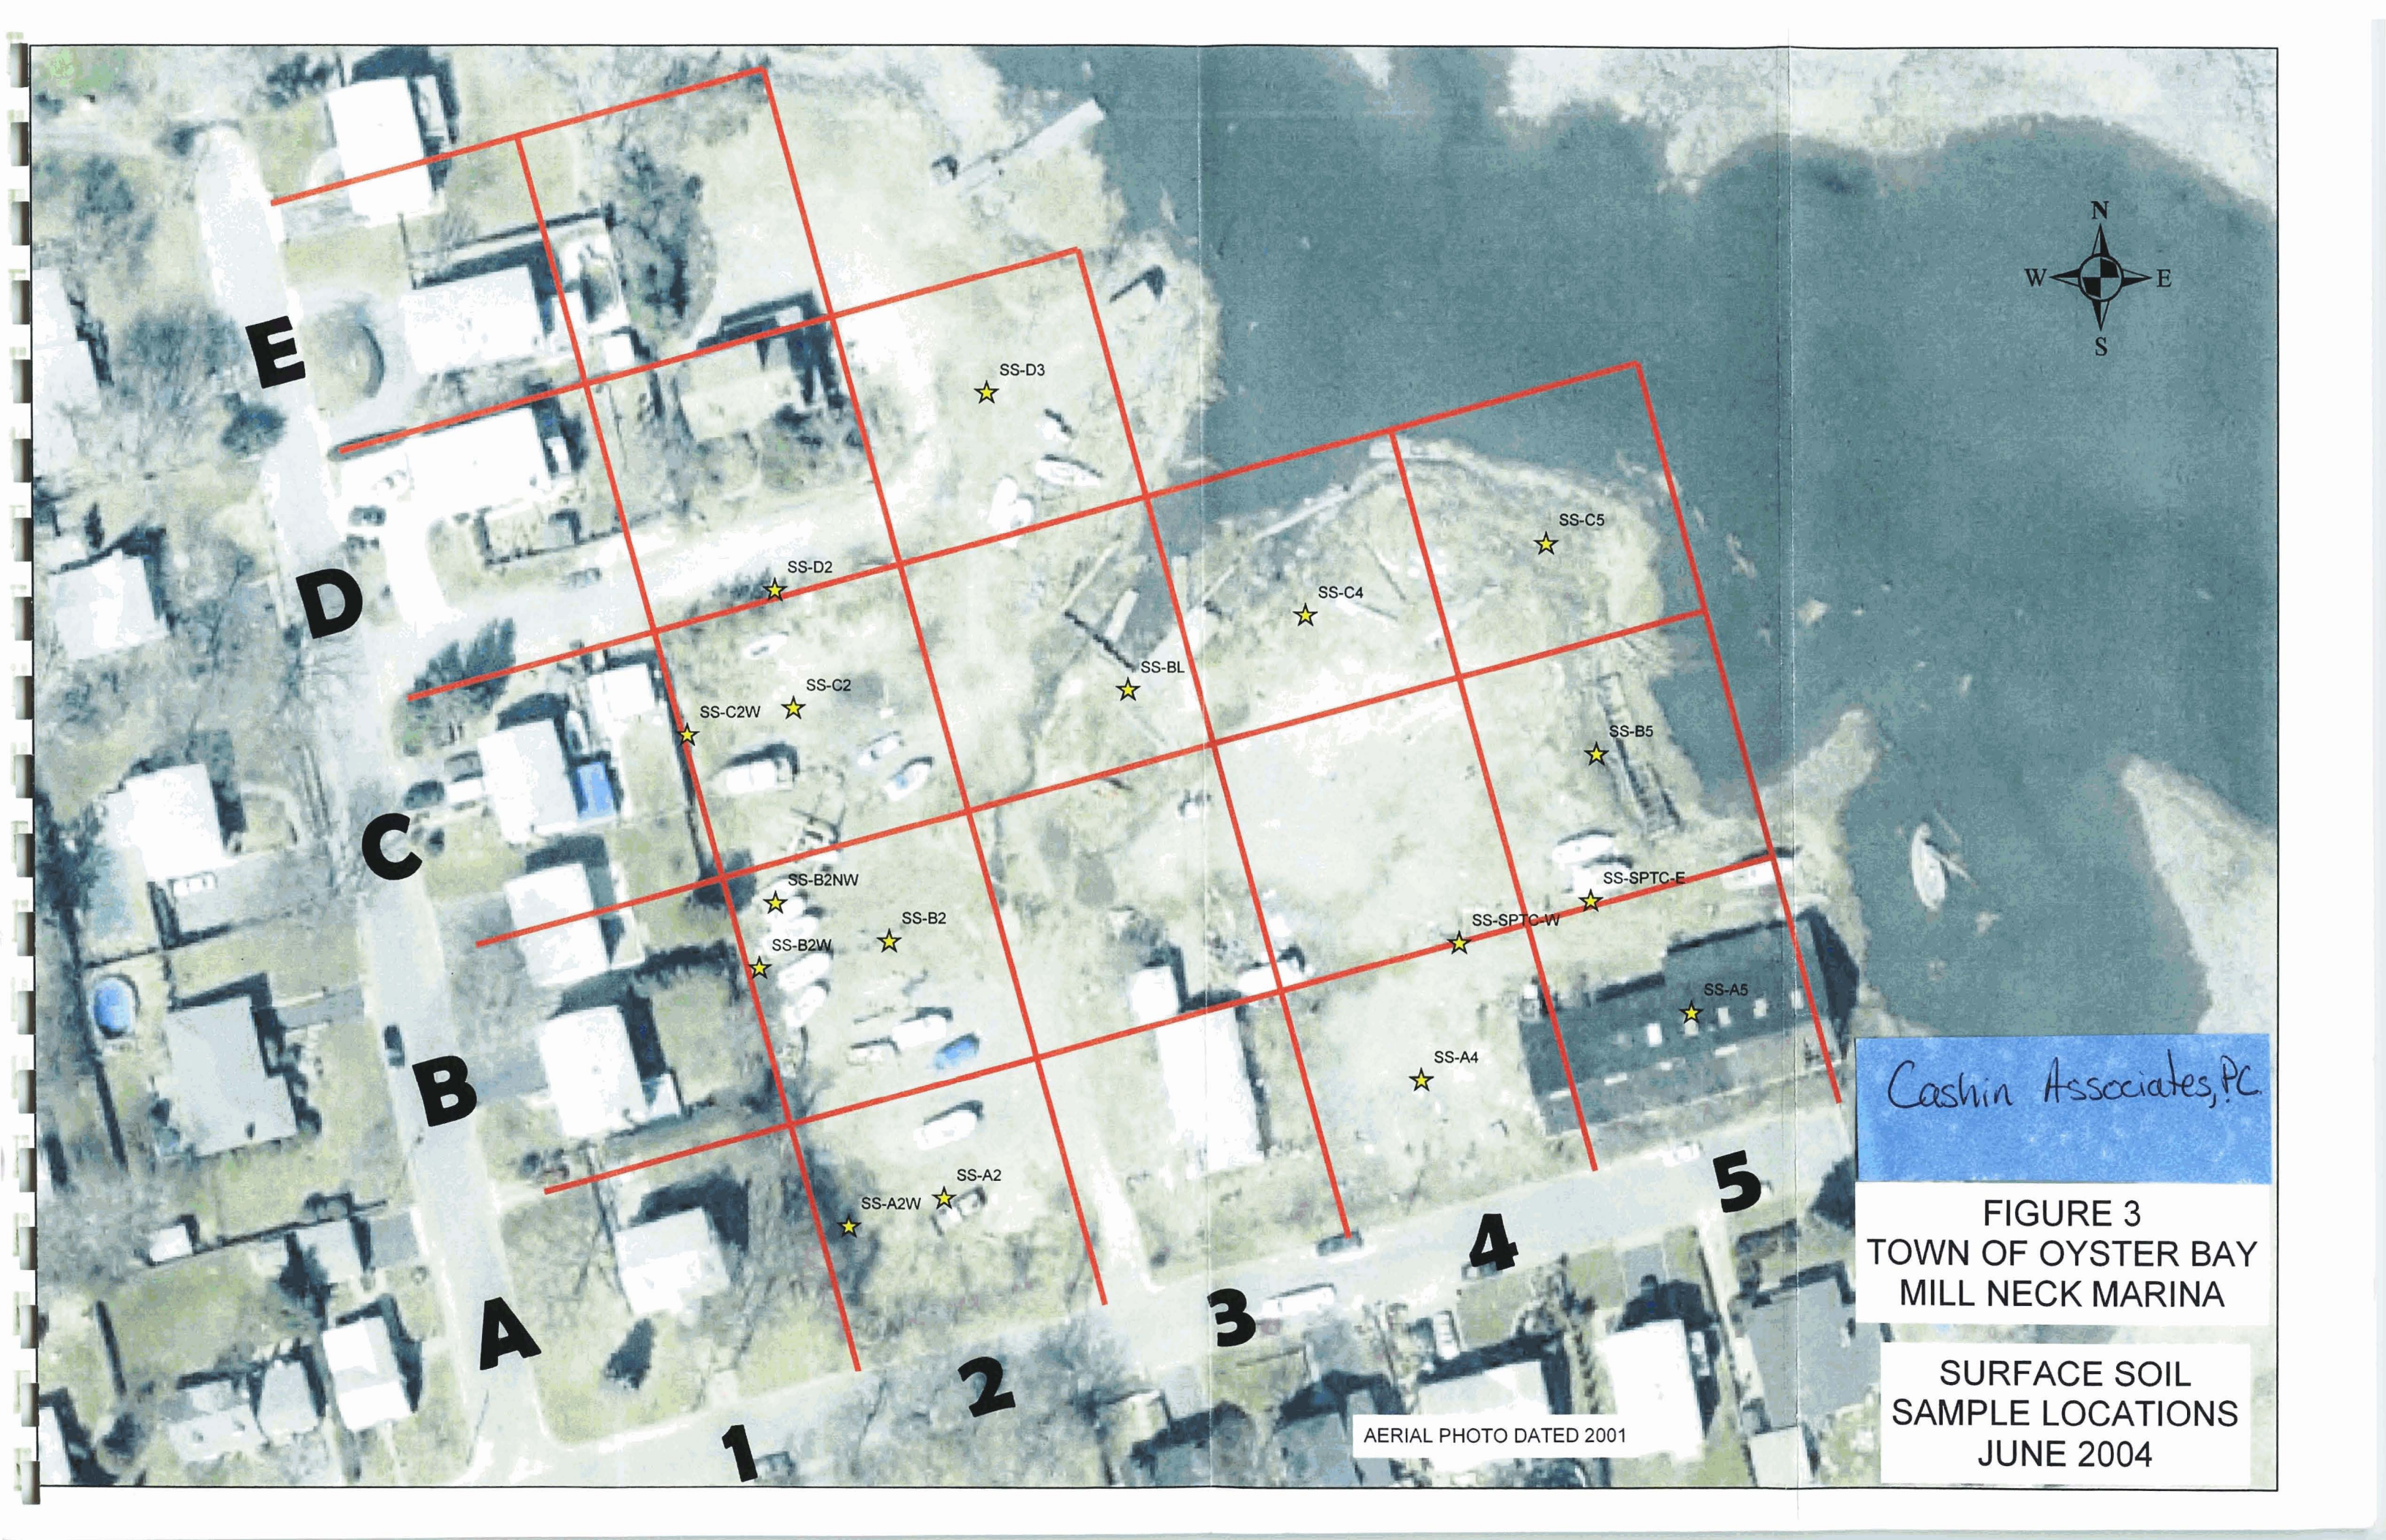
FIGURE 3
TOWN OF OYSTER BAY
MILL NECK MARINA

Each of the sixteen sampling points had two soil samples collected. The soil samples consisted of a surface sample and a soil boring. Surface samples were collected from the top three inches of soil using a hand auger (see Figure 3). Soil borings were drilled to the water table using a drill-rig and were collected one foot above the water table (see Figure 7). In areas where drill-rig access was difficult, a hand auger was used. All of the soil borings were two inches in diameter.

SURFACE SOIL
SAMPLE LOCATIONS
JUNE 2004

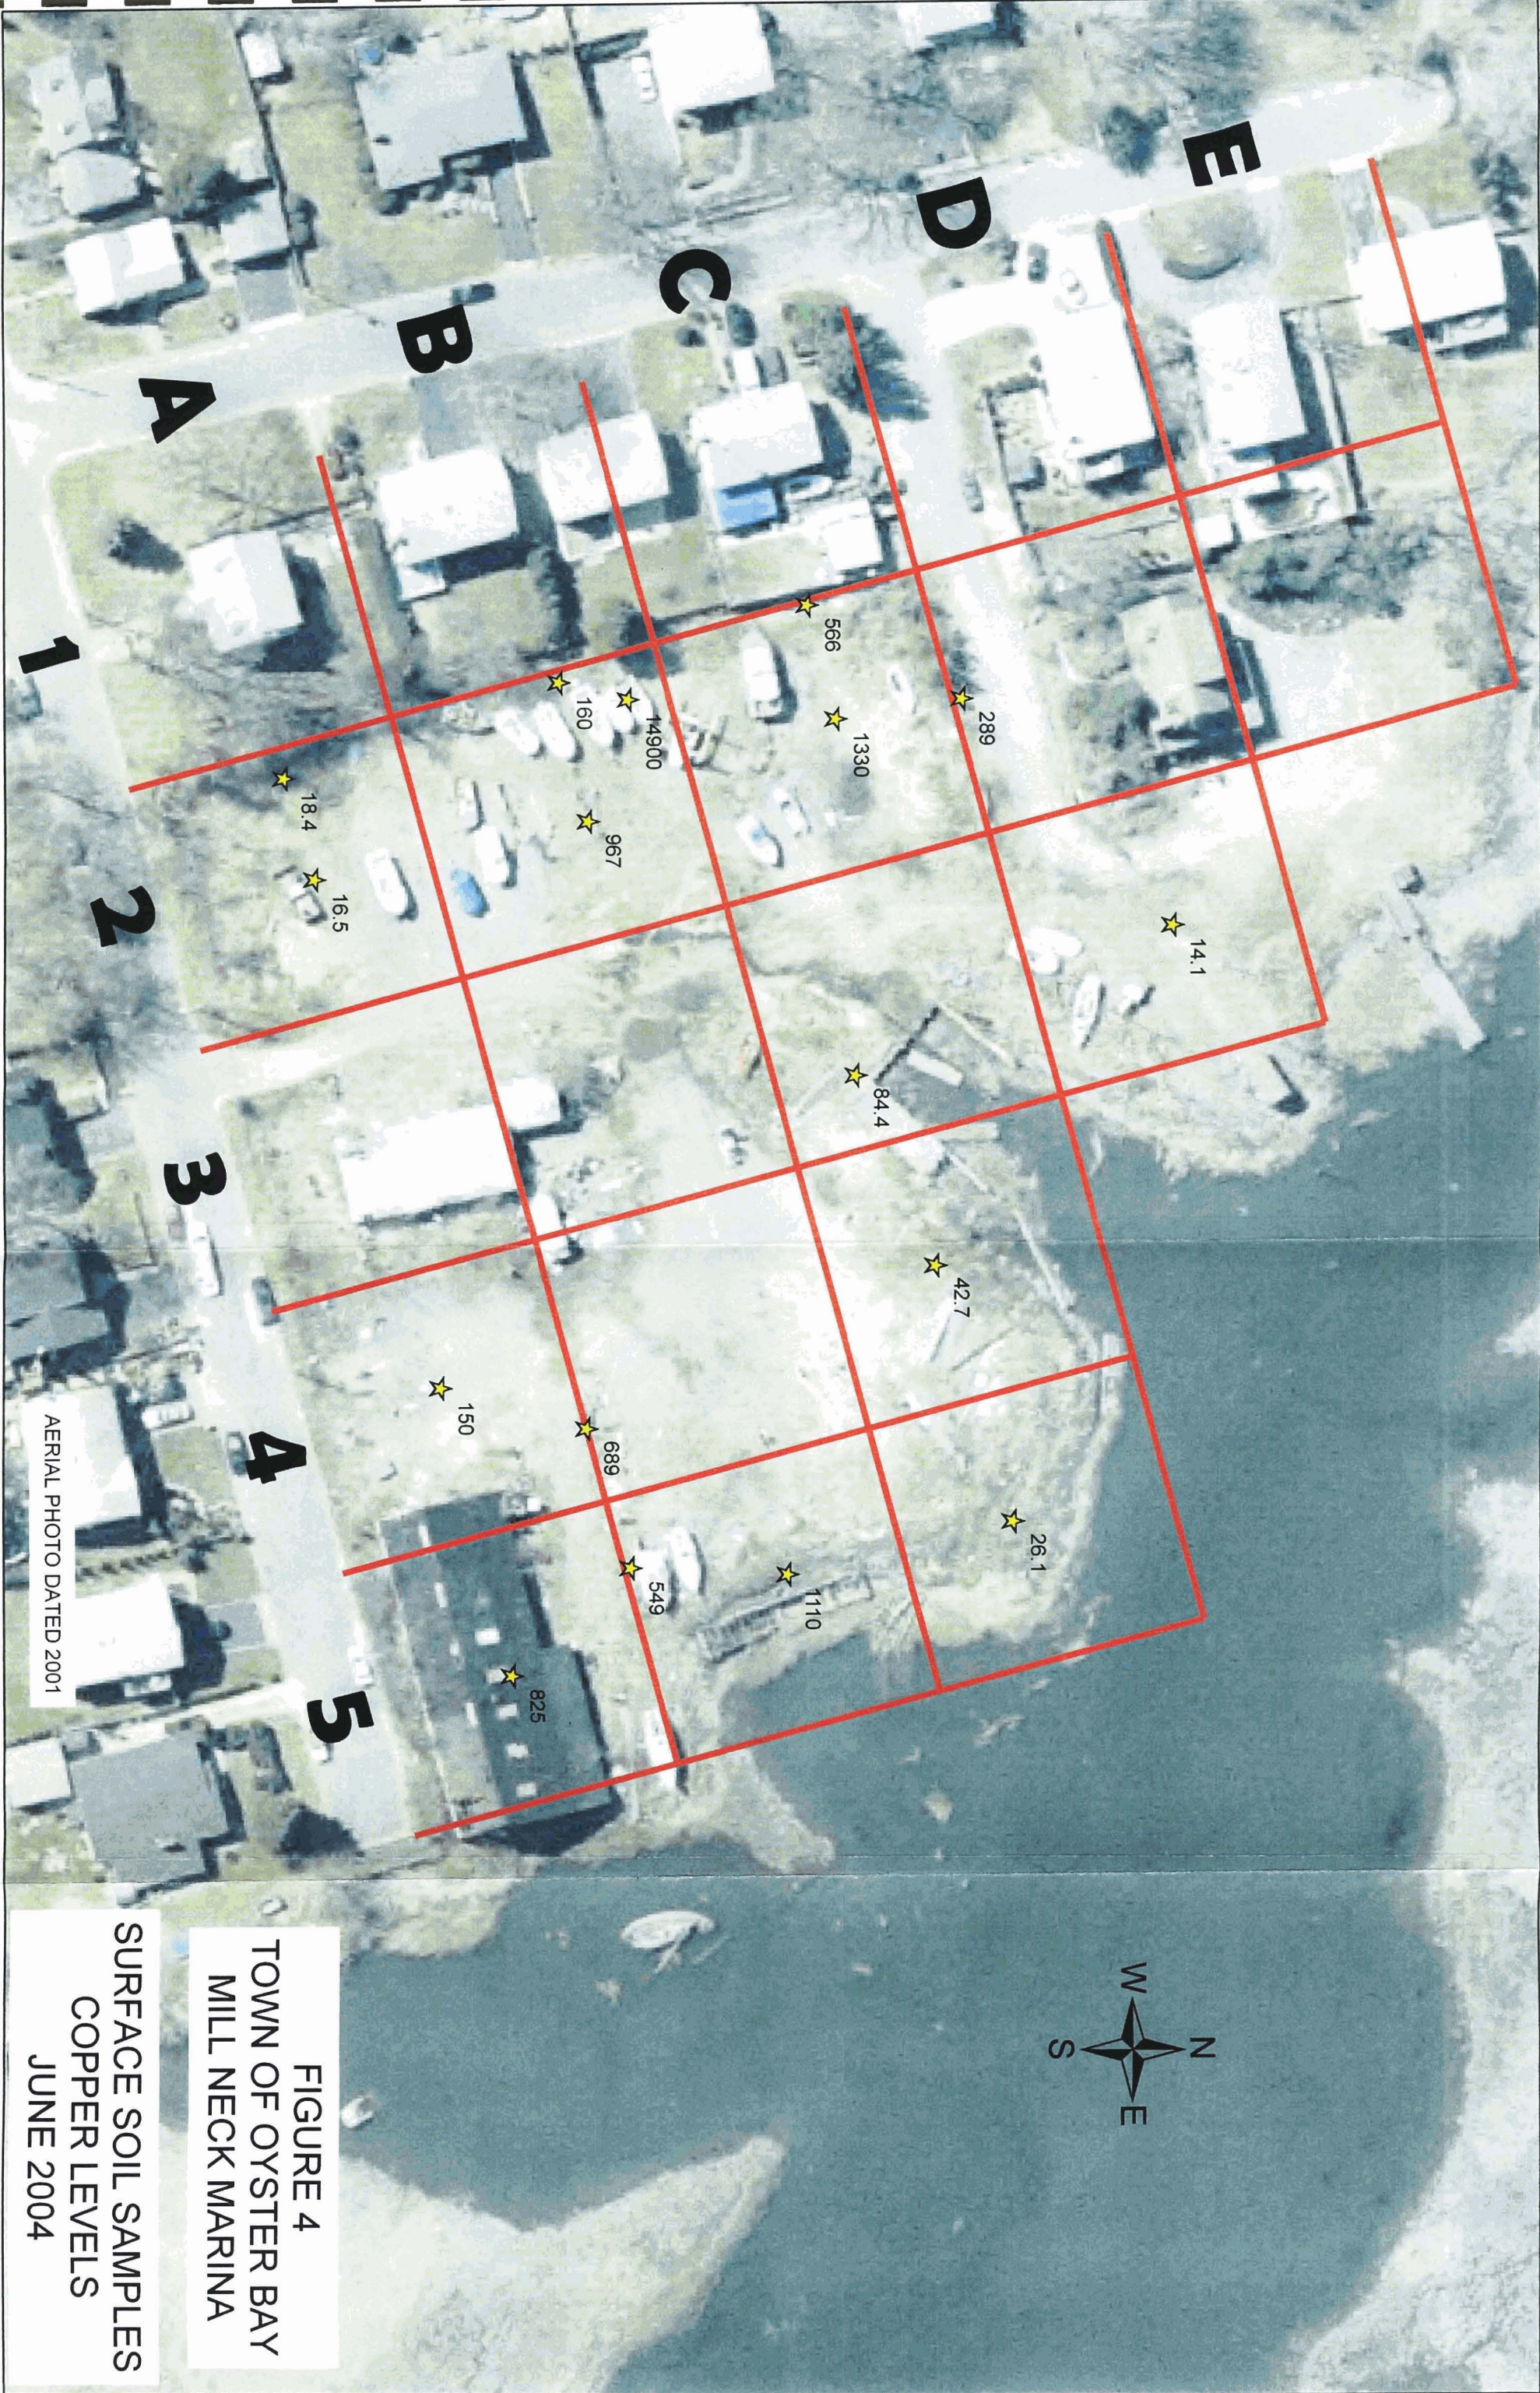
FIGURE 4
TOWN OF OYSTER BAY
MILL NECK MARINA

Metals were detected in all surface and subsurface soil samples. Eleven metals were reported at detections above recommended clean-up values or Eastern US Background concentrations listed in the TAGM in surface samples. These metals include the following: arsenic, barium, cadmium, chromium, copper, iron, lead, magnesium, mercury, nickel, and zinc. Thirteen metals were found in subsurface soil samples at levels that exceed recommended clean-up values or Eastern US Background concentrations listed in the TAGM, which include arsenic, barium, cadmium, calcium, chromium, copper, iron, lead, magnesium, mercury, nickel, selenium, and zinc. CA will hereafter refer to such levels as "elevated". Elevated levels of copper, lead and mercury are shown in Figures 4, 5, and 6, respectively for surface soil samples, and Figures 8, 9, and 10 for subsurface soil samples.

Elevated levels of copper, mercury, arsenic, zinc and lead were found at multiple soil sample locations. Copper is a primary active component found in most antifouling boat bottom paints, and is the metal most often associated with contaminated marina sediments (Fields, 2003). Elevated levels of mercury may be related to previous marina activities involving boat paint. Mercury is known to have been used as an anti-fouling agent in boat paints to reduce organism growth on the bottom of boats. Boat paint is known to also contain other metals such as copper, mercury, arsenic, or tributyltin (TBT). Mercury also serves as the contact for float switches in bilge pumps, shower water storage tanks, and thermostats. One float switch can contain as much mercury as 100 fluorescent lamps (Fields, 2003). Arsenic is found in paint pigments as well as in wood preservatives. Arsenic, chromium and copper leach from docks, pilings and other structures constructed of wood treated with chromated copper arsenate (Fields, 2003). Zinc anodes are used to deter corrosion of metal hulls and other metal boat parts that are exposed to seawater (USEPA).

SURFACE SOIL SAMPLES
COPPER LEVELS
JUNE 2004

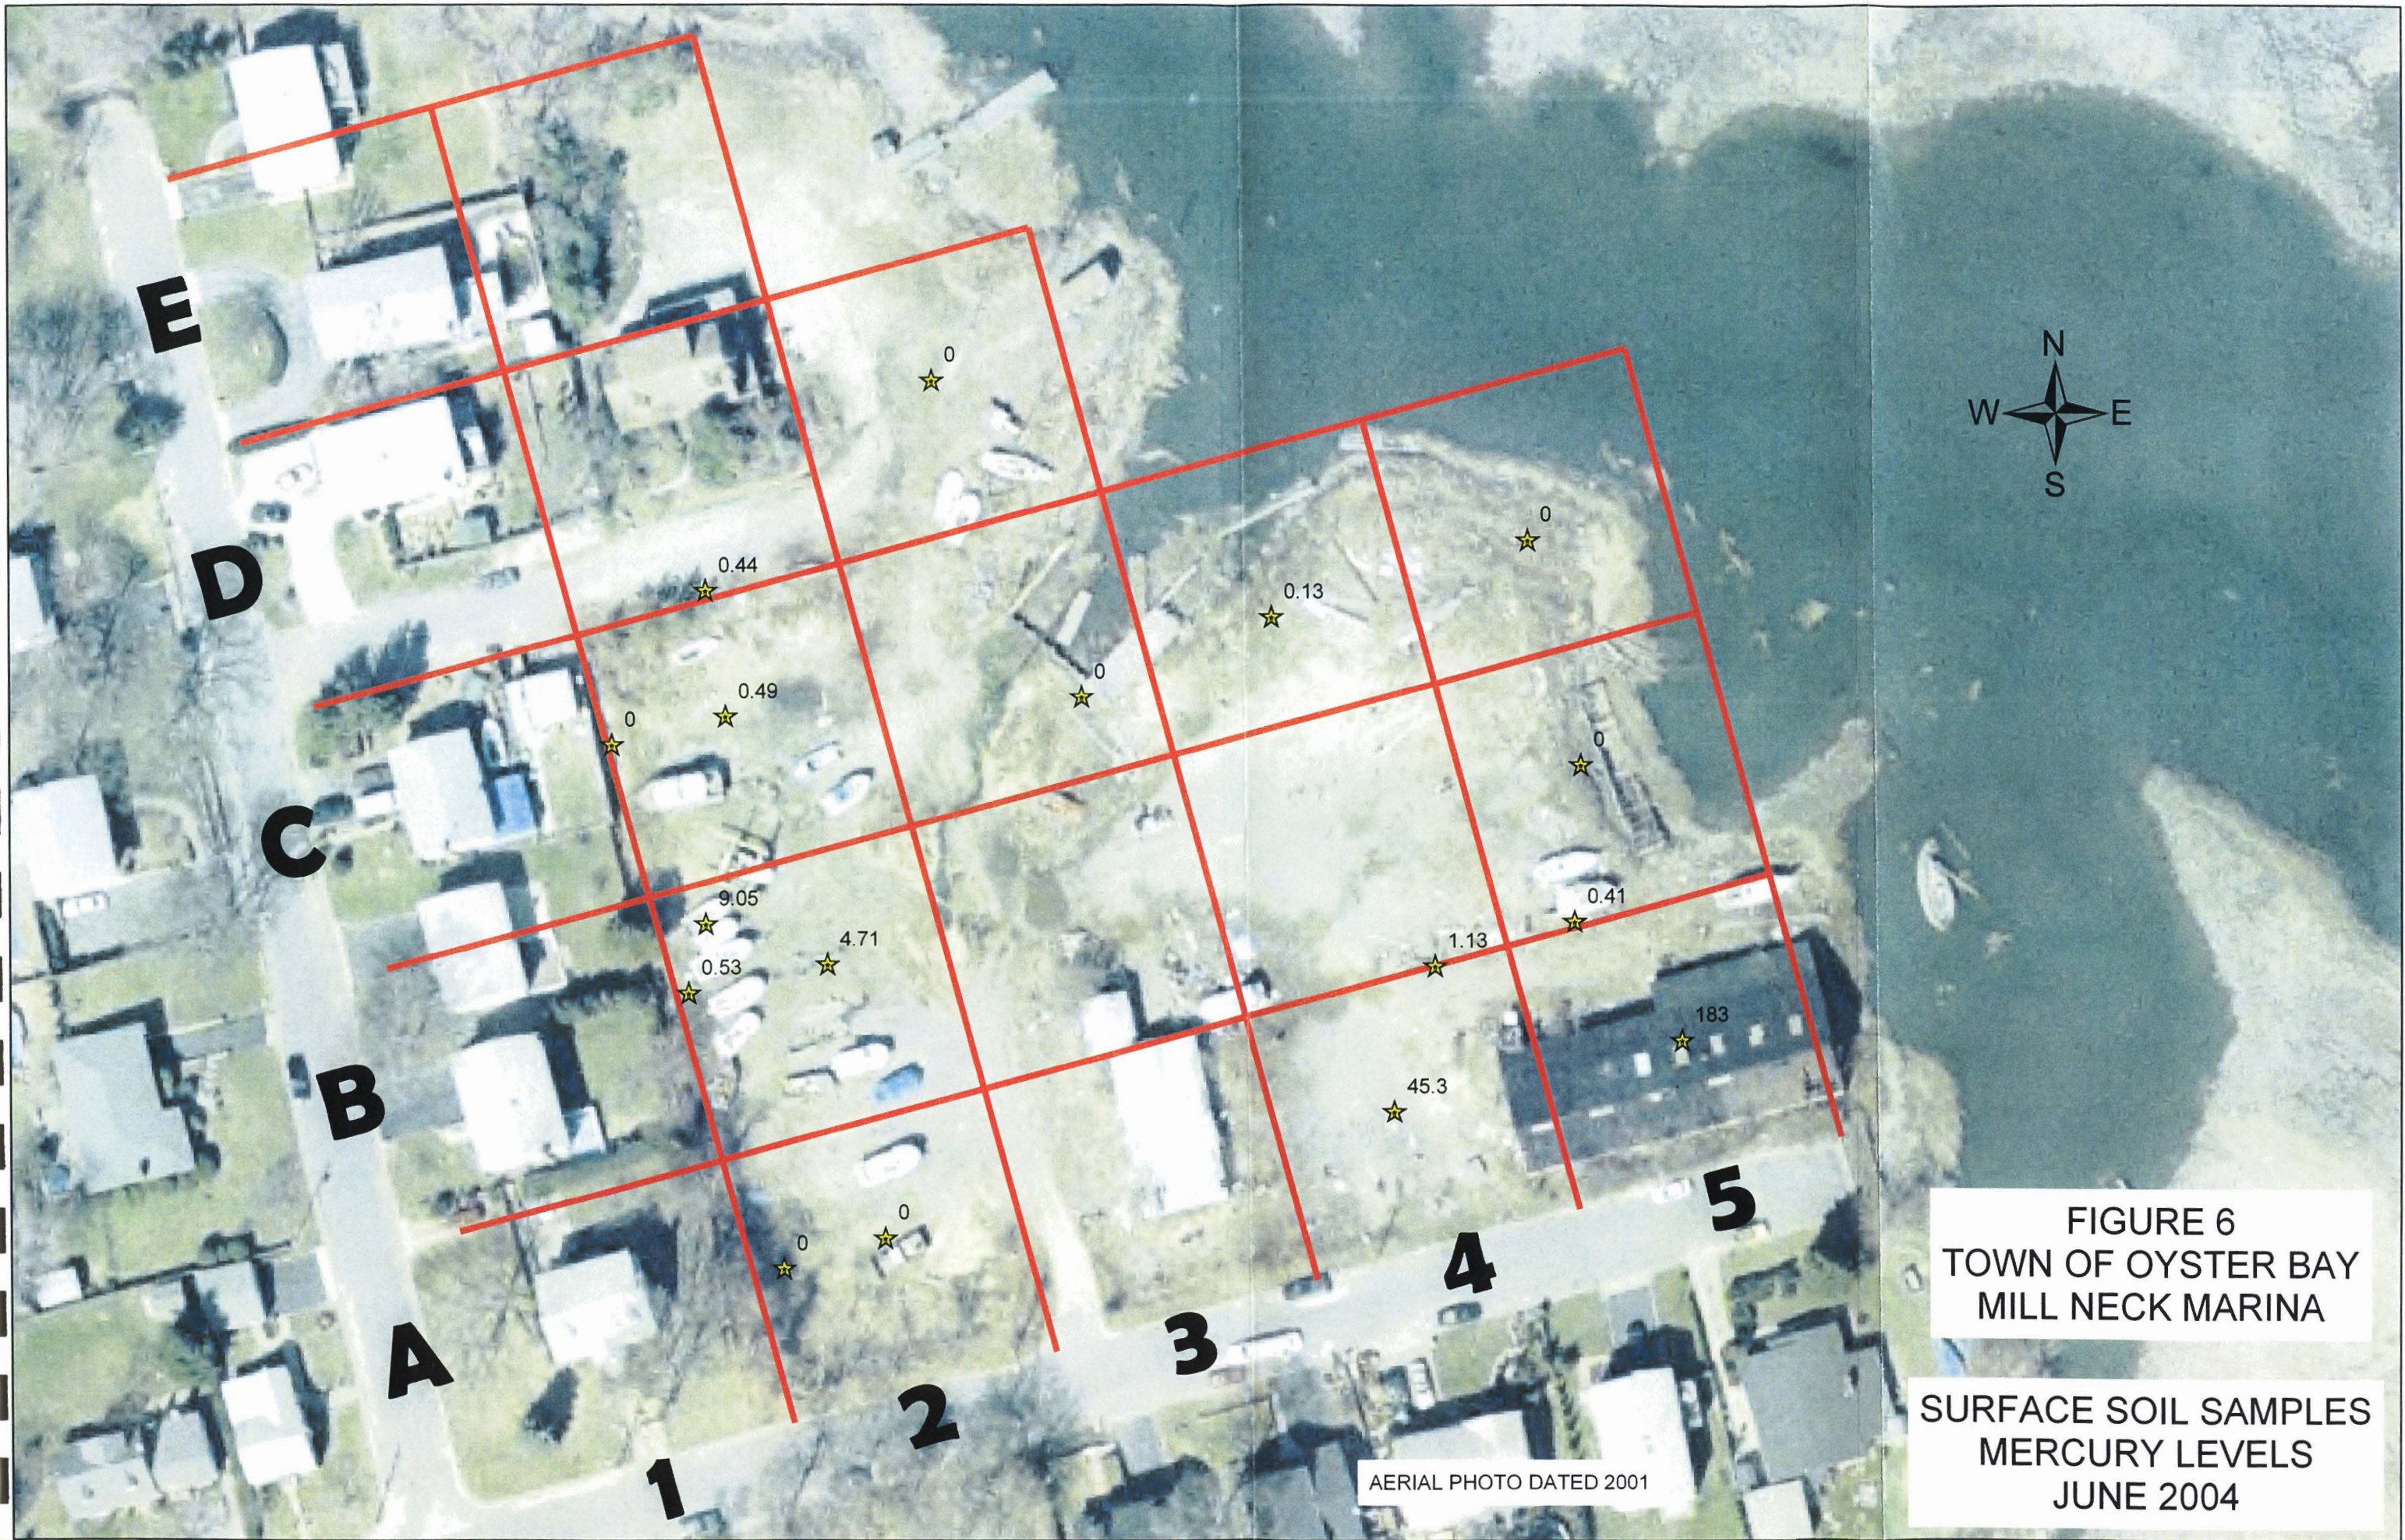
FIGURE 6
TOWN OF OYSTER BAY
MILL NECK MARINA

SURFACE SOIL SAMPLES
MERCURY LEVELS
JUNE 2004

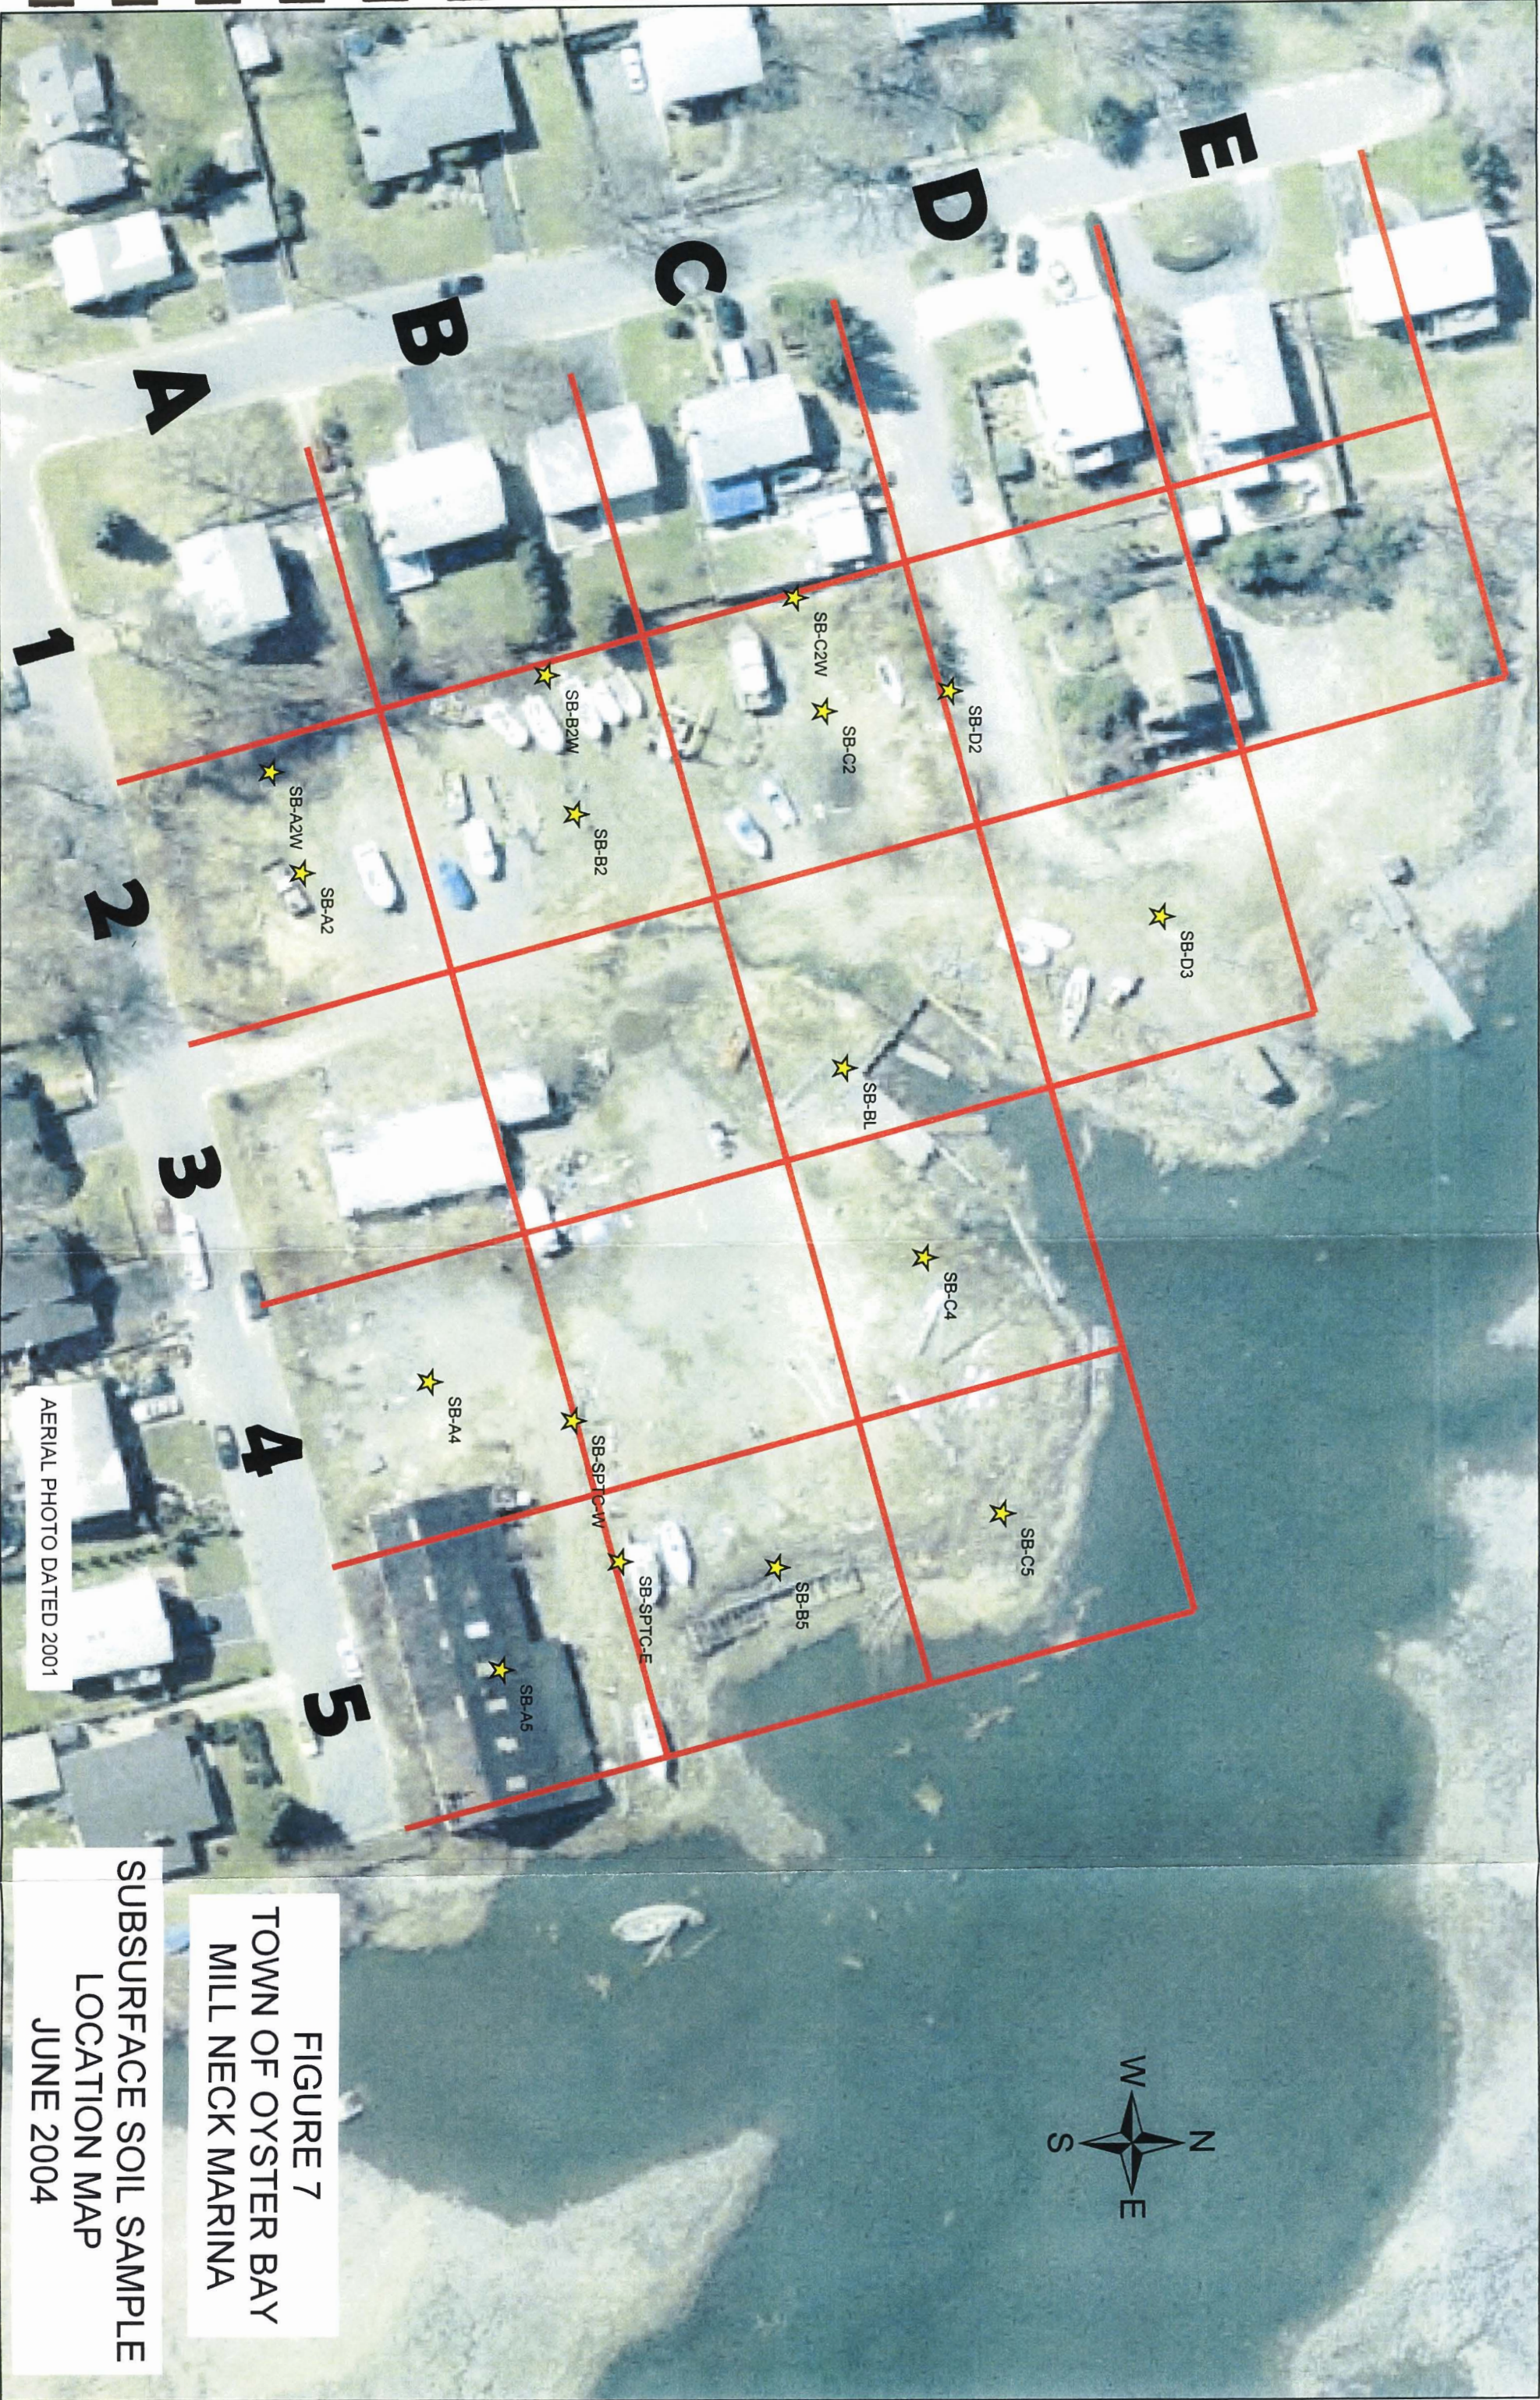
FIGURE 7
TOWN OF OYSTER BAY
MILL NECK MARINA

SUBSURFACE SOIL SAMPLE
LOCATION MAP
JUNE 2004

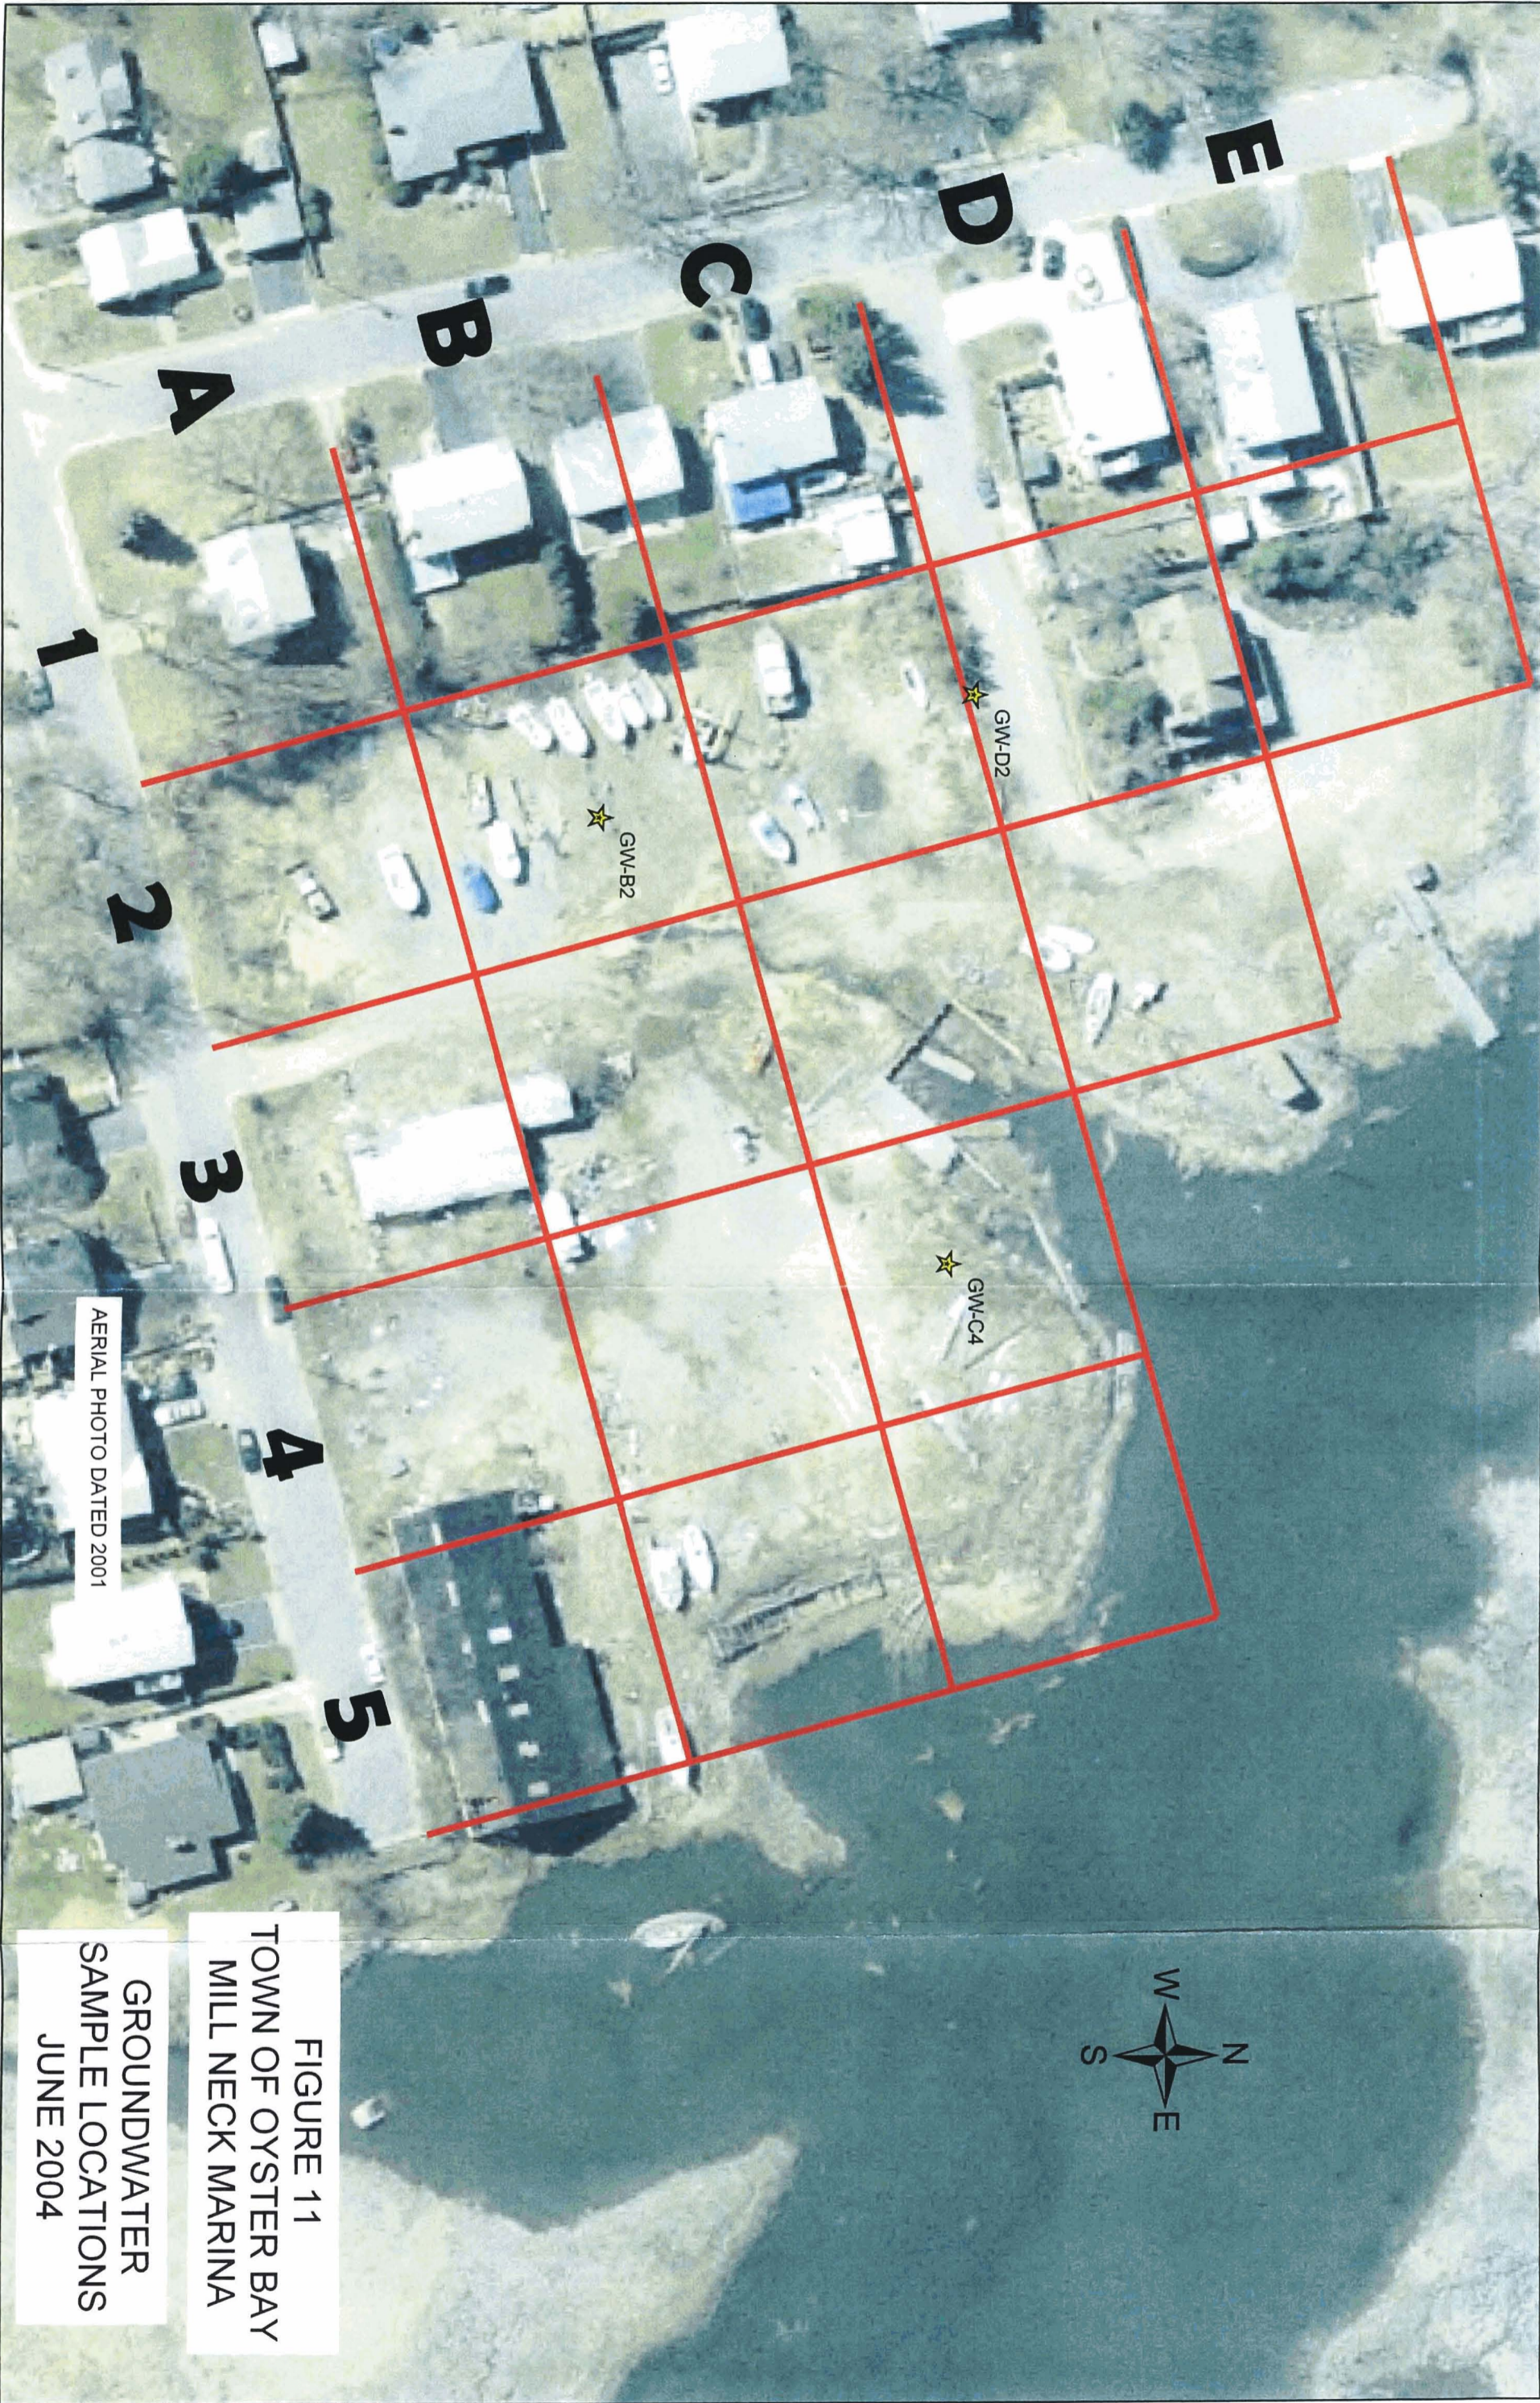
Groundwater samples were taken from the central grid points in grids B2 and D2, which were presumed to represent upgradient (ambient) water. An additional groundwater sample was collected from the approximate location of the septic system in grid A5. This location was based on previous interviews with the site owner. Based on the review of historical photographs, the location of the former building in grid A5 and the approximate location of previous boat lifting activities in grid C4 were also sampled for groundwater analysis. Figure 11 shows the locations of the groundwater samples.
