FORMER CHEZ VALET DRY CLEANERS

Final Engineering Report

NYSDEC Site Number: 1-30-169

This section will serve to document the as-built conditions of the Soil Vapor Extraction (SVE)/Sub Slab Depressurization System (SSD) installed underneath the floor slab structures located at 1–3 Manorhaven Blvd., Port Washington, NY (the "Site").

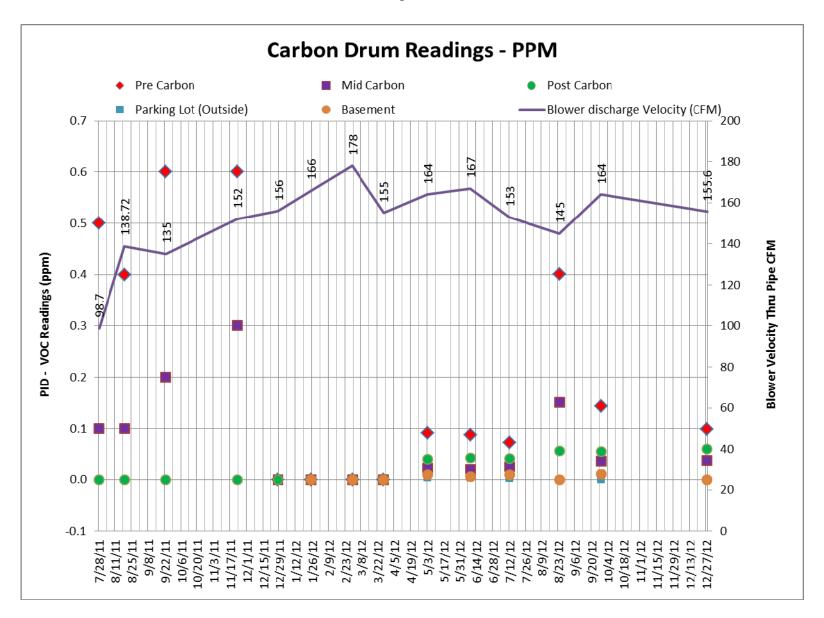
Figure 6

diamonds). This incoming airstream represents the conditions of the sub slab vapors at the Site. Through the 7/12/12 sampling event, the inlet soil vapors had steadily declined to the point where a more sensitive PID was utilized that is capable of reading ppb levels of VOCs. However, at the 8/23/12 reading the PID reading had climbed back up to 0.4 ppm. This higher number correlates closely to the placement of new asphalt around and up to the perimeter of the building. We suspect that the VOCs from this paving effort caused the increase in the measurements obtained by our field screening PID and anticipate that a more accurate vapor analysis targeted for PCE specifically will show that those target concentrations have continued to decrease. It should be noted that the PID readings have again dropped dramatically by our 12/28/12 reading.

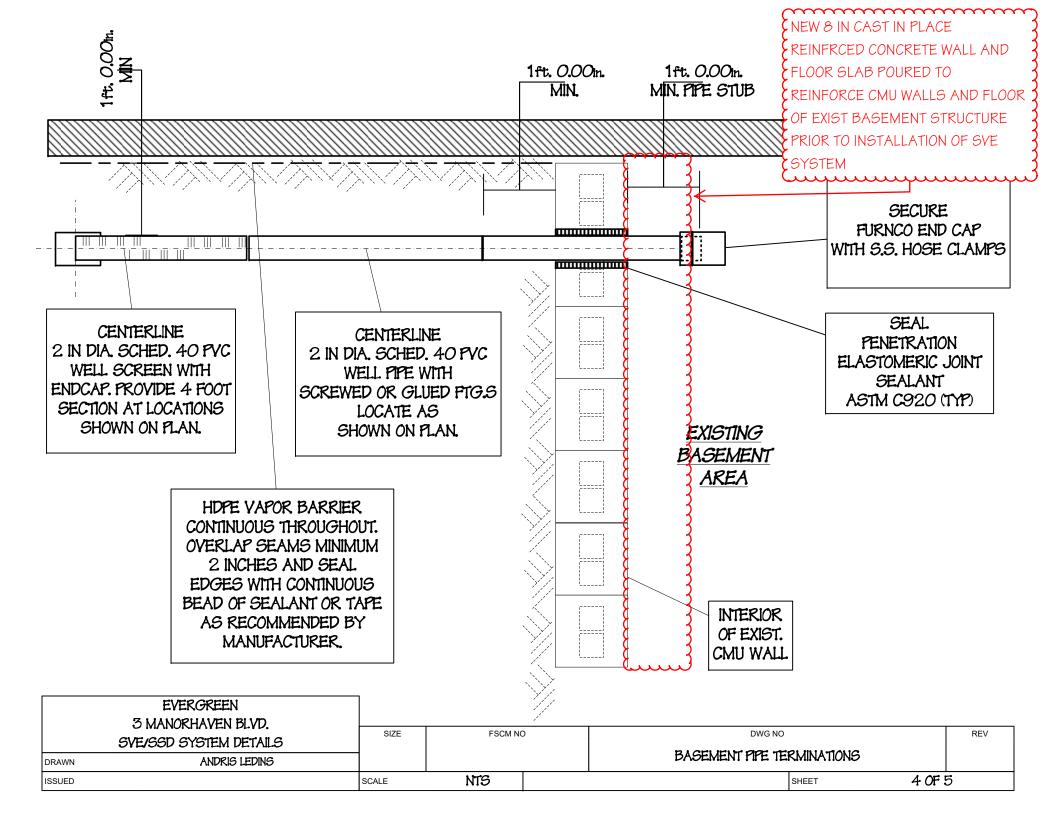
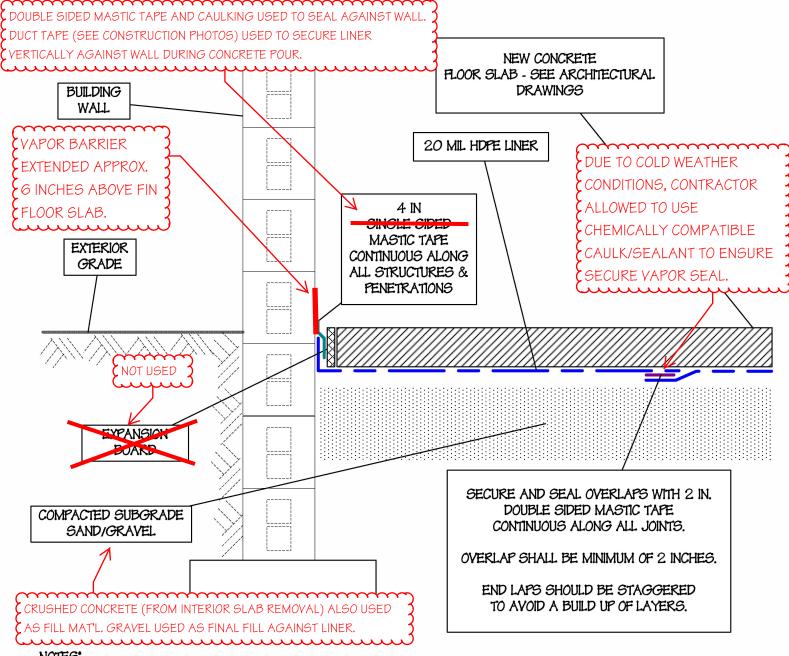
NEW SLAB INSTALLATION

- A 20 MIL HDPE LINER WILL BE USED AS A VAPOR BARRIER BETWEEN THE PERFORATED PIPES AND THE BOTTOM OF THE FOUNDATION FLOOR.
- EARTH AND STONE SUBSTRATES SHALL BE WELL COMPACTED TO PRODUCE AN EVEN. SOLID SUBSTRATE. REMOVE LOOSE AGGREGATE OR SHARP PROTRUSIONS. CONCRETE SUBSTRATES SHALL BE SMOOTH OR BROOM FINISHED AND MONOLITHIC. REMOVE STANDING WATER PRIOR TO MEMBRANE APPLICATIONS.

- INSTALLATION SHALL BE IN ACCORDANCE WITH MANUFACTURER'S INSTRUCTIONS.
- THE HDPE LINER WILL BE LAID DOWN IN 20 FT X 50 FT SECTIONS.
- TWO INCH DOUBLE-SIDED BUTYL MASTIC TAPE PROVIDED BY THE LINER MANUFACTURER WILL BE UTILIZED TO ATTACH THE SECTIONS OF VAPOR BARRIER TO EACH OTHER AND TO THE FOUNDATION WALL FOOTINGS.

- A LAYER OF FOUR INCH SINGLE-SIDED MASTIC TAPE WILL BE PLACED OVER THE SEAMS BETWEEN SECTIONS OF HDPE LINER AND ALONG THE FOUNDATION FOOTINGS.
- A SAMPLE OF THE LINER MATERIAL WILL BE PROVIDED ALONG WITH THE DESIGN PLANS FOR THE SUB-SLAB DEPRESSURIZATION SYSTEM.

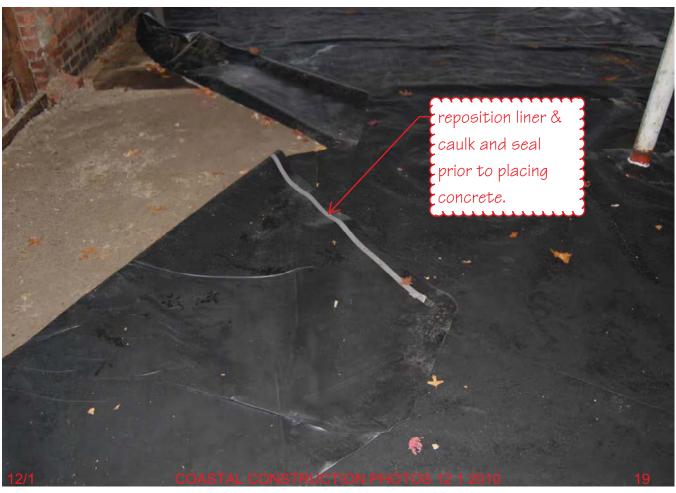
reposition liner,
and caulk and seal
prior to placing
concrete

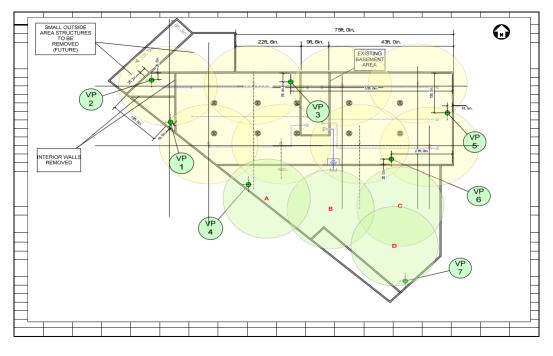
Avg Vacume @ VP (in H ₂ O)	-0.054	-0.055	-0.305	-0.039	-0.083	-0.062	-0.052	-0.060	-0.063	-0.068	-0.040	-0.055	-0.063	-0.092	-0.126	-0.050	-0.054	-0.047

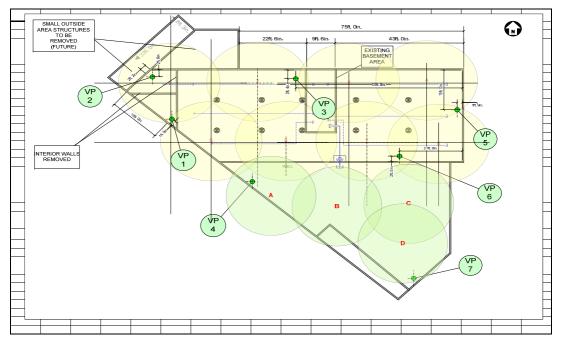
2	-0.107	-0.083	-0.343	-0.046	-0.093	-0.092	-0.048	-0.082	-0.084	-0.086	-0.048	-0.066	-0.083	-0.082	-0.124	-0.078	-0.062	-0.066	-0.069	
3	-0.058	-0.051	-0.453	-0.065	-0.073	-0.079	-0.077	-0.087	-0.078	-0.070	-0.043	-0.061	-0.066	-0.068	-0.047	-0.074	-0.073	-0.072	-0.070	
Avg Vacume @ VP (in H ₂ O)	-0.054	-0.055	-0.305	-0.039	-0.083	-0.062	-0.052	-0.060	-0.063	-0.068	-0.040	-0.055	-0.063	-0.092	-0.126	-0.050	-0.054	-0.047	-0.053

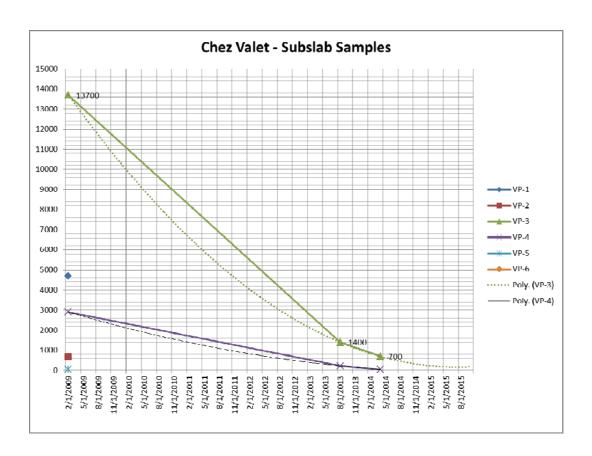
The site's , most recent (April 2014), highest recorded subslab vapor concentration is 700 $\mu g/m^3$ which is not far from the 100 $\mu g/m^3$ target value. For this reason the engineer recommended to continue operating the SVE/SSD through the 2014/2015 winter heating season, in an effort to further reduce the sub slab vapor concentrations. The basis for this recommendation is further represented in the following graph.
