# **PHASE I ENVIRONMENTAL ASSESSMENT**

*Esselte-Pendaflex Company, Inc.  
71 Clinton Road  
Garden City, New York 11530*

*September 1995*

**Norfolk Environmental  
1583 Post Road  
Fairfield, Connecticut 06430  
(203)259-7722**

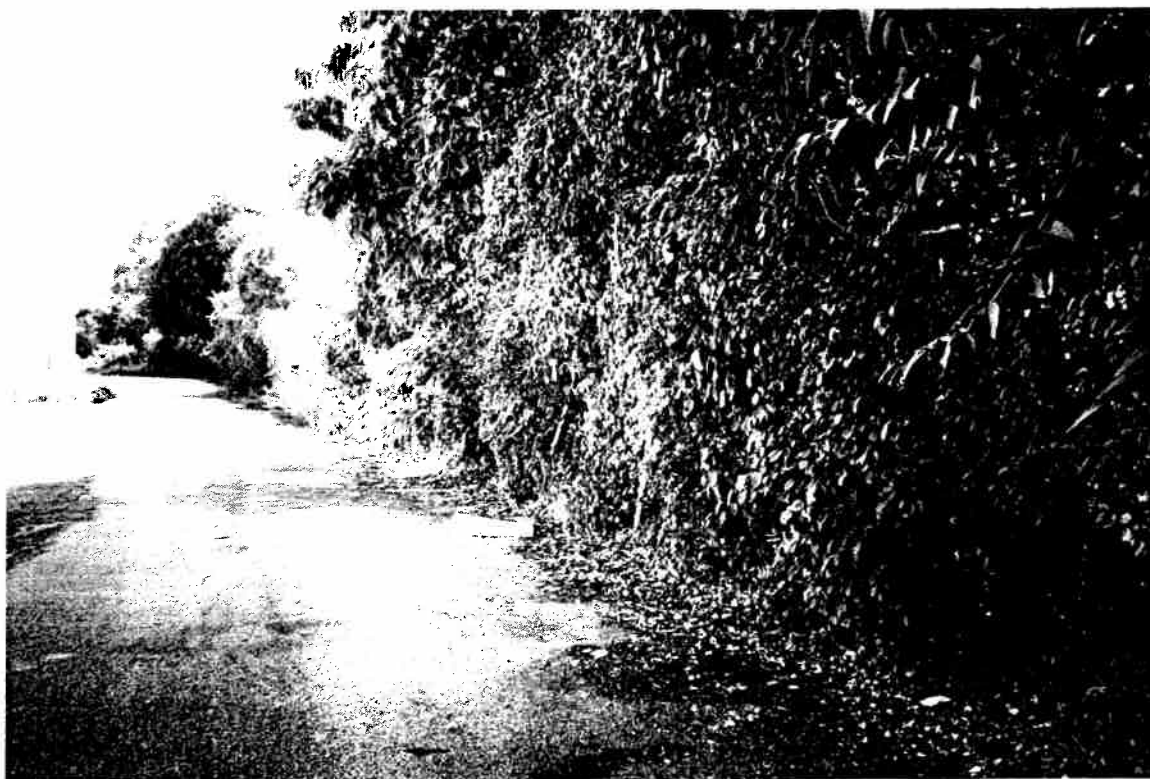
Area of 1986 drum clean up along southern property line.

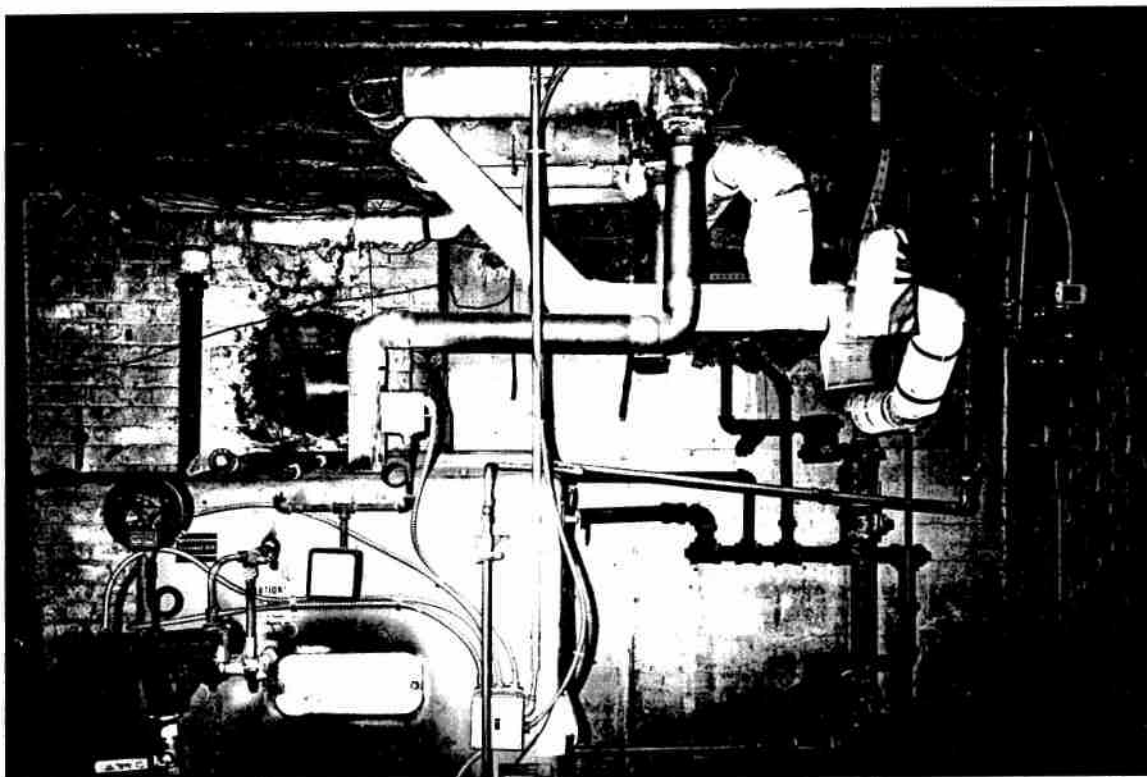
Asbestos-lined pipes and oil-fired burner in Bank of New York building.

According to Pendaflex representatives, some asbestos insulation was reportedly removed from pipes beneath the Bank of New York building during foundation repairs. No records of disposal of this material were available during this assessment. Asbestos pipe insulation still remains on steam conveyances in the basement of this building as well.

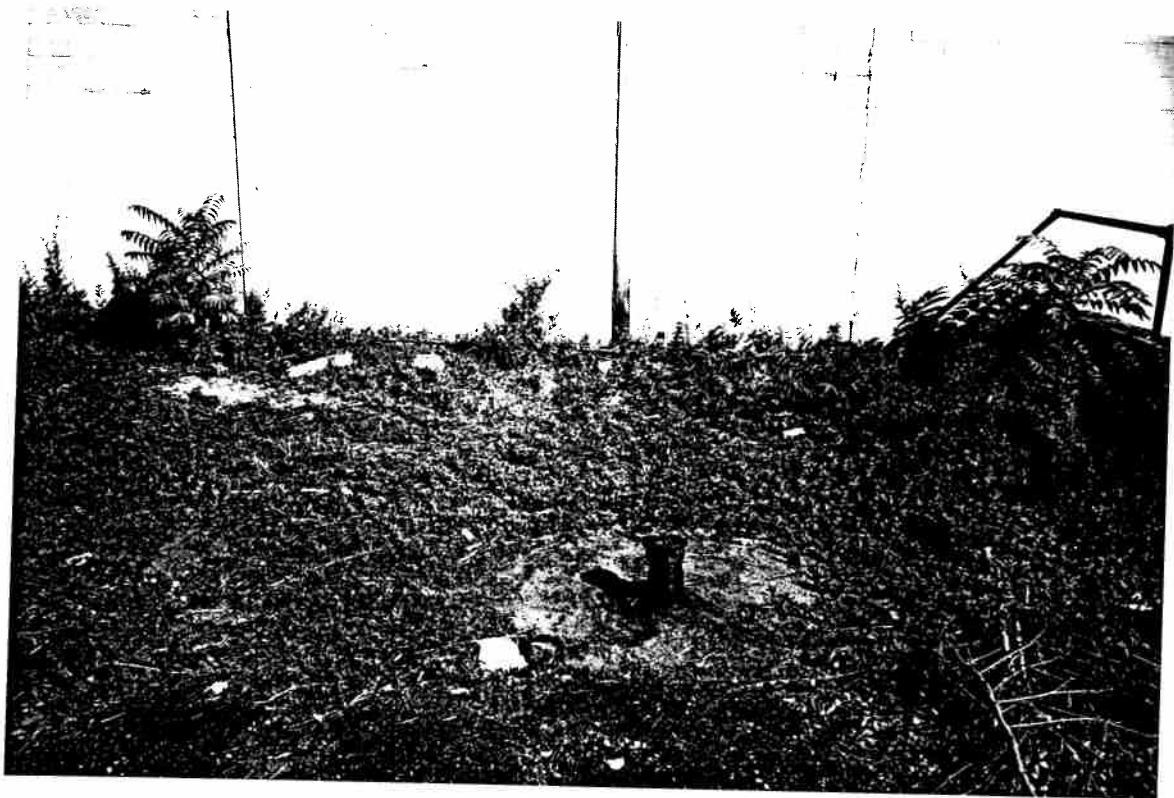
Fill pipe for 20,000 gallon fuel oil tank south of Building 10.

1. One 20,000 gallon underground storage tank is currently in service at the facility for fuel oil storage. This tank is located south of Building 10 near the former septic system, and was installed in approximately 1982. The condition of the former tank is unknown. The tank is registered with the Nassau County Department of Health and is integrity tested once each year. The tank is scheduled to be tested again in September 1995.
2. A 3,000 gallon underground fuel oil tank was removed from the Bank of New York building in approximately 1991 when the building was converted to gas

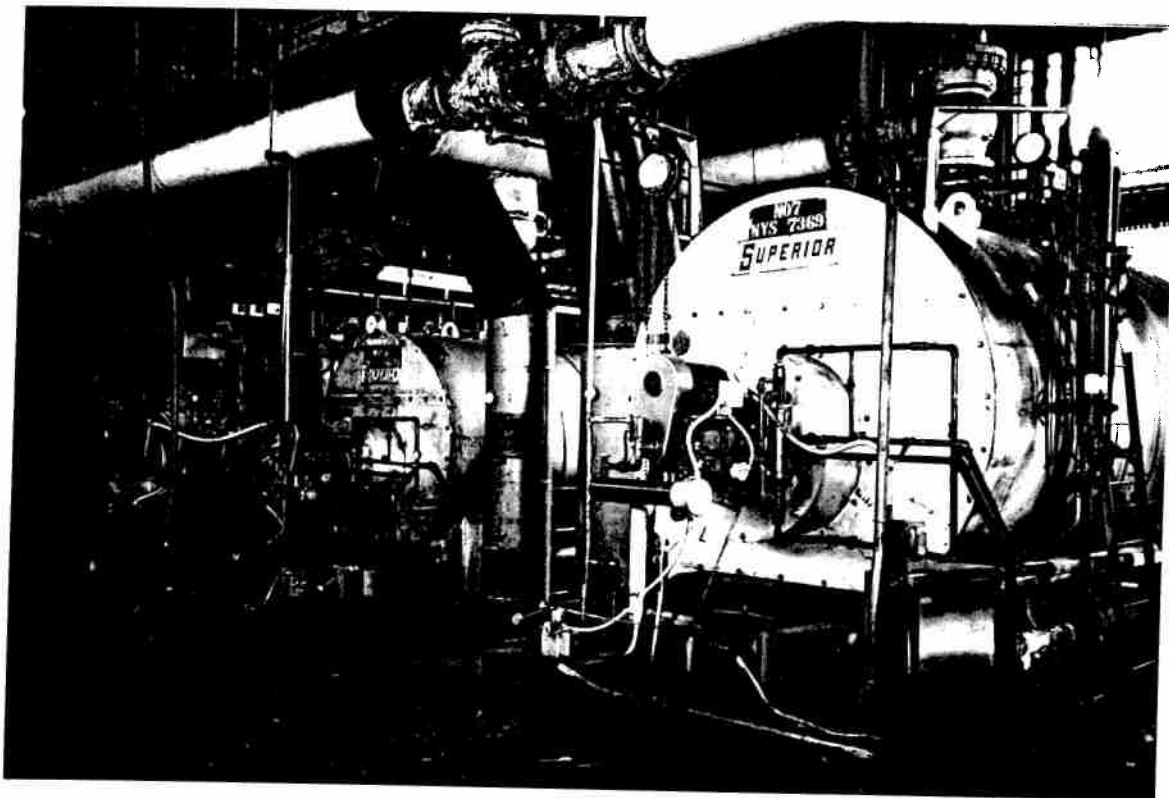
Three Superior boilers in Building 7.

The subject property has three (3) oil-fired furnaces located in Building 7 used for heating purposes. These boilers have a capacity of 6.3, 11.9, and 16.0 million BTU, respectively, and have been issued Certificates to Operate from the Nassau County Department of Health and NYSDEC. No other processes producing air emissions were observed at the subject property.

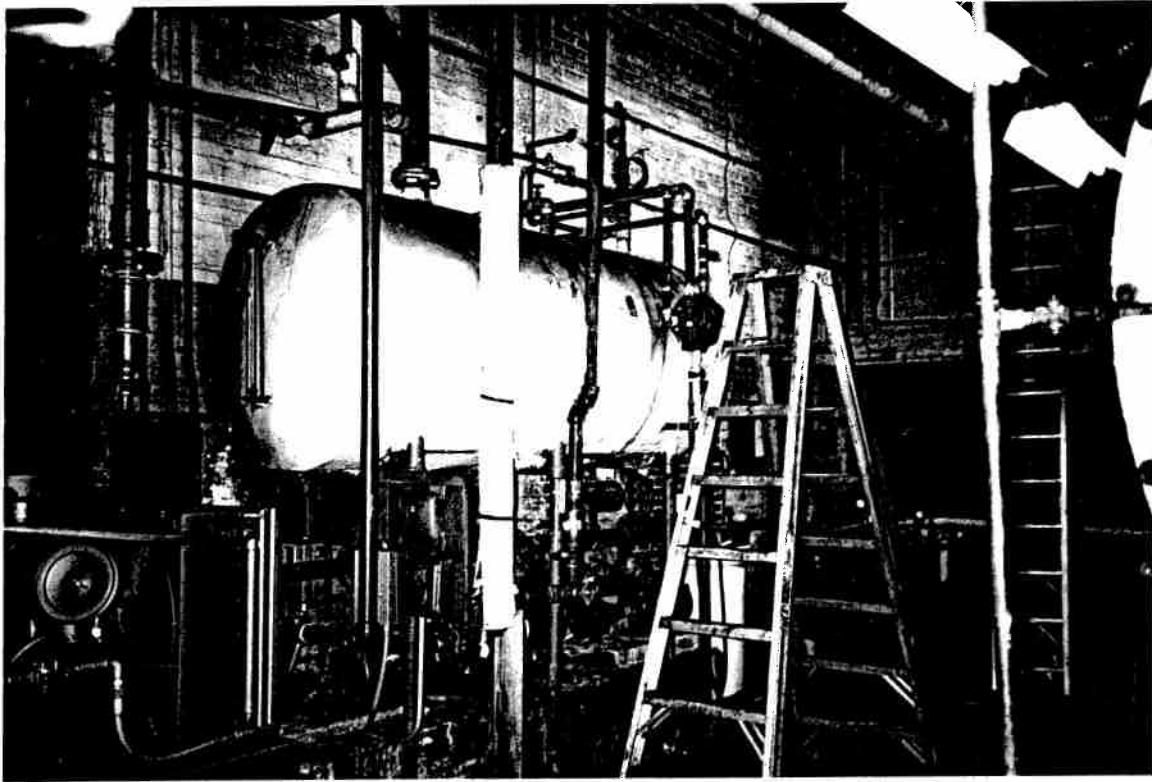
Asbestos-lined hot water tank and piping in Building 7.

Asbestos-containing insulation is present on the hot water tank and condensate return tank in Building 7. In addition, steam conveyances throughout the facility are lined with asbestos-lined aircell insulation. Many portions of this insulation is in a friable condition.

Asbestos-containing insulating material is present on the hot water tank and condensate return tank in Building 7. In addition, asbestos-lined air cell insulation is present on steam conveyances throughout all buildings on the subject property. This material is in friable condition in several places. Previous investigations at the

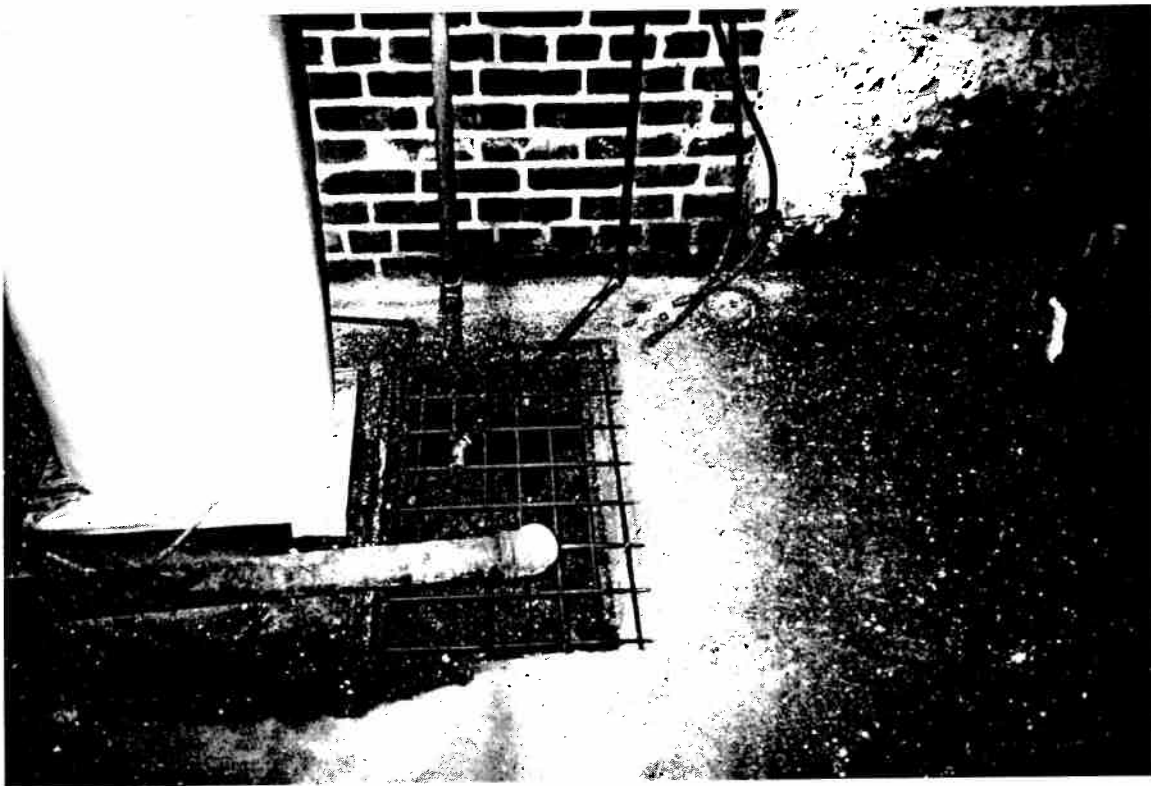
Floor drain in Building 7 that recieves compressor blowdown.

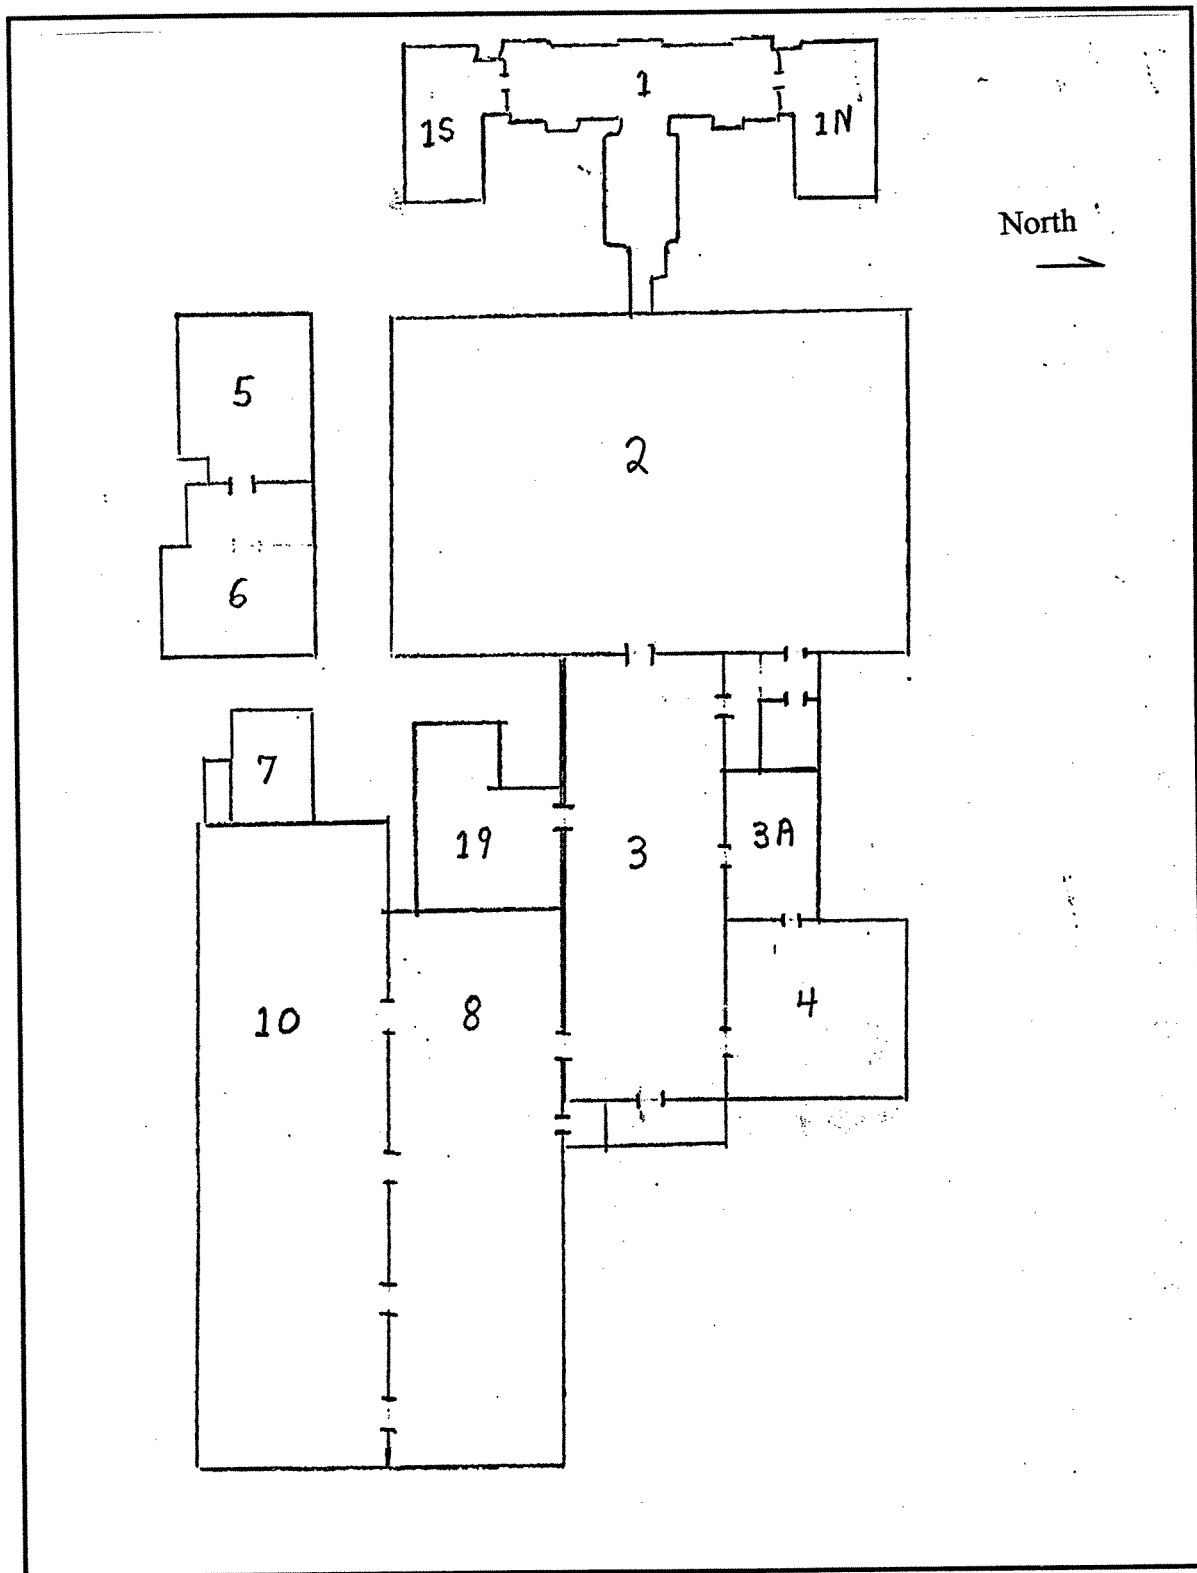
Figure 1:  
Site Plan  
Esselte-Pendaflex Corporation, Garden City, New York

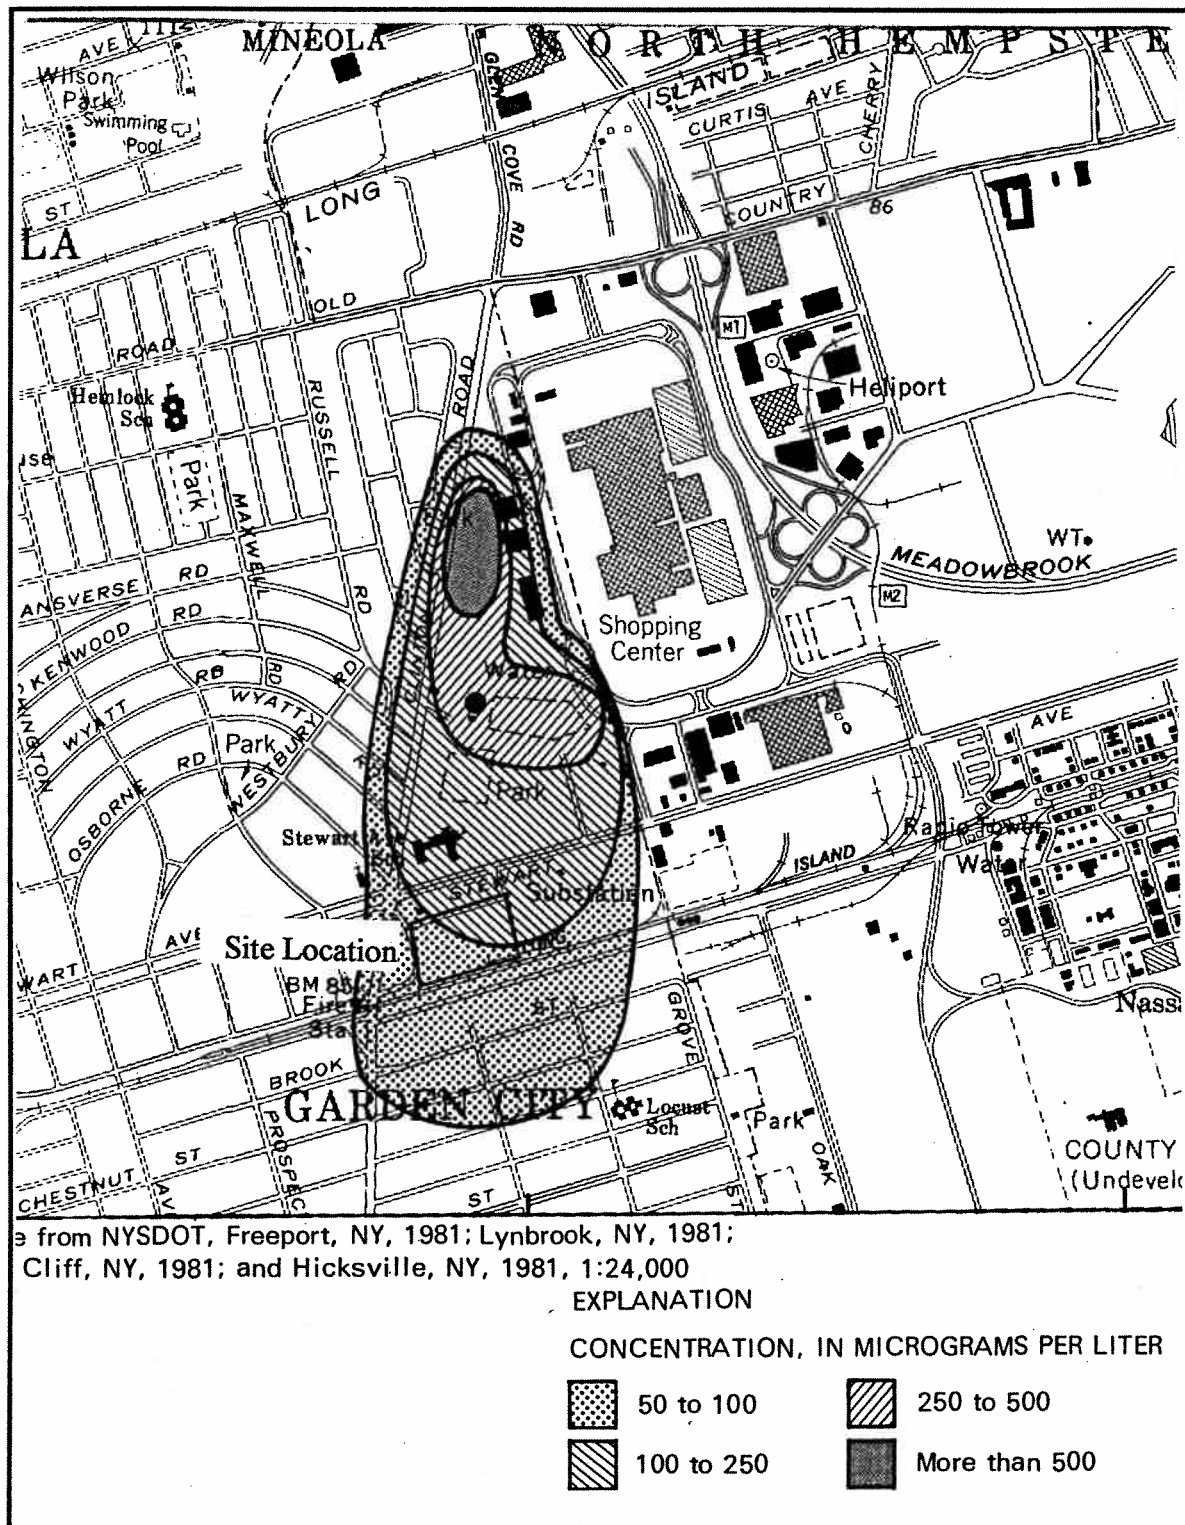
Figure 2:  
Trichloroethylene concentrations in the Upper Glacial Aquifer, 1984. Adapted from *Chlorinated Organic Compounds in Groundwater at Roosevelt Field, Nassau County, Long Island, New York*. USGS, 1989.

According to information provided by the United States Geological Survey (USGS), trichloroethylene (TCE), 1,2-dichloroethylene (DCE), and tetrachloroethylene (PCE) have been detected in groundwater in the area of Roosevelt Field near Garden City. This site is a New York State inactive hazardous waste site, referred to as the Old Roosevelt Field Aircraft Hangar. The 200 acre Roosevelt Field was once an airfield and is now a large shopping mall and office building complex. One well screened 300 feet below land surface in the Magothy aquifer yielded 38,000 ppm of trichloroethylene, the principal contaminant.

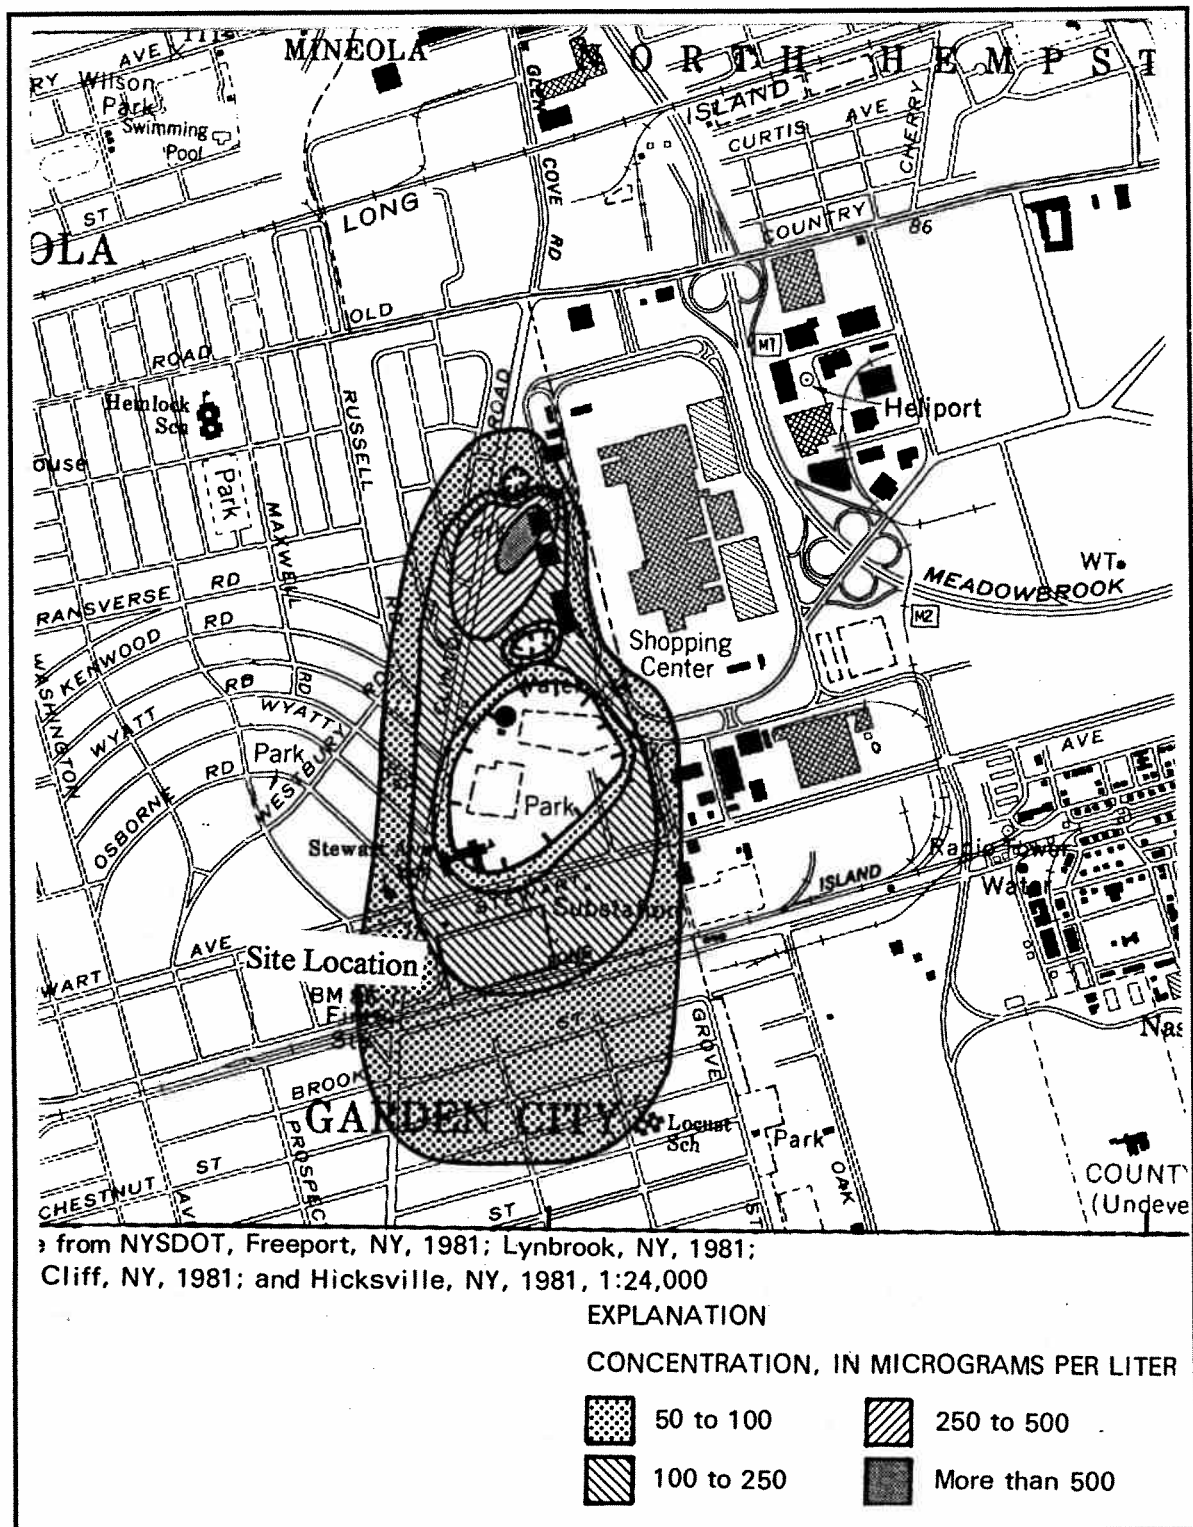
Figure 3:  
Trichloroethylene concentrations in the Magothy Aquifer, 1984. Adapted from *Chlorinated Organic Compounds in Groundwater at Roosevelt Field, Nassau County, Long Island, New York*. USGS, 1989.
